Powder Valley School

Unio_sch10A

FEMA 154 Rapid Visual Screening Score Card

Rapid Visual Screening - Senate Bill #2 - Seismic Needs Assessment
Oregon Department of Geology and Mineral Industries

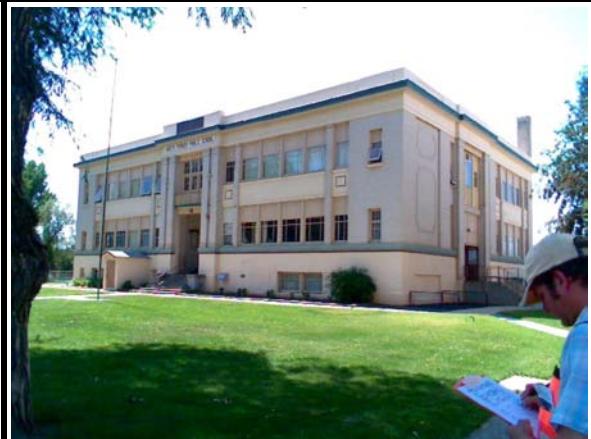
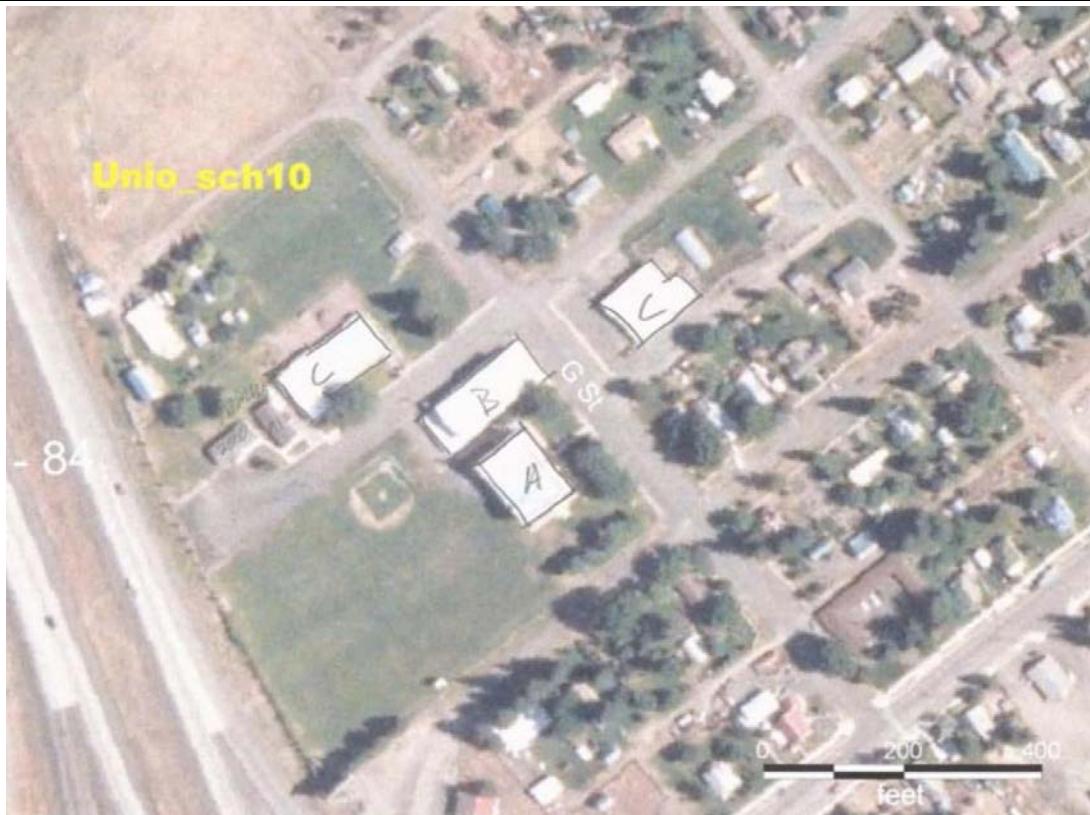
Type	Basic Score	Vert Irreg	Plan Irreg	Pre-Code	Post-Bench	Soil C	Soil D	Soil E	RVS Score
Primary	URM	3.4	-1.5	0	-0.4	0	0	-0.8	0	0.7
Secondary		0	0	0	0	0	0	0	0	0
Tertiary		0	0	0	0	0	0	0	0	0

Final Type	Final Score
URM	0.7

High (>10%)

Enrollment 211	Year Built (Field Verified) 1937	Year Built (Alt. Source) 1937	Est. Decade Built 1910
Total Area (square ft) 47764	Number of Stories 2	Basement	Pounding Potential No
Plan Irregularities None None None		Vertical Irregularities Steps in Elevation View: Single Change None None	
Falling Hazards Unreinforced Chimneys Parapets: Unreinforced Around Entire Building None		Poor Conditions None None None

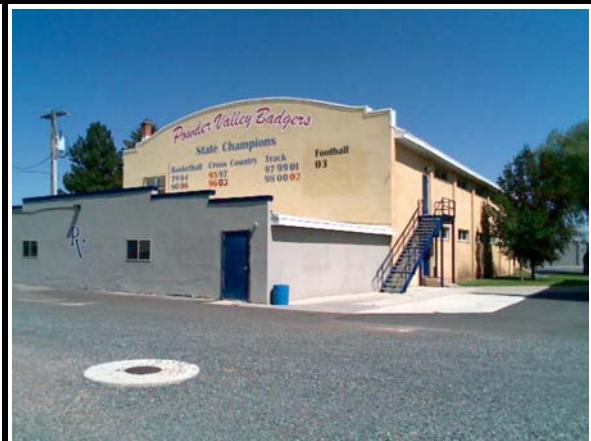
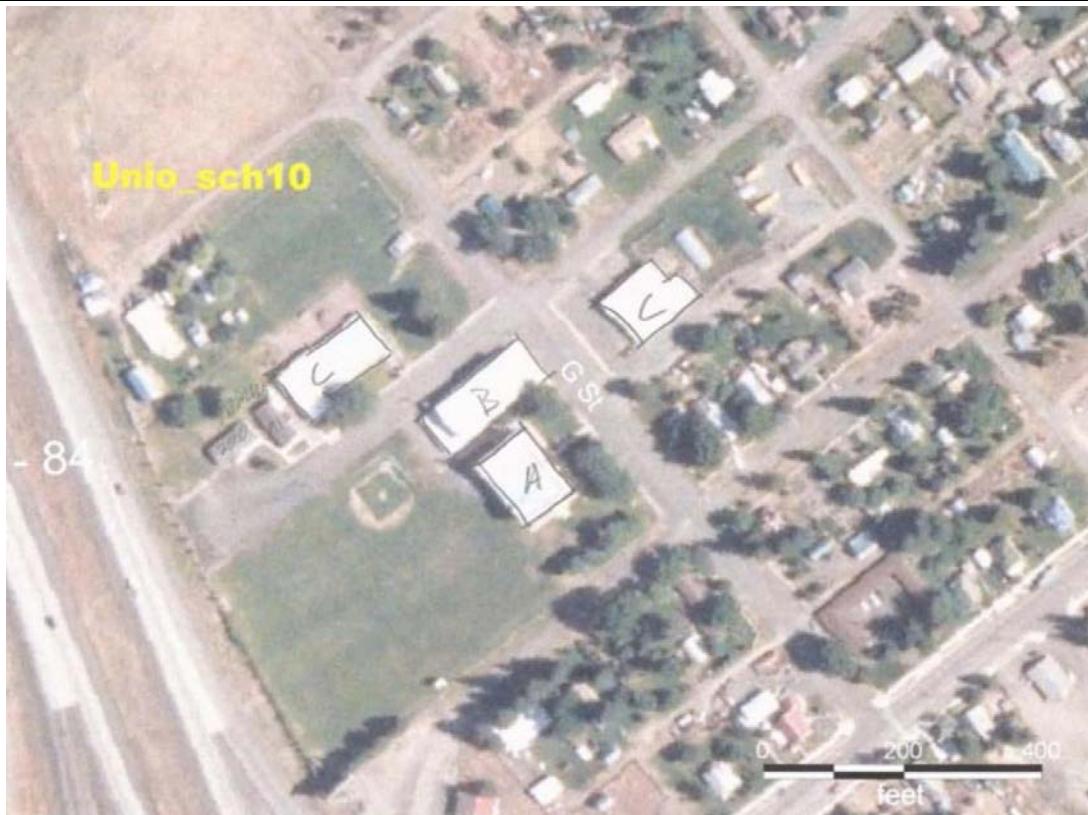
Unio_sch10B

Type	Basic Score	Vert Irreg	Plan Irreg	Pre-Code	Post-Bench	Soil C	Soil D	Soil E	RVS Score
Primary	W2	4.8	-3	0	-0.2	0	0	-1.2	0	0.4
Secondary	C2	3.6	-2	0	-0.4	0	0	-1.2	0	0
Tertiary		0	0	0	0	0	0	0	0	0

Final Type	Final Score
C2	0

Very High (100%)

Enrollment 211	Year Built (Field Verified) 1937	Year Built (Alt. Source) 1937	Est. Decade Built 1930
Total Area (square ft) 47764	Number of Stories 2	Basement	Pounding Potential No
Plan Irregularities None None None		Vertical Irregularities Steps in Elevation View: 2 to 3 Changes None None	
Falling Hazards None None None		Poor Conditions None None None

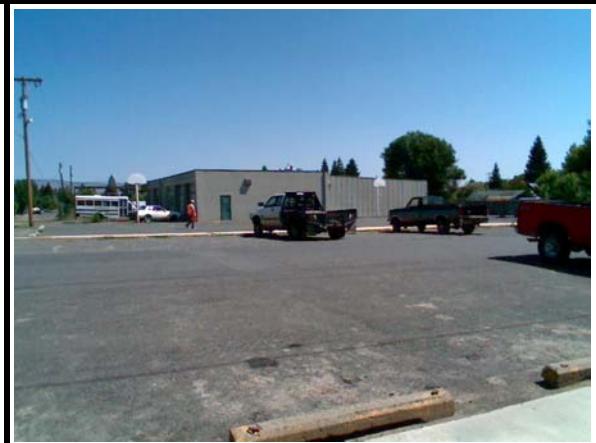
Unio_sch10C

Type	Basic Score	Vert Irreg	Plan Irreg	Pre-Code	Post-Bench	Soil C	Soil D	Soil E	RVS Score
Primary	RM1	3.6	-2	-0.5	0	0	0	-1.2	0	-0.1
Secondary	S3	3.8	0	-0.5	0	0	0	-1	0	2.3
Tertiary		0	0	0	0	0	0	0	0	0

Final Type	Final Score
RM1	-0.1

Very High (100%)

Enrollment 211	Year Built (Field Verified) 1955	Year Built (Alt. Source) 1937	Est. Decade Built 1950
Total Area (square ft) 47764	Number of Stories 1	Basement	Pounding Potential No
Plan Irregularities Torsion: Eccentric Stiffness None None		Vertical Irregularities Steps in Elevation View: 2 to 3 Changes None None	
Falling Hazards None None None		Poor Conditions None None None

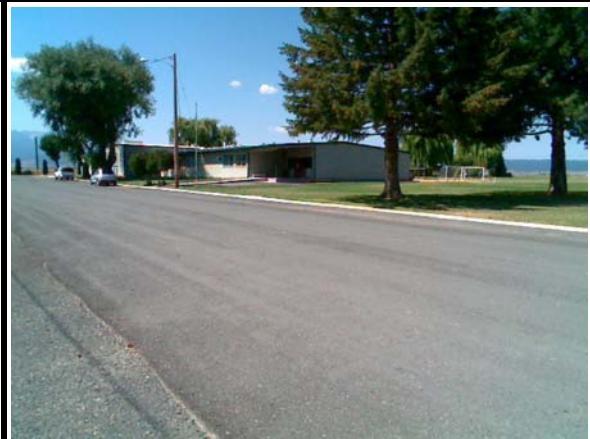
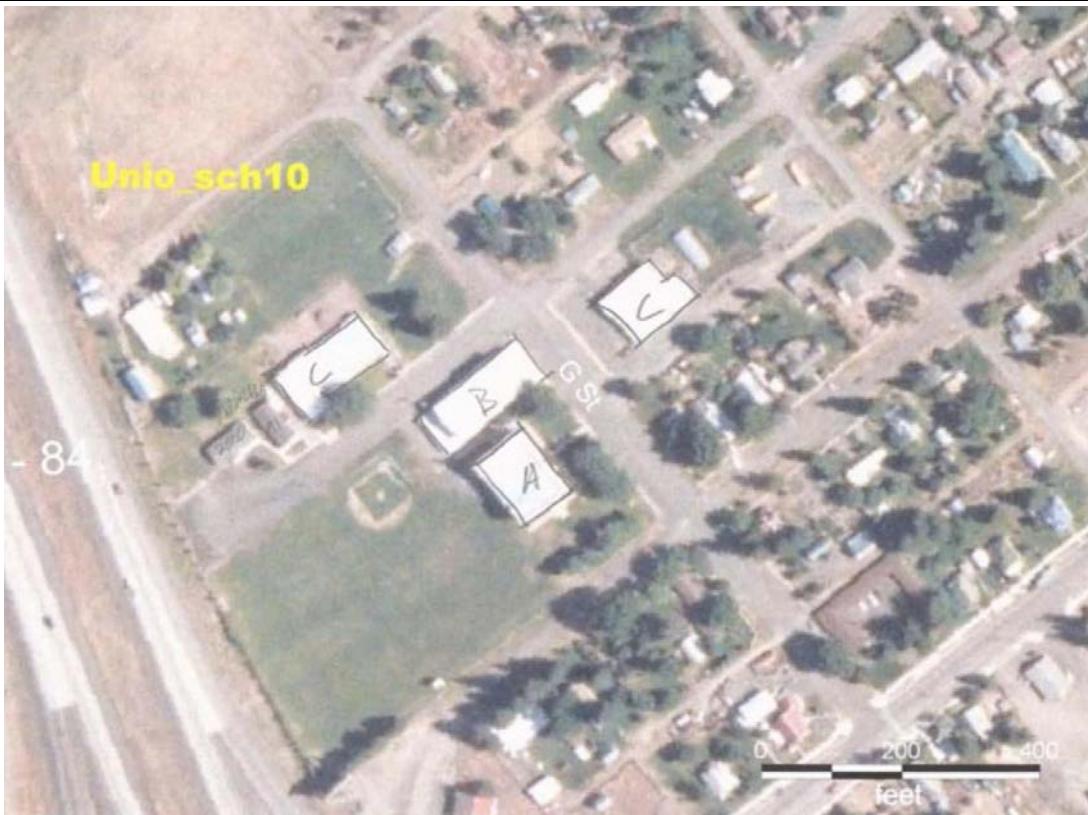
Unio_sch10D

Type	Basic Score	Vert Irreg	Plan Irreg	Pre-Code	Post-Bench	Soil C	Soil D	Soil E	RVS Score
Primary	W2	4.8	-3	-0.5	0	0	0	-1.2	0	0.1
Secondary		0	0	0	0	0	0	0	0	0
Tertiary		0	0	0	0	0	0	0	0	0

Final Type	Final Score
W2	0.1

High (>10%)

Enrollment 211	Year Built (Field Verified) 1937	Year Built (Alt. Source) 1937	Est. Decade Built 1960
Total Area (square ft) 47764	Number of Stories 1	Basement	Pounding Potential No
Plan Irregularities Reentrant Corners: T shaped None None		Vertical Irregularities Steps in Elevation View: Single Change None None	
Falling Hazards None None None		Poor Conditions None None None
