# Emergency Operations Center

Wallowa County

Wall\_eoc01A

Rapid Visual Screening - Senate Bill #2 - Seismic Needs Assessment  
Oregon Department of Geology and Mineral Industries

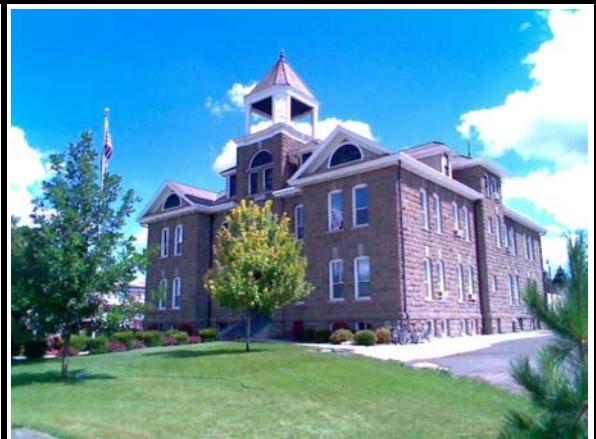
Type	Basic Score	Vert Irreg	Plan Irreg	Pre-Code	Post-Bench	Soil C	Soil D	Soil E	RVS Score
Primary	URM	3.4	-1.5	-0.5	-0.4	0	0	-0.8	0	0.2
Secondary		0	0	0	0	0	0	0	0	0
Tertiary		0	0	0	0	0	0	0	0	0

Final Type	Final Score
URM	0.2

High (>10%)

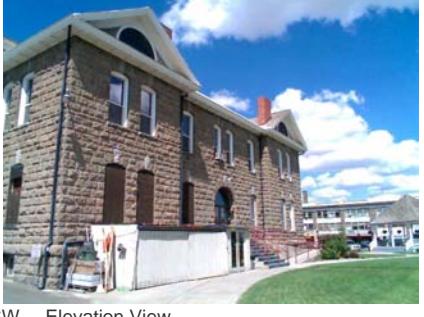
SW Elevation View

Enrollment	Year Built (Field Verified)	Year Built (Alt. Source)	Est. Decade Built
	1909	1909	1900
Total Area (square ft)	Number of Stories	Basement	Pounding Potential
	2	Yes	No
Plan Irregularities		Vertical Irregularities	
Reentrant Corners: Other		Steps in Elevation View: 2 to 3 Changes	
None		None	
None		None	
Falling Hazards		Poor Conditions	
None		None	
None		None	
None		None
