Wallowa FD

Building Type		County	
Fire - RFPD		Wallowa	
Street			
104 N Pine St			
City	State	Zip	
Wallowa	OR	97885	
Latitude	Longitude		
45.5708	117.52843		
Tracking Code	Inspection Date		
RVS in 2006	8/14/2006

FEMA 154 Rapid Visual Screening Score Card

Rapid Visual Screening - Senate Bill #2 - Seismic Needs Assessment
Oregon Department of Geology and Mineral Industries

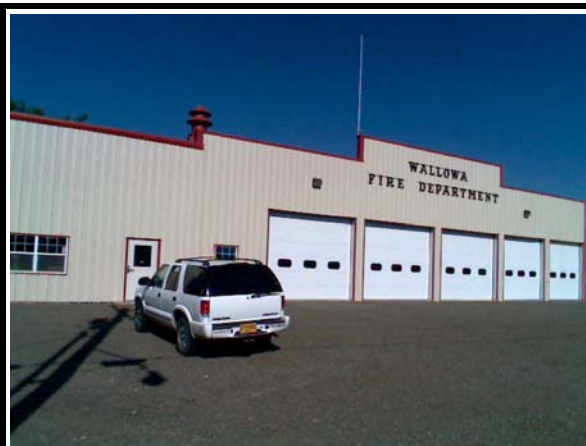
Seismicity Zone: Moderate

Type	Basic Score	Vert Irreg	Plan Irreg	Pre-Code	Post-Bench	Soil C	Soil D	Soil E	RVS Score
Primary	S3	3.8	0	-0.5	0	0	0	-1	0	2.3
Secondary		0	0	0	0	0	0	0	0	0
Tertiary		0	0	0	0	0	0	0	0	0

2.3

Low (<1%)

Plan Irregularities	Vertical Irregularities
Torsion: Eccentric Stiffness	None
None	None
None	None

Falling Hazards	Poor Conditions
None	None
None	None
None	None
