Rock Creek - Building 5

FEMA 154 Rapid Visual Screening Score Card

Rapid Visual Screening - Senate Bill #2 - Seismic Needs Assessment
Oregon Department of Geology and Mineral Industries

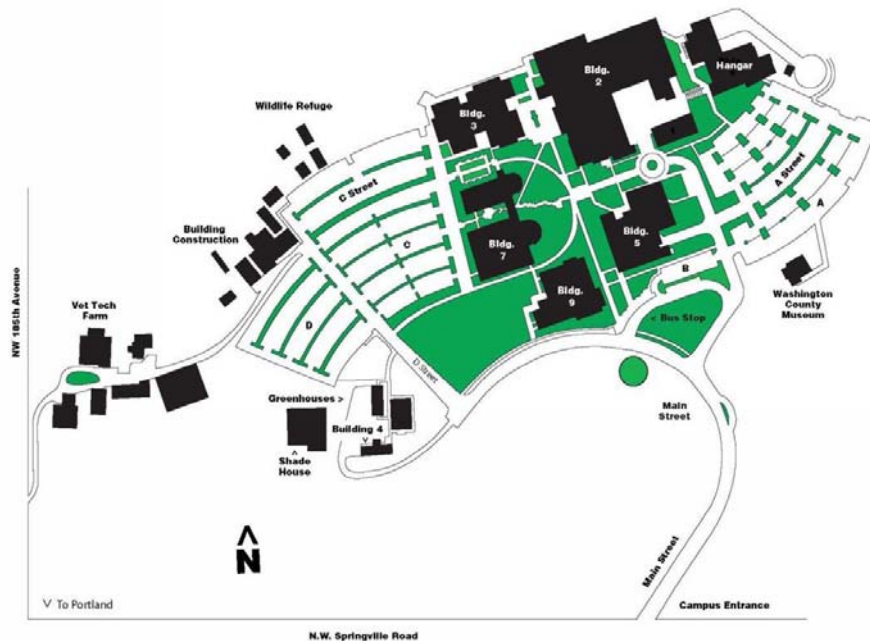
Rock Creek - Building 5

Type	Basic Score	Vert Irreg	Plan Irreg	Pre-Code	Post-Bench	Soil C	Soil D	Soil E	RVS Score
Primary	RM1	2.8	-1	-0.5	0	0	-0.4	0	0	0.9
Secondary	C2	2.8	-1	-0.5	0	0	-0.4	0	0	0.9
Tertiary		0	0	0	0	0	0	0	0	0

RM1

0.9

FEMA-154 Collapse Potential

High (>10%)

Plan Irregularities	Vertical Irregularities
Yes: Unknown	Yes: Unknown

Falling Hazards	Poor Conditions
None	
None	
None
