King City Police Dept

Wash_pol12A

FEMA 154 Rapid Visual Screening Score Card

Rapid Visual Screening - Senate Bill #2 - Seismic Needs Assessment
Oregon Department of Geology and Mineral Industries

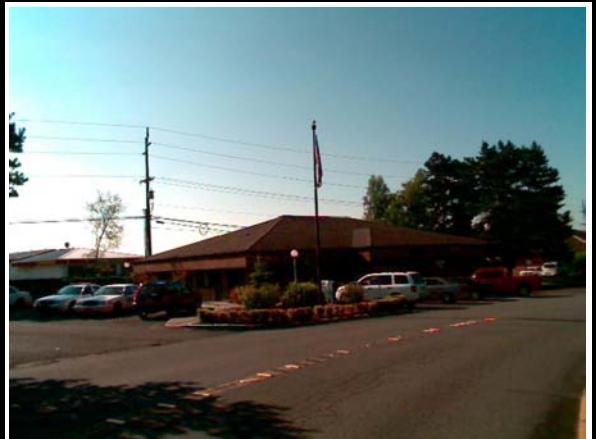
Building Type Police - City	County Washington	
Street 15300 Sw 116th Ave		
City King City	State OR	Zip 97224
Latitude 45.40894	Longitude 122.7951	
Tracking Code RVS in 2006	Inspection Date 7/3/2006

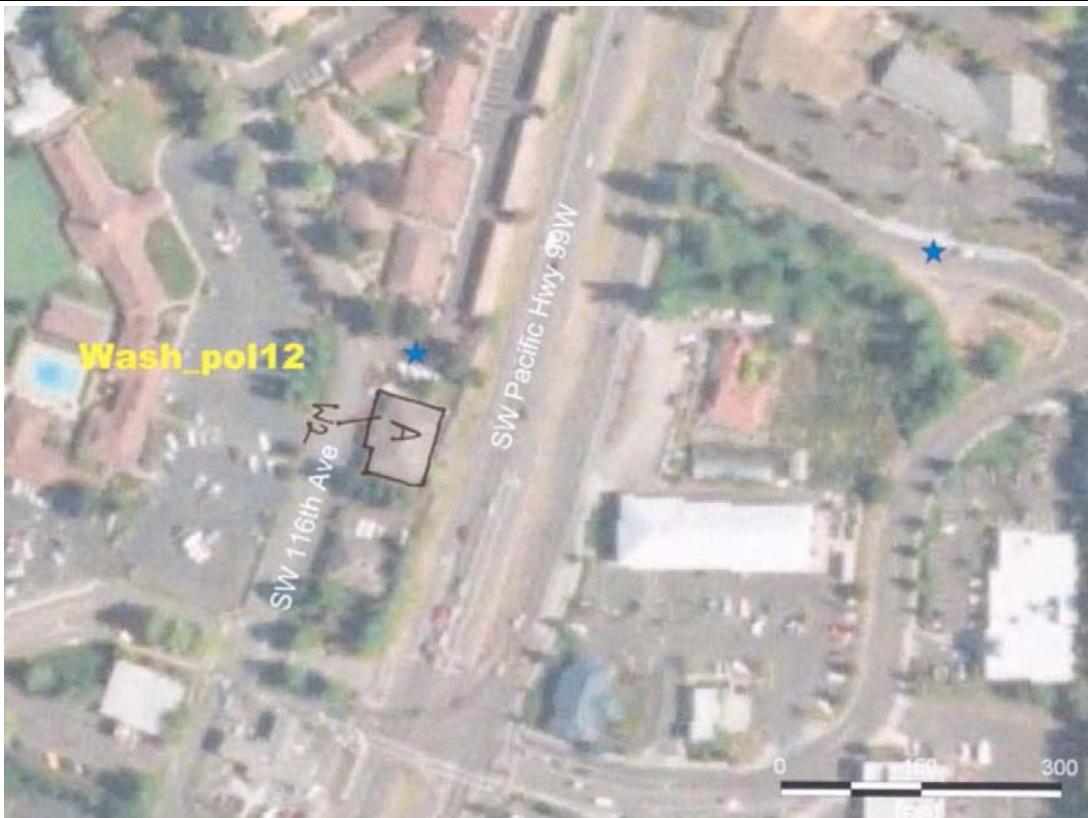
Enrollment	Year Built (Field Verified)	Year Built (Alt. Source)	Est. Decade Built
			1970
Total Area (square ft)	Number of Stories	Basement	Pounding Potential
	1	No	No
Plan Irregularities		Vertical Irregularities	
Reentrant Corners: L Shaped		None	
None		None	
None		None	
Falling Hazards		Poor Conditions	
Other: Brick Veneer		None	
None		None	
None		None

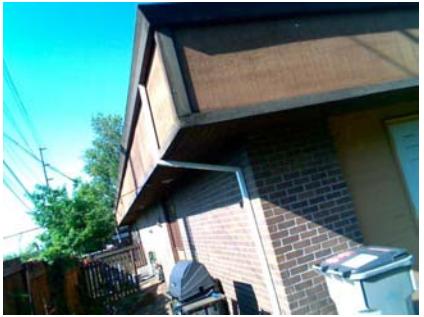
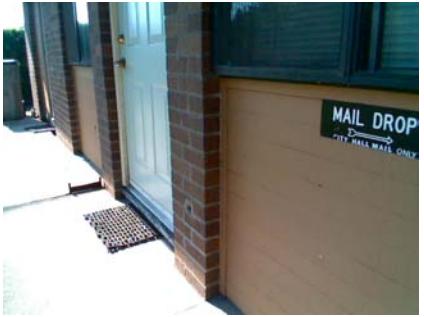
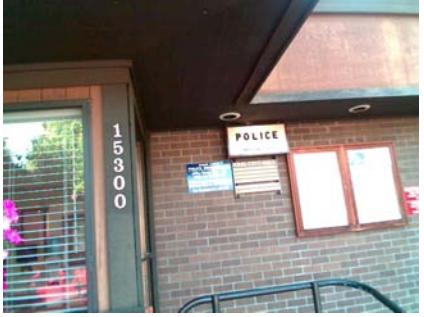
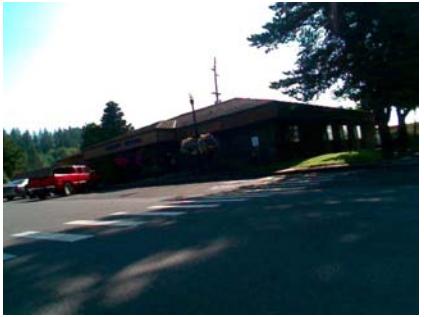
NE Other		NW Primary Structural Type lots of nails W1	SW General Site
