# David Hill Elementary School

Hillsboro SD 1J

## FEMA 154 Rapid Visual Screening Score Card

Rapid Visual Screening - Senate Bill #2 - Seismic Needs Assessment  
Oregon Department of Geology and Mineral Industries

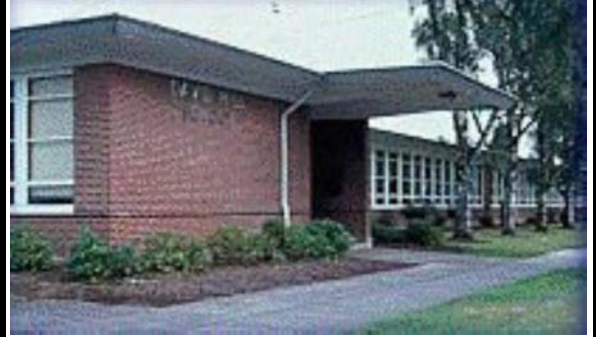
Seismicity Zone: High

Type	Basic Score	Vert Irreg	Plan Irreg	Pre-Code	Post-Bench	Soil C	Soil D	Soil E	RVS Score
Primary	W2	3.8	-2	-0.5	0	0	0	-0.8	0	0.5
Secondary		0	0	0	0	0	0	0	0	0
Tertiary		0	0	0	0	0	0	0	0	0

## Final RVS Score

Final Type

Final Score

W2

0.5

FEMA-154 Collapse Potential

High (>10%)

Enrollment	Year Built (Field Verified)	Year Built (Alt. Source)	Est. Decade Built
332		1948	
Total Area (square ft)	Number of Stories	Basement	Pounding Potential
33904	1	No	No
