# West Union Elementary School

Hillsboro SD 1J

## FEMA 154 Rapid Visual Screening Score Card

Rapid Visual Screening - Senate Bill #2 - Seismic Needs Assessment  
Oregon Department of Geology and Mineral Industries

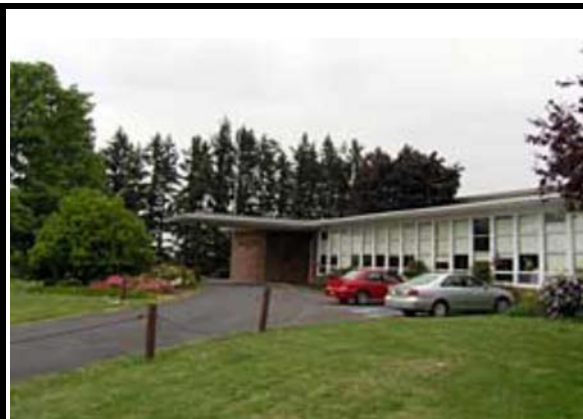
Type	Basic Score	Vert Irreg	Plan Irreg	Pre-Code	Post-Bench	Soil C	Soil D	Soil E	RVS Score
Primary	W2	3.8	-2	-0.5	0	0	-0.4	0	0	0.9
Secondary		0	0	0	0	0	0	0	0	0
Tertiary		0	0	0	0	0	0	0	0	0

W2

0.9

FEMA-154 Collapse Potential

Moderate (>1%)
