Subject: Agenda Item E (Information Item):
Oregon Trail Solar Facility Construction Update for the June 26, 2026 EFSC Meeting

Oregon Trail Solar Facility is a 41 megawatt (MW) solar photovoltaic power generation facility currently under construction in Gilliam County, which will use or occupy 400 acres.

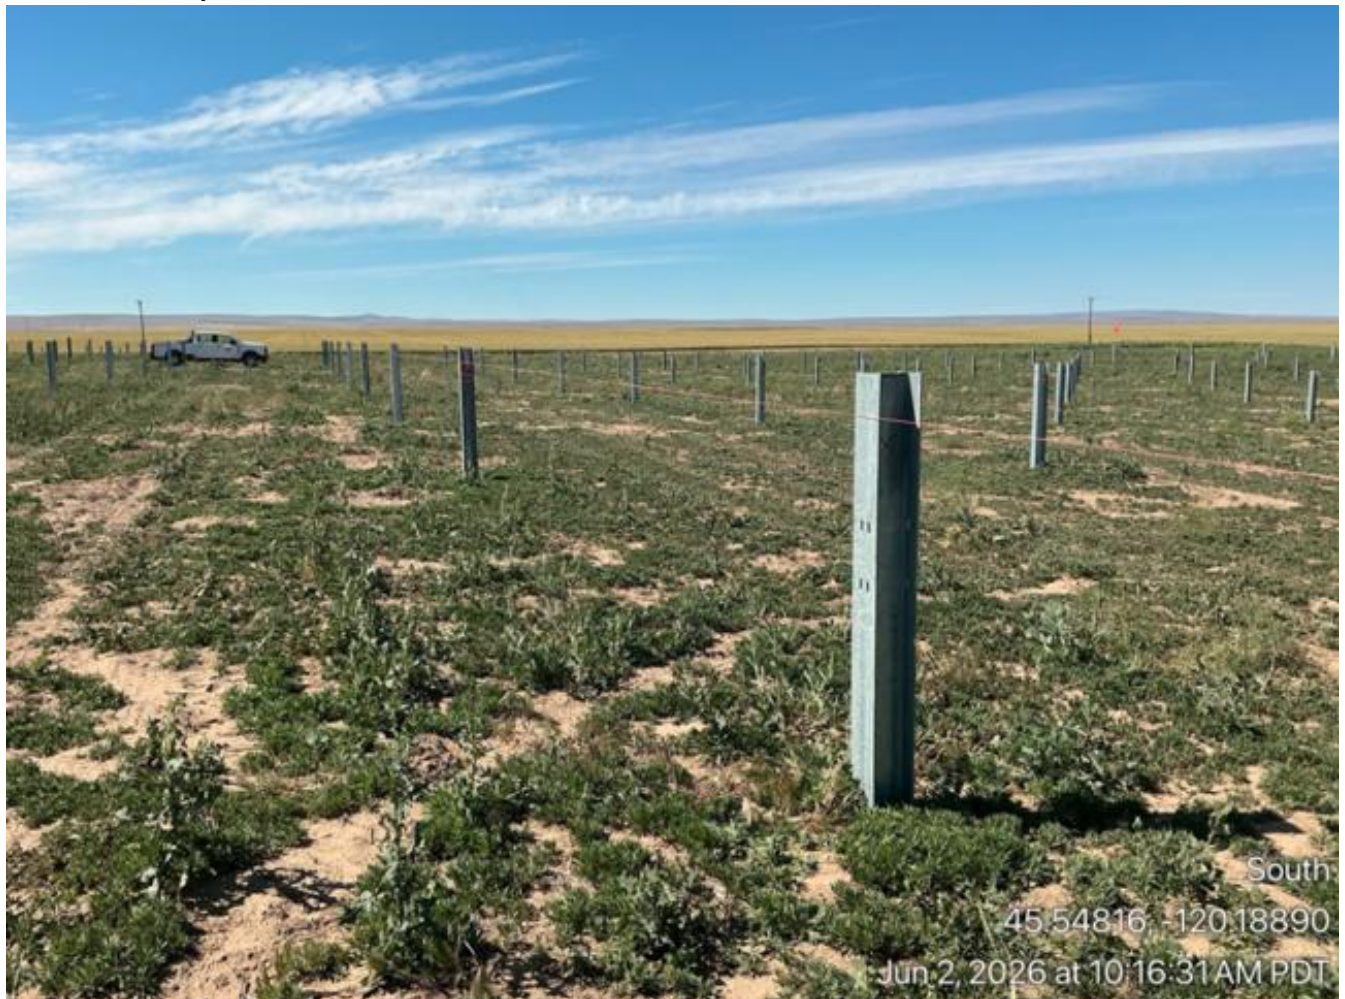
Photo 1. Solar panel foundation installation.

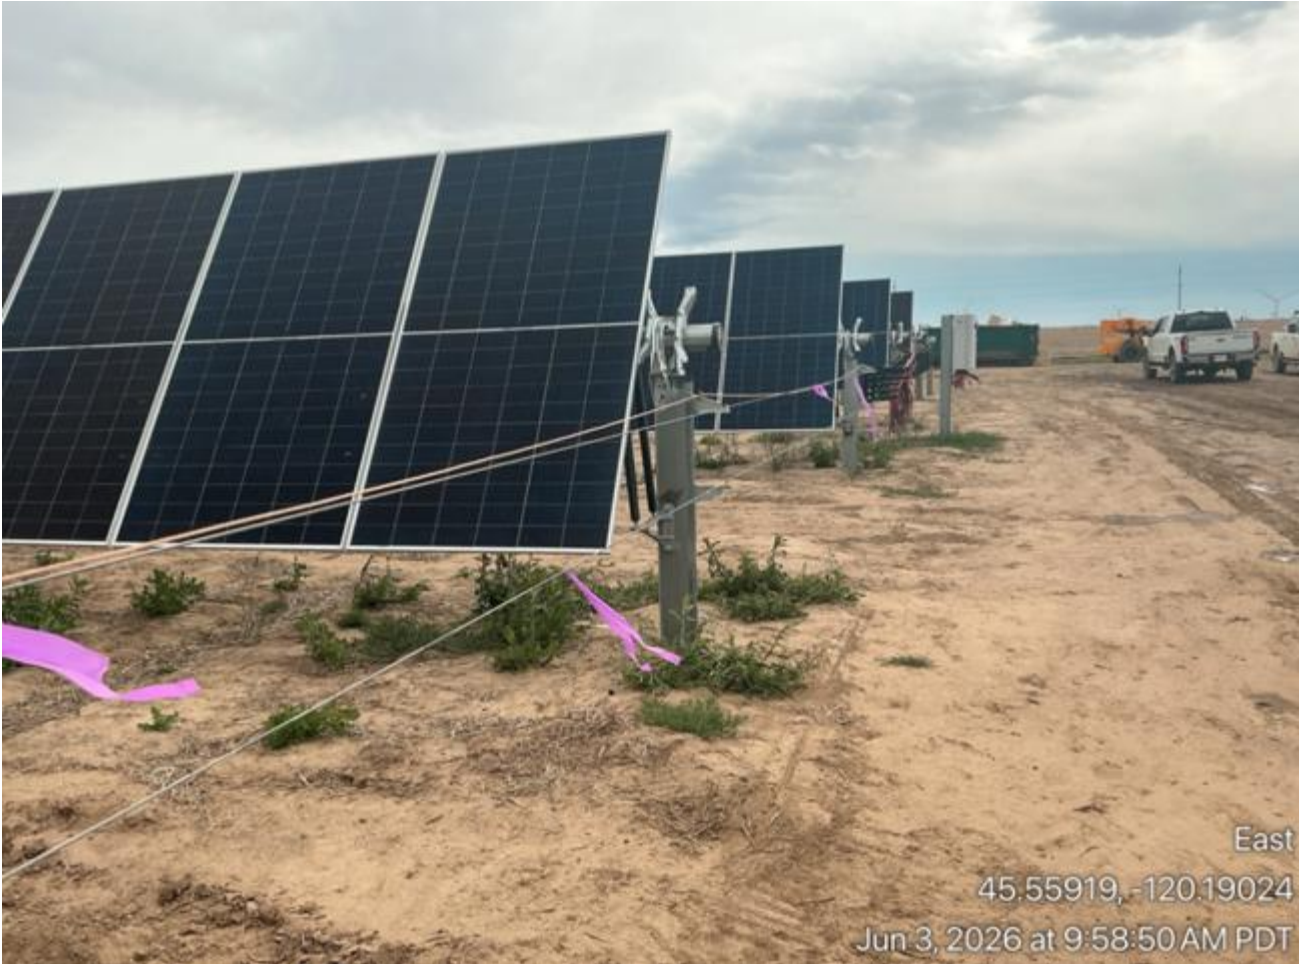
Photo 2. Solar panels are installed on foundations and trackers.

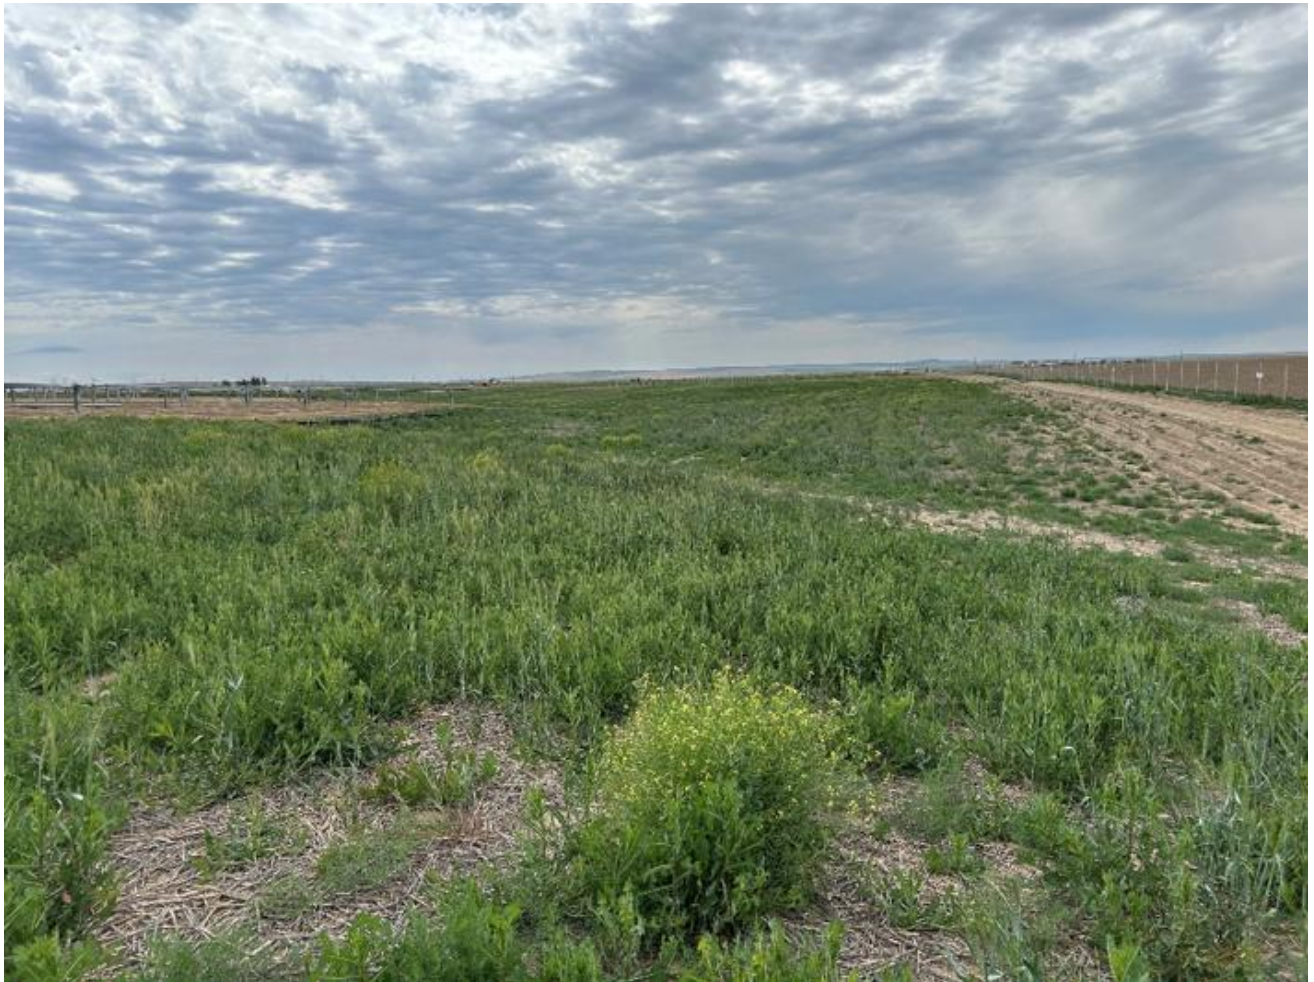
The certificate holder's construction contractor, Cupertino Electric, continues to work closely with Vegetation Solutions to manage weed growth during construction activities. Most recently, Vegetation Solutions conducted mowing activities during the week of June 8, 2026, to reduce vegetation prior to seed production. Herbicide treatment is anticipated to occur within the coming weeks. Photo 3 shows weeds just prior to mowing.

Photo 3. View of Yellow Mustard and Russian Thistle growth. Mowing Week of June 8th followed by herbicide application and continued monitoring.

The certificate holder intends to continue providing weekly updates regarding weed management activities, and weed control remains a focus of monthly compliance inspections. Cupertino Electric's project management team coordinates weed management efforts directly with Vegetation Solutions.

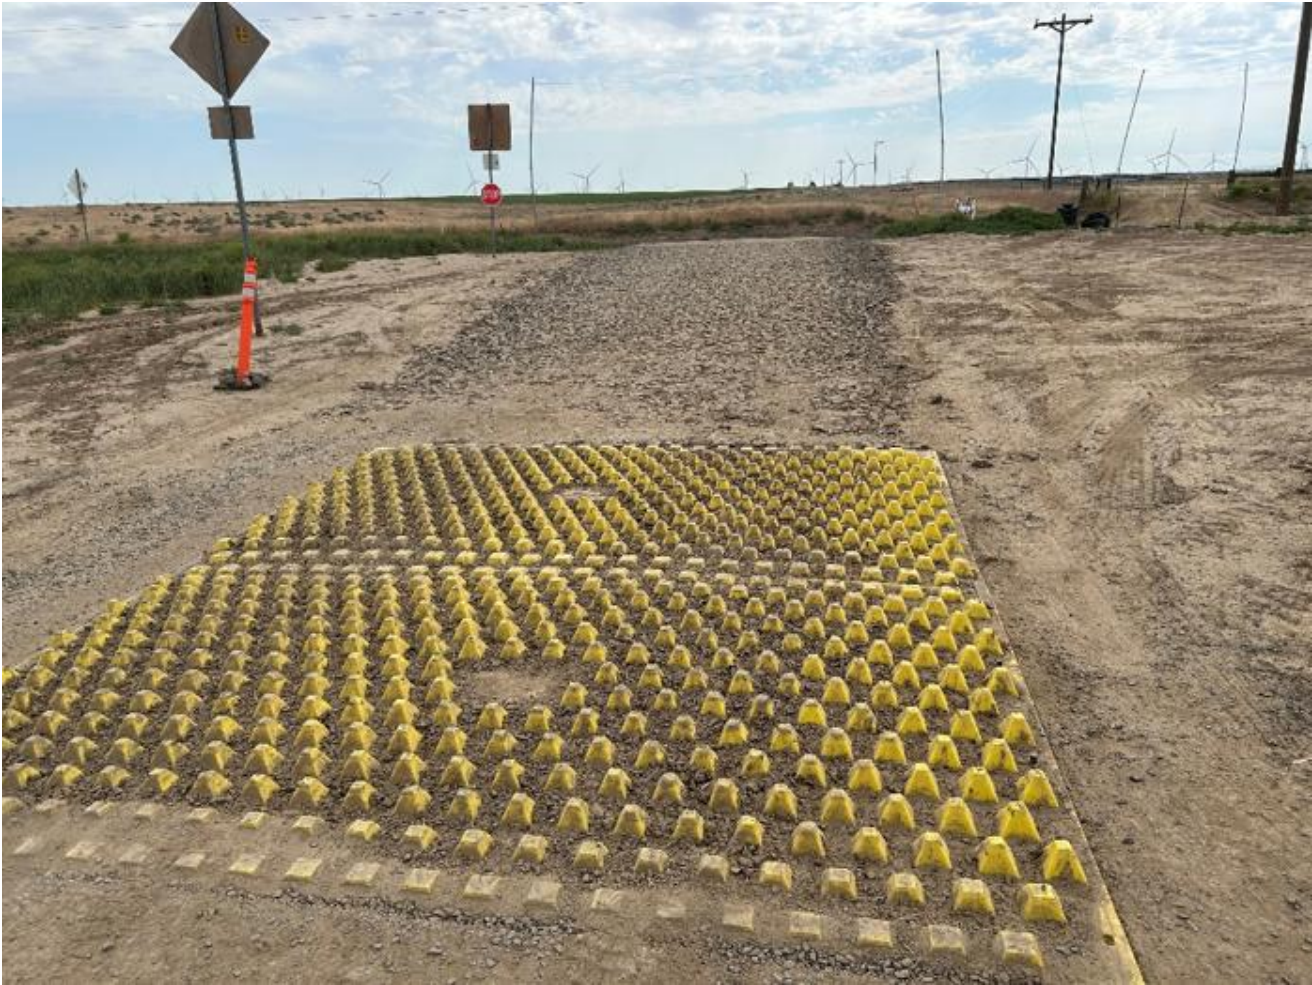
Minor challenges were identified with the implementation of Cupertino Electric's track-in/track-out system, which is designed to minimize the transfer of gravel, soil, and potential weed seed from the construction site onto adjacent county roads (Photo 4).

The certificate holder reported that some drivers were bypassing the rumble mat system intended to remove accumulated dirt and gravel from vehicle tires prior to exiting the site. To address the issue, certificate holder installed a rope barrier to direct all outbound traffic over the rumble mats. The corrective action appears to have resolved the issue, and certificate holder and Cupertino Electric continue to monitor the effectiveness of the control measure and report on its performance.

Photo 4. View of entrance/exit track out of the solar array area before corrective action.
