SAFETY INVESTIGATION MANUAL WORKSHEET

CASE STUDY: OR-43 AND RICHARDSON CT.

OR-43 and Richardson Ct.

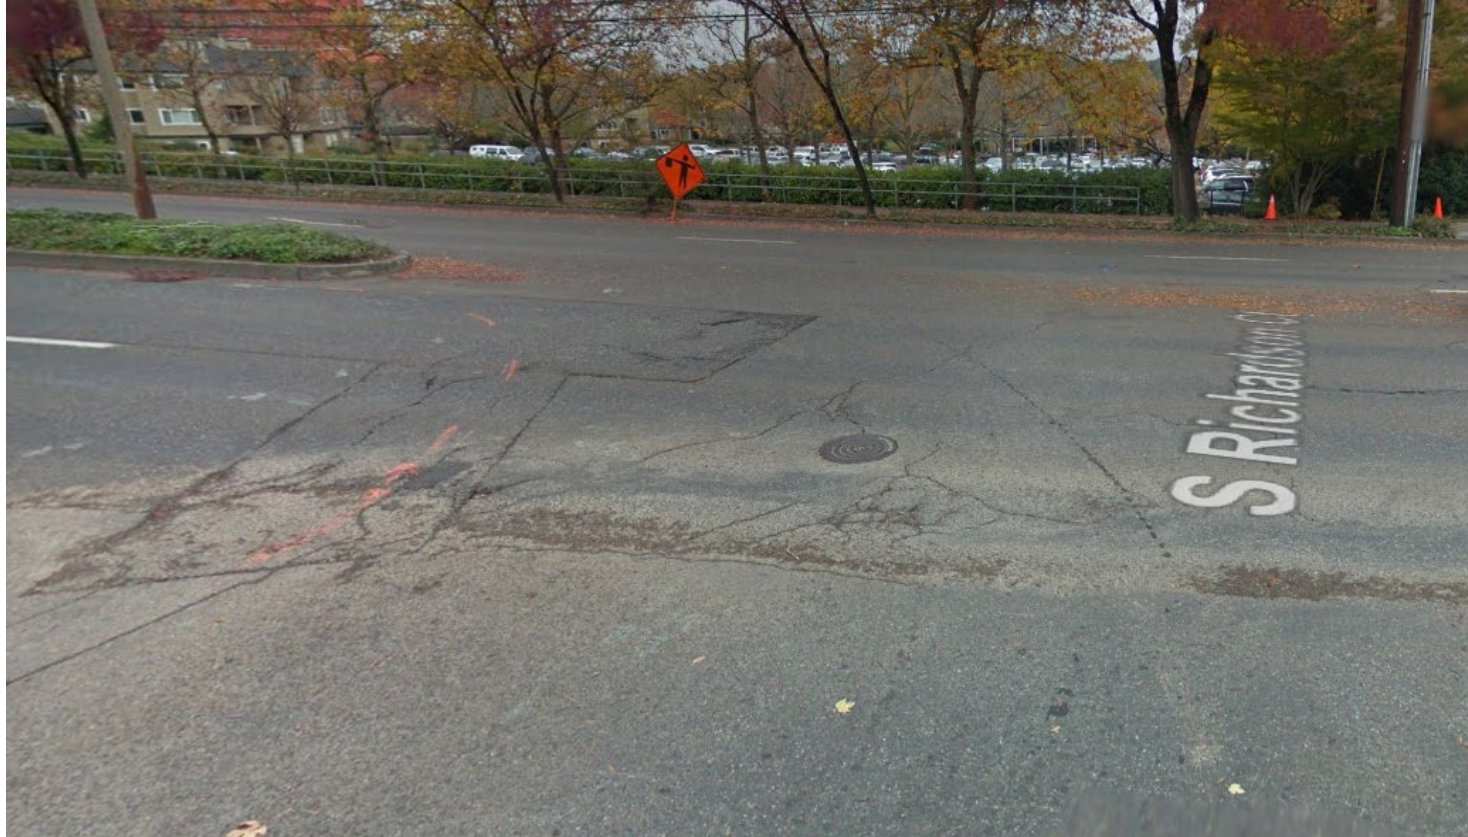
- Before

- Unsignalized intersection
- Six year study period (1/1/2011 – 12/31/2016)
 - MP 1.11 to MP 1.15 on OR-43
- 21 total crashes
 - 18 turning movement crashes
 - Leading cause = failed to yield right-of-way
 - All turning movement crashes were vehicles turning left from Richardson Ct. onto OR-43
- Obtain crash data
 - <https://tvc.odot.state.or.us/tvc/>

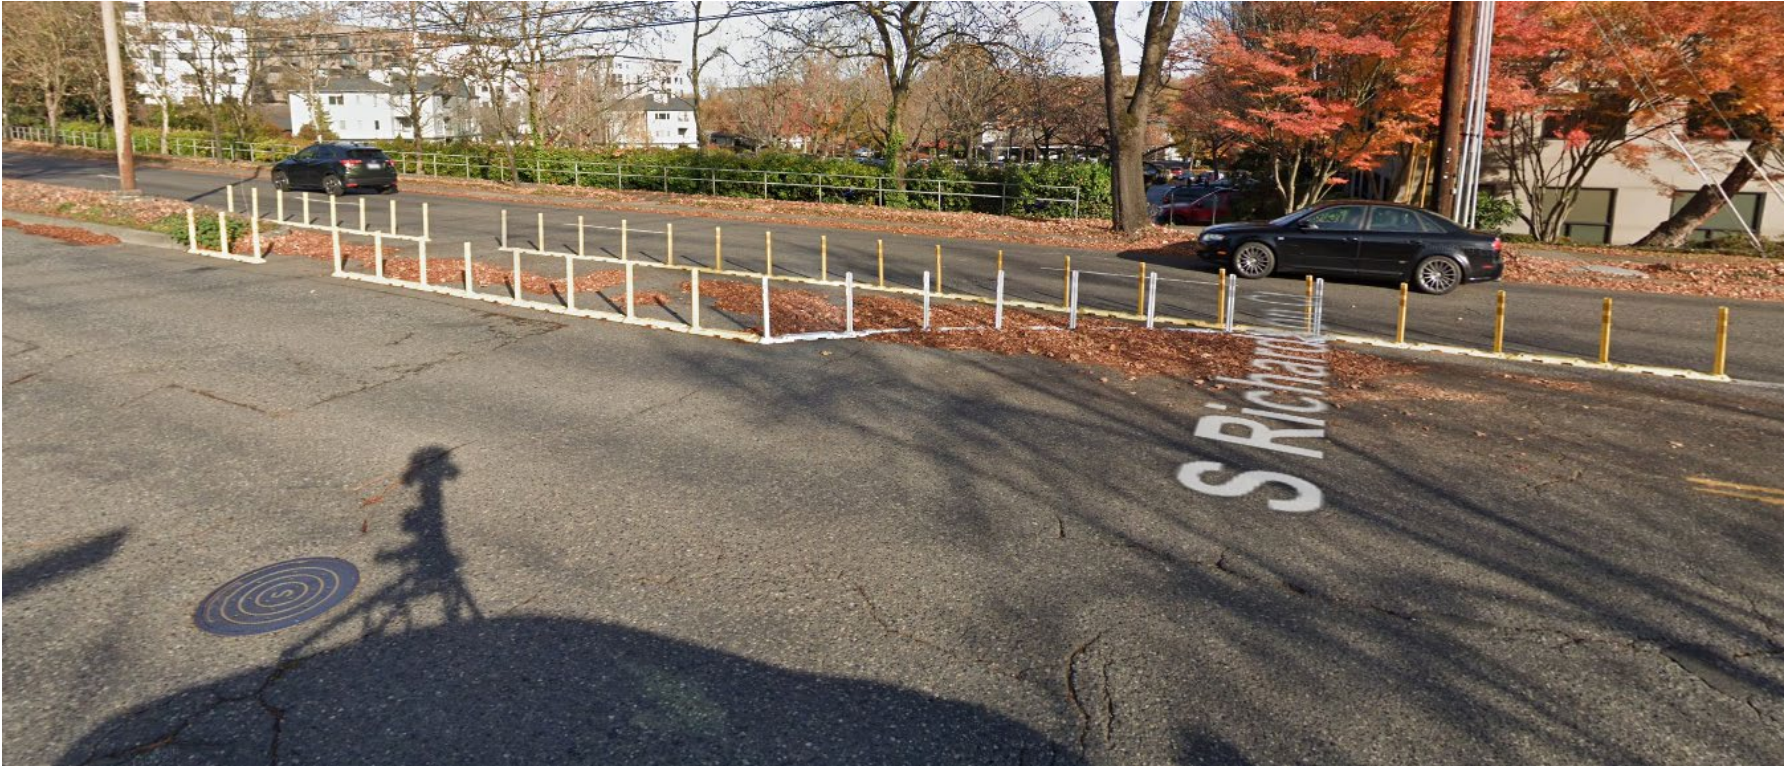
- Solution/After

- Solution
 - Two rows of polyethylene traffic separators across the intersection to extend the median island.
 - Restrict Richardson Ct. to right in, right out, and left in.
 - Selected to restrict left turns and the number of associated crashes.
 - Closed Northerly crosswalk due to extension of median island.
