**Journal Title:** Transportation research record.

# Testing of Roadside Vegetation for Highway Runoff Pollutant Removal

ROBERT J. KAIGHN, JR., AND SHAW L. YU

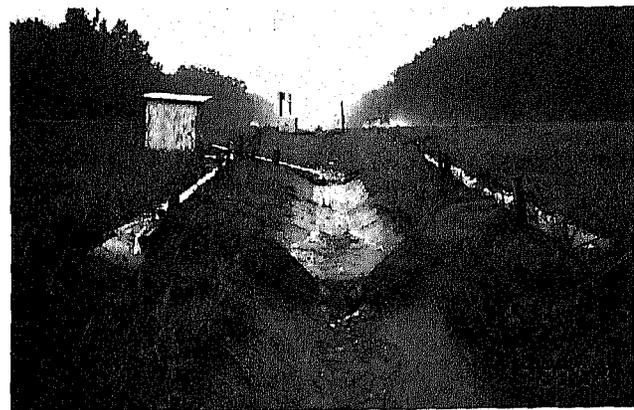
FIGURE 2 US-29S site.

29S site (Figure 2) was modified to eliminate the check dam at the downstream end.

The weir was located in a concrete channel downstream from the sampling point, sampling the runoff before it ponded behind the weir. Sampling was done just before the flow entered the concrete channel, using half a polyvinyl chloride (PVC) pipe to collect runoff. Because the weir was placed in a concrete channel, ponded stormwater could not infiltrate.
