**IMPLEMENTATION OF ODOT TACK
COAT TECHNOLOGIES AND
PROCEDURES TO IMPROVE LONG-
TERM PAVEMENT PERFORMANCE**

Final Report

PROJECT SPR 818

Oregon Department of Transportation

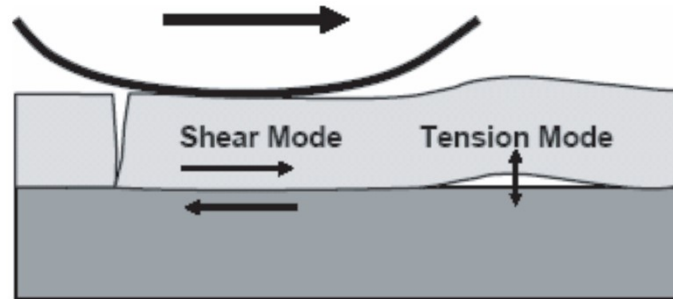
Figure 2.1: Diagram of shear and tensile strength modes under field conditions (Mohammad et al. 2012).

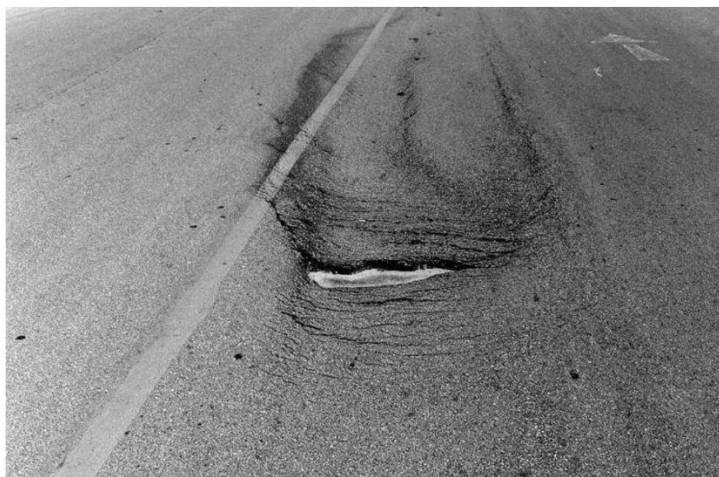
Excessive tack coat application can also create problematic conditions for other types of pavement distress. Slippage cracking is a failure that occurs from tack coat being over-applied, whereby slick spots in the pavement structure are created that are prone to movement under heavy acceleration and braking (Al-Qadi et al. 2012b). Figure 2.2 shows an example of slippage cracking caused by excessive tack coat application.

Figure 2.2. Slippage cracking caused by excessive tack coat (Al-Qadi et al. 2012b).

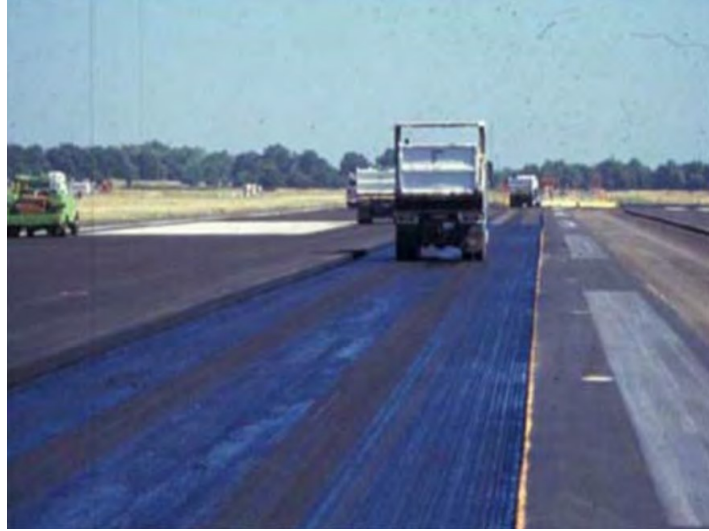
Emulsions are temporally constraining since the break and set times, otherwise known as curing time, must be reached before paving operations can ensue. Break time of emulsions refers to the time needed for the water to separate from the asphalt, whereas set time refers to the point at which all water is completely evaporated. Diluted emulsions require higher break and set times due to the additional water content. The residual asphalt, defined as the effective amount of asphalt available to facilitate interlayer bonding, is what remains after the water has evaporated, or when the tack coat has set. Emulsions which have not had sufficient time to break and set also give rise to the “tracking” phenomenon, where emulsion is picked up on construction vehicle tires, effectively reducing the amount of tack coat on the pavement surface (FHWA 2016). This occurs mostly in the wheelpaths where interlayer bonding is most critical. The severity of tracking is determined mostly by the emulsion properties and the curing time allotted before construction (Covey et al. 2018). Figure 2.3 shows an example of tack coat tracking by construction vehicles.

Figure 2.3: Tracking by haul truck during pavement construction (Mohammad et al. 2012).

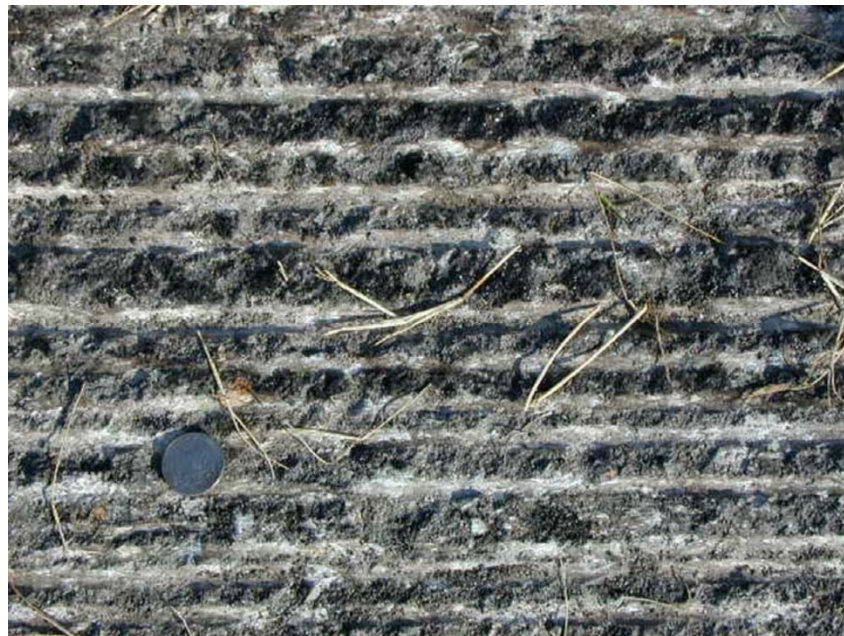
Figure 2.4: Typical milled pavement surface texture (Mokarem 2006).

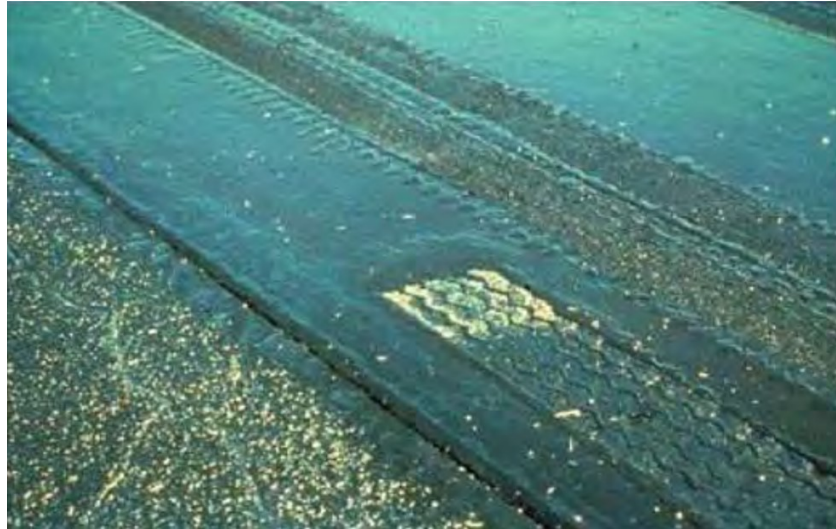
Excess applied tack coat can also cause other extraneous problems during construction. Excess tack can cause an effective decrease in the air void content of the layer due to the emulsion seeping into the new pavement layer during compaction and traffic. Excess tack can also amplify tracking problems, since it is easily tracked onto construction vehicle tires and displaced to other locations nearby the construction area, which can compromise pavement marking legibility and cause safety issues (Mohammad et al. 2010). Figure 2.5 shows an example of excessive tack coat application and its exacerbation of tracking problems.

Figure 2.5: Excessive tack coat application (Mohammad et al. 2012).

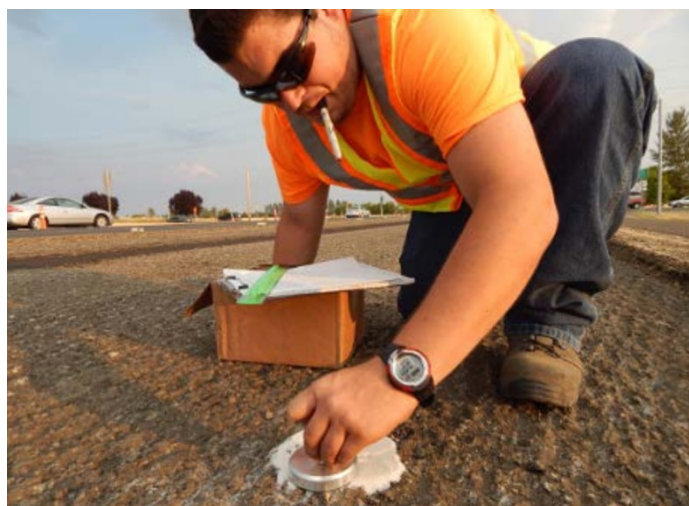
Figure 2.6: Sand patch testing on milled pavement surface (Coleri et al. 2017).

A common method of quantifying the texture is the Sand Patch Test (ASTM E965, 2015). Figure 2.6 shows the sand patch test being applied to a milled pavement surface in the field.

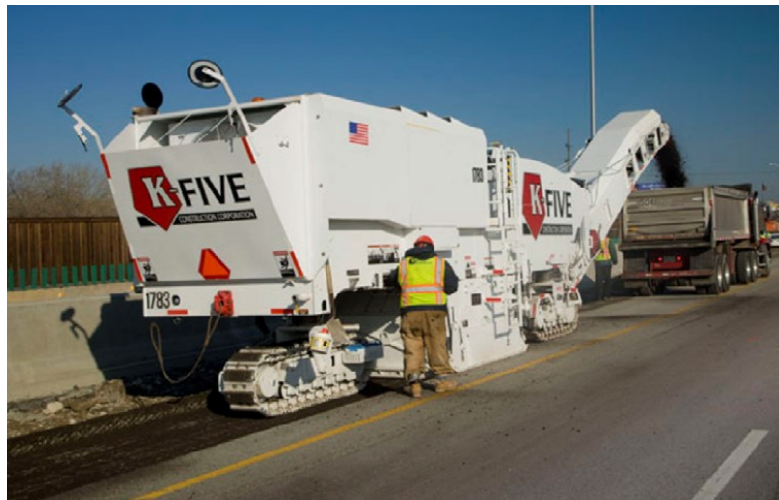
Figure 2.7: Pavement milling operations in the field (West 2010).

A report by West (2010) discusses some considerations for milled pavement surface texture characteristics. It was suggested that a texture should have no more than ½ in. between peaks and valleys of the milled surface, as is specified by some agencies as a texture verification check during the inspection process. Milling texture can also affect the properties of the finished pavement roughness. A micro-milling drum is said to produce a smoother finished pavement surface texture, whereas a standard milling drum can create irregularities in smoothness of thin pavement layers, stemming from the deep grooves it produces in the resulting surface texture. A uniform texture was suggested to be imperative for the compactibility of thin overlays on a milled pavement surface. Worn or damaged milling drums can create nonuniform milled surface textures, which can cause problems for compaction of thin overlays and also create potential hazards for motorcycles if the milled surface is opened to traffic during construction. Figure 2.7 shows an example of pavement milling equipment in the field.

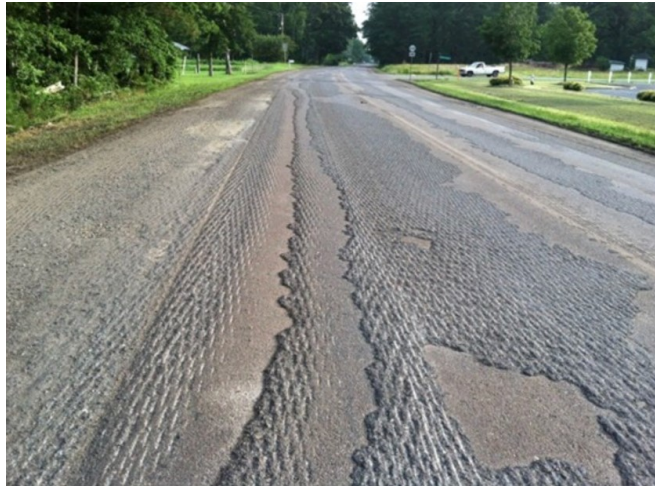
with the new asphalt overlay. An example of scabbing after milling is shown below in Figure 2.8.

Figure 2.8: Scabbing of existing pavement after milling (Shiells 2015).

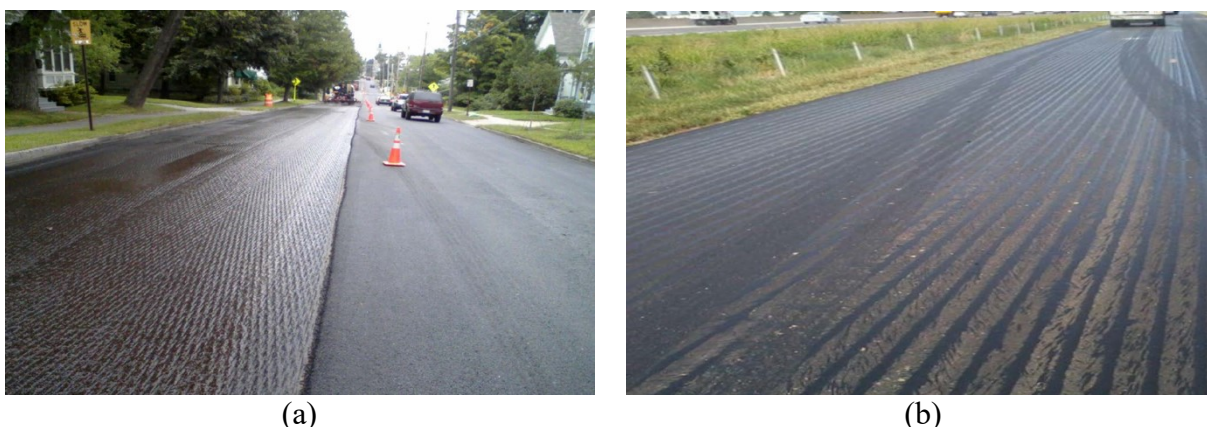
According to FHWA (2016), it is important that application of tack coat materials is uniform in all directions (transverse and longitudinal). Figure 2.9 shows acceptable and unacceptable uniformity in tack coat application.

Figure 2.9: Tack coat application uniformity (a) Acceptable tack coat application uniformity (uniform), and (b) unacceptable tack coat application uniformity (non-uniform).

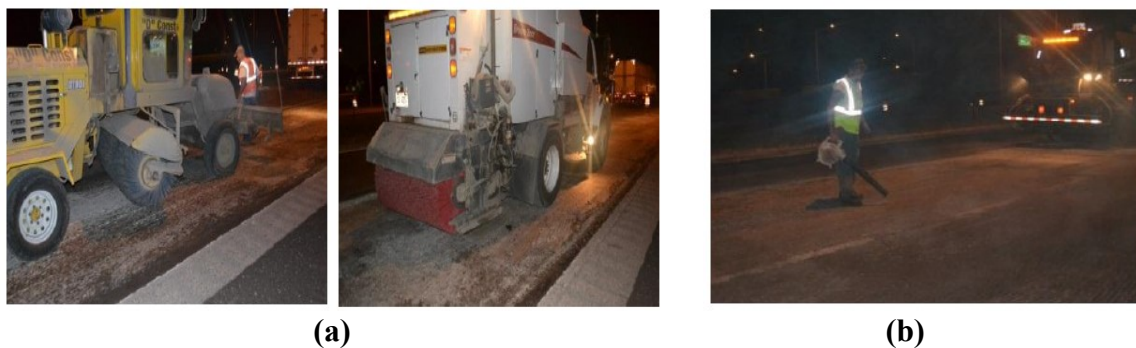
Surface contaminants, such as dust, can significantly affect the tack coat bond strength exhibited between pavement layers. Provided that all other factors are befitting, such as tack coat application rate, coverage and curing time, minimizing the amount of dust on the pavement surface can help to ensure that adequate tack coat bond strength is achieved. This is particularly important for milled pavement surfaces, where excess dust is produced from the milling of existing pavement layers. According to FHWA (2016), milling of existing pavement is shown to generate high amounts of dust which can impact bond strength. To combat this, milled surfaces require adequate cleaning, commonly done by sweeping, to ensure that bonding is not compromised (FHWA 2016). As it stands, contractors typically clean the pavement surface using one of two methods: sweeping/vacuuming and air blasting (Al-Qadi et al. 2012b). Figure 2.10 shows these two methods being employed in the field during paving operations.

Figure 2.10: Cleaning methods (a) Sweeping and vacuuming and (b) air blasting (Al-Qadi 2012b).

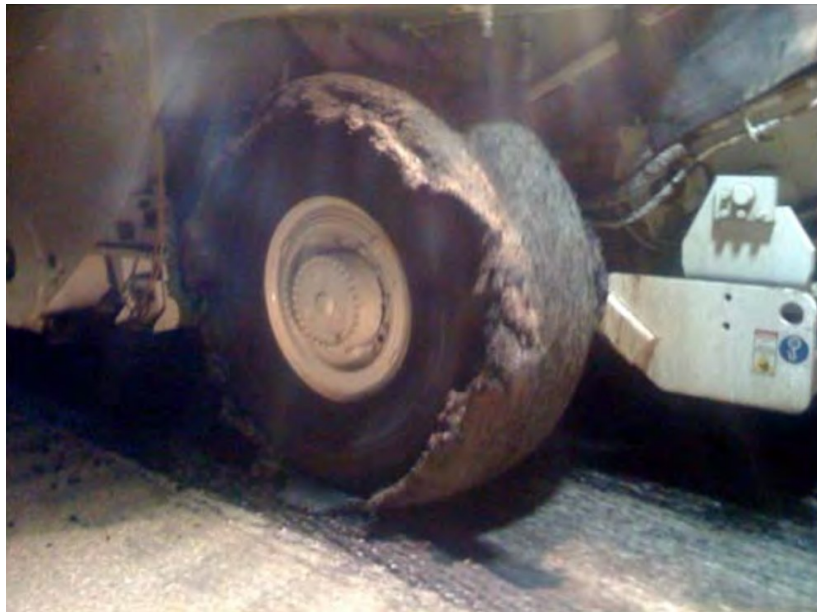
Dust can also affect the propensity of tracking during construction operations. A dustier surface can induce additional tracking, as the dust coating the existing pavement surface readily adheres to tack coat materials which are easily picked up by construction vehicles during paving operations (Mohammad et al. 2012). This tracked debris accumulates and falls off construction vehicle tires, creating inconsistencies in the pavement surface and additional debris on the roadway. Figure 2.11 shows an example of tracking by a paver during construction due to excess dust on the pavement surface.

Figure 2.11: Tracking on paver wheels due to excess dust (Mohammad et al. 2012).

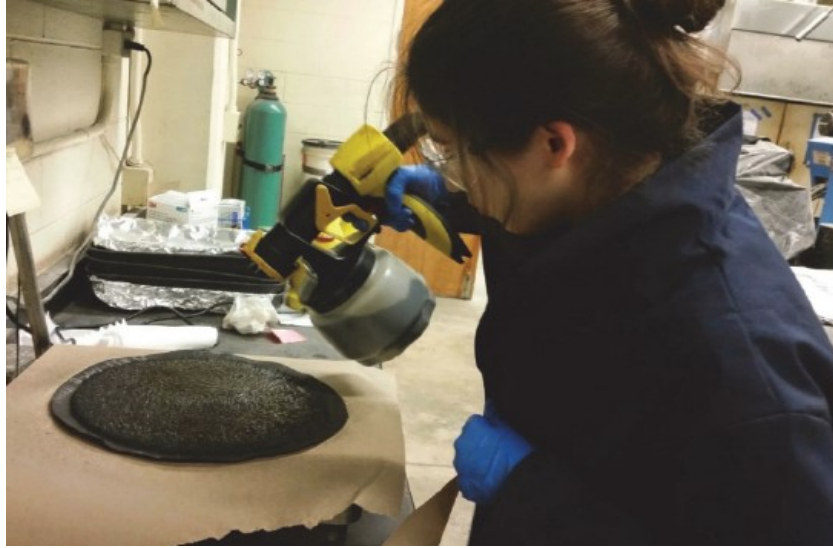
Rawls et al. (2016) employed a pneumatic sprayer device in order to distribute tack coat to pavement surfaces in the laboratory. Figure 2.13 shows the application system employed by Rawls et al. (2016). Coleri et al. (2017) also experimented with this method but did not achieve good results due to clogging of the spray nozzle and uneven distribution of the tack coat.

Figure 2.13: Application of tack coat in the laboratory (Rawls et al. 2016).

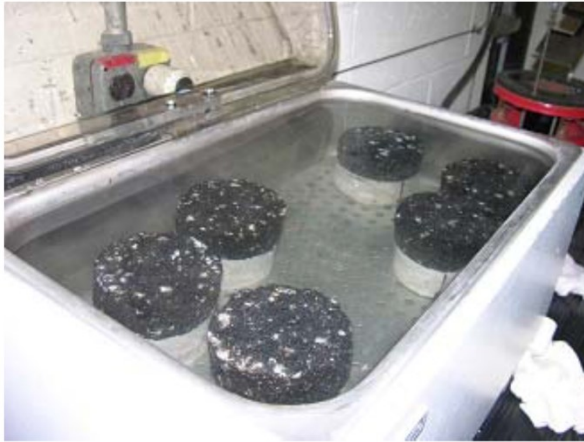
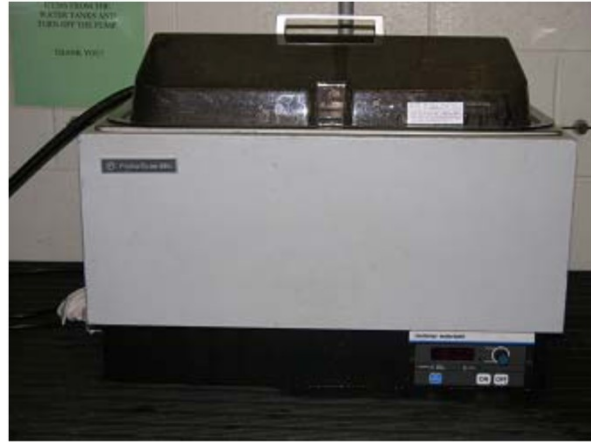
Figure 2.14: Samples conditioning in 140°F water bath prior to testing (Al-Qadi et al. 2008).

Samples meeting the 70-80% saturation criteria were then placed in a 140°F water bath for 24hrs followed by a 68°F water bath for 2hrs prior to testing. Figure 2.14 shows photographs of the water bath conditioning chambers used for this process.

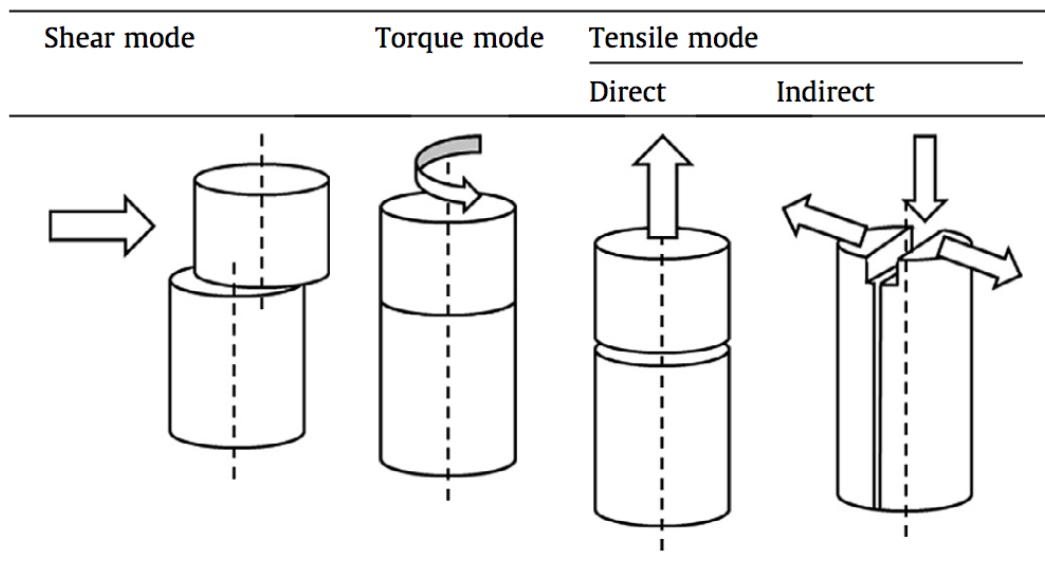
actual traffic loading conditions (Amelian and Kim 2017), shear testing of the tack coat bond is the most commonly employed test (Wang et al. 2017). Figure 2.15 below shows a diagram of the various failure modes commonly used for testing.

Figure 2.15: Diagram of various tack coat bond failure modes (Wang et al. 2017).

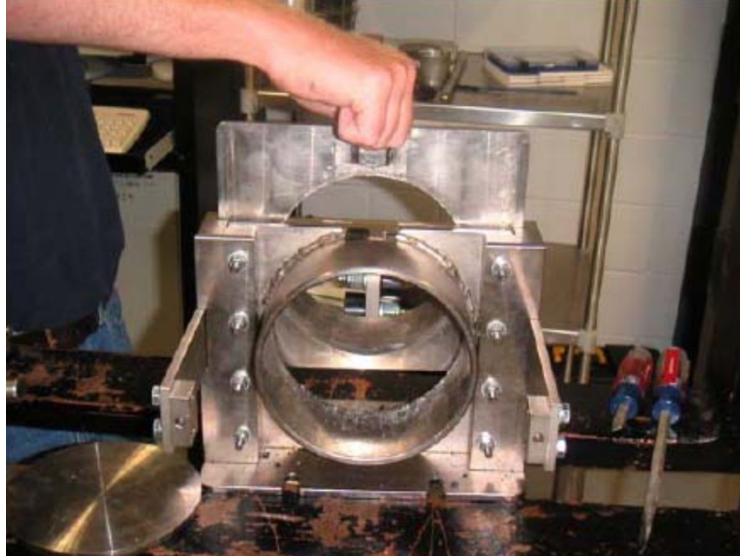
Figure 2.16: Florida direct shear test device (Tashman et al. 2006).

The Florida direct shear test (or FDOT shear tester) was developed by Florida Department of Transportation (Sholar et al. 2004) to measure the interface bond strength by applying a shear load in the vertical direction (Figure 2.16). Two-layered specimens with a diameter of 6 in. (152.4 mm) were tested in shear by moving one of the loading collars (loading frame) in the vertical direction. The gap between the loading frame and the reaction frame was specified to be 4.8 mm. A loading rate of two inches per minute (50.8mm/min.) was used.

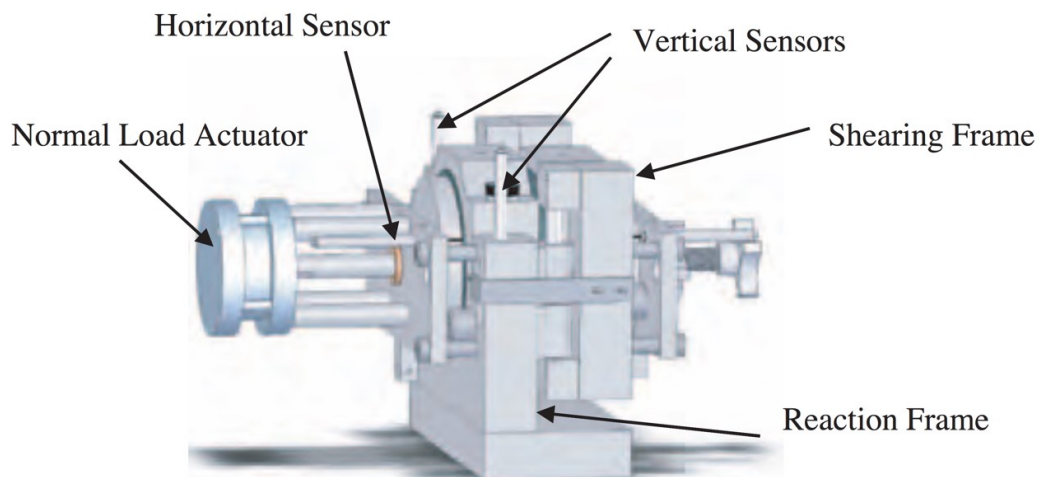
A notable test device developed recently for tack coat ISS measurement was used in research by Mohammad et al. (2012), called the Louisiana Interface Shear Strength Tester (LISST). This device, comprised of a simple jig, measures the shear strength of the tack coat bond using monotonic strain-controlled loading. The authors examined the effect of variables such as surface type/texture, tack coat type, surface cleanliness and paving method on the ISS. ISS was evaluated with the interface shear strength test using the LISST and with the torque bond test, a test device used to quantify the shear resistance of the tack coat bond using an applied torque to cylindrical samples, with great success. These test devices have since been used by several researchers to quantify the bond strength of tack coats. Figure 2.18 shows a diagram of the LISST.

Figure 2.18: Diagram of LISST test device (Mohammad et al. 2012).

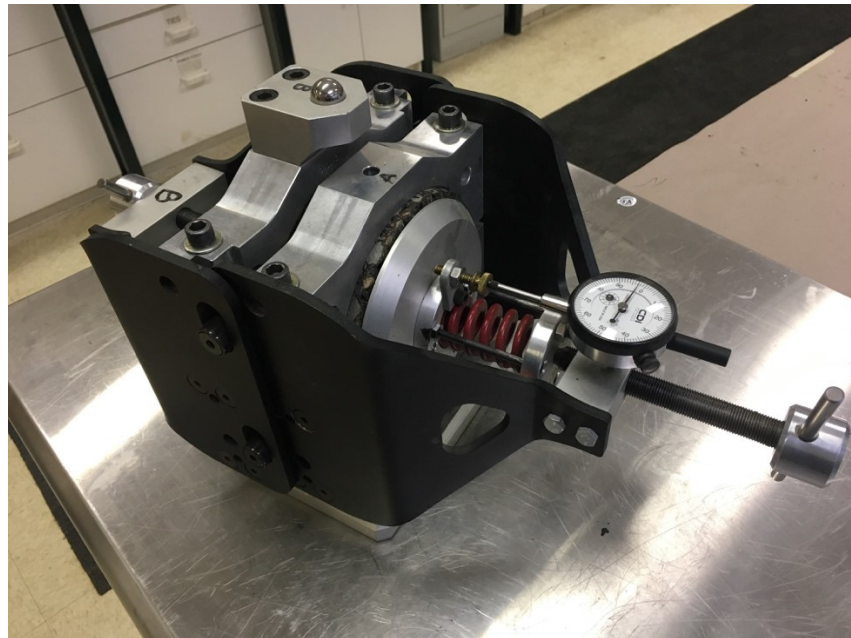
Coleri et al. (2017) also used a variation of the NCAT bond strength test device, but used LISST test procedures (2.54 mm/min loading rate) in laboratory testing of their samples. This device also employed a confining pressure actuator. However, the confining pressure load in this actuator is driven by a spring, whereas the LISST is a pneumatically operated. The device used by Coleri et al. (2017) is shown below in Figure 2.19.

Figure 2.19: Shear test device used by Coleri et al. (2017).

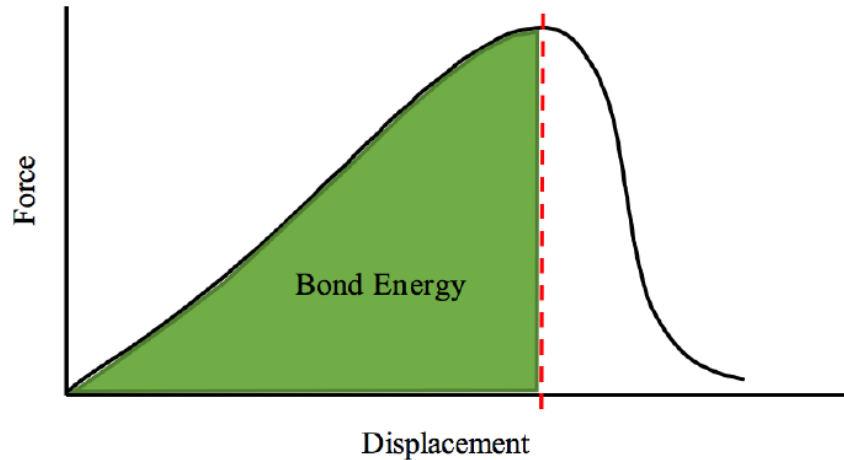
Amelian and Kim (2017) found that fatigue of the tack coat bond is highly dependent upon the load-induced strain experienced by the interlayer. The authors found a useful parameter that can be extracted from the load-displacement curve yielded by the LISST, known as the interlayer bond energy, can yield the dissipated energy in the tack coat bond as it resists shear loads. Interlayer bond energy is defined as the area under the load-displacement curve up to the peak shear strength observed, as is shown below in Figure 2.20.

Figure 2.20: Interlayer bond energy shown graphically on the force-displacement curve (Amelian and Kim 2017).

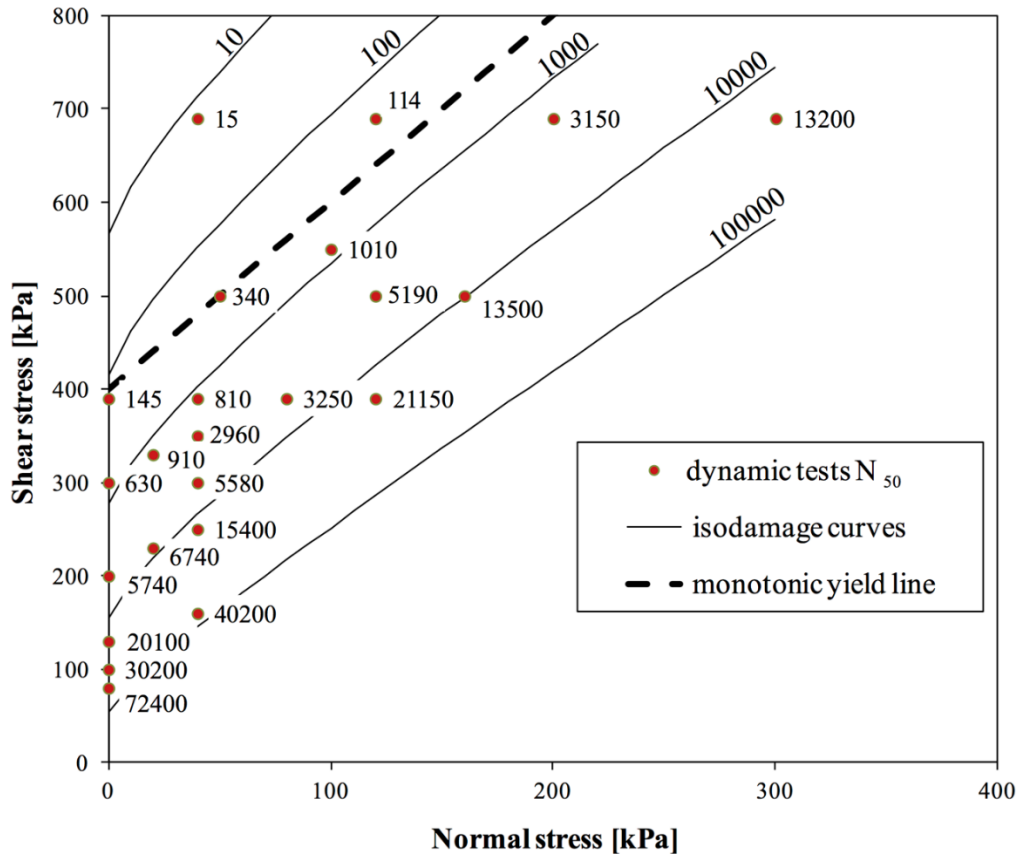
Tozzo et al. (2014) found that the normal load had a considerable impact on the fatigue resistance of the interlayer based on their N_{50} failure criteria as well. The authors also proposed a 3D linear regression model to estimate the combinations of normal load and shear stress that would yield equivalent fatigue damage. The authors displayed this result graphically by creating an “isodamage” plot, where equality in the different combinations of shear and normal stress were visualized. The isodamage plot is shown below in Figure 2.21. Finally, the authors compared the normal load sensitivity of cyclic DST to monotonic DST and observed a similarity in response, indicating the normal load had equivalent sensitivity in both of the tests. This similarity is also shown in Figure 2.21 and is represented by the equivalent slopes of the isodamage lines with the monotonic yield line.

Figure 2.21: Isodamage plot for N_{50} failure criteria for 10 to 10,000 loading cycles (Tozzo et al. 2014).

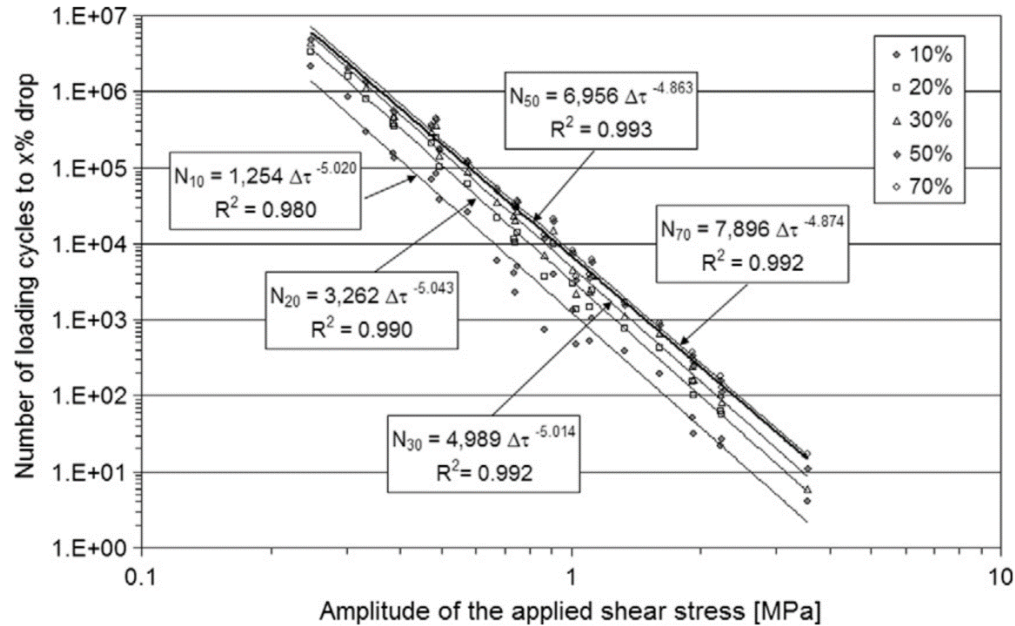
Figure 2.22: Number of loading cycles to predefined interface shear stiffness modulus reduction versus applied shear stress (Diakhate et al. 2011).

Diakhate et al. (2011) studied cyclic shear testing of the interlayer bond between thin asphalt overlays and underlying pavement layers. This study obtained strong correlations between the number of loading cycles to a defined level of interface

shear stiffness modulus reduction and the applied shear stress using a power law. This result is shown graphically in Figure 2.22 below. This was true for the two testing temperatures of 10°C and 20°C used in this study. The authors also note that at 10°C, a reduced amount of tack coat will lead to a reduction in bond strength, testifying to the importance of tack coat for improving shear strength at lower temperatures.

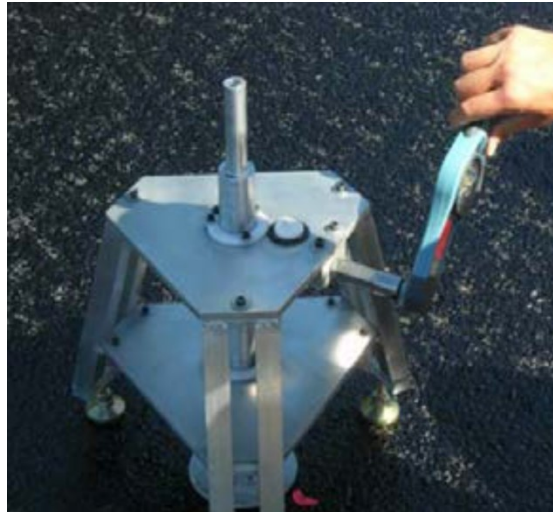
Figure 2.23: Texas pull-off test (Tashman et al. 2006).

The Texas Pull-Off test device (Figure 2.23) was a field test device developed at the University of Texas at El Paso (UTEP) (Deysarkar 2004) to measure the tensile strength of applied tack coat before constructing a new overlay. After the tack coat is applied on the pavement surface, the tack coat layer was left to set. After it was set, the device was placed on the tacked surface. The load plate was lowered to come in contact with the tacked pavement surface. Then, a 40-pound load was applied on the device for 10

minutes prior to testing to create bonding between the test plate and the pavement surface. After 10 minutes, the load was removed and a torque wrench was manually rotated in the counter-clockwise direction to move the plate in the vertical direction. The torque required to break the bond between the plate and the pavement surface was recorded and converted to bond strength using a calibration factor. A problem with this test method is that the rate of displacement applied to the core is subjective. It is impossible to control the displacement rate accurately using a manual torque wrench, resulting in high variability in shear strength results. A stepper motor is necessary to provide greater control over the displacement rate in this test.

Tashman et al. (2006) conducted several Florida direct shear and Texas pull-off tests on milled and non-milled test sections to investigate the effectiveness of Texas pull-off test for interface bond strength characterization. Test results showed that although measured interface bond strength values for the Florida direct shear test are higher for the milled sections (as expected), tack coat strength values measured by Texas pull-off test during construction appeared to be lower for the milled test sections. This result suggested that smaller contact area for the milled sections (due to high texture) increased the applied stresses and resulted in early failure at lower load levels for the milled sections. Mohammad et al. (2012) avoided this problem by attaching a polyethylene foam to the loading plate to increase contact area for milled sections.

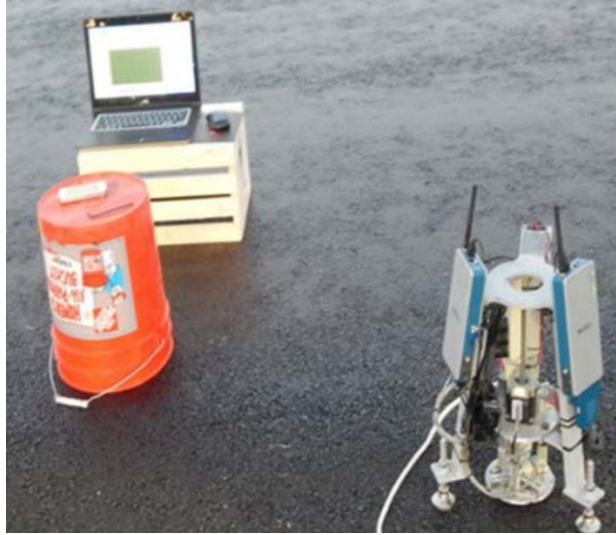
Figure 2.24: OFTCT in the field (Coleri et al. 2017).

Coleri et al. (2017) also developed a wireless tack coat tensile strength test device, the Oregon Field Tack Coat Tester (OFTCT), to evaluate bond strength in the field. The OFTCT, which is similar to the pull-off test and LTCQT, measures the tensile strength of the tack coat after the emulsion has set and was previously used to quantify the effect of surface cleanliness on tack coat bond strength (Mahmoud et al. 2017b). This device employed a computer-controlled strain rate and a wireless load-displacement sensor system to allow for in-situ evaluation of the tack coat tensile bond strength. Figure 2.24 shows the OFTCT being used in the field.

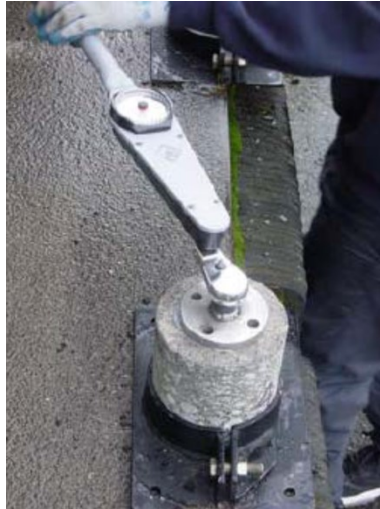
The torque bond test was developed in Sweden and used as an in-situ test method to evaluate field bond strength. The test was adopted by the UK as a part of the approval system for tack coats (Walsh and Williams 2001). After an asphalt overlay is constructed, it is cored about one-half inch deeper than the layer interface. A loading plate is glued to the overlay surface using fast setting epoxy. Torque is manually applied to the surface at a constant rate using a torque wrench. The torque at failure is used as a parameter to characterize interface bond shear strength. The torque bond test can also be conducted on laboratory samples under controlled temperature. Manual load application with the torque wrench was later replaced by a servo motor actuator in the ATacker device to improve repeatability (Buchanan and Woods 2004). Figure 2.25 shows a photo of the torque bond test device.

Figure 2.25: Torque bond test device (Tashman et al. 2006).

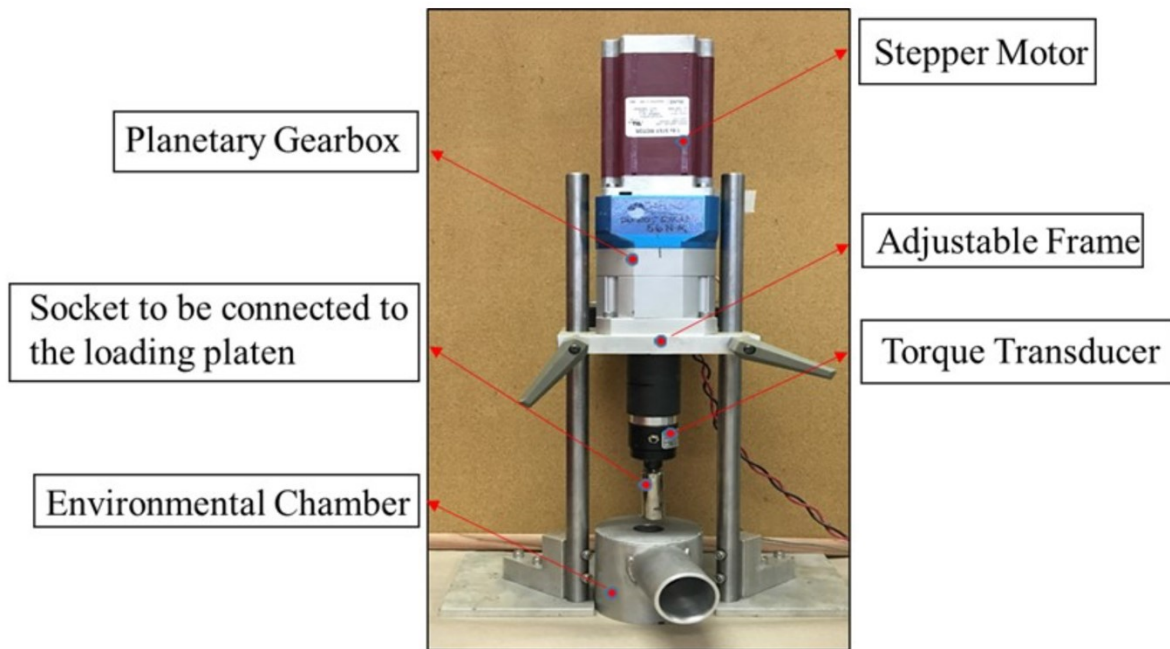
Figure 2.26: OFTT test device (Coleri et al. 2017).

More recently, Coleri et al. (2017) developed a novel torque test device, the Oregon Field Torque Tester (OFTT), to evaluate the post-construction tack coat bond shear strength in the field. The OFTT is a highly refined version of the torque bond test that measures the shear strength of the bond shortly after construction using torque applied at a constant displacement rate. Making use of a stepper motor, the torque can be applied consistently for each test, thereby reducing the variability that is inherent with a manually-operated handheld torque wrench. This device is controlled from a laptop computer using a software developed at Oregon State University. This device was found to yield shear strengths with a high correlation to laboratory-observed shear strengths ($R^2 = 0.6544$), suggesting that the OFTT can be an effective, low-cost, less destructive and practical technology to monitor long-term in-situ bond strength (Mahmoud et al. 2017a). Figure 2.26 shows the OFTT and its principal components. Figure 2.27 shows a plot of laboratory shear strengths versus OFTT-measured shear strengths and their correlation.

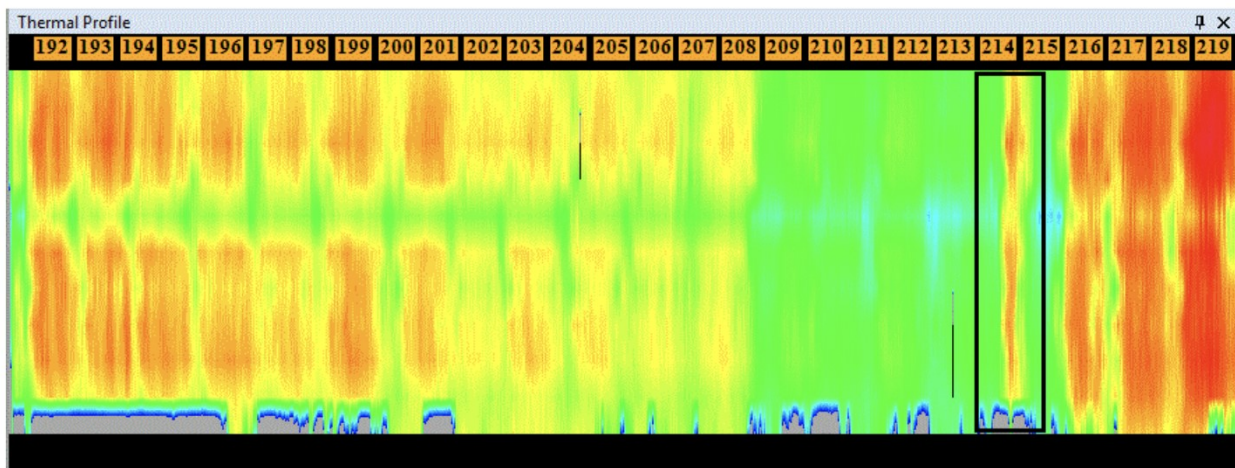
Figure 2.28: Thermal gradient of placed HMA (Landefeld 2014).

The Ohio Department of Transportation has evaluated a variant of this technology, called Pave-IR, in various projects to determine its effectiveness in identifying density variability due to segregation. According to Landefeld (2014), discrete measurement criteria are used to evaluate the thermal uniformity profiles in asphalt mats at 10ft intervals as they are placed. 150ft sublots are considered as analysis units since a change of trucks can be captured in this length. The maximum and minimum temperatures of the profiles are then used to determine the temperature differential and relate this to levels of segregation in the asphalt mat. By correlating the results obtained from the Pave-IR scanner with nuclear gauge density measurements for each 150ft sublot, this study was able to conclude that thermal imaging is effective for determining suspect areas of thermal segregation, allowing the inspector to evaluate the problems and hold the contractor accountable for any problems (Landefeld 2014). Figure 2.28 shows an example of the thermal gradient yielded by the thermal imaging system.

This technology is therefore useful for determining temperature differentials in asphalt materials in real-time as they are placed. A permutation of this technology could be applied to tack coat placement in order to determine gaps in coverage after application. Although temperature differentials between tack coat and the pavement surface are not as drastic as that of freshly placed HMA, thermal imaging cameras capable of detecting minute differences in temperature do exist, some of which are handheld (FLIR 2017). Thermal imaging would be a viable way of detecting the level of tack coat coverage across the width of the lane being paved. A bonus system similar to that of thermal segregation and density variability detection could also be implemented to provide the contractor with more incentive to ensure the tack coat is applied properly.

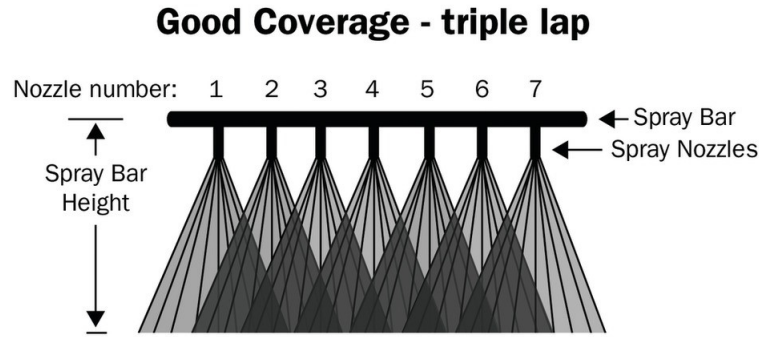
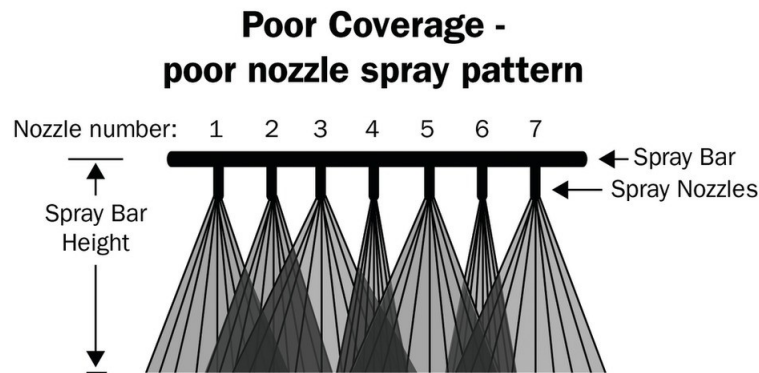
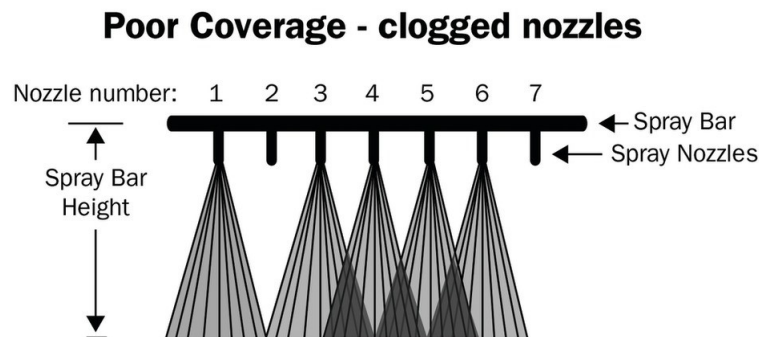
Figure 2.29: (a) Triple lap coverage; (b) Improper spray nozzle pattern from different nozzle angles; (c) Clogged nozzles (ForConstructionPros.com 2018).

The assurance of a uniform tack coat application to a pavement surface is governed by geometric and hydraulic factors of the equipment: spray nozzle patterns, spray bar height and distribution pressure (Mohammad et al. 2012). ODOT defines minimal specifications for the geometry of tack coat applicators on distributor trucks. They specify that applicators shall be adjustable both horizontally and vertically and shall be capable of applying “triple lap coverage” (ODOT 2015). “Triple lap coverage” refers to the overlap of three spray streams at the pavement surface interface (Mohammad et al. 2012). Different examples of coverage and how they are affected by nozzle geometry and clogging are shown below in Figure 2.29.

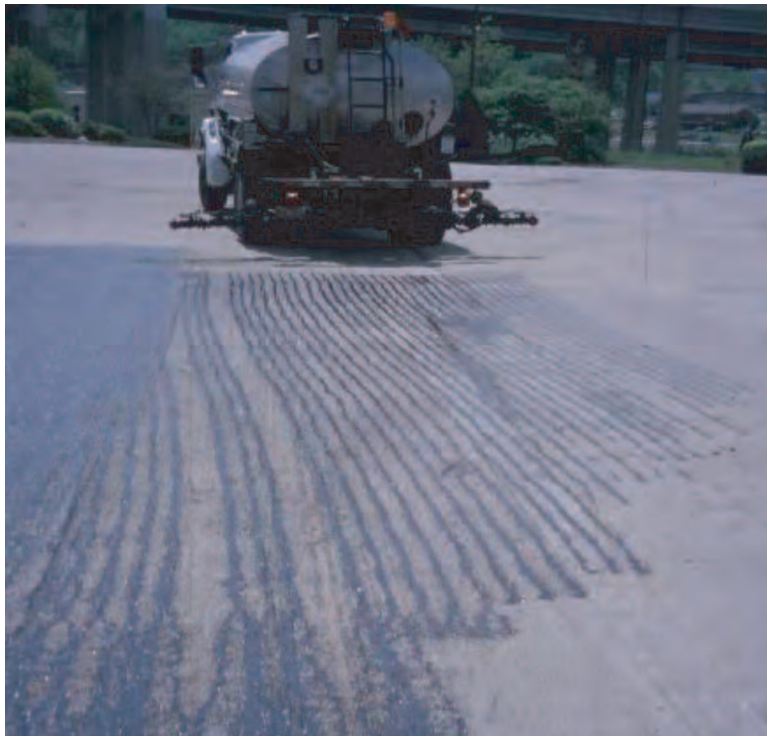
Geometric specifications are useful in ensuring that theoretical tack coat application is adequate. However, the construction specifications fall short on requirements for tack coat distributor truck control equipment. Not all tack coat distributor vehicles are equipped with the same spray control technology, which can lead to inherent variability in target application rate between trucks. Also, contractors, when in the height of construction season, often do not maintain their tack coat distributor equipment regularly. Long shifts and hectic schedules cause maintenance and cleaning of equipment to be deferred. This leads to tack coat spray nozzles that become clogged which ultimately causes nonuniform coverage in the transverse direction, often termed “streaking”, during tack coat application. This streaking phenomenon causes early pavement failure due to poor interlayer bonding. An example of streaking is shown below in Figure 2.30.

Figure 2.30: Tack coat streaking due to clogged nozzles (Mohammad et al. 2012).

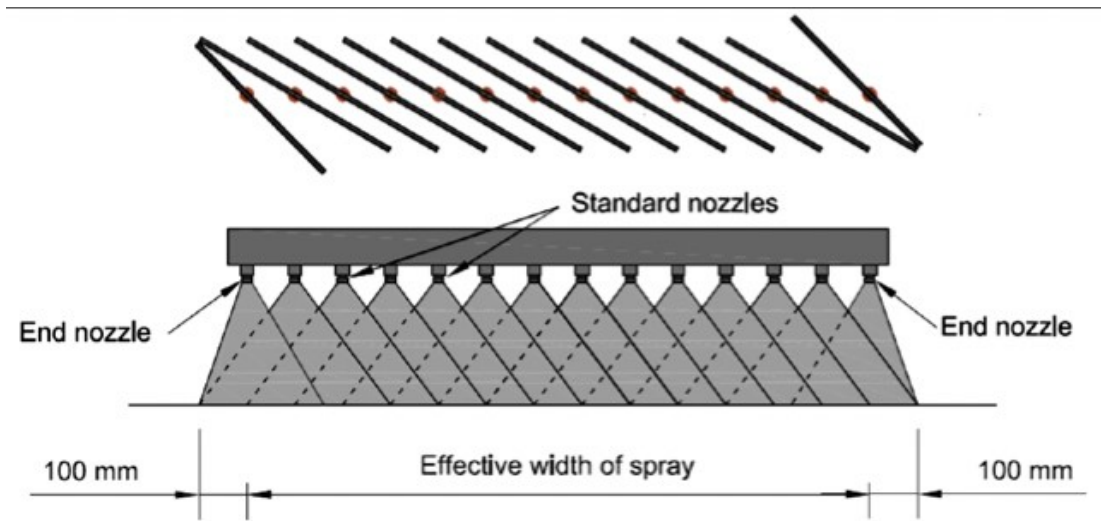
Figure 2.32: Effective width of spray bar and nozzle distribution (Holtrop and Patrick 2014).

A technical report by Holtrop and Patrick (2014) on behalf of Austroads details the specifications for pump-actuated bitumen distributor trucks, or sprayer trucks that are currently enforced in Australia. Austroads specifies that sprayers shall be annually inspected by an accredited facility before being used in construction activities. This inspection involves issuing calibration certificates for each truck which certify the equipment meets necessary requirements. These certificates are valid for 12 months and sprayers are subject to random audits throughout the 12-month period. The certification takes into account the width of the spray bar and all components of the spray system, such as nozzle arrangement and angle, in ensuring that the target application rate can be met with the geometry of the sprayer. The certificate information is published to an online database for public reference. If out of specification, Austroads requires re-calibration or field audit testing before the sprayer truck is allowed for use in construction. Austroads also specifies that sprayer trucks should be able to ascend 10% grades while fully loaded without compromising uniform application rate. Austroads also has provisions for effective width of the spray bar, accounting for the outside edges of the spray bar where lap coverage is reduced. They specify that the uniform spray rate

shall be the same across the entire effective width. A diagram showing the effective width of a spray bar is shown below in Figure 2.32.

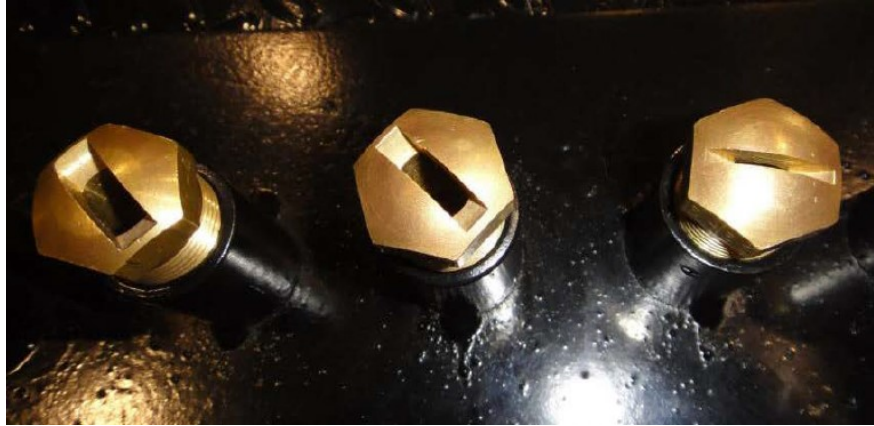
adequate to suit the tack coat material being used and achieve the desired application rate. Figure 2.33 shows different nozzle sizes that correspond to different application rates.

Figure 2.33: Various nozzle sizes corresponding to different application rates (FHWA 2016).

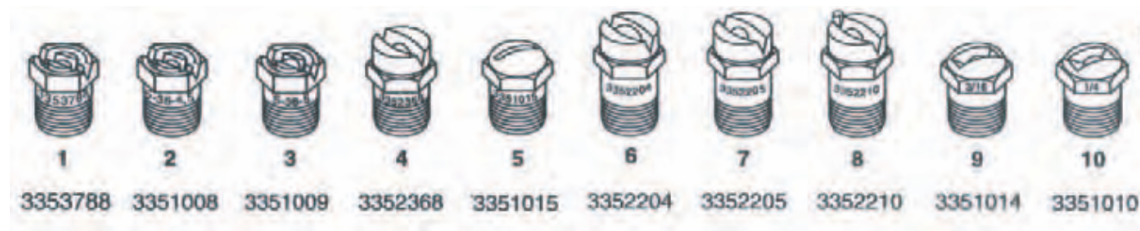
Figure 2.34: Nozzle types for different application rates/flow rates (Mohammad et al. 2012).

Spray nozzles were a consideration in the study by Mohammad et al. (2012). Various spray nozzle types are available to suit a variety of application and flow rates. It is important that the proper nozzles be selected according to the desired range of target application rates and the capabilities of the distributor equipment. Selection of nozzle sizes should also be done in light of recommendations from the tack coat and distributor truck manufacturers. Figure 2.34 shows an example of different nozzle types from Etnyre that are employed for different application and flow rates.

Ref.	Part No.	Description	Application (per square yard)	Application (Metric) Liters per square meter	Flow Gallons per minute per foot
1	3353788	V Slot Tack Nozzle	0.05 - 0.20	0.19 - 0.75	3.0 to 4.5
2	3351008	S36-4 V Slot	0.10 - 0.35	0.38 - 1.30	4.0 to 7.5
3	3351009	S36-5 V Slot	0.18 - 0.45		7.0 to 10.0
4	3352368	Multi-Material V Slot	0.15 - 0.40	0.57 - 1.50	6.0 to 9.0
5	3351015	3/32-inch Coin Slot	0.15 - 0.40	0.57 - 1.50	6.0 to 9.0
6	3352204*	Multi-Material V Slot	0.35 - 0.95	1.30 - 3.60	12.0 to 21.0
7	3352205*	Multi-Material V Slot	0.20 - 0.55	0.75 - 2.08	7.5 to 12.0
8	3352210	End Nozzle	0.20 - 0.55	0.75 - 2.08	7.5 to 12.0
9	3351014	3/16-inch Coin Slot	0.35 - 0.95	1.30 - 3.60	12.0 to 21.0
10	3351010	¼-inch" Coin Slot	0.40 - 1.10	1.50 - 4.16	15.0 to 24.0

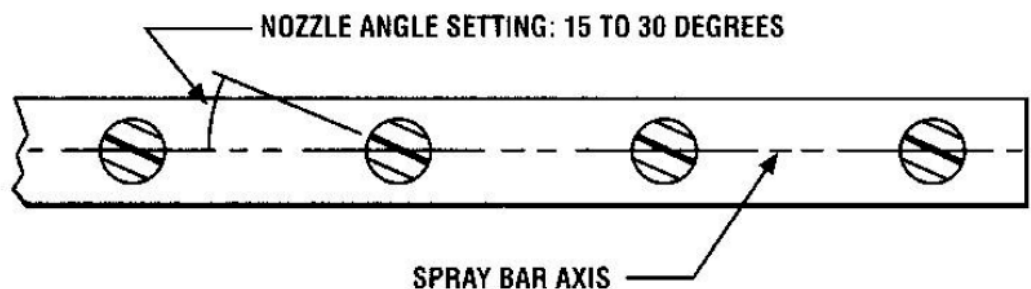
Figure 2.35: Proper nozzle orientation (FHWA 2016).

Nozzle orientation should also be checked to ensure they are within the 15-30° offset range from the spray bar, as suggested by FHWA (2016). Proper nozzle orientation ensures that spray streams from adjacent nozzles do not conflict with one another. Mohammad et al. (2012) suggested that all nozzles be set at the same angle, typically 30° for most equipment. However, calibration of the distributor truck is still necessary after nozzle orientation to verify proper application rates. Figure 2.35 shows a diagram of proper nozzle orientations in relation to the spray bar.
