**IMPLEMENTATION OF ODOT TACK
COAT TECHNOLOGIES AND
PROCEDURES TO IMPROVE LONG-
TERM PAVEMENT PERFORMANCE**

Final Report

PROJECT SPR 818

Oregon Department of Transportation

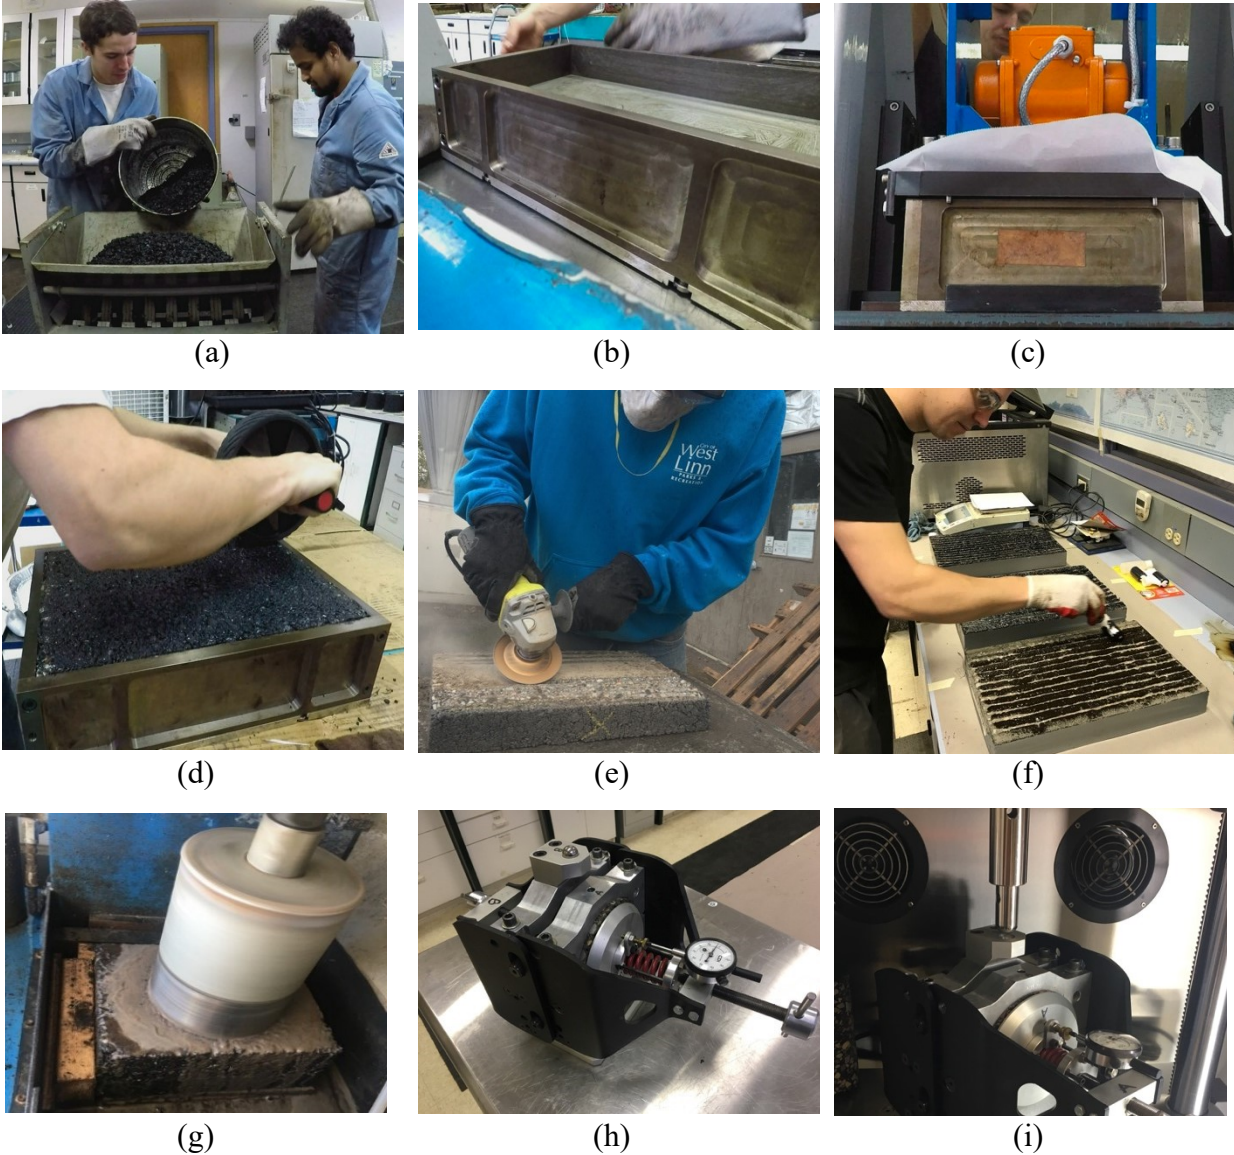
Figure 3.1: General sample preparation process for laboratory shear test samples.

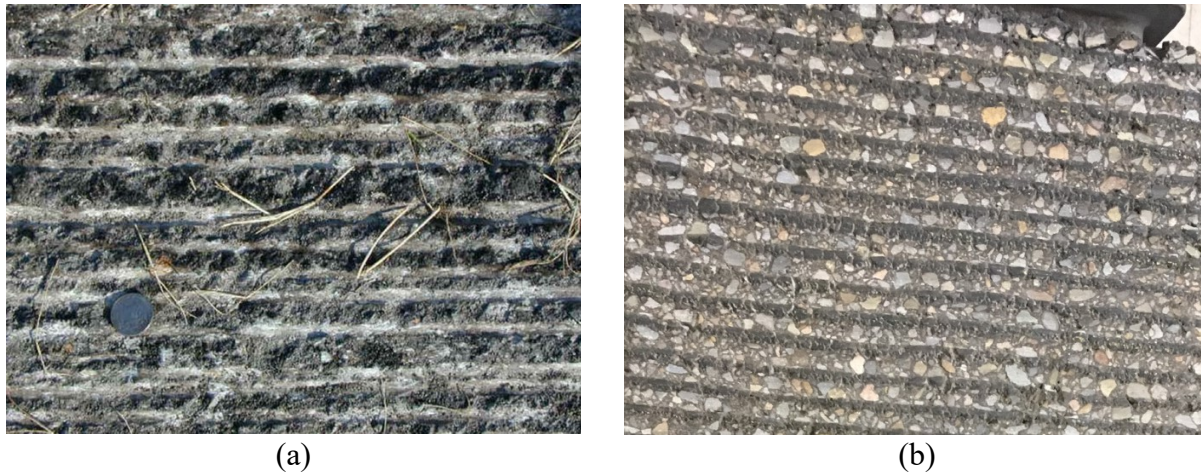
Figure 3.2: Comparison of milled pavement surfaces (a) in the field (Mokarem 2006) and (b) in the laboratory.

Milling was performed on first lift samples accordingly. Milling was only performed on those samples which were intended for milled surface tests. A milled surface texture with a mean texture depth (MTD) of 0.07 in - 0.09 in (1.78 mm - 2.29 mm) was targeted in order to closely replicate actual milled surface textures in the field (Coleri et al. 2017). Milling was performed using a 4.5 in (114.3 mm) angle grinder with a concrete cutting wheel. The grinder was held at a 45° angle to produce straight grooves on the samples, similar to the pattern of milled surfaces in the field. Figure 3.1e shows milling taking place on first lift samples. Figure 3.2 below shows a comparison of laboratory milled surface samples to an actual milled surface in the field.

After milling, the sample was cleaned with a coarse wire brush to simulate sweeping in the field. Sand patch testing, according to ASTM E965 (ASTM 2015a), was performed after milling in order to quantify the MTD of each sample for later use. Although milling of the samples increased the volume of the second lift in the compaction mold, no adjustments were made to the amount of HMA in the second lift. It was assumed that a similar phenomenon would result in the field as a result of milling.

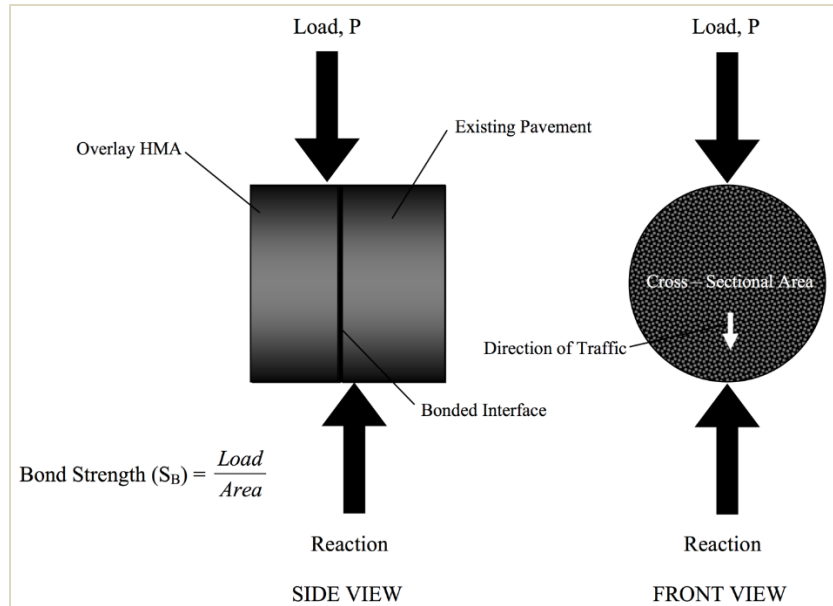
Figure 3.3: Sample loading configuration for shear testing (ALDOT 2008).

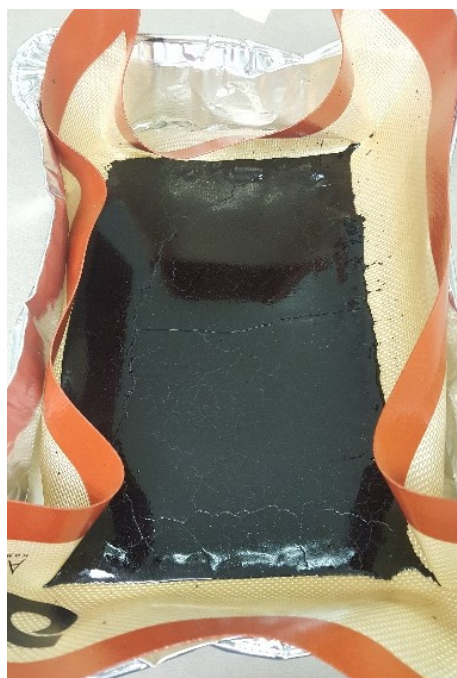
Figure 3.4. Tack coat binder after low temperature distillation

Isolation of the tack coat binders was done by distillation at 60 °C (140 °F) (ASTM D7497 2016) (Figure 3.4). Water contents were measured for three replicate samples for each tack coat type and averages are summarized in Table 3.4. This low temperature distillation method was preferred over the conventional standard (ASTM D6997 2012) due to its decreased level of heat. The use of high temperatures has the potential to change the binder’s rheological properties and increase chances of inconsistent test results. A previous study compared distillation temperatures of 338 °F (170 °C) and 500 °F (260 °C) and found that the temperature of the distillation process had insignificant effects on the viscosities of the binders (Covey 2017). However, the authors of this study also concluded that these temperatures were too high to properly recover binder from new engineered emulsions with high polymer contents.

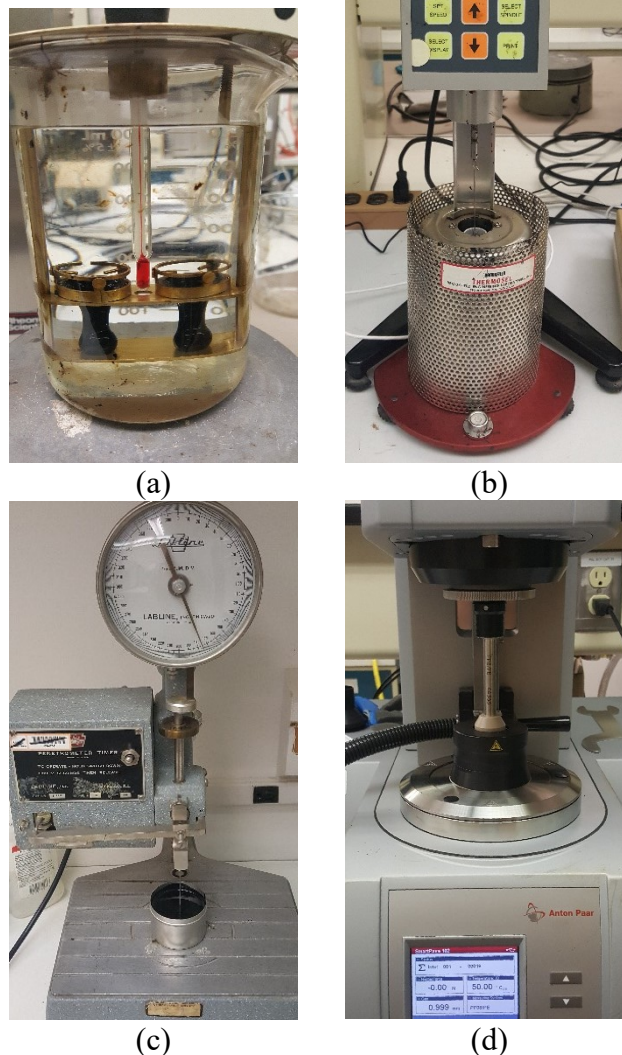
Figure 3.5. Rheological tests conducted: (a) Softening point, (b) Rotational viscosity, (c) Penetration (d) DSR

A total of nine tack coats were tested and analyzed. Each tack coat emulsion was distilled according to ASTM D7497 (2016) in order to extract their binder from the tack coat. Softening point and rotational viscosity tests were performed according to ASTM D36 (2014) (Figure 3.5a) and ASTM D4402 (2015) (Figure 3.5b), respectively. Penetration and Dynamic Shear Rheometer tests were also conducted, in accordance with ASTM D5 (2013) (Figure 3.5c) and ASTM D7175 (2015) (Figure 3.5d), respectively.

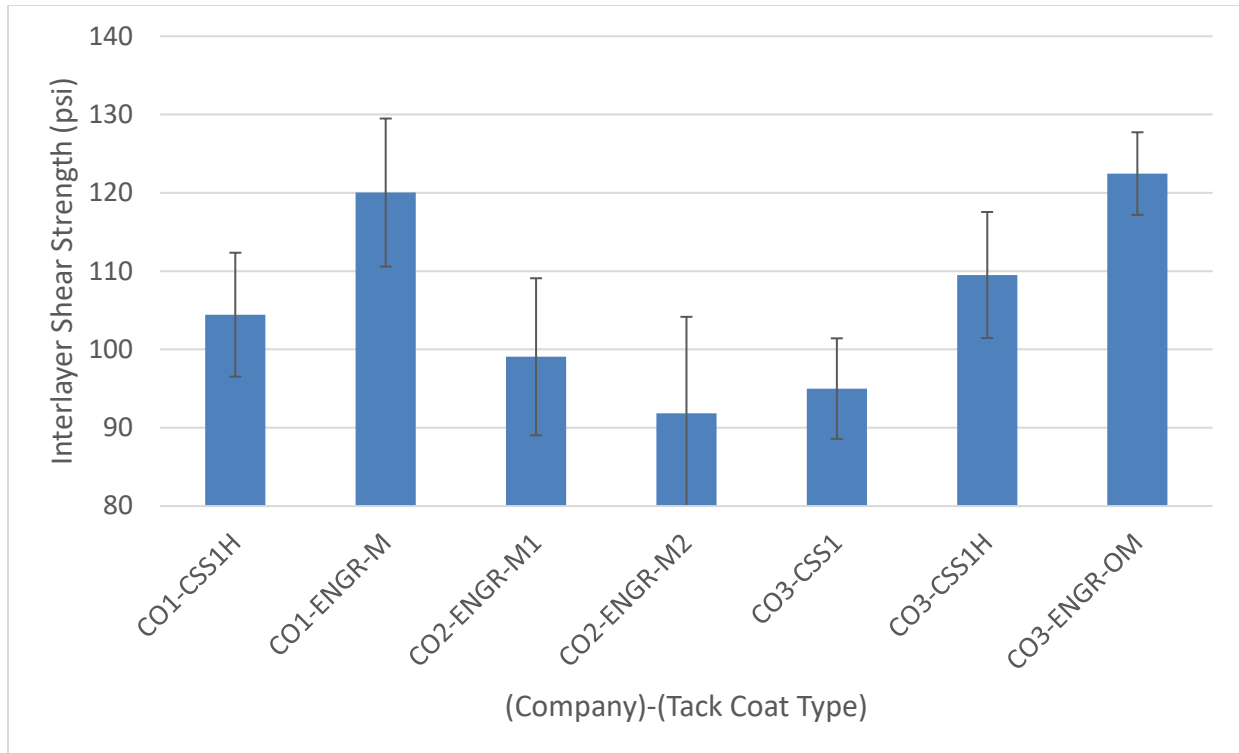
Figure 3.6: Average ISS results for all tack coats with error bars indicating ± 1 standard deviation (1.0 psi = 6.89 kPa)

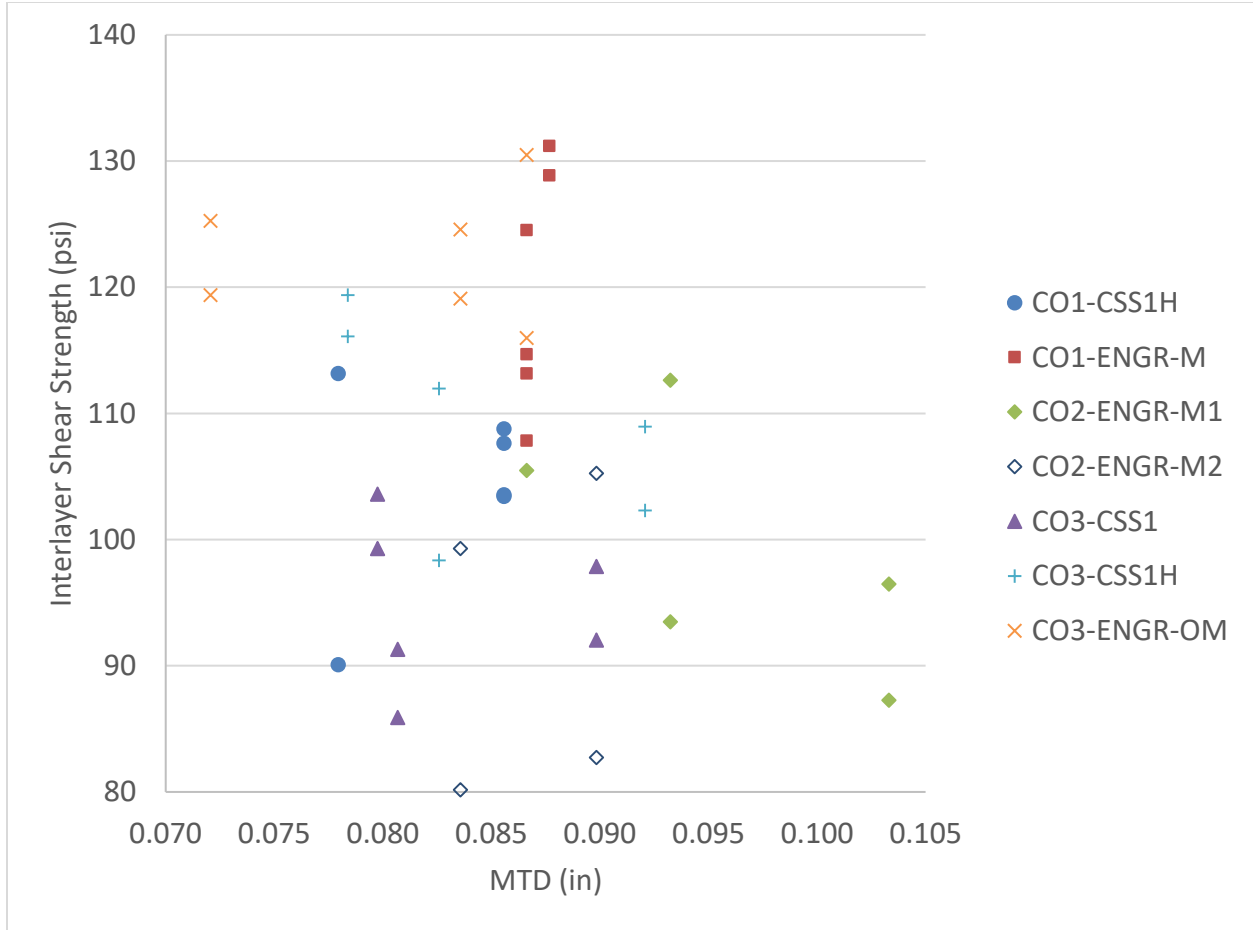
Figure 3.7: Peak shear strength versus MTD for each tack coat type (1.0 psi = 6.89 kPa; 1.0 in = 2.54 cm)

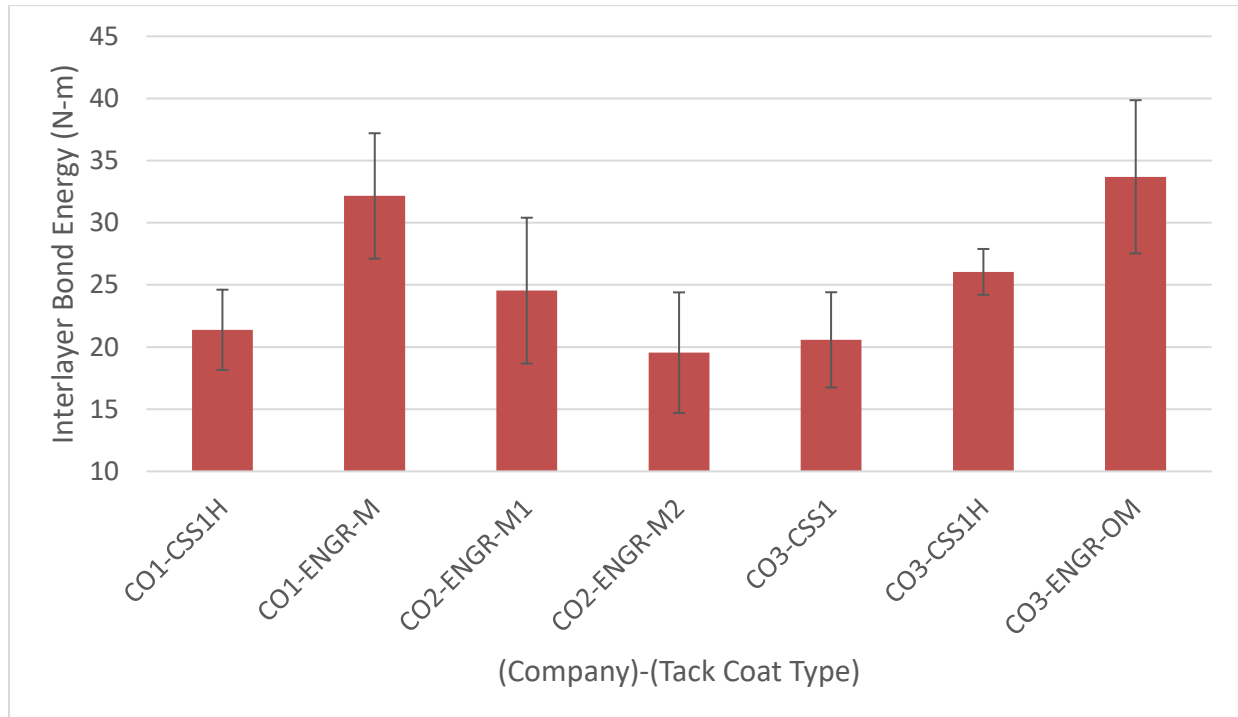
Figure 3.8: Average interlayer bond energy results for all tack coats with error bars indicating ± 1 standard deviation (1.0 N-m = 8.85 in-lbs).

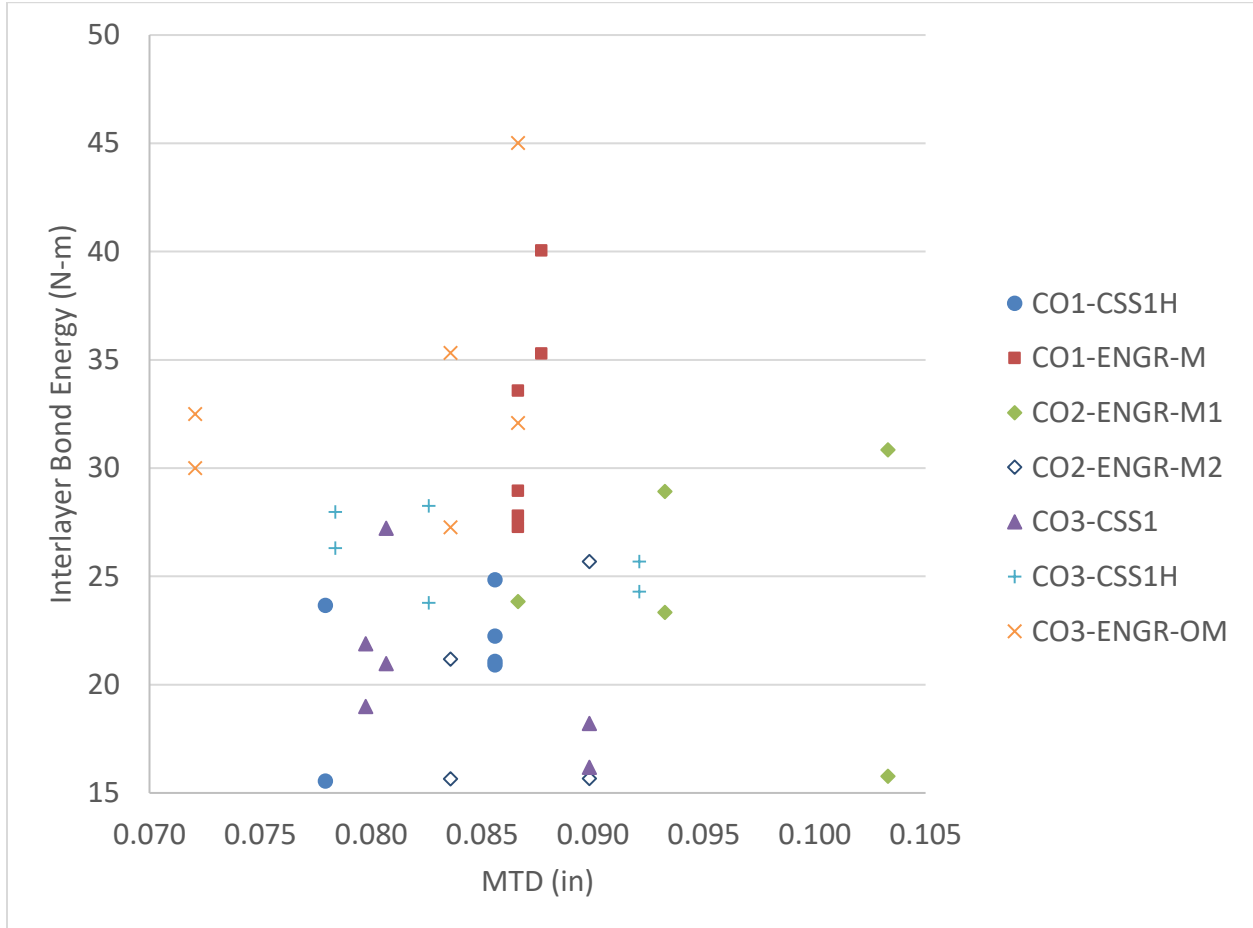
Figure 3.9: Interlayer bond energy versus MTD for each tack coat type (1.0 N-m = 8.85 in-lbs; 1.0 in = 2.54 cm).

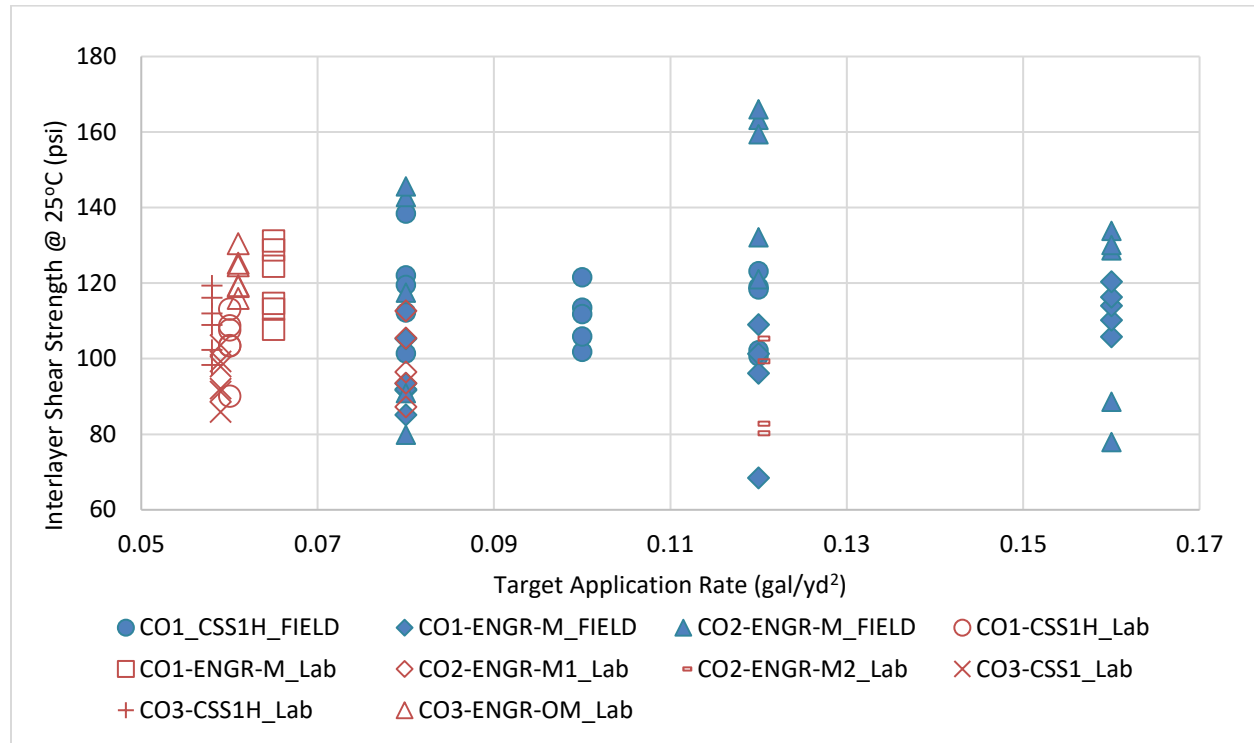
Figure 3.10: Peak shear strength versus application rate for field-cored samples and laboratory-produced samples (25 °C = 77 °F; 1.0 psi = 6.89 kPa; 1.0 gal/yd² = 4.53 L/m²)

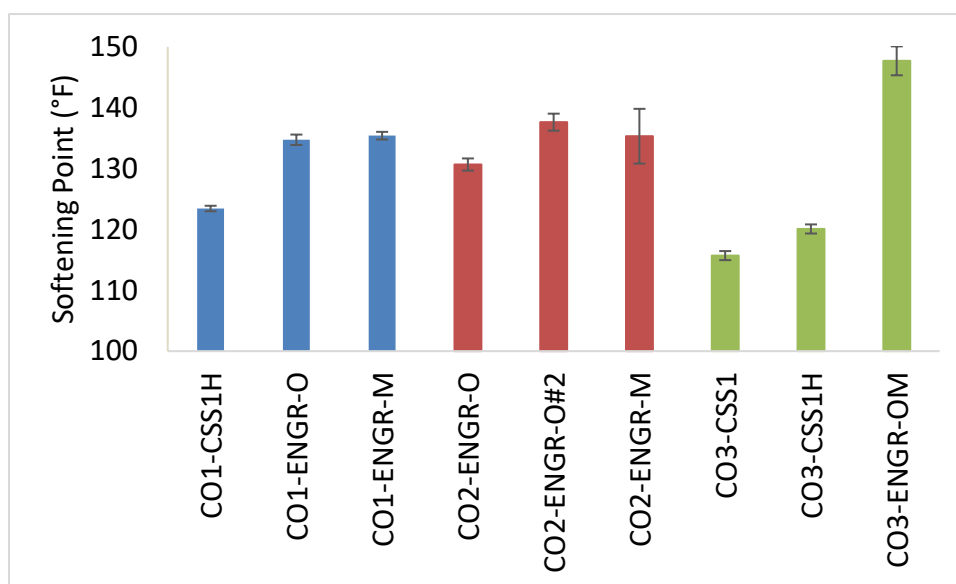
Binders that displayed higher softening points indicated a more viscous binder. The engineered binders displayed the highest softening point values, while the CSS-1H binders gave the lowest (Figure 3.11). This suggests that these tack coat binders are softer than the newly engineered binders.

Figure 3.11: Softening point test results (77 °F = 25 °C)

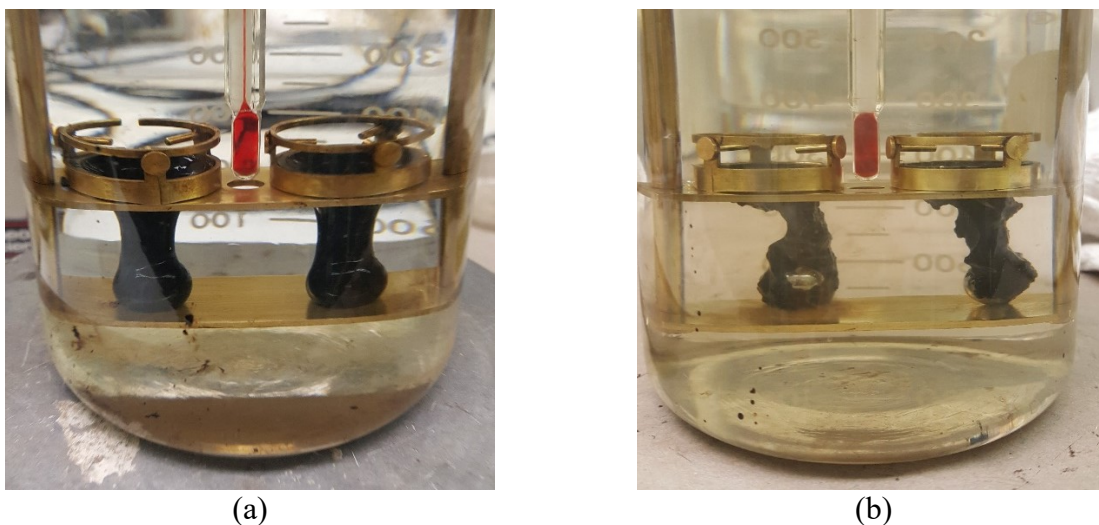
A discrepancy in the results for the softening point test can be seen in the values displayed for the CO2-ENGR-M distilled emulsion. This particular binder did not have a smooth consistency when poured (Figure 3.12a), as was typical with the other binders, presumably due to the binder being polymer-modified and not able to withstand the sample preparation temperatures. As a result, the binder was not evenly distributed throughout the test rings. During the testing process, the deformed CO2-ENGR-M binder around the steel balls softened, resulting in the steel balls to break through the binder (Figure 3.12b). This resulted in inconsistent values to be obtained, and may explain the high variability in test results associated with this particular tack coat binder. Additionally, as the binder softened and the steel balls broke through, the binder released a residue that diffused throughout the water.

Figure 3.12: Softening point experiment of (a) CO1-CSS1H (b) CO2-ENGR-M

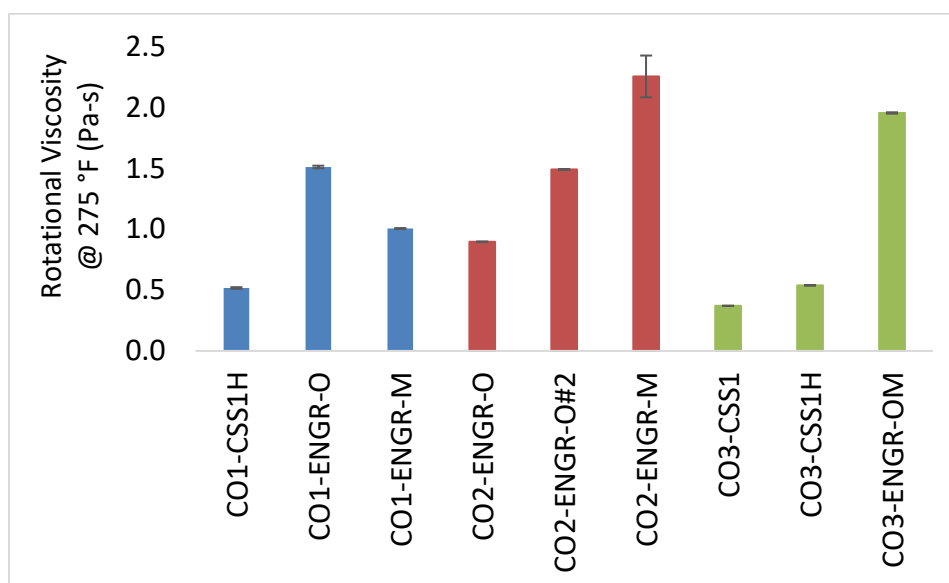
Figure 3.13 illustrates the results of the RV test. Rotational viscosity values for the engineered binders are higher than CSS-1H binders, again implying that these binders are stiffer.

Figure 3.13: Rotational viscosity test results

Company 3 displays consistent results between RV and SP. On the other hand, Company 2 had slightly skewed results between RV and SP tests. CO2-ENGR-M displayed very high RV values as well as large amounts of variation within these results. The test was conducted at 275 °F (135 °C), a temperature that may have been too high for this particular binder to withstand. Therefore, the viscosity may be higher than expected and

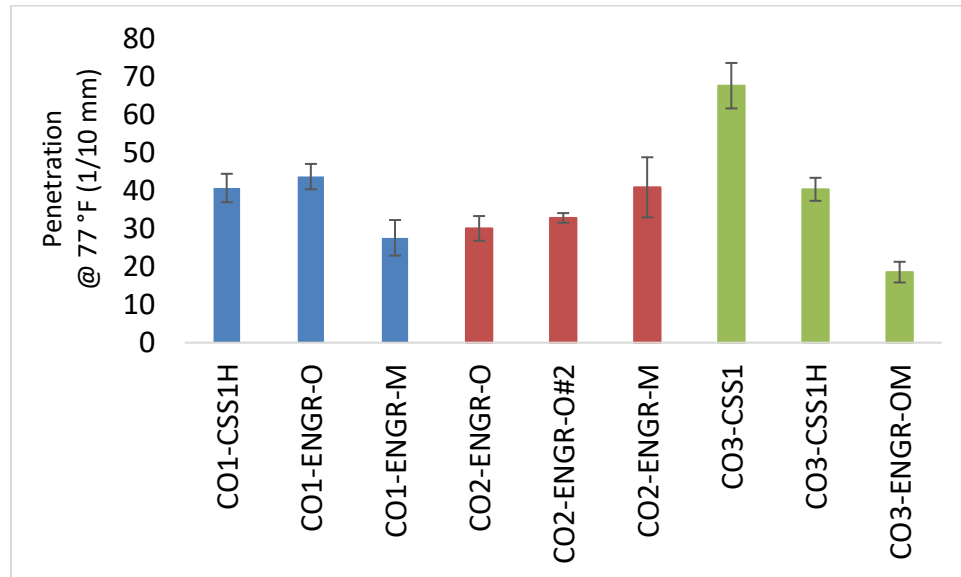
Penetration results are illustrated in Figure 3.14. Again, results from Company 3 are consistent with the results from the previous tests. CO1-ENGR-M shows a relatively lower penetration than most other tack coat binders, signifying a stiff binder, which is consistent with the RV results.

Figure 3.14: Penetration test results (77 °F = 25 °C; 1.0 mm = 3.94x10⁻² in)

The test results obtained for the CO2-ENGR-M distilled emulsion had high variability, as can be seen by the error bar associated with the results (Figure 3.14). The surface of the binder was not smooth, which made it difficult to pinpoint areas to perform the test (Figure 3.15). The non-uniformity of the binder may have contributed to the high variability seen in the results. Additionally, penetration test results for this binder did not align with the results from the other rheological tests, as the values obtained from this test suggest a soft binder.

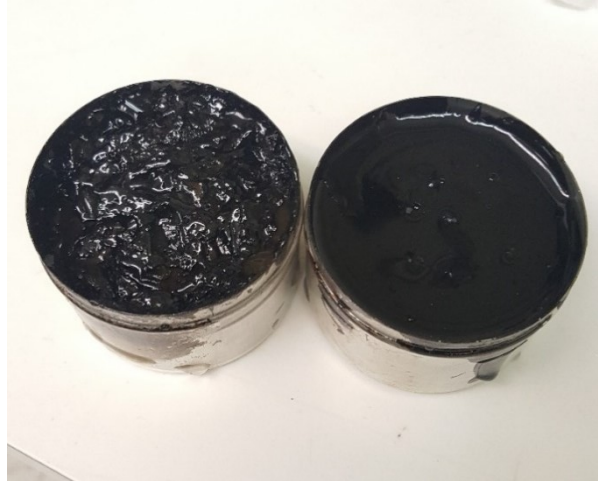
Figure 3.15: Comparison of CO2-ENGR-M binder (left) and CO1-CSS1H binder (right)

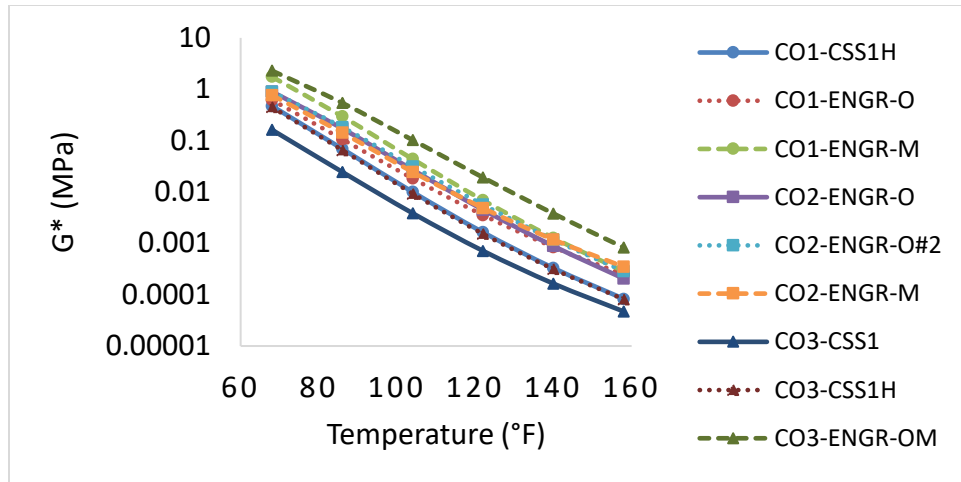
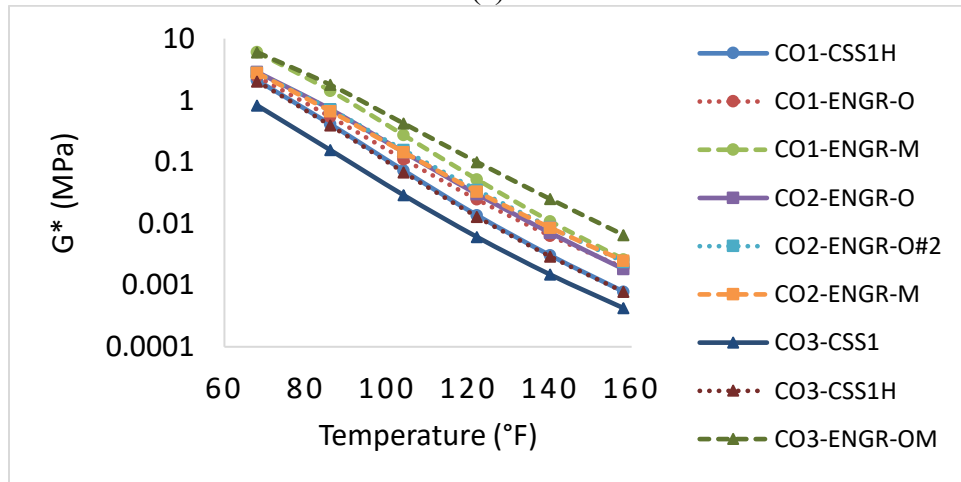
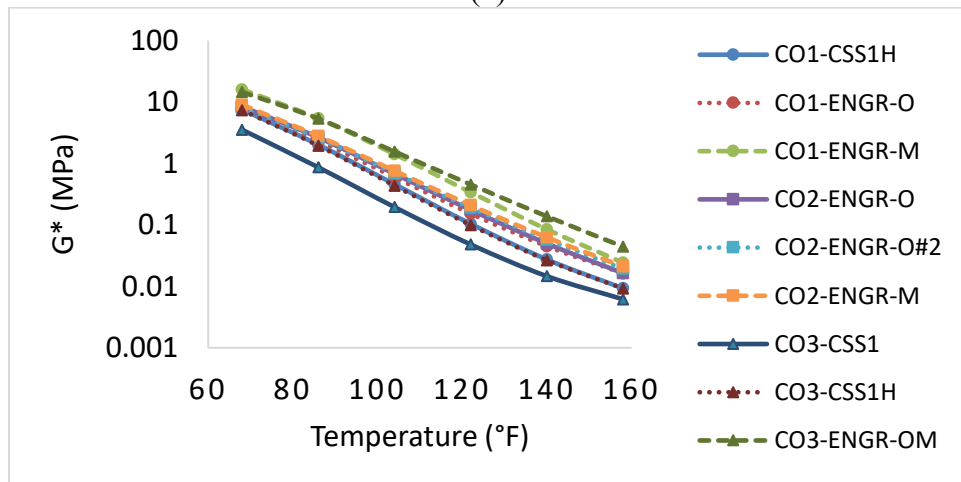
The results given by DSR testing allowed for comparisons to be made between each of the tack coat binders in terms of complex shear modulus (G^*) and phase angle (δ). Binders with smaller G^* values were expected to be softer while smaller phase angles were expected to be less viscous. Figure 3.16 shows the G^* values for each of the tack coat binders at various temperatures and frequencies. The general trend is similar between each of the frequencies. Stiffer binders like CO3-ENGR-OM were observed to have higher G^* values while softer binders like CO3-CSS1 had lower G^* values. CO1-CSS1H and CO3-CSS1H had almost identical phase angles and G^* values for all loading frequencies and temperatures.

Figure 3.16: DSR results for complex shear modulus results at (a) 0.1 Hz, (b) 1 Hz (c) 10 Hz (1.0 MPa = 145.0 psi; 77 $^{\circ}\text{F}$ = 25 $^{\circ}\text{C}$)

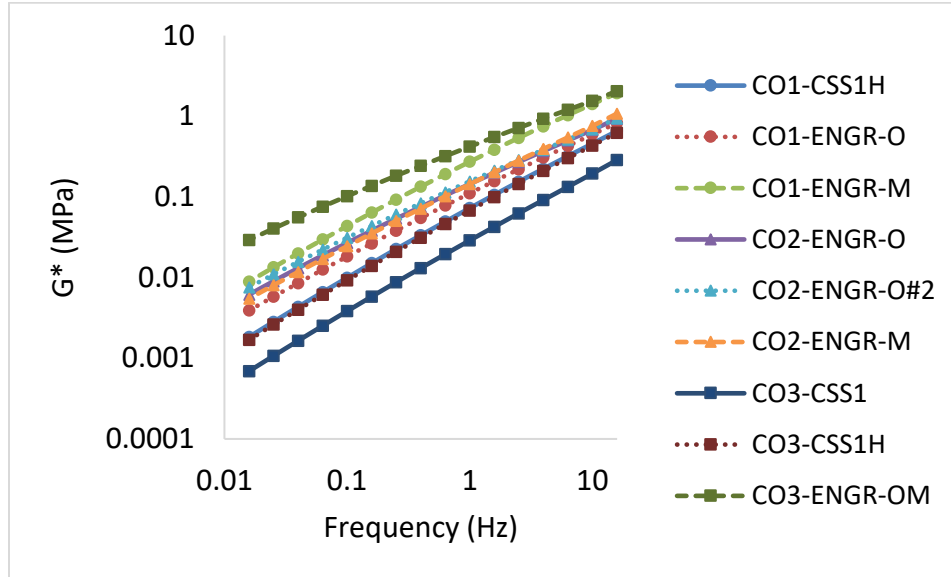
G^* was also plotted against frequency. Figure 3.17 shows the results of the test at 104 °F (40 °C).

Figure 3.17: DSR results for complex shear modulus results at 104 °F (40 °C) (1.0 MPa = 145.0 psi)

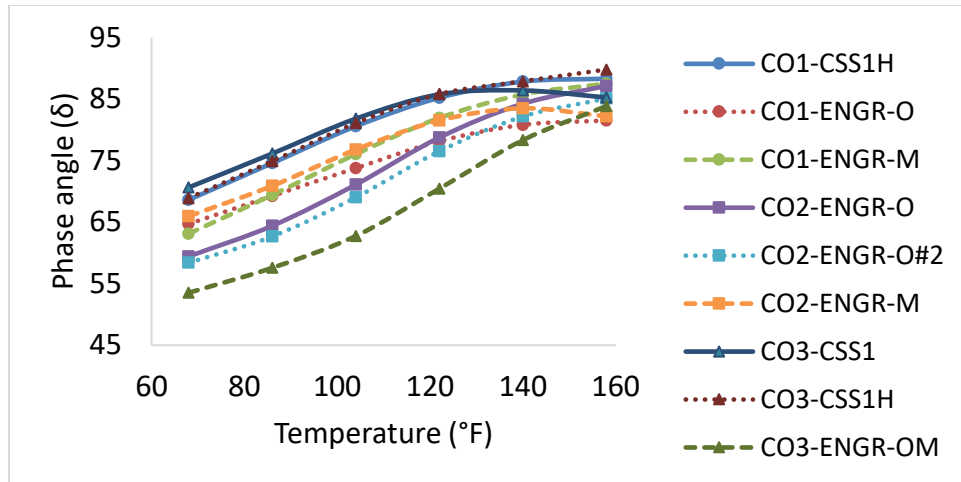
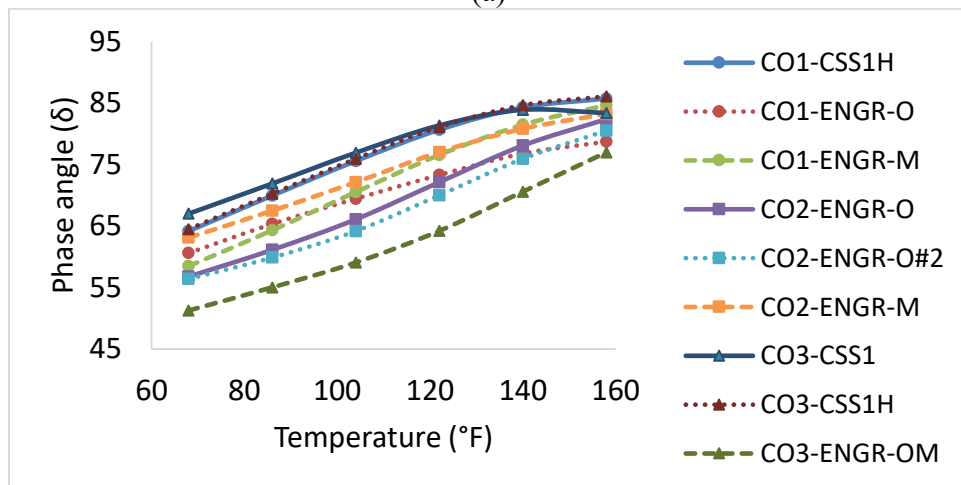
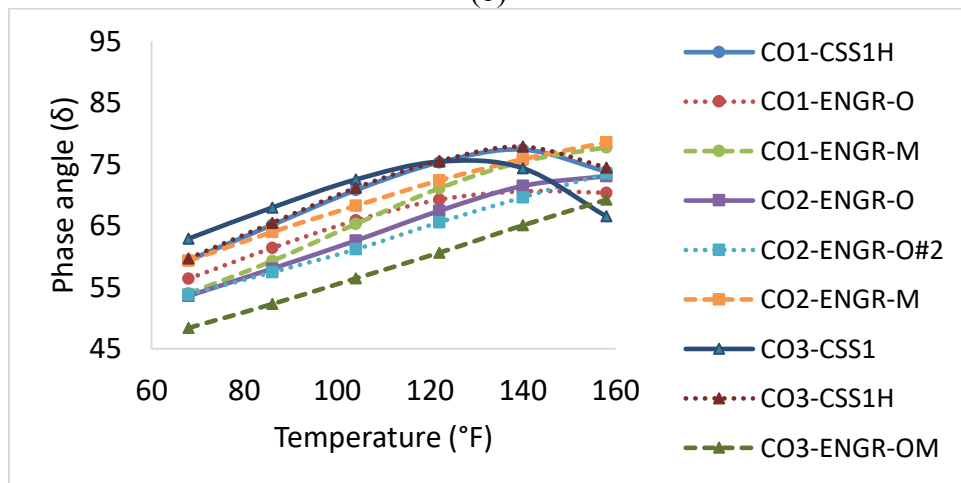
Figure 3.18 shows the phase angle values for each of the tack coat binders at various temperatures and frequencies. A lower phase angle indicates more elastic behavior. However, as the temperature increases, the viscosity of the binder decreases, which can also be easily identified at lower frequencies for the softer binders (Figure 3.18). For some binders, phase angles increase with increasing temperature but then start to decrease after reaching a peak value. This is due to the changing mechanical properties of the binder with the changes in temperature. Asphalt binder is acting more like an elastic material (low phase angles) at lower temperatures, and then it starts to turn into a viscoelastic material (higher phase angles) with increasing temperature. At very high temperatures, it starts behaving more like a low viscosity material (more like a fluid), which starts reducing the phase angles after reaching the peak. It can be observed that CSS-1H and CSS-1 binders have the highest phase angles (more delayed elastic and viscous behavior and less elastic behavior).

Figure 3.18: DSR results for phase angle at (a) 0.1 Hz, (b) 1 Hz (c) 10 Hz (77 °F = 25 °C)

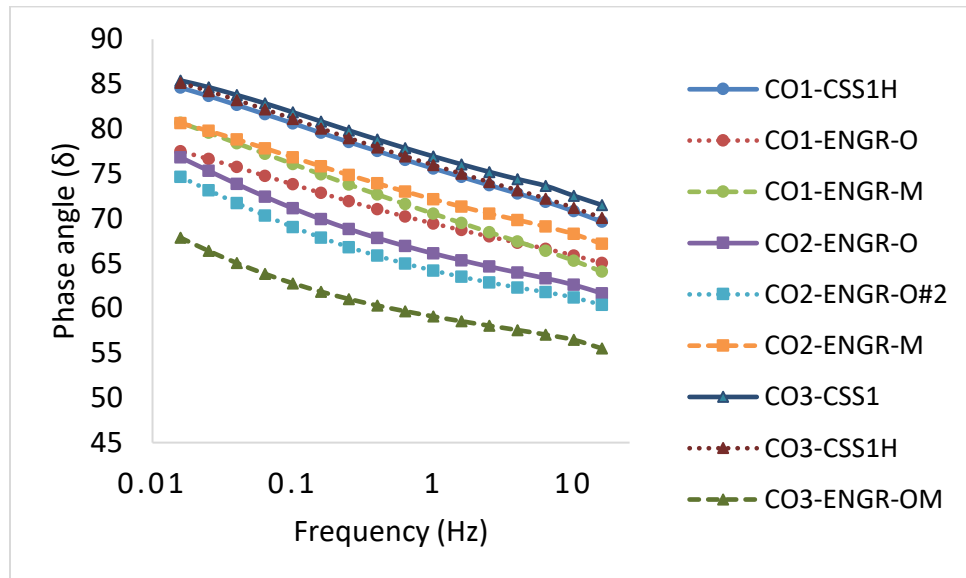
Figure 3.19: DSR results for phase angle at 104 °F (40 °C)

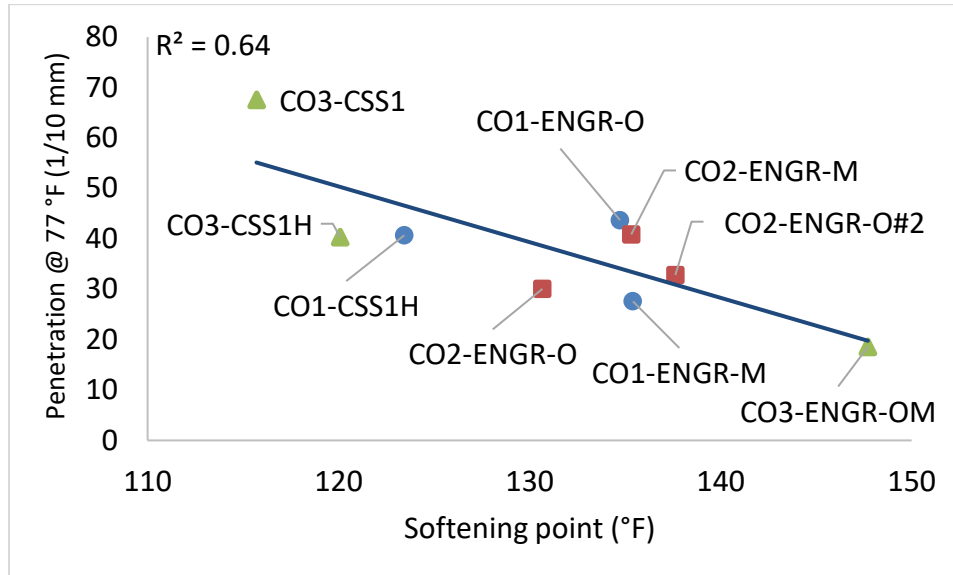
Figure 3.20: Relationship between penetration and softening point tests (1.0 mm = 3.94×10^{-2} in; 77 °F = 25 °C)

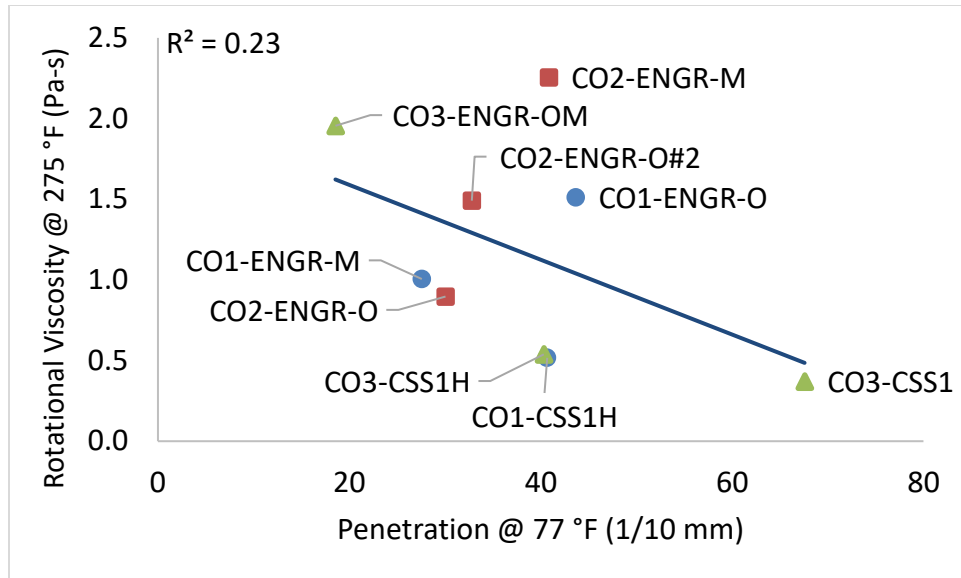
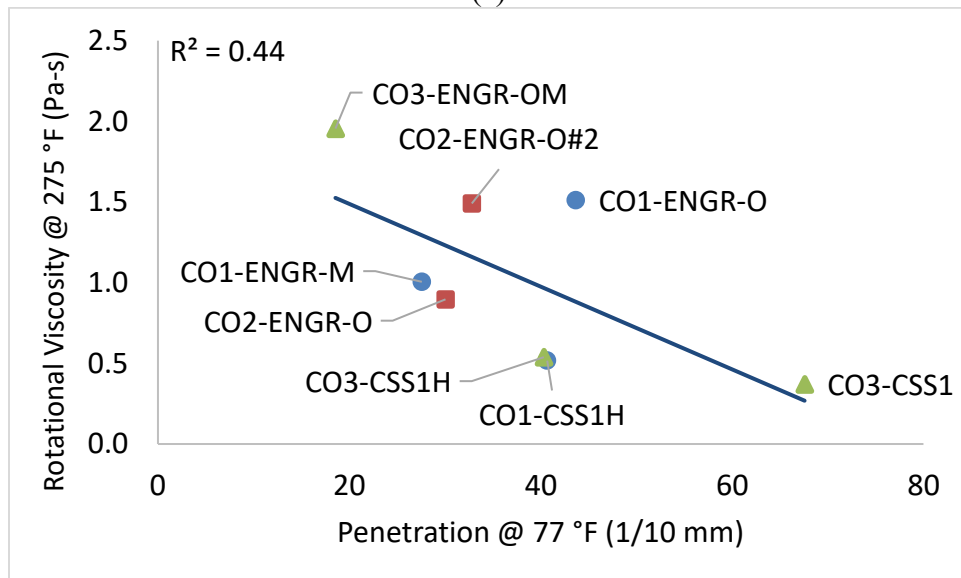
Figure 3.21: Relationship between rotational viscosity and penetration tests (a) including CO2-ENGR-M (b) excluding CO2-ENGR-M (77 °F = 25 °C)

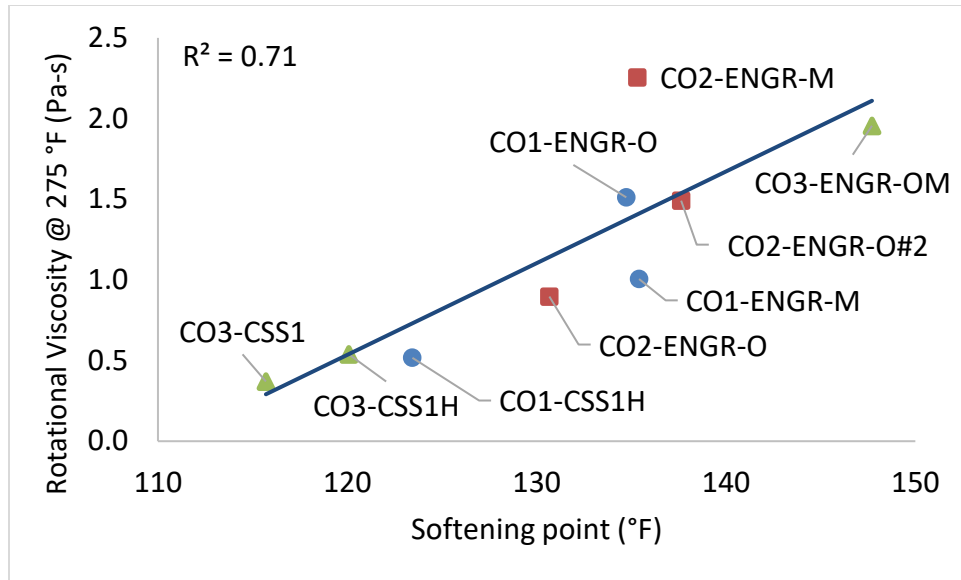
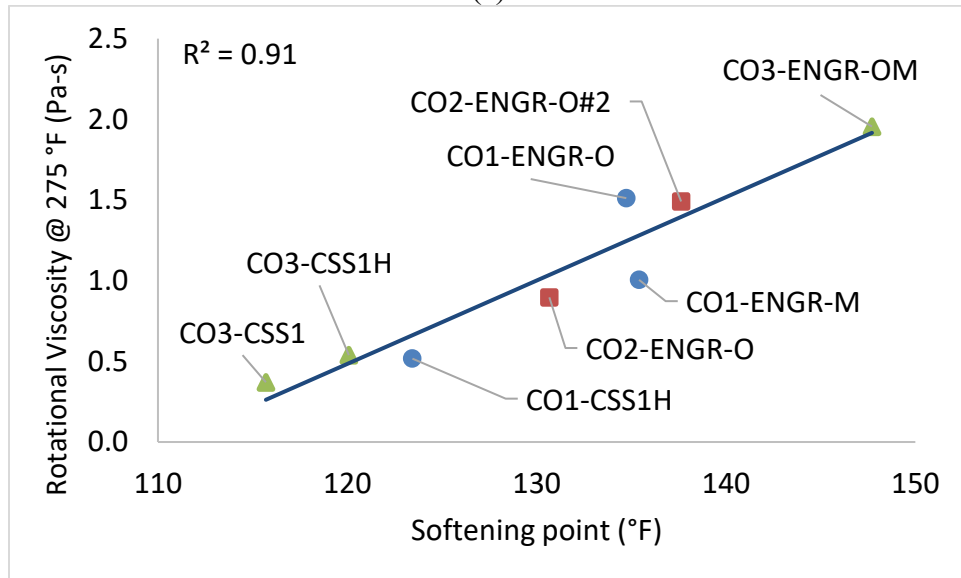
The results from penetration and softening point testing show a negative relationship (Figure 3.20). This is expected, as higher softening point values give way to lower penetration results. The values obtained for each of the tack coat types show an acceptable correlation, with an R^2 value of 0.65. A negative relationship is also observed when comparing rotational viscosity and penetration test results (Figure 3.21). This is expected, as softer binders have lower viscosity readings. However, in this comparison, CO2-ENGR-M did not necessarily follow the trend that was seen in the other tack coat binders. This may be due to the unusually high rotational viscosity value that was obtained for this particular tack coat. An R^2 value of 0.23 suggests that these tests were not well correlated (Figure 3.21a), presumably due to the large difference in temperature between each of the tests [RV test temperature was 275 °F (135 °C) and penetration test temperature was 77 °F (25 °C)]. However, when the point representing CO2-ENGR-M was excluded, the coefficient of determination for the relationship between rotational viscosity and penetration almost doubled to 0.44 (Figure 3.21b). Results from rotational viscosity and softening point experiments were positively correlated, as lower softening points gave way to lower viscosity readings (Figure 3.22). Again, CO2-ENGR-M stood out from the general trend,

though the R^2 value for these tests was still 0.64 (Figure 3.22a). However, excluding this point from the plot allowed the relationship between the tests to become stronger, with a strong correlation of 0.91 (Figure 3.22b). The discrepancy in this particular data point (CO2-ENGR-M) may be due to the unexpected values obtained from both tests.

Figure 3.22. Relationship between rotational viscosity and softening point tests (a) including CO2-ENGR-M (b) excluding CO2-ENGR-M (77 °F = 25 °C)

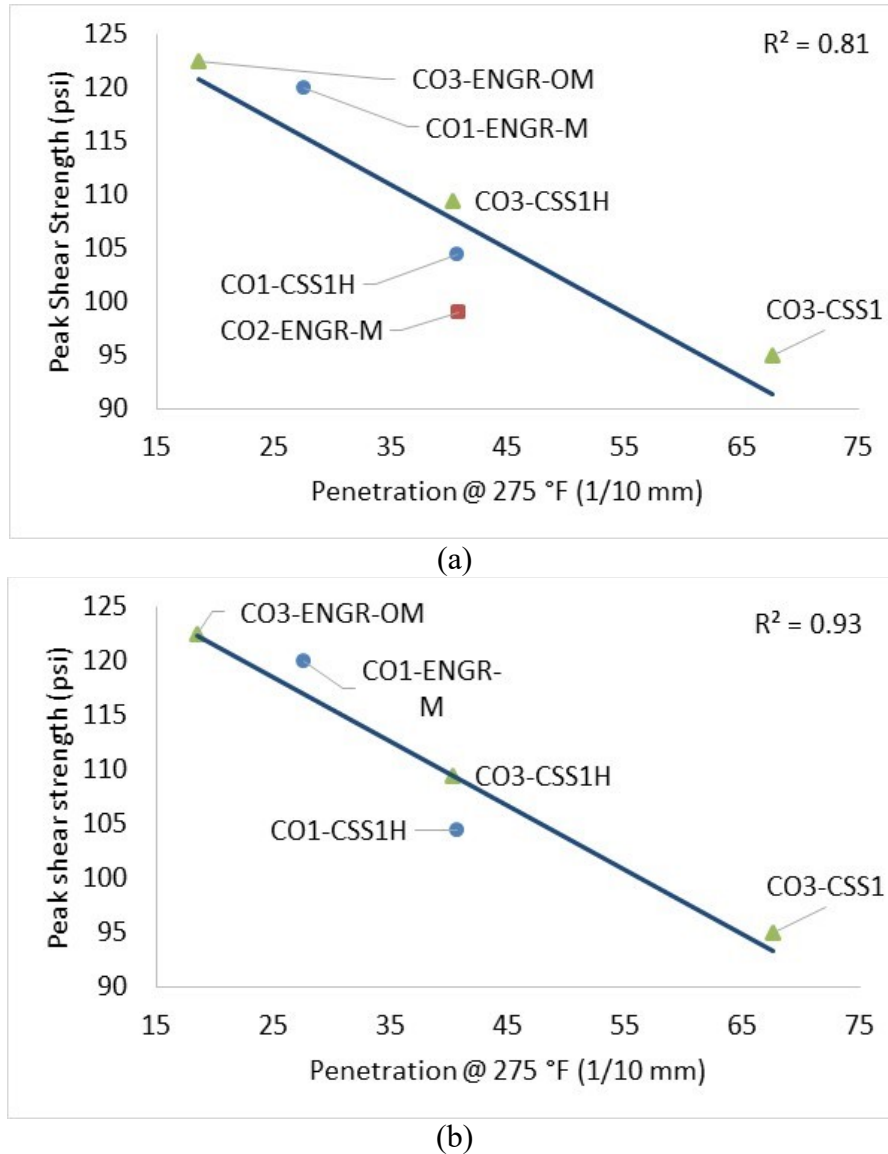
Figure 3.23. Relationship between ISS and Penetration (a) with CO2-ENGR-M (b) without CO2-ENGR-M (1.0 psi = 6.89 kPa; 77 °F = 25 °C; 1.0 mm = 3.94x10⁻² in)

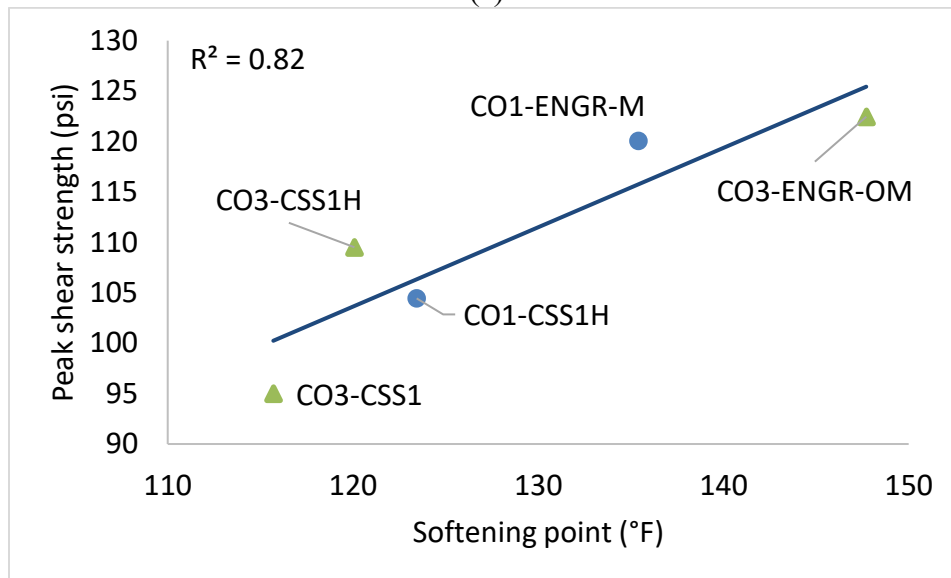
A positive correlation is illustrated for the relationship between shear strength and softening point (Figure 3.24). Again, the discrepancy seen with CO2-ENGR-M can be attributed to the inaccurate softening point value obtained, resulting in an R^2 of 0.50. The R^2 increases to 0.82 when this point is excluded, suggesting that softening point is a satisfactory test that can be used to predict the bond performance of tack coats. Correlations between bond energy and SP were also made, and resulted in similar trends.

Figure 3.24. Relationship between ISS and SP (a) with CO2-ENGR-M (b) without CO2-ENGR-M (1.0 psi = 6.89 kPa; 77 °F = 25 °C)
