**IMPLEMENTATION OF ODOT TACK
COAT TECHNOLOGIES AND
PROCEDURES TO IMPROVE LONG-
TERM PAVEMENT PERFORMANCE**

Final Report

PROJECT SPR 818

Oregon Department of Transportation

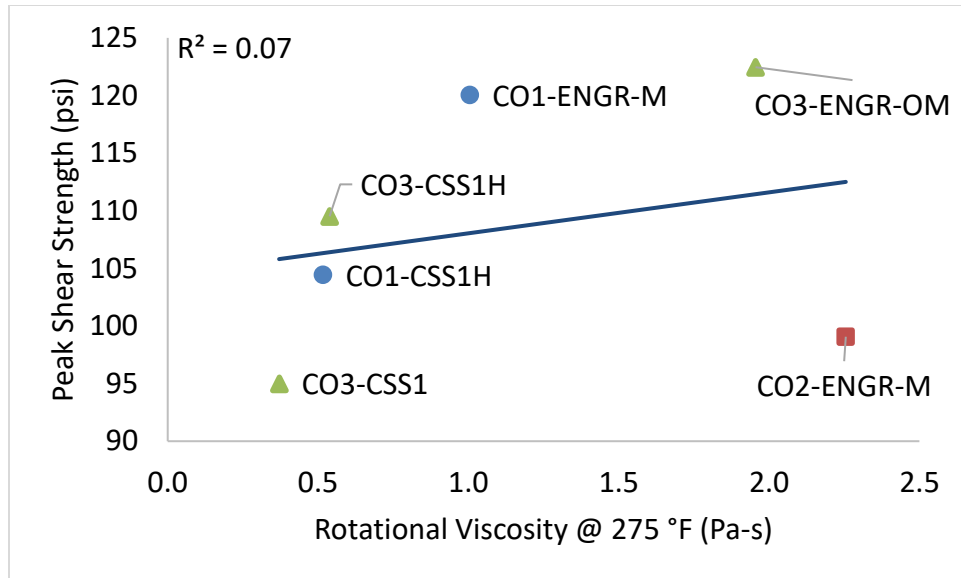
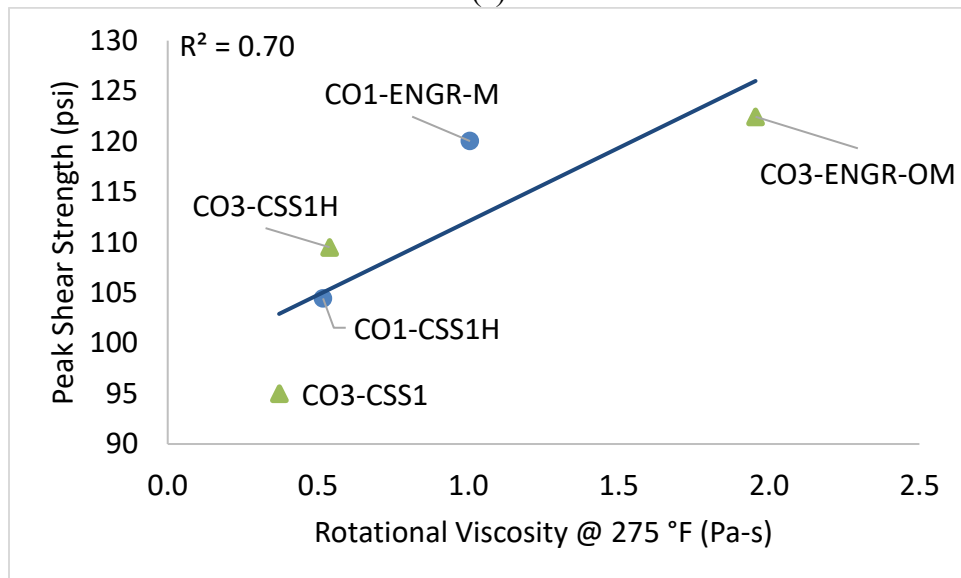
Results plotted for shear strength of the tack coat emulsions and rotational viscosity of the binder tests indicated that CO2-ENGR-M is an outlier, likely due to the skewed results from the rotational viscosity test for this particular binder (Figure 3.25a). When excluded from the plot, it is clear to see that a positive relationship exists between the shear strength of the tack emulsions and that of the rotational viscosity results (Figure 3.25b).

Figure 3.25. Relationship between ISS and RV results (a) including CO2-ENGR-M (b) excluding CO2-ENGR-M (1.0 psi = 6.89 kPa; 77 °F = 25 °C)

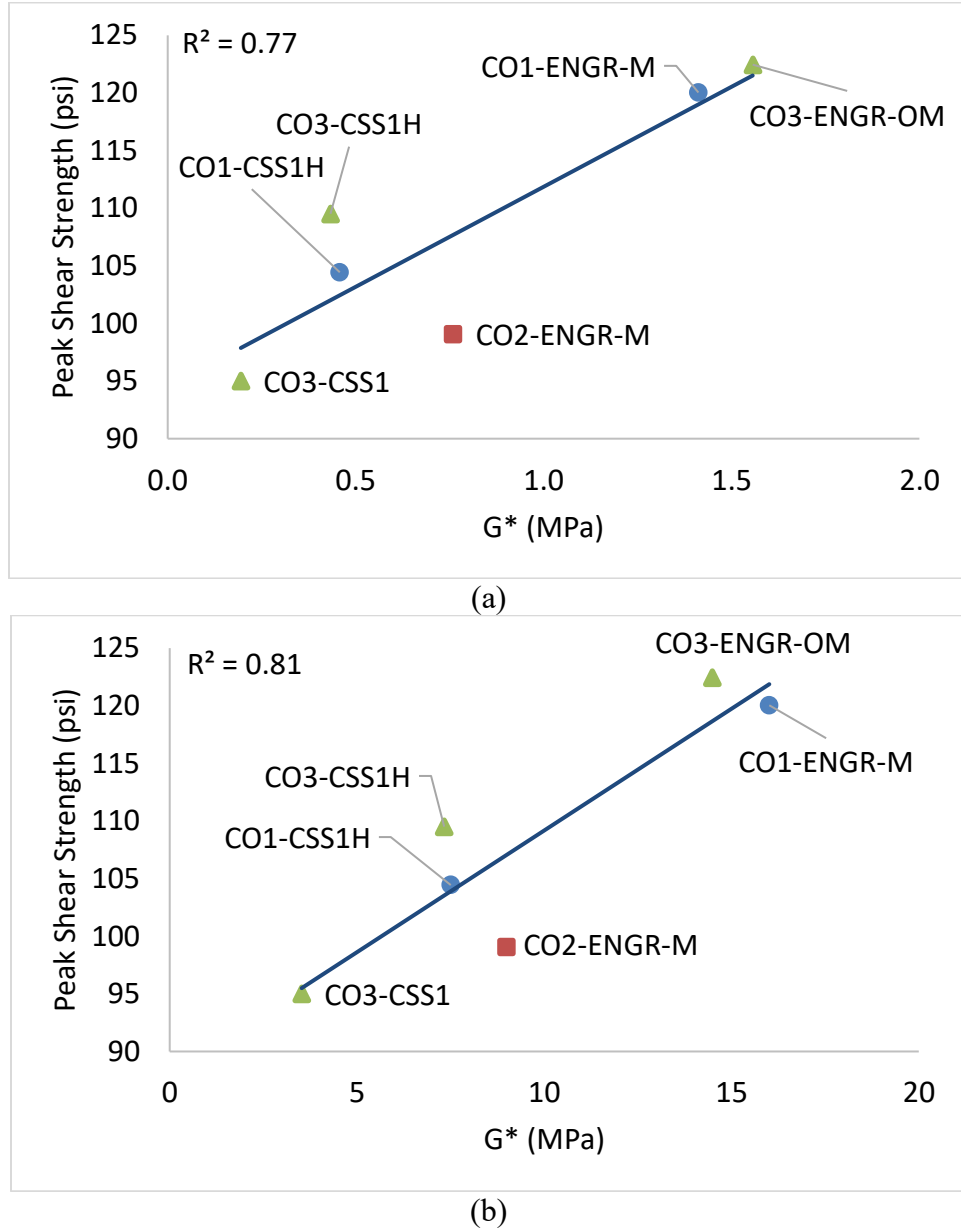
Figure 3.26. Relationship between interlayer shear strength and complex shear modulus at 10 Hz for (a) 104 °F (40 °C) (b) 68 °F (20 °C) (1.0 psi = 6.89 kPa)

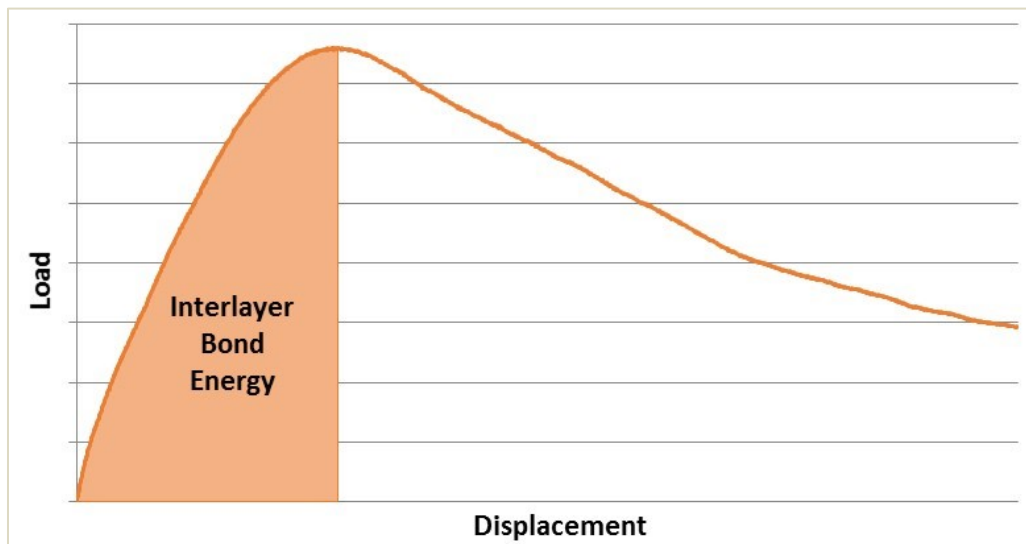
Figure 4.1: Graphical representation of interlayer bond energy

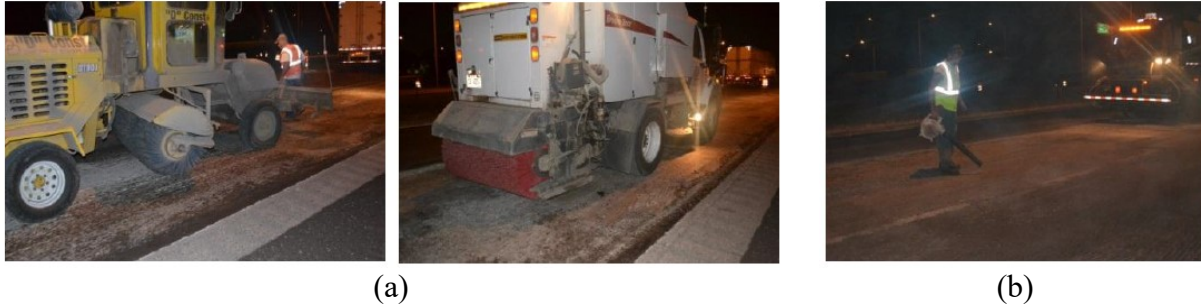
Figure 4.2. Common field cleaning methods: (a) Sweeping and vacuuming and (b) air blasting (Al-Qadi et al. 2012).

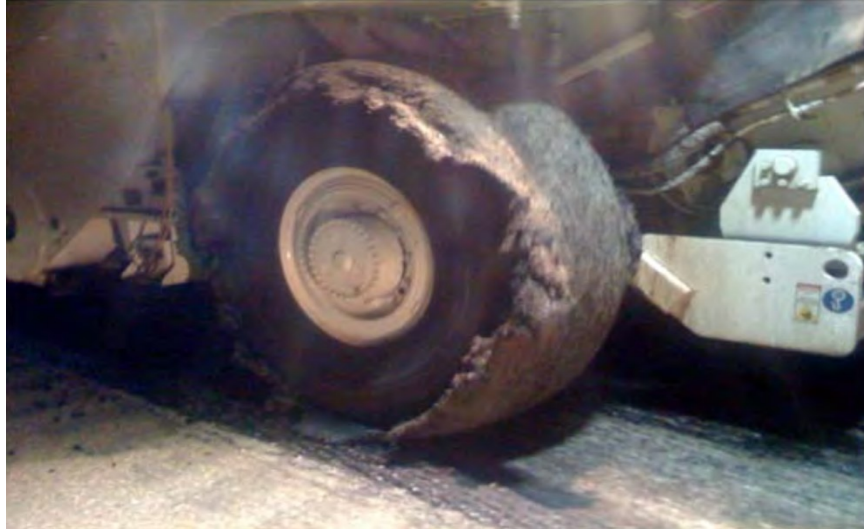
Figure 4.3: Tracking on paver wheels due to excess dust (Mohammad et al. 2012).

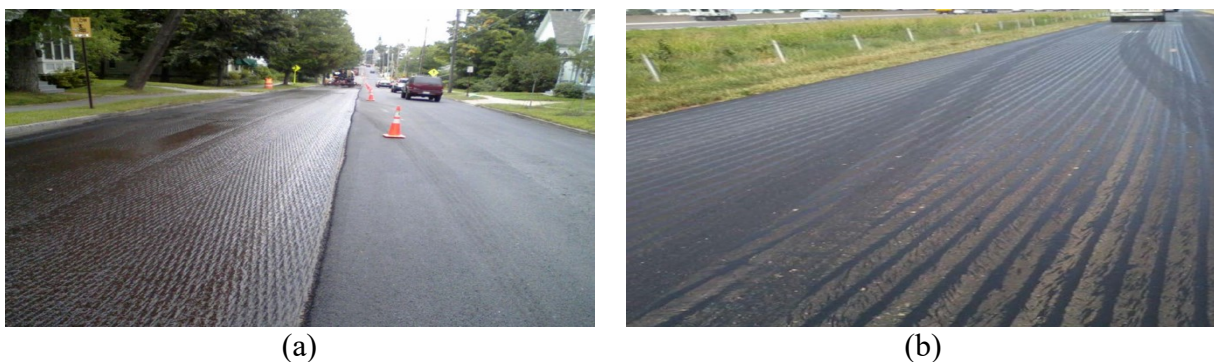
Figure 4.4: Tack coat application uniformity: (a) Acceptable tack coat application uniformity, and (b) unacceptable tack coat application uniformity (streaking) (FHWA 2016).

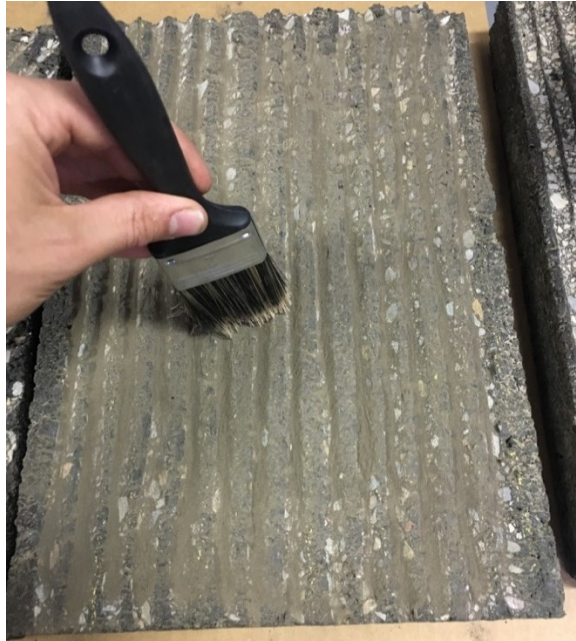
Figure 4.5: Dust being applied to pavement surface.

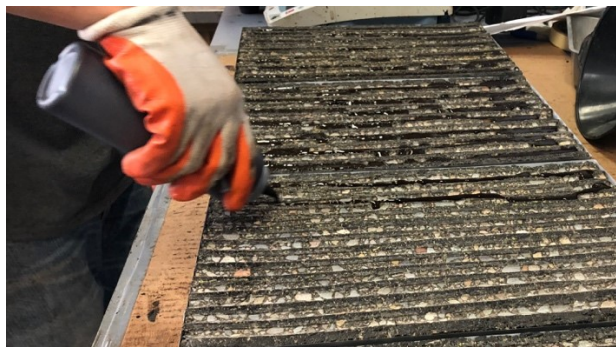
Figure 4.6: Application of tack coat using condiment bottle for coverage/streaking samples.

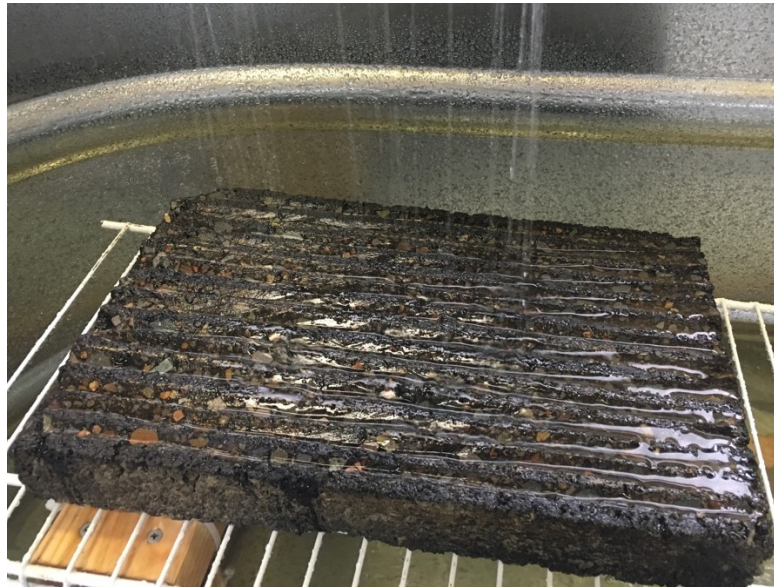
Figure 4.7: First lift samples in the rainfall simulator.

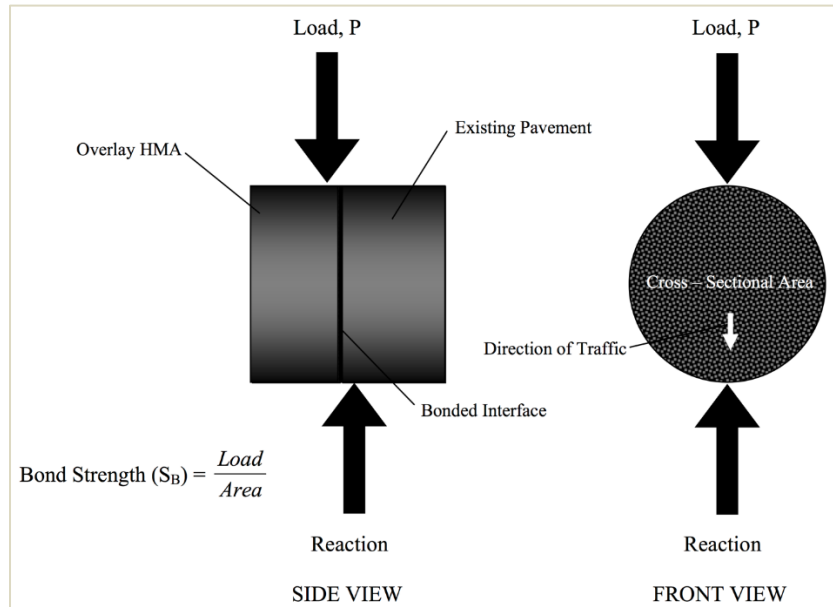
Figure 4.8: Sample loading configuration for shear testing (ALDOT 2008).

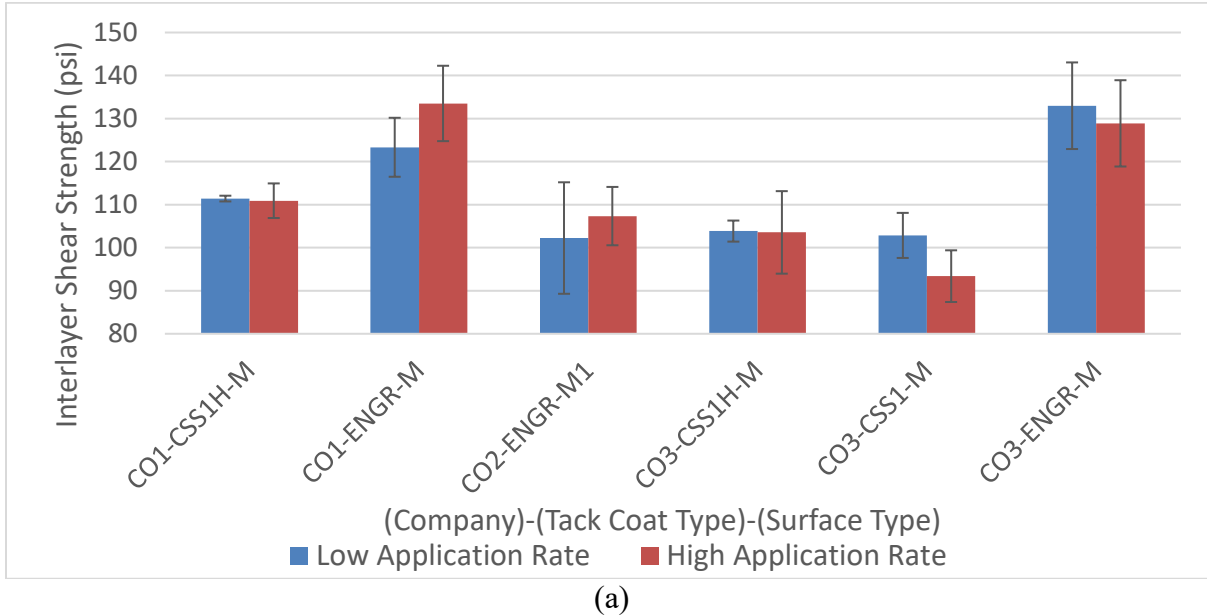
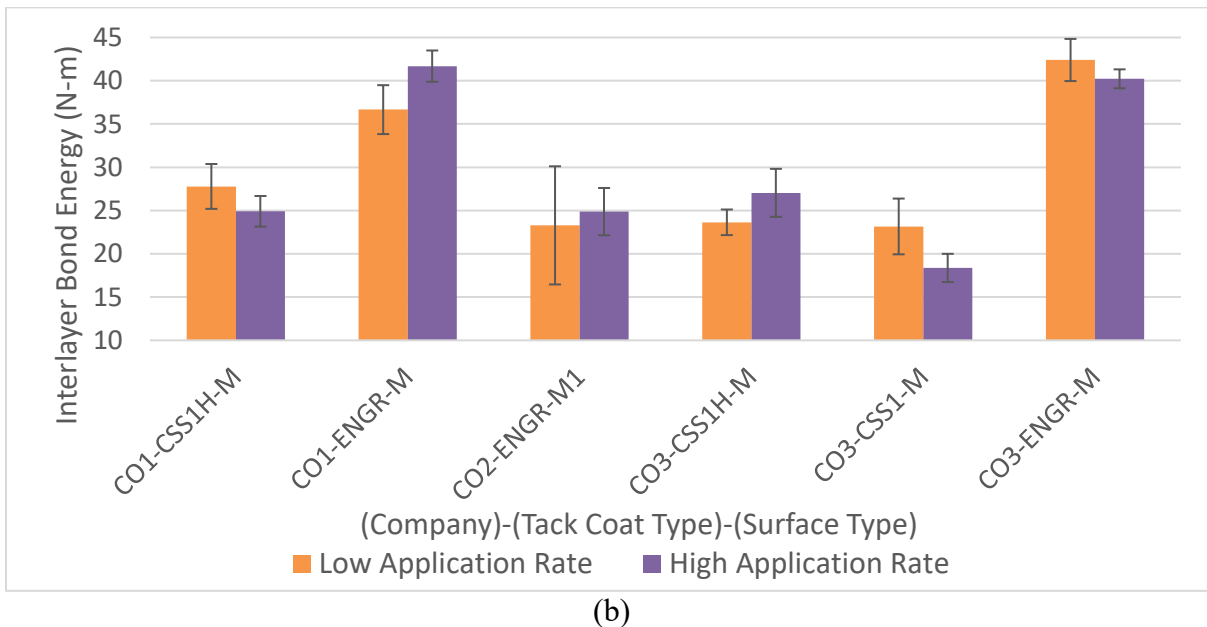
Figure 4.10 shows the ISS and IBE response for all tack coats tested applied to milled surfaces at two application rates (low rate of 0.09 gal/yd² and high rate of 0.15 gal/yd²). The “-M” designation on the CSS-1, CSS-1H and CO3-ENGR tack coats are merely meant to indicate it was applied to a milled surface, and does not depict the intended design surface type of these tack coats. Error bars indicate ± 1 standard deviation.

Figure 4.10: Milled surface tack coat response for (a) ISS and (b) IBE at two application rates with error bars indicating ± 1 standard deviation (1.0 psi = 6.89 kPa; 1.0 N-m = 8.85 in-lbs).

As can be seen in Figure 4.10, CO2-ENGR-M1 did not have performance that was congruent with the other two companies' engineered tack coats. This tack coat yielded ISS/IBE results that were within the range of conventional tack coats (CSS-1 and CSS-1H) provided by other companies. This contradicts the expected result, as milled surfaces typically exhibit better bond quality due to aggregate interlock of the new pavement layer with the coarse milled surface texture (Coleri et al. 2017; FHWA 2016; Mohammad et al. 2010). This result is attributed to the tack coat's low residual asphalt content. This tack coat was observed to have a very high water content in comparison to other engineered tack coats, which translates into a low amount of residual asphalt binder that is available to facilitate interlayer bonding once the tack coat sets. Additionally, it was noted during sample preparation that the CO2-ENGR-M1 tack coat permeated through the voids of the first lift samples during tack coat application, causing some of the tack coat to soak through to the bottom of the sample instead of being retained on the pavement surface. This may have reduced the effective amount of residual asphalt available for bonding at the interlayer, since some of the residual asphalt soaked through the voids of the underlying asphalt layer. This phenomenon is likely due to the high water content of this tack coat. The tack coat flowed much more readily through the voids of the first lift samples since it had a lower viscosity than other tack coats used on milled surfaces.

From Figure 4.10 above, a clear advantage is exhibited for engineered tack coats from Company 1 and Company 3, in terms of both ISS and IBE. It is also clear to see in Figure 4.9 and Figure 4.10 that the CO3 engineered tack coat had superior performance as compared to conventional CSS-1 and CSS-1H tack coats, both in terms of ISS and IBE. The CSS-1 tack coat did not achieve the performance of the CSS-1H or engineered tack coats. CSS-1H tack coats also exhibited similar performance on both milled and overlay surfaces, whereas the engineered tack coats tended towards slightly higher ISS/IBE on milled surfaces.

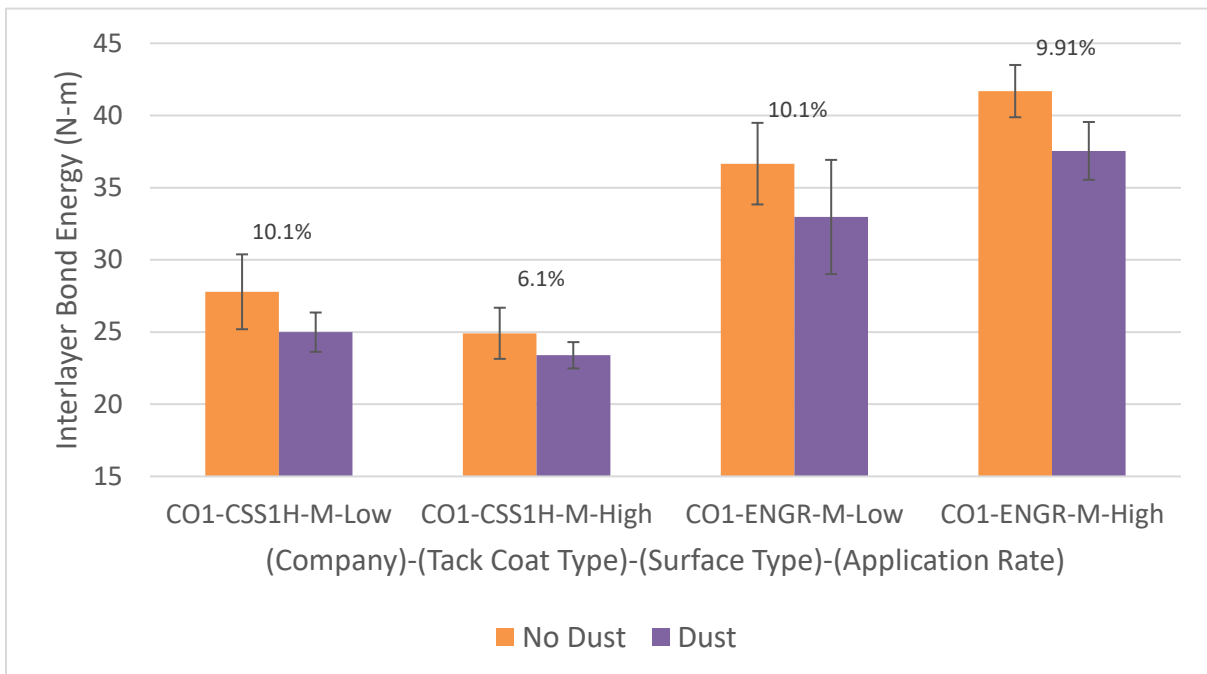
Figure 4.11 shows the average ISS/IBE responses for CO1 tack coats on milled surfaces in the presence of dust and without dust at two application rates (low rate of 0.09 gal/yd² and high rate of 0.15 gal/yd²). The “-M” designation on the CSS-1H tack coat is merely meant to indicate it was applied to a milled surface, and does not depict the intended design surface type of this tack coat. Error bars indicate ± 1 standard deviation. Percentage differences for dust/no dust cases are shown above the columns.

Figure 4.11: Milled surface tack coat response for (a) ISS and (b) IBE with and without dust at two application rates, with error bars indicating ± 1 standard deviation (1.0 psi = 6.89 kPa; 1.0 N-m = 8.85 in-lbs).

From Figure 4.11, it can be deduced that dust does impact tack coat bond quality. There is no discernable difference in ISS/IBE reduction between engineered and conventional tack coats,

In general, dust did not significantly impact the bond quality of tack coats. The reduced impact of dust on ISS for low application rates is illustrated by the low percentage differences shown in Figure 4.11. Percentage differences are generally higher for high application rates. Percentage differences for IBE were slightly higher for low application rates, indicating that IBE may be better representing the difference in performance for dust/no dust cases. Table 4.10 and Table 4.11 below show correlation matrices for the ISS and IBE of Company 1 tack coats tested on milled surfaces with and without dust present at a low application rate (0.05 gal/yd²). A p-value of less than 0.05 indicates a significant difference between the two cases under comparison. The decision rule for significance was the same as was used for comparisons shown in Section 4.3.1.1.

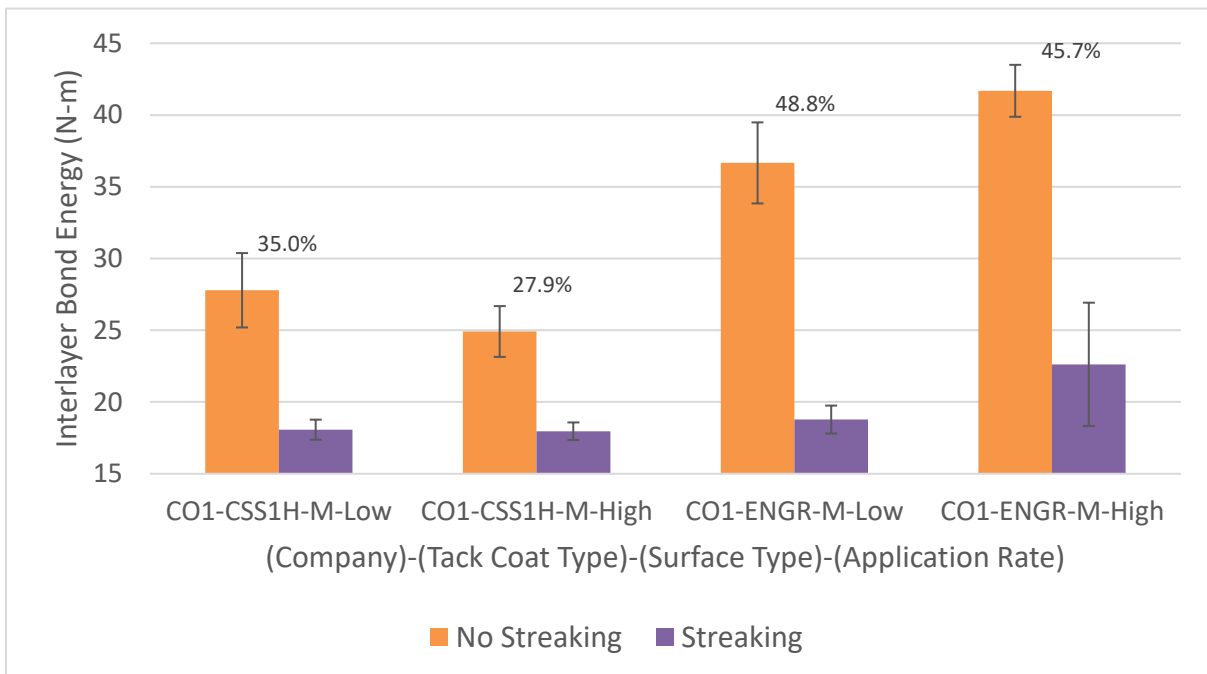
Figure 4.12: Milled surface tack coat response for (a) ISS and (b) IBE with and without streaking at two application rates, with error bars indicating ± 1 standard deviation (1.0 psi = 6.89 kPa; 1.0 N-m = 8.85 in-lbs).

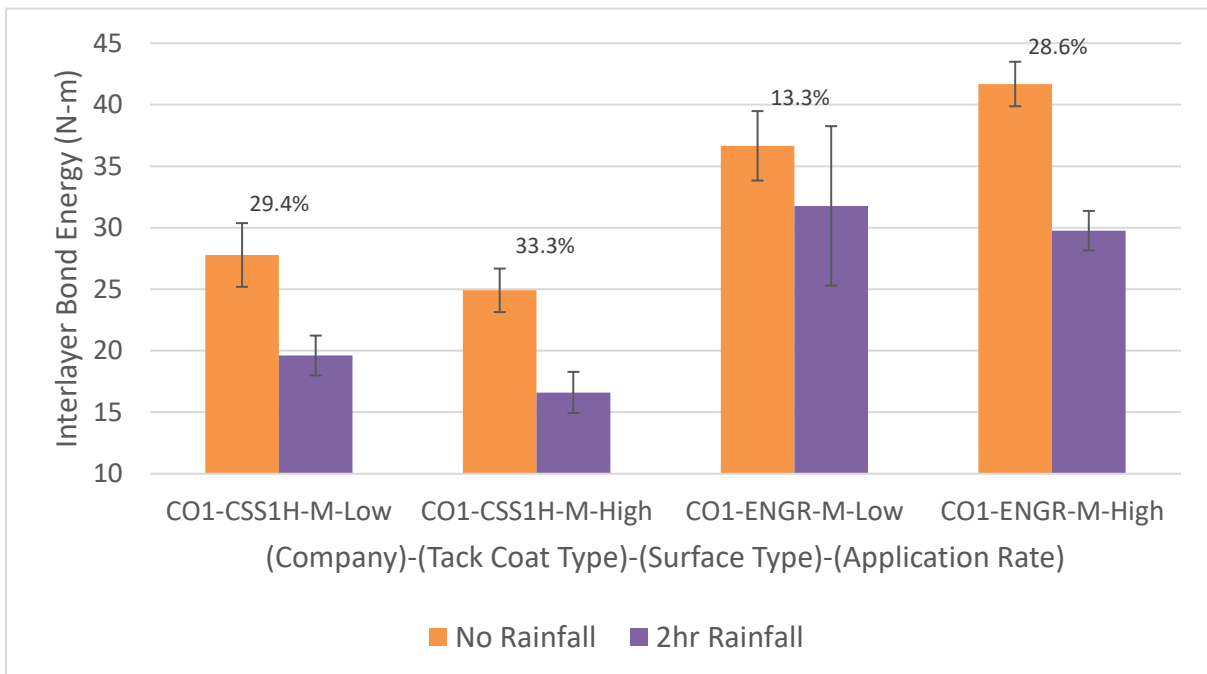
Figure 4.13: Milled surface tack coat response for (a) ISS and (b) IBE with 2hr rainfall after tack coat application and no rainfall at two application rates, with error bars indicating ± 1 standard deviation (1.0 psi = 6.89 kPa; 1.0 N-m = 8.85 in-lbs).

The correlation matrices above show that rainfall did not produce statistically significant differences in ISS for CO1-CSS1H or CO1-ENGR-M, based on p-values of 0.1143 and 0.8774 at a 95% confidence level. The IBE response of CO1-CSS1H was indeed statistically different from the reference case, however, which is confirmed by the p-value of 0.0039 at a 95% confidence level. Another notable observation is that the p-values for the comparison of rainfall to no rainfall cases for CO1-ENGR-M were much higher than for CO1-CSS1H. This result affirms the conclusion from Figure 4.13 that engineered tack coats are affected less by rainfall than are conventional tack coats due to the presence of polymers which are sticking to the aggregates better than conventional tack coats under rainfall conditions.

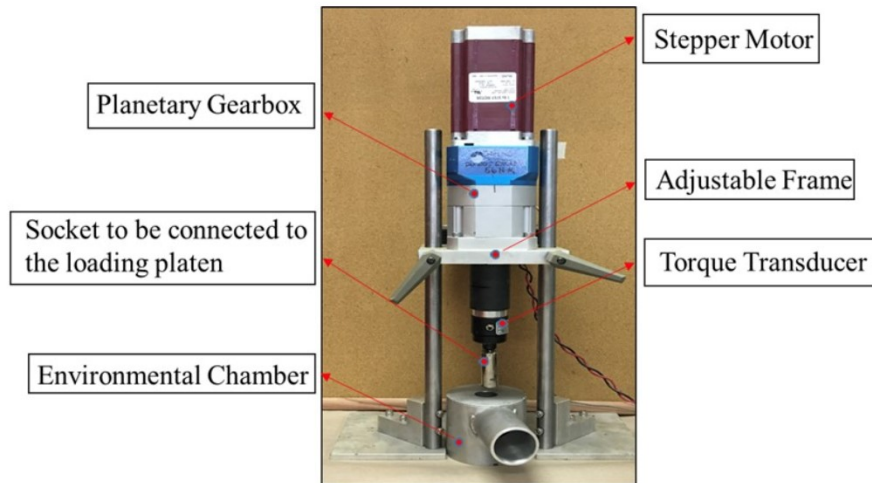
Figure 5.1: First generation OFTT device developed by Coleri et al. (2017).

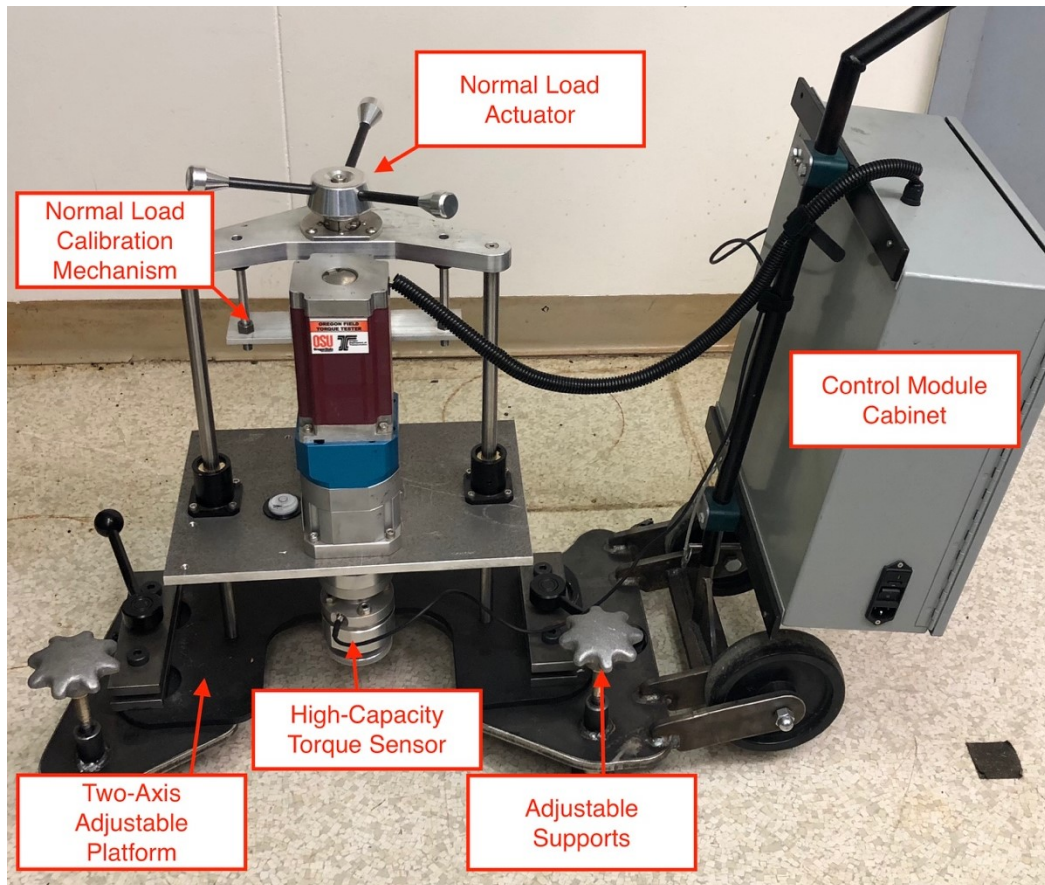
Figure 5.2: 2nd generation OreTackBond device.

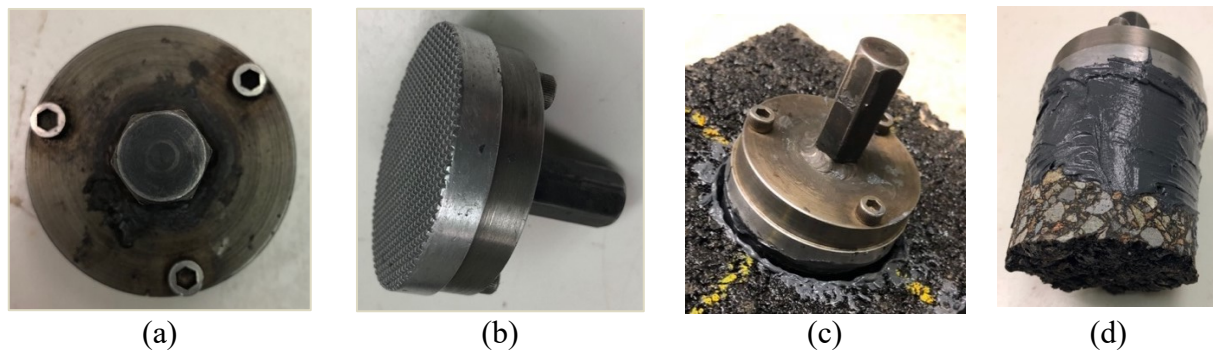
Figure 5.3: Metal platen used in OreTackBond testing showing (a) hex-shaped shaft, (b) core contact area, (c) platen glued to pavement surface and (d) inspection of failed OreTackBond sample.

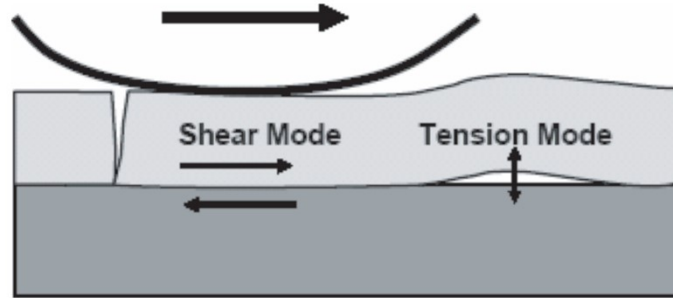
Figure 5.4. Diagram of shear and tensile strength modes under field conditions (Mohammad et al. 2012).

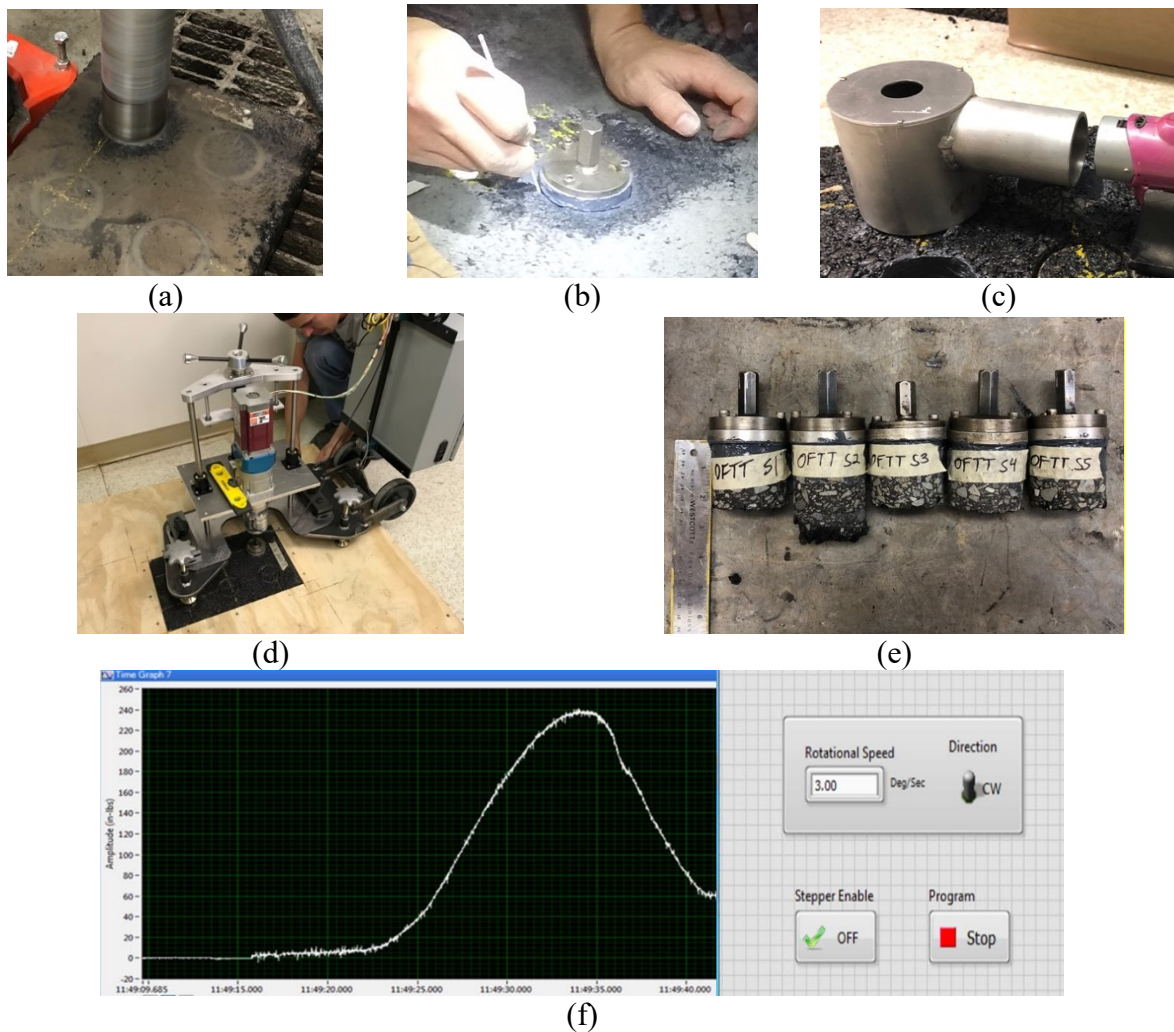
Figure 5.5: General sample preparation and testing procedure for OreTackBond tests in the laboratory and field.

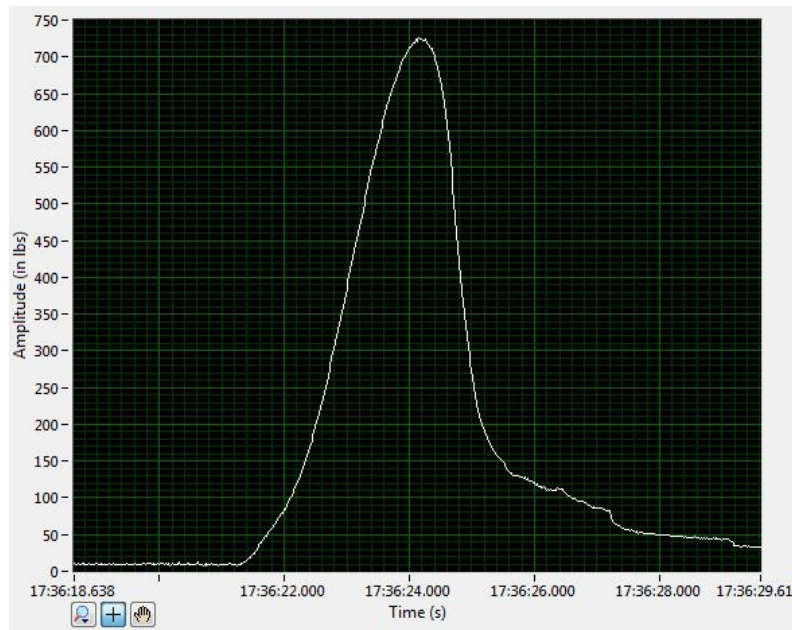
Figure 5.6: Raw torque-displacement data obtained from OreTackBond testing in custom software.

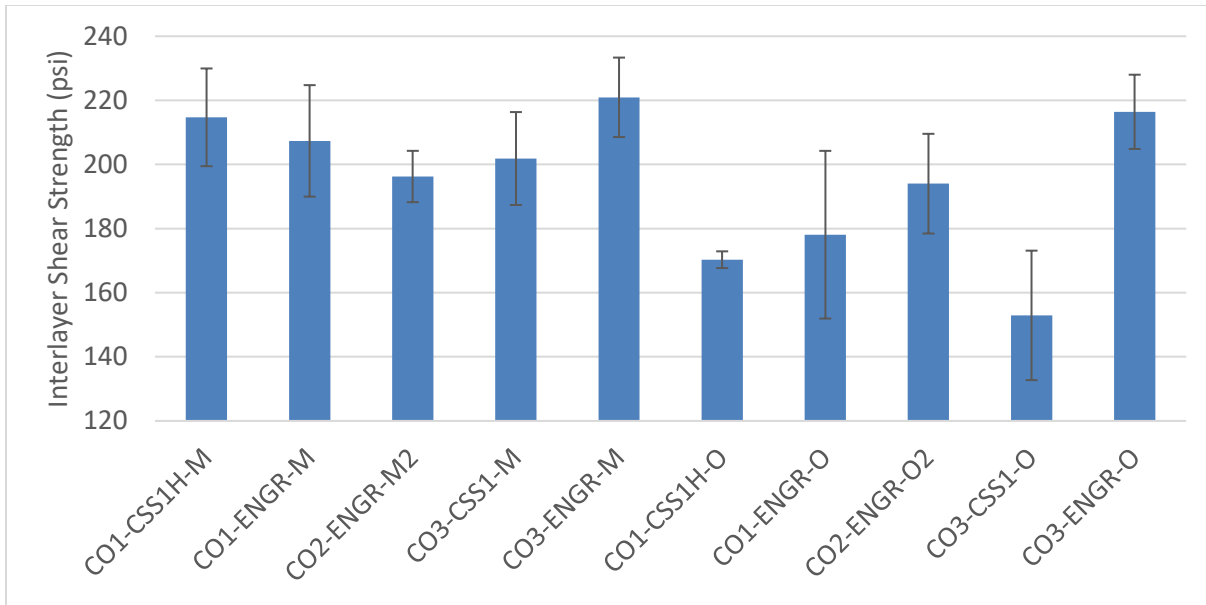
Figure 5.7: Average ISS response from OreTackBond testing for all tack coats with error bars indicating ± 1 standard deviation (1.0 psi = 6.89 kPa).

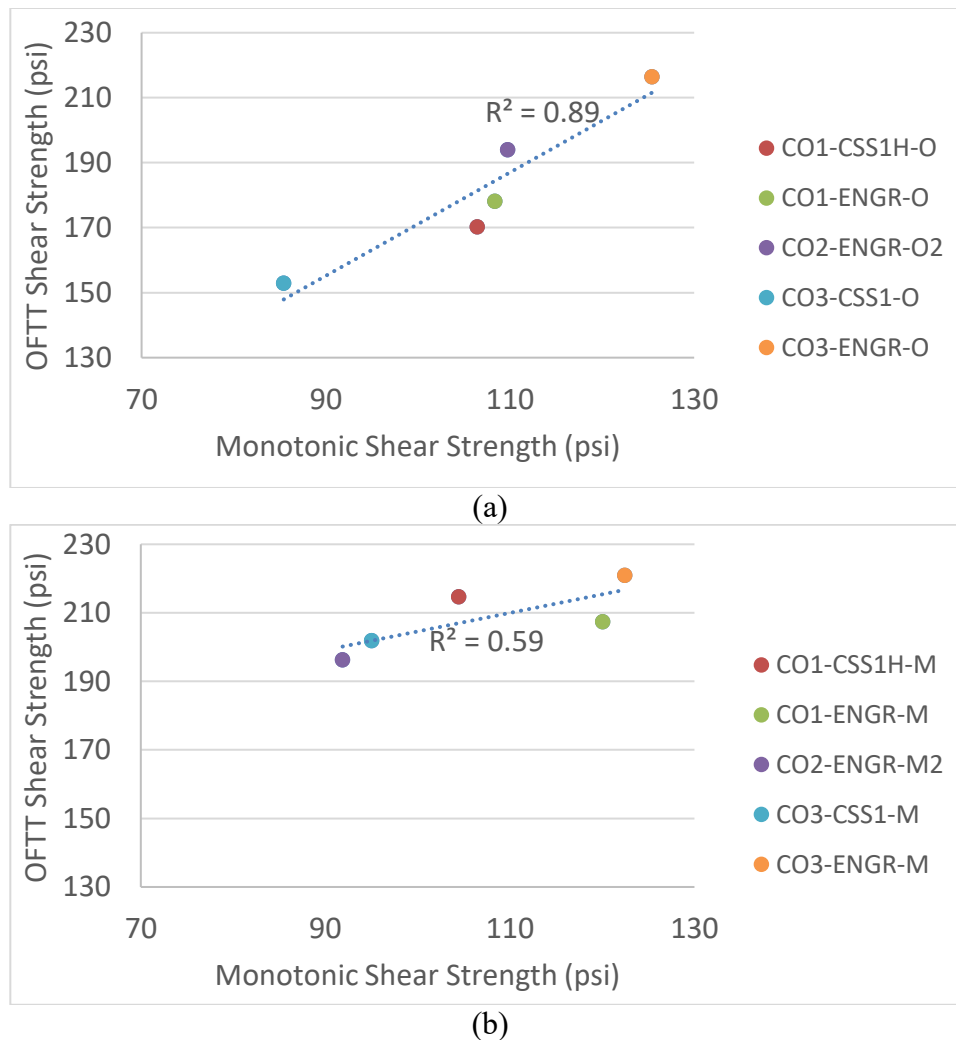
Figure 5.8: Correlation plots for ISS of OreTackBond and monotonic DST for (a) tack coats tested on overlay surfaces only, and (b) tack coats tested on milled surfaces only (1.0 psi = 6.89 kPa).

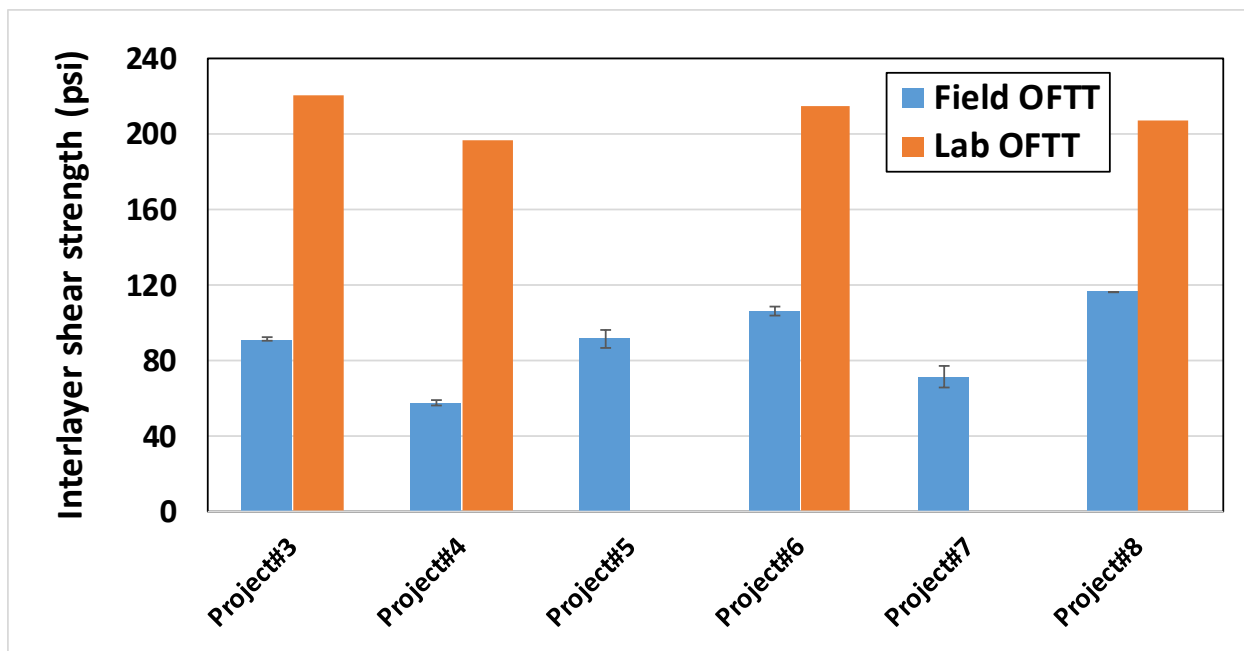
Figure 5.9: Average ISS response of OreTackBond field tests versus OreTackBond lab tests, with error bars indicating one standard deviation (1.0 psi = 6.89 kPa).

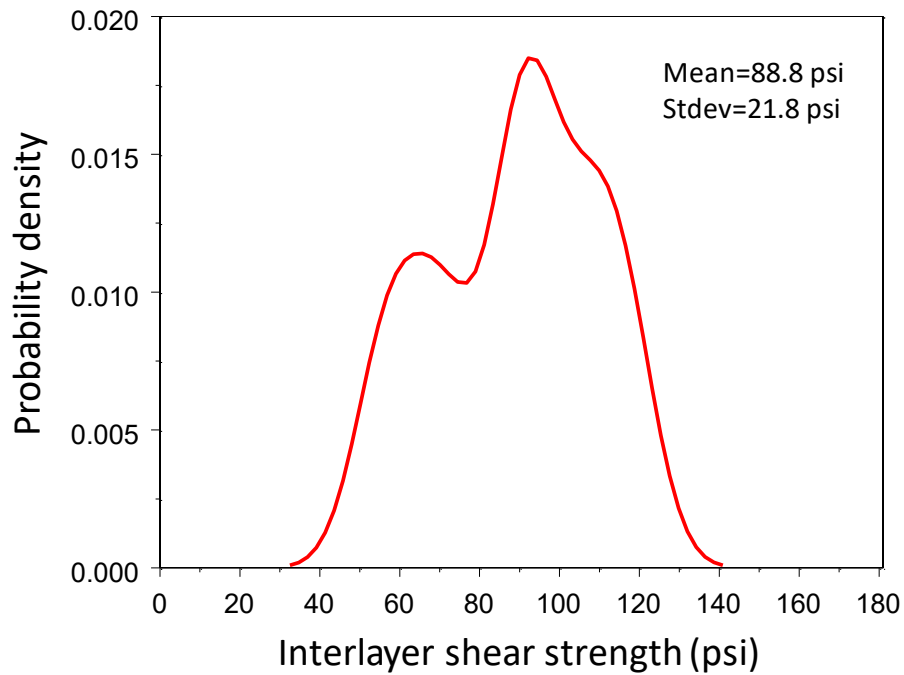
Figure 5.10: Probability density for the test results from all six projects.

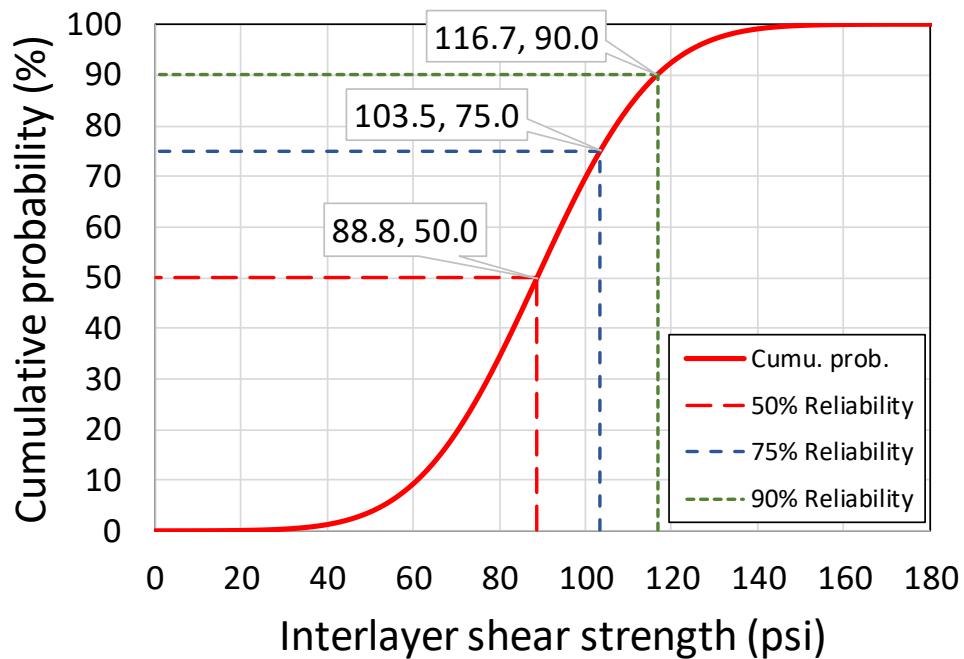
Figure 5.11: Cumulative probability curve representing milled surface bond strength distribution in Oregon.

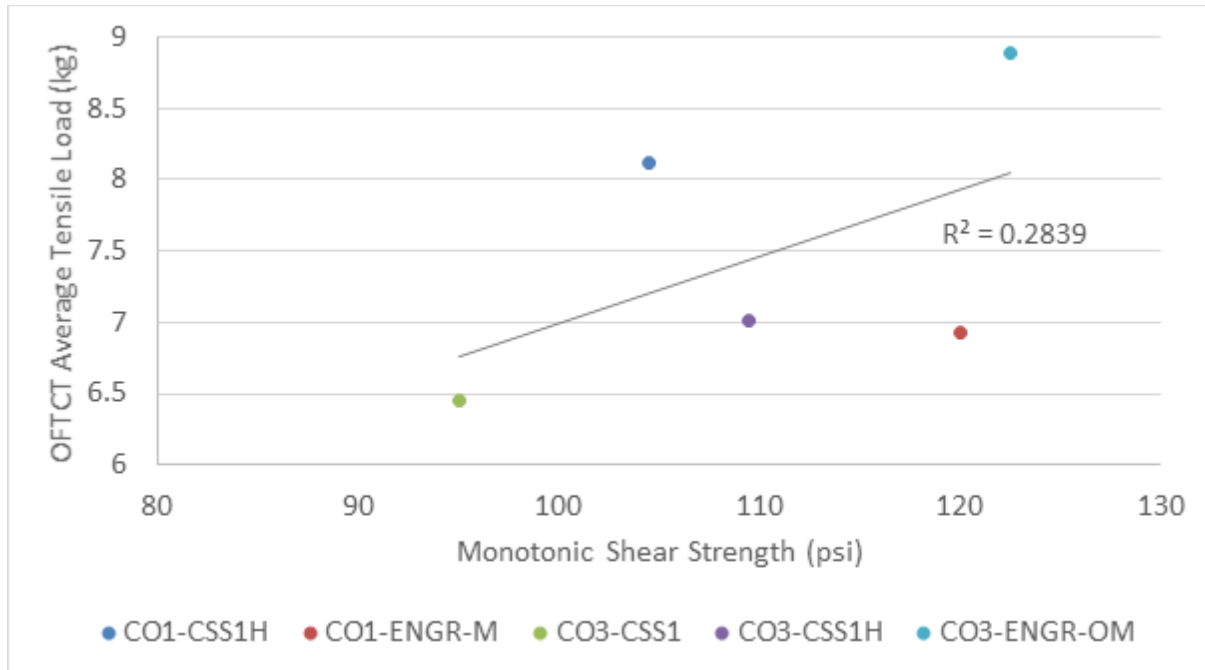
OFTCT testing was performed in the laboratory using tack coats and application rates described in Table 5.5. Results of OFTCT tests were correlated against monotonic DST test results from Section 3.5. A plot showing the correlation between these results is presented below in Figure 5.12.

Figure 5.12: Correlation plot of OFTCT and monotonic DST results.

Since monotonic DST is a well-accepted testing methodology adopted by many researchers, it serves as a ground-truth measurement of tack coat bond quality and hence is suitable for comparison against the OFTCT results. As can be seen above in Figure 5.12, the correlation between OFTCT and monotonic DST results was not strong. This indicates that OFTCT testing is likely not a reliable means of quantifying tack coat bond quality before construction.

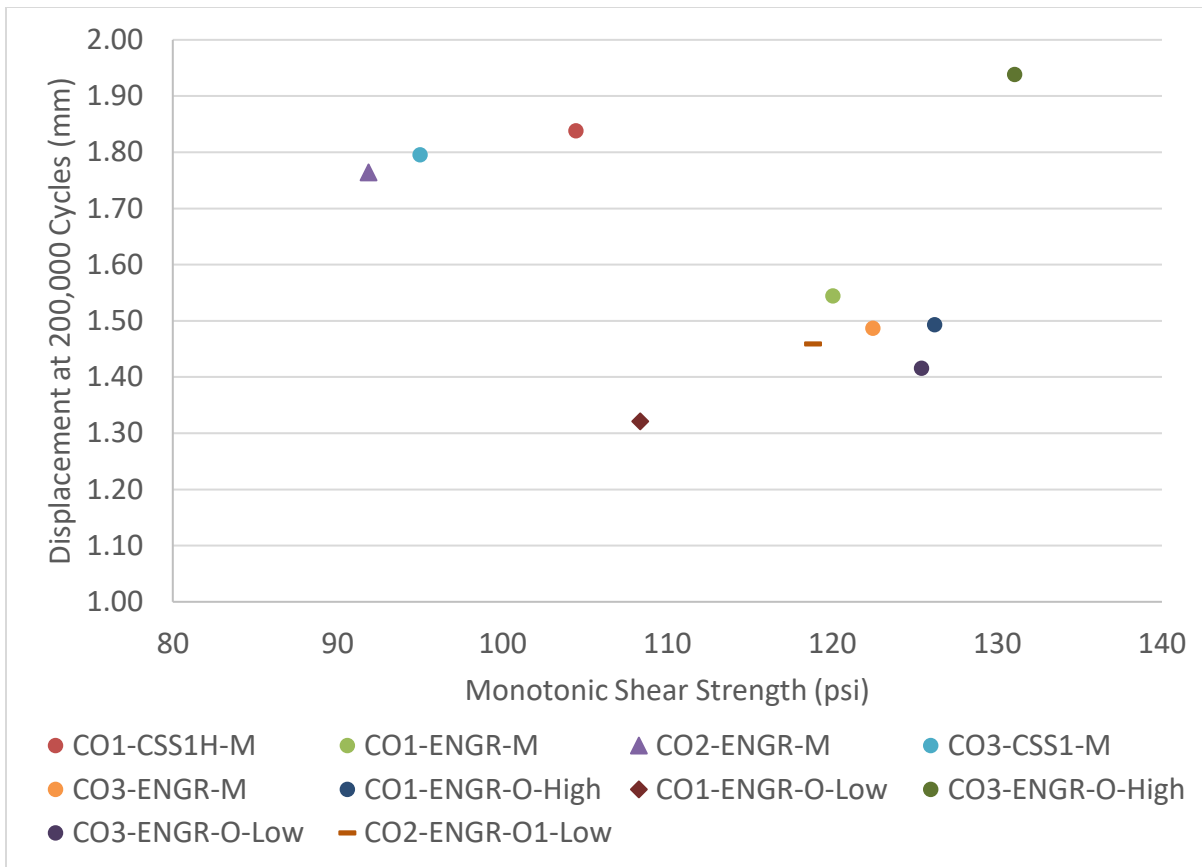
Figure 5.13. Correlation plot of cyclic DST and monotonic DST results.

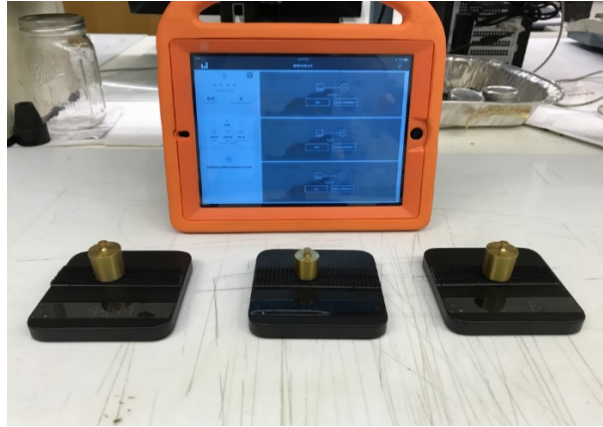
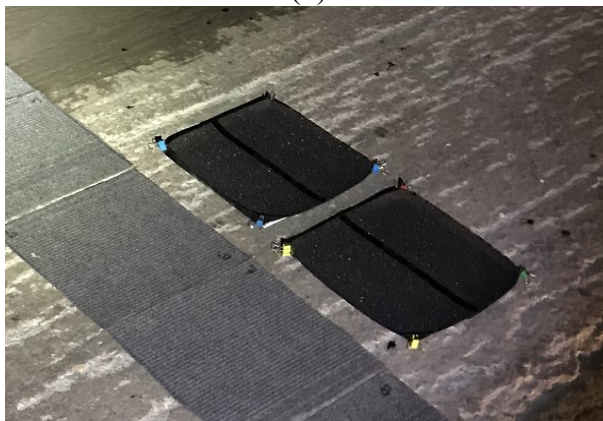
increments and had a weight measurement limit of 2,000g. Up to three scales can be wirelessly controlled from a tablet computer via an app. Photo of the scale system and the version with the asphalt shingle surface is shown in Figure 6.1. For the weight measurement of applied tack coat during construction, a 11.2inch by 11.2inch plastic plate with asphalt shingles taped on top was attached to the top of each scale using Velcro (Figure 6.1c). The reason for selecting the asphalt shingle surface is described in Section 6.3.1.

Wireless scales were controlled from a tablet app as shown in Figure 6.1. A Bluetooth connection was established between the scales and the tablet computer. The tablet computer app is capable of connecting up to three scales. Tablet computer should not be more than 15 meters away from the scales to keep the connection active during measurements.

Figure 6.1: OreTackRate system for application rate measurement (a) Wireless scale set up with the table computer (b) App interface for weight measurements (c) Scale system with asphalt shingles before tack coat application in the construction lane.

It was required to validate the accuracy of OreTackRate measurements during construction. Validations were performed by placing the wireless scale systems with attached asphalt shingles close to the textile pads (Figure 6.1c and Figure 6.2b). Measurements from the textile pads were assumed to be the reference (ground truth) measurements and used to validate the measurements of the developed wireless scale system (OreTack Rate). Wireless scales were placed adjacent to textile pads #1, #6, and
