**IMPLEMENTATION OF ODOT TACK
COAT TECHNOLOGIES AND
PROCEDURES TO IMPROVE LONG-
TERM PAVEMENT PERFORMANCE**

Final Report

PROJECT SPR 818

Oregon Department of Transportation

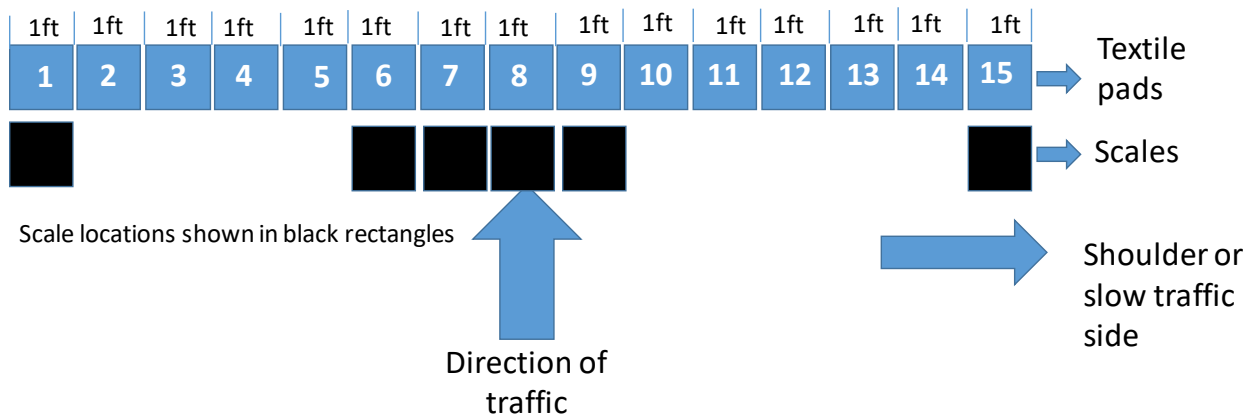
Figure 6.3: Textile pad and wireless scale (OreTackRate) locations.

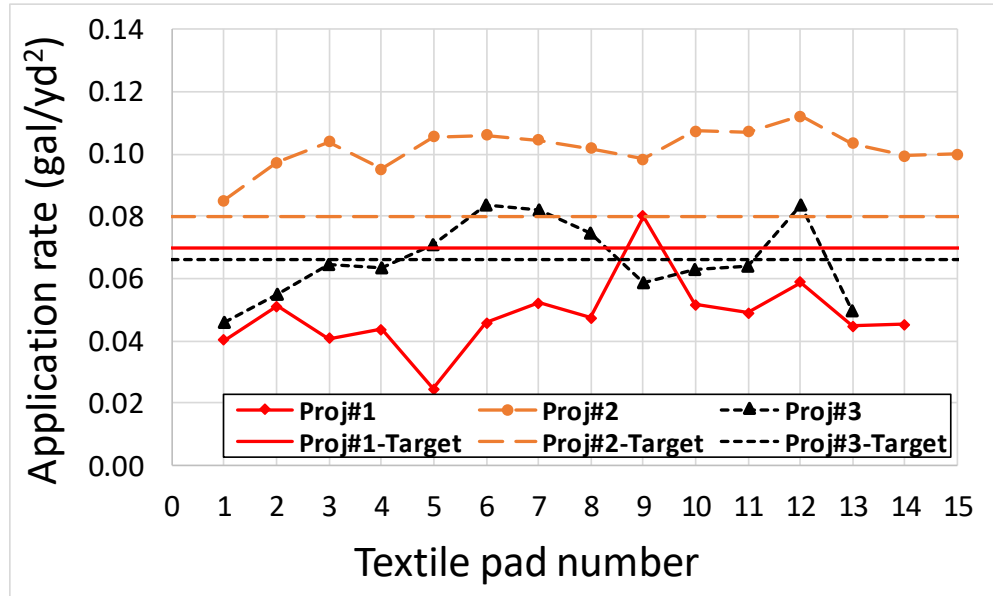
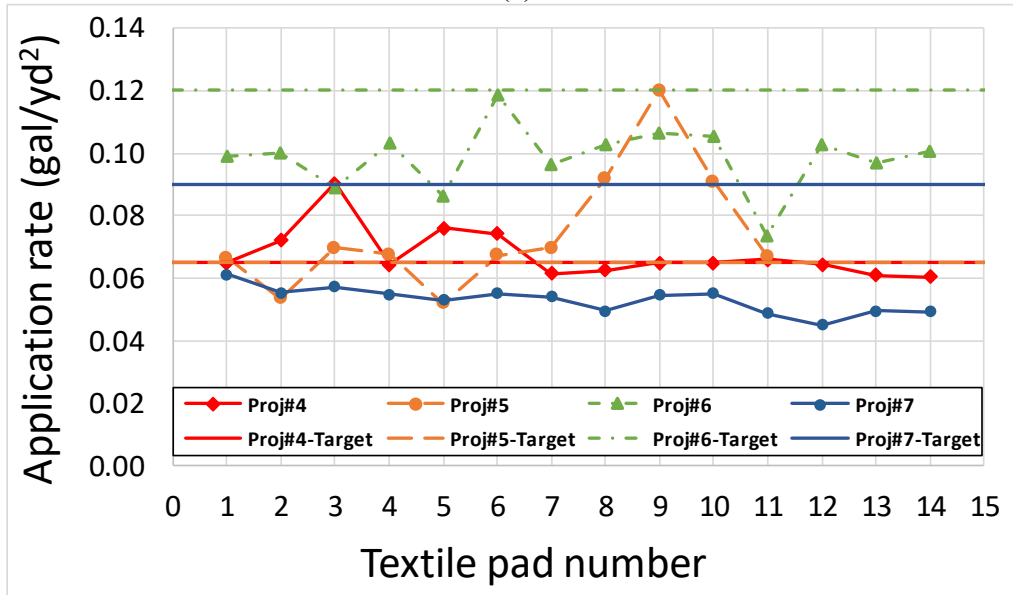
Figure 6.4 shows the tack coat application rates for all textile pads placed in the transverse direction. Textile pad #1 was closest to the adjacent lane while the textile pad with the largest number was closest to the shoulder (ascending order from adjacent traffic lane to the shoulder or slow traffic side). Target application rates for all projects were also shown in Figure 6.4 with straight horizontal lines.

Figure 6.4: Tack coat application rates measured by using textile pads (a) Projects #1, #2, and #3 (b) Projects #4, #5, #6, and #7.

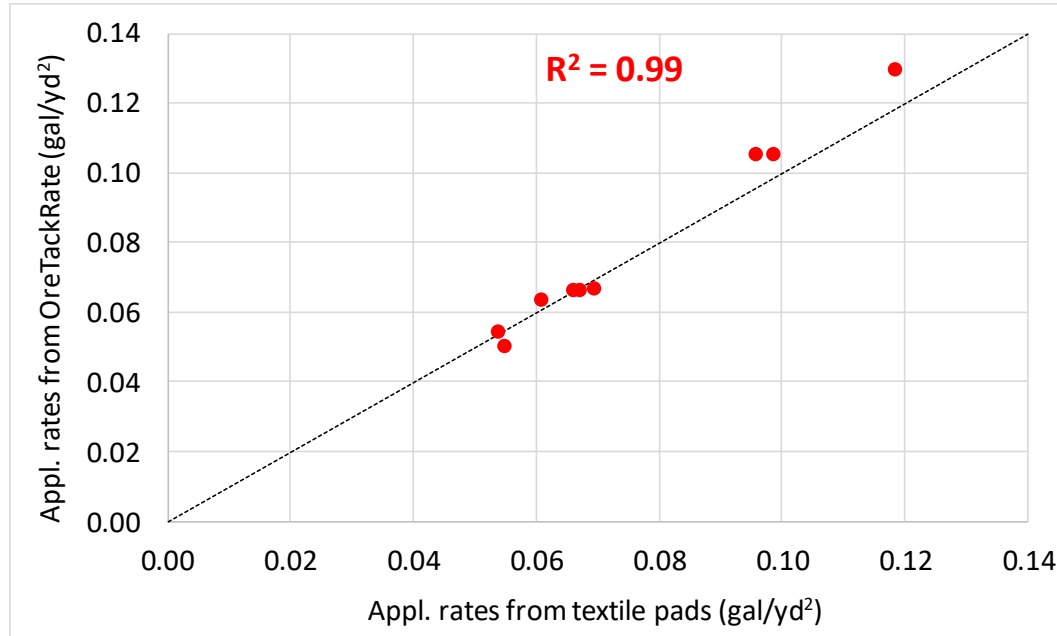
Figure 6.5: Comparison of OreTackRate measurements to application rates from textile pad measurements.

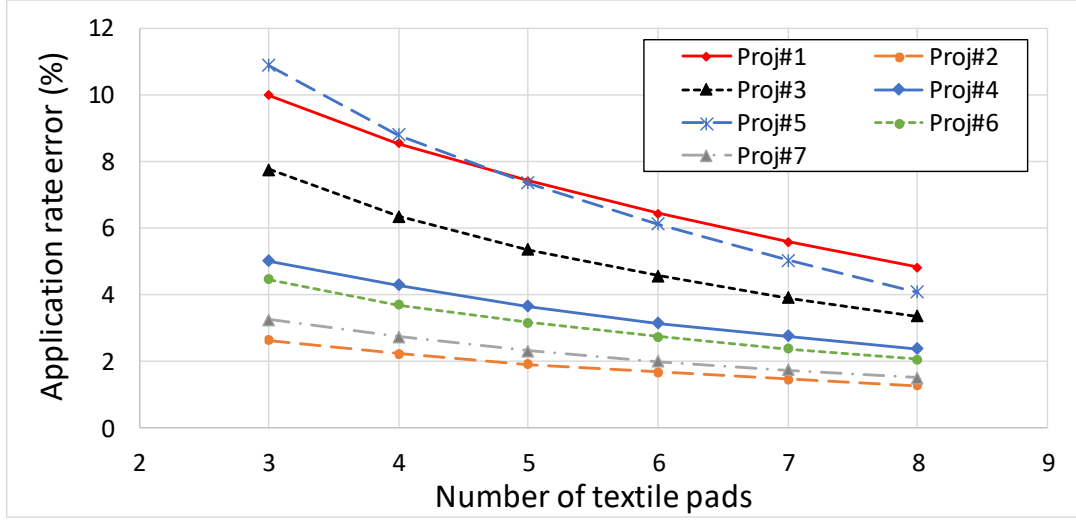
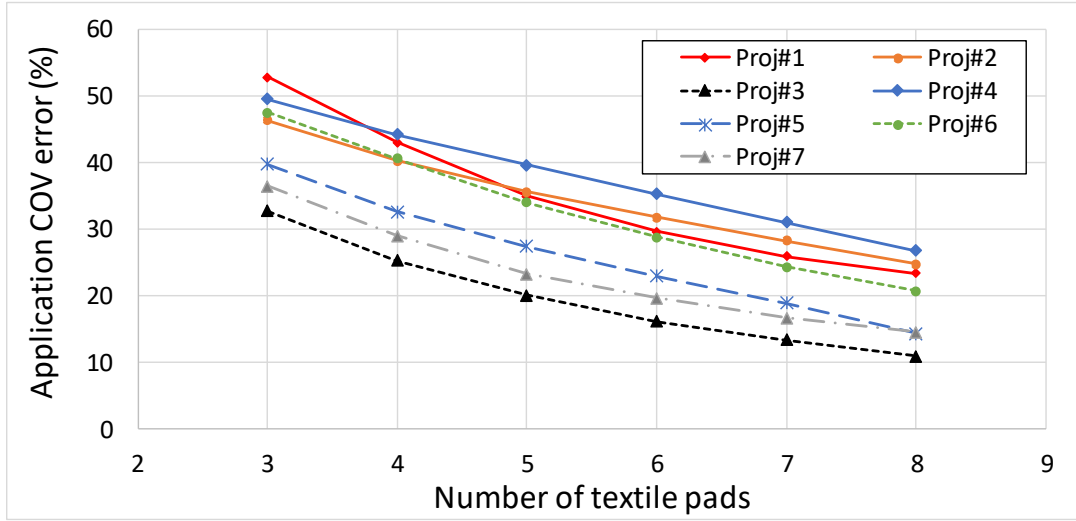
This process was repeated for 1 million times using the developed algorithm and percentage error for application rate average and COV were recorded for each case. Finally, the algorithm outputs the average of the percentage error for average rate [Equation 6-1] and the average of the percentage error for COV [Equation 6-2]. It is expected that increasing the number of textile pads will reduce these two average error rates for application rate and uniformity. However, it was important to conduct these analyses to determine the required number of textile pads to achieve reasonable percentage error rates. Figure 6.6 shows the impact of increasing number of textile pads on application rate and uniformity (COV) error rates. It can be observed that error rates for average application rates were lower than 12 percent for all construction projects (Figure 6.6a). This result suggested that average application rate calculated from three textile pads (or OreTackRate system with three scales) provides a reasonable average application rate estimate with a low error rate. However, it can be observed from Figure 6.6b that error rates for COV (uniformity) are significantly higher than the average application rate errors. This result suggested that more than three textile pads maybe needed to achieve reliable COV (tack coat application uniformity) estimates.

Figure 6.6: The impact of increasing number of textile pads on (a) application rate and (b) uniformity (COV) error rates.

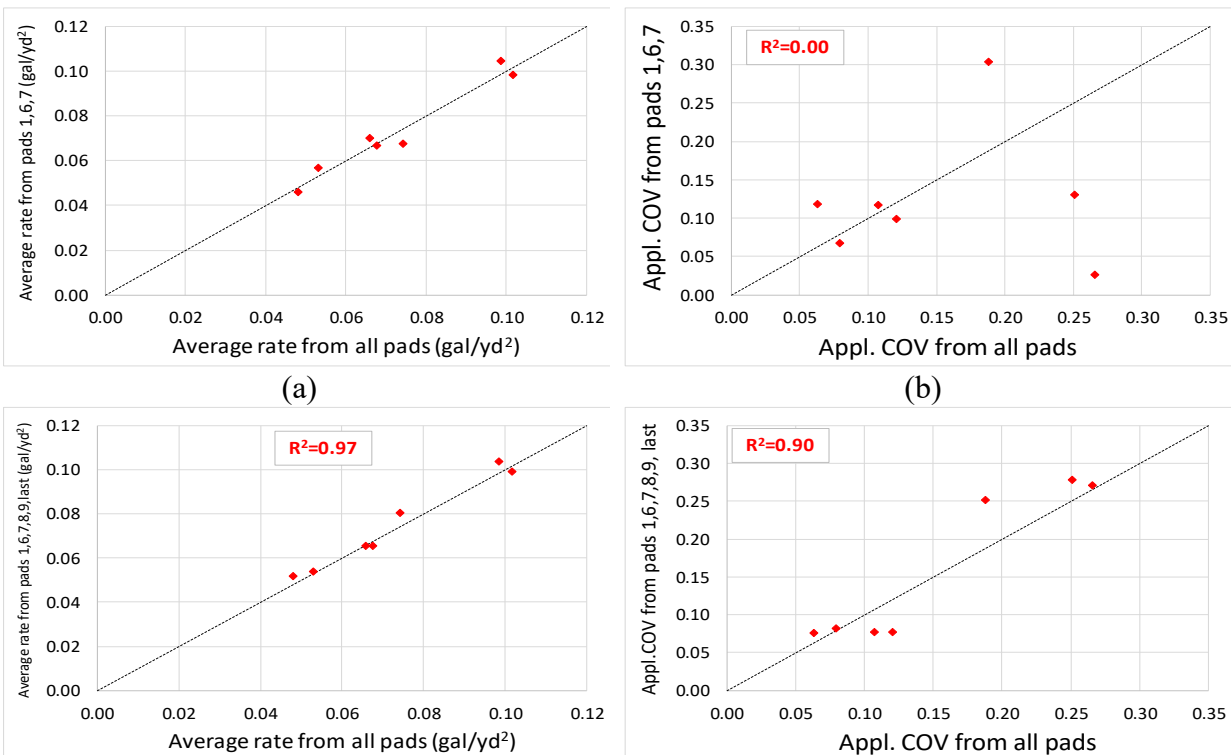
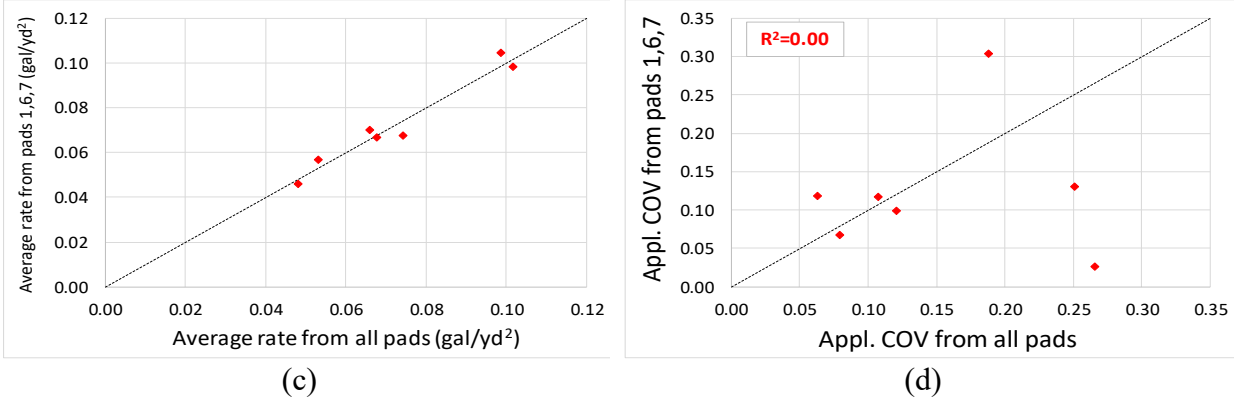
) provides an accurate average rate estimate that is very close to the average rate from all textile pads. The coefficient of determination for the correlation was 0.95. However, the correlation between COVs from the same three scales (positions 1, 6, and 7) were not correlated with the COVs from all textile pads (see Figure 6.7b) for the seven construction projects. The coefficient of determination for the correlation was 0.00, which pointed out no statistically significant correlation. This result again suggests that more than three scales are required to achieve reliable uniformity measurements.

Figure 6.7c and Figure 6.7d shows the correlations for six textile pads. By comparing Figure 6.7a and Figure 6.7c, it can be concluded that having three scales in positions 1, 6, and 7 provides average application rates that are close to the average from all textile pads. However, to achieve reliable uniformity (COV) estimates for the distributor truck, six wireless scale measurements from positions 1, 6, 7, 8, 9, and the scale closest to the slowest lane or shoulder (called as “last” in the plots) are required. This result suggested that for distributor truck certification for application rate accuracy and uniformity, two OreTackRate system would be required. Since each OreTackRate system with three scales and a tablet computer costs around \$1,000, having a second system would increase the cost by another \$1,000. Alternatively, to reduce the total cost, readings for positions 1, 6, and 7 can be taken during the first pass of the distributor truck during the certification process. Then, the scales can be placed in positions 8, 9, and “last” to collect the application rates from the right side of the truck. Using those six measurements, application rate accuracy and uniformity can be accurately quantified. However, during construction, to measure and calibrate/validate application rate accuracy, having three scales positioned in 1, 6, and 7 would provide reliable average application rate estimates. Proposed distributor truck certification process is given in Section 6.2.3 below.

Figure 6.7: Impact of increasing the number of scales on application rate and uniformity measurement accuracy (a) average application rate comparison for three scales (b) COV (uniformity) comparison for three scales (c) average application rate comparison for six scales (d) COV (uniformity) comparison for six scales.

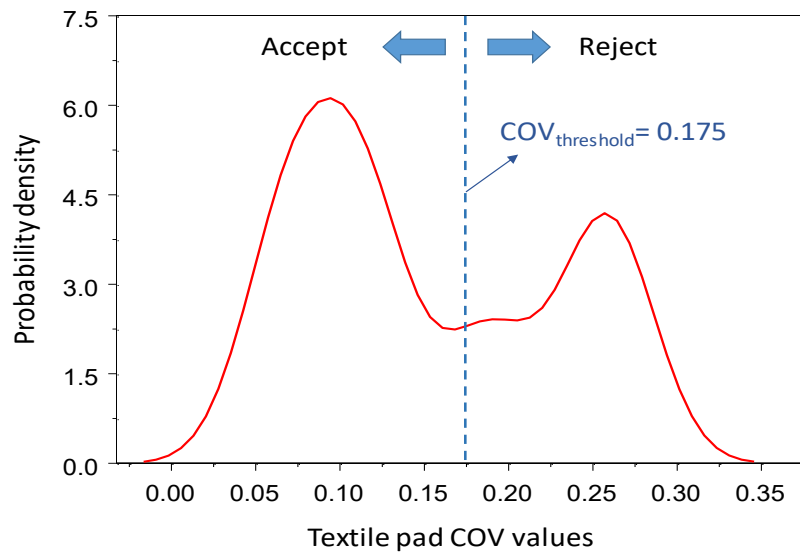
Figure 6.8: Distribution of application COV (representing uniformity) values for all seven construction projects.

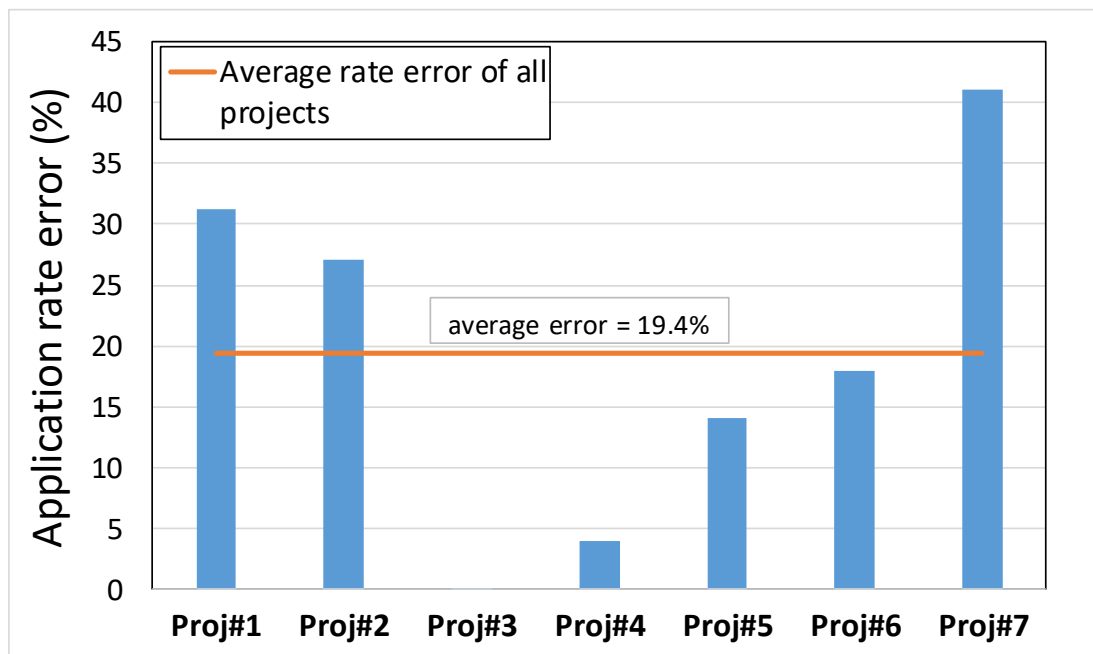
Figure 6.9: Error for target and measured application rates for all seven construction projects.

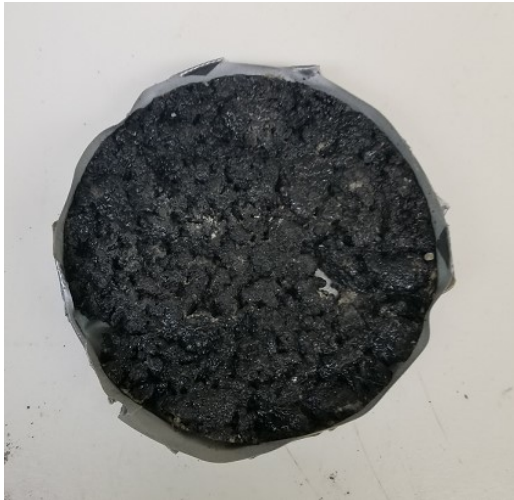
(a)

Wireless scale system, OreTackRate, developed in Section 6.2.1, can also be used to determine the curing time of the tack coat emulsions during construction. After the application of the tack coat on the plate placed on the wireless scale, weight change can be monitored periodically to determine whether the tack coat is cured. However, a surface for the plastic plate that is similar to a pavement surface was needed to be determined to achieve reasonable curing times that reflect the curing of the tack coat on the pavement surface. For this reason, laboratory curing tests were conducted with different surface types in the laboratory using a high accuracy scale. Evaluated surface types were: i) asphalt core-control; ii) plastic plate; iii) plastic plate with asphalt binder/aggregate on surface; and iv) asphalt shingle. Figure 6.11 shows the samples used for curing time testing in the laboratory.

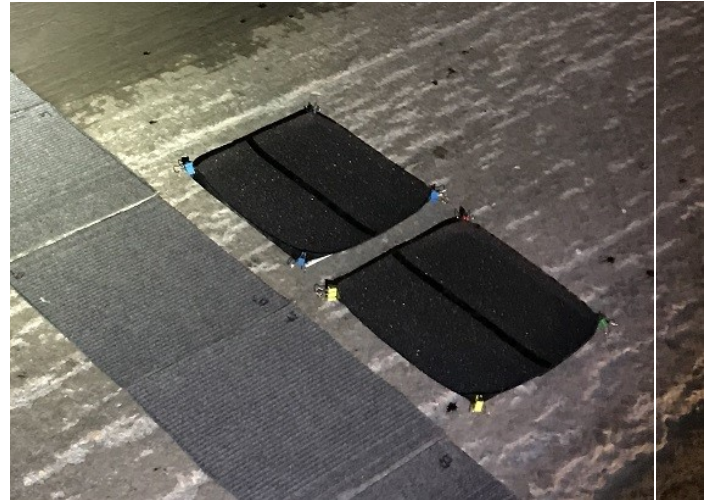
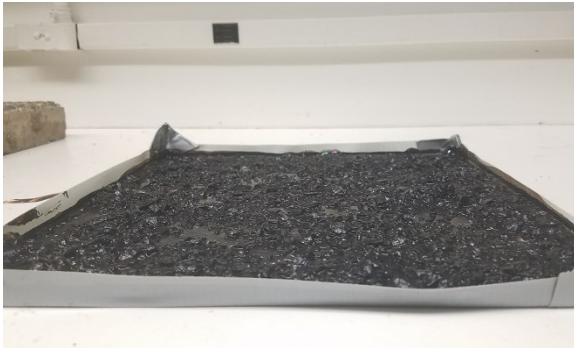
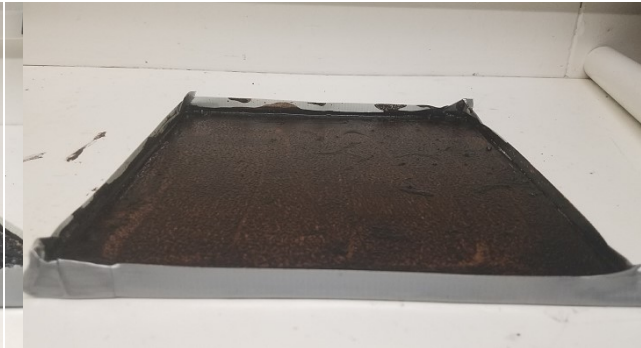
Figure 6.11: Surfaces used for curing time testing in the laboratory (a) Asphalt surface used as control (b) Asphalt shingle layer adhered to a plastic plate (c) Aggregate/asphalt binder surface on a plastic plate (d) Plastic plate-No texture case.

Tack coat evaporation tests were conducted in the laboratory at 25°C temperature to determine the curing time for all four surface types at two application rates (0.05 gal/yd² and 0.10 gal/yd²). Two replicate tests were conducted for each case. A total of 16 evaporation tests were conducted (for four surface types, two application rates, and two replicate tests). Curing time from the laboratory evaporation tests were determined by calculating the percentage weight of applied tack coat, plotting the result in a time versus percentage of applied tack coat plot, and then reducing the accuracy of the plot to 1%. When the percentage of applied tack coat weight for the curve with 1% accuracy does not change for 10 minutes, this time point was selected as the curing time for the tack coat. An example calculation for the curing time for an asphalt-surfaced sample with 0.1 gal/yd² application rate is given in Figure 6.12.

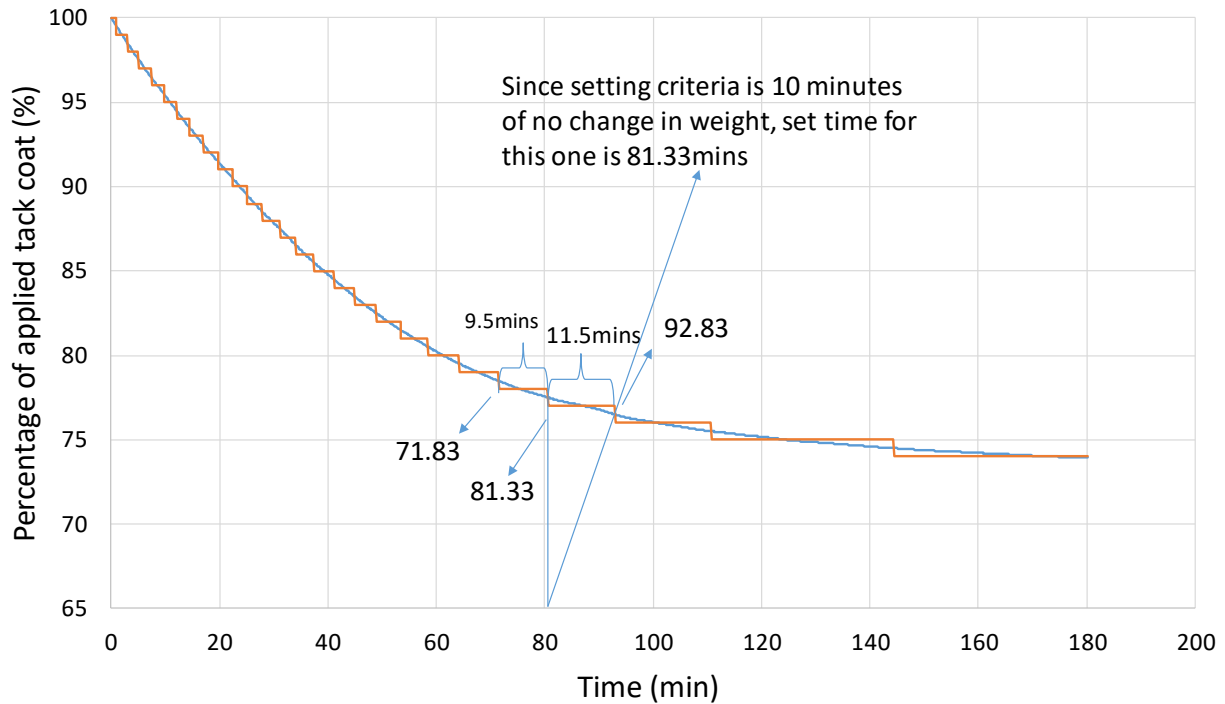
Figure 6.12: Example curing time calculation for the test with asphalt surface and 0.1 gal/yd² application rate.

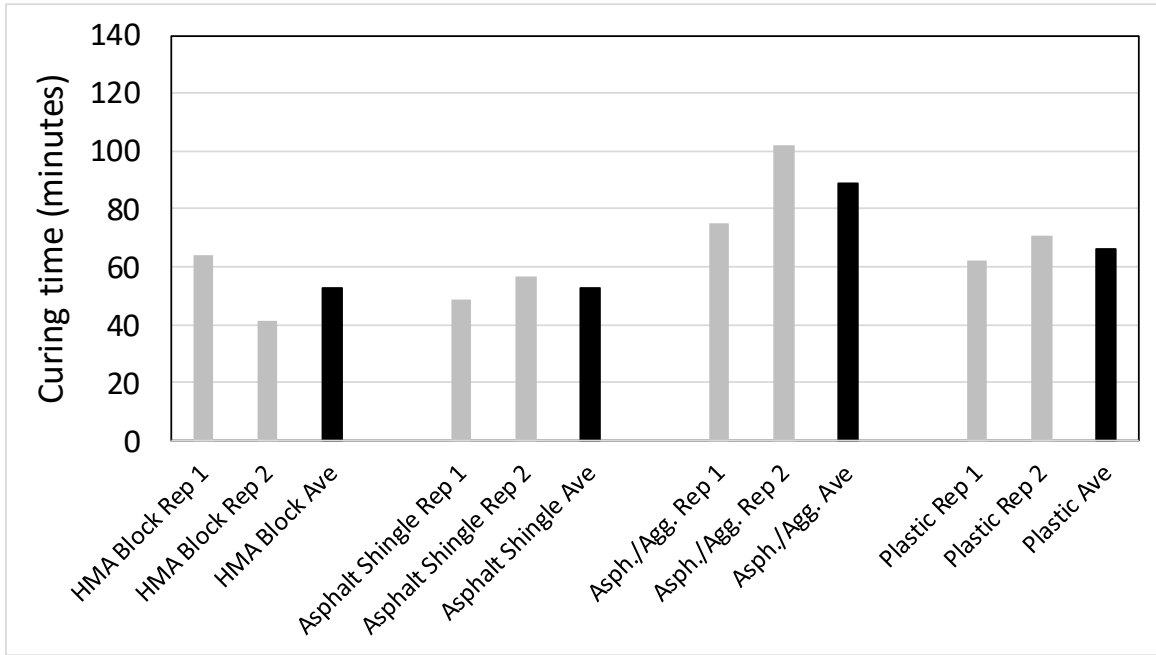
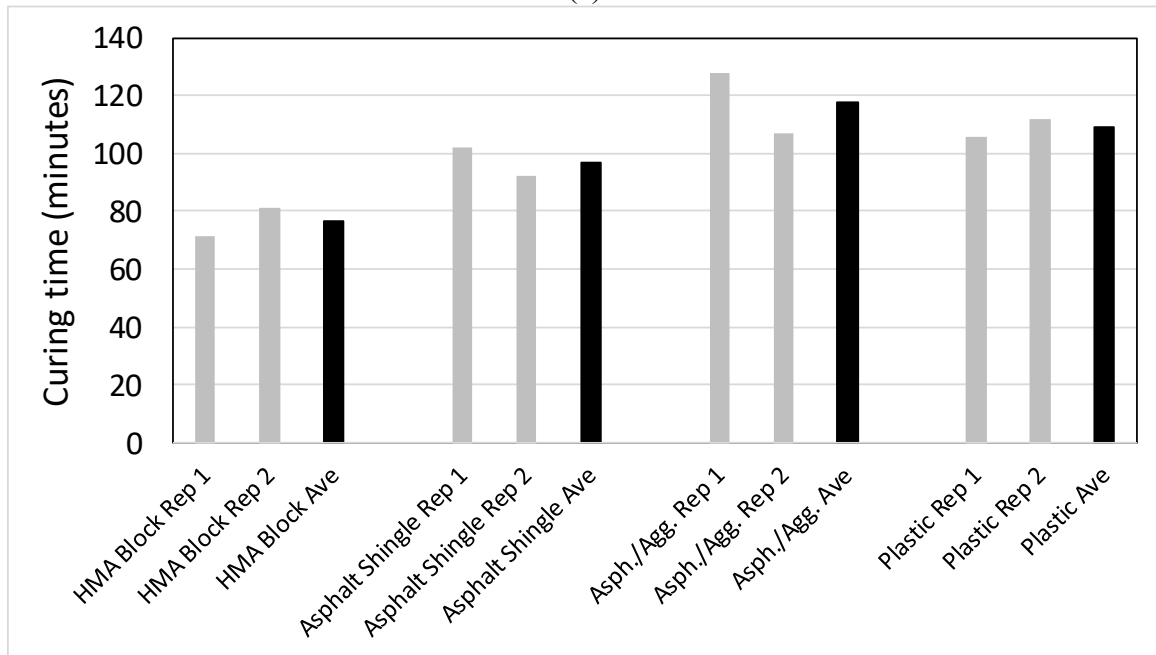
Figure 6.13: Curing time for all surface types (a) 0.05 gal/yd² application rate (b) 0.10 gal/yd² application rate.

Figure 6.13 shows the curing times from all laboratory evaporation tests. It can be observed that curing times for the plastic plate with asphalt shingle layer on top provides curing times that are closest to the curing times for the asphalt cores. Since the asphalt binder/aggregate and plastic (no texture) surfaces are impermeable, a thin layer of tack coat on the surface of the applied tack coat cures within the first 15-20 minutes and slows down the evaporation for the underlying tack coat emulsion. On the other hand, asphalt shingle and asphalt core surfaces both absorb some of the tack coat and avoids the formation of this thin tack coat layer. For this reason, cases with asphalt core and asphalt shingle surface result in closer curing times that are lower than asphalt binder/aggregate and plastic surfaces. Thus, plastic plate with asphalt shingle surfacing was selected to evaluate tack coat emulsion curing time during construction.

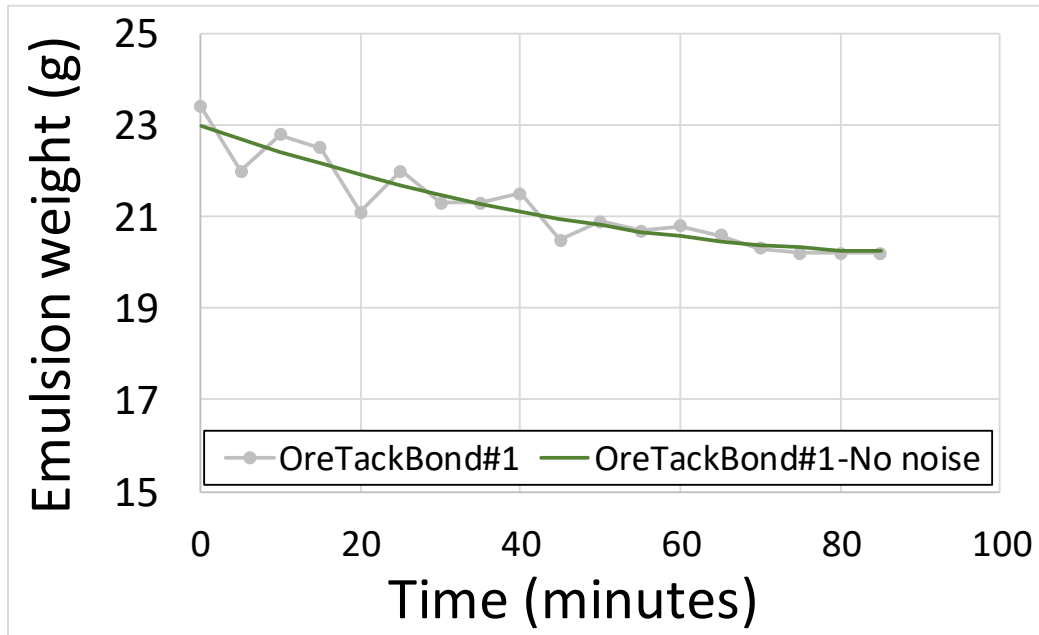
Figure 6.14: Project#5 OreTackRate evaporation data with and without noise reduction.

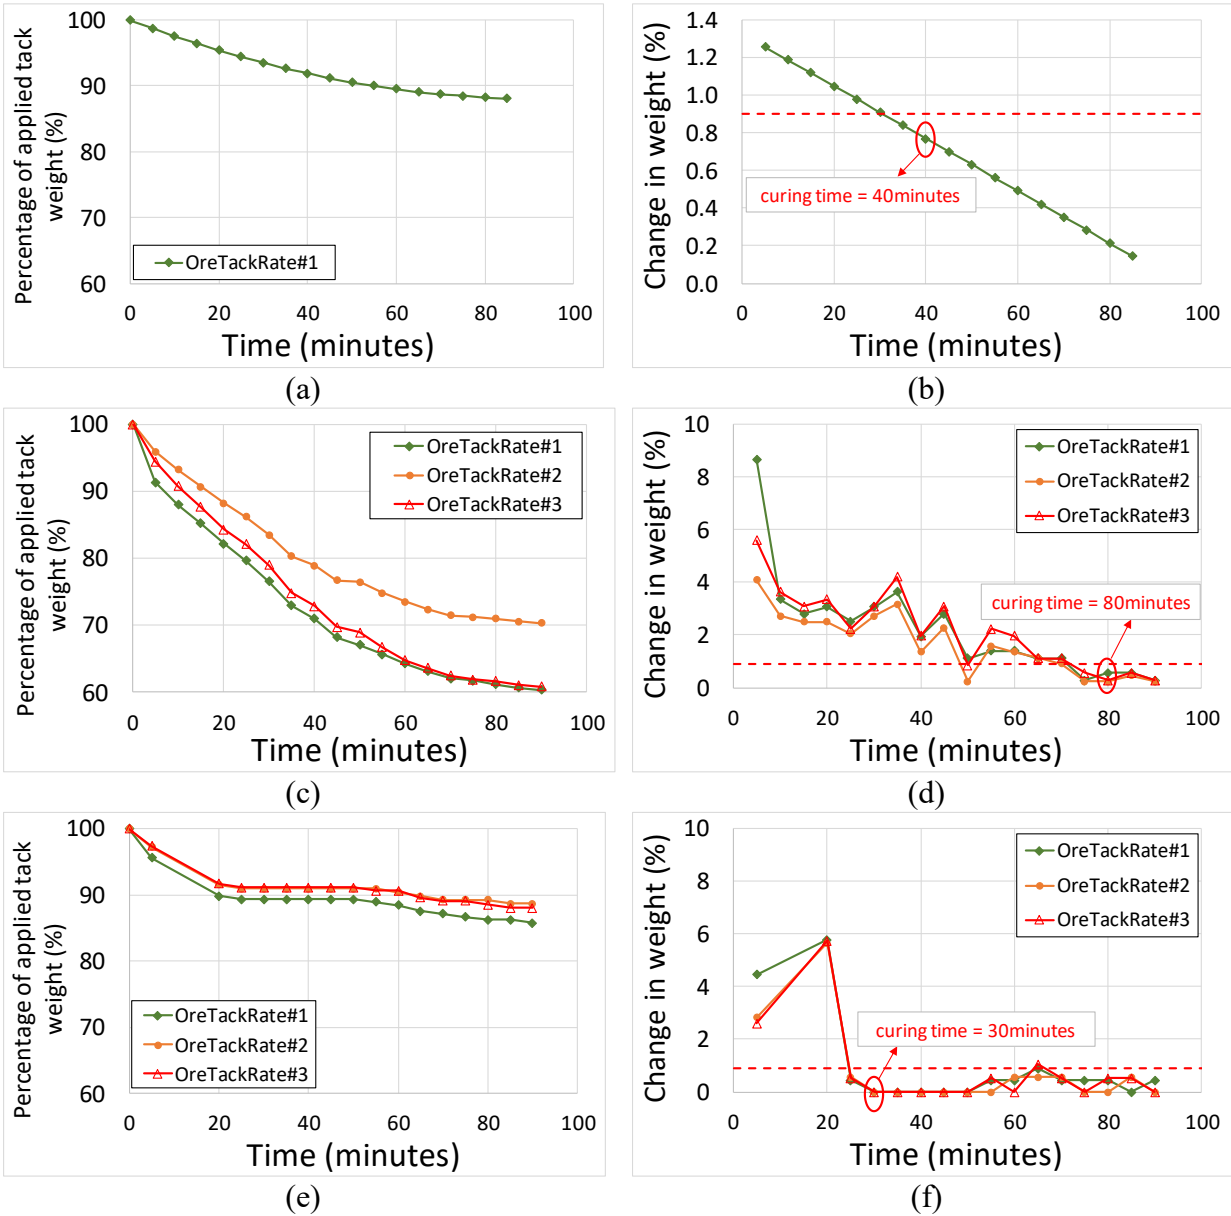
Figure 6.15: Percentage of applied tack coat and change in weight plots from all three construction projects (a) Evaporation curve for Project#5 (b) Change in weight percentage for Project#5 (c) Evaporation curve for Project#6 (d) Change in weight percentage for Project#6 (e) Evaporation curve for Project#7 (f) Change in weight percentage for Project#7.

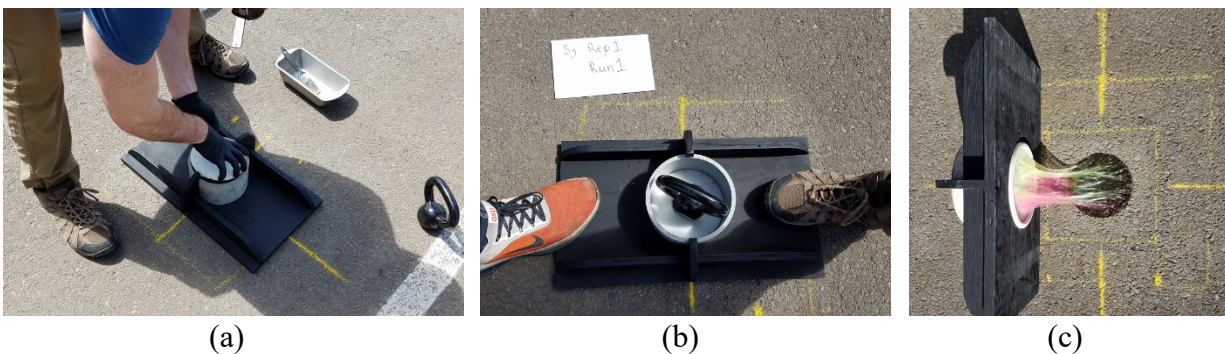
Figure 6.17: Testing the putty for cleaning electronics for surface dust/particle content measurement (a) Placing the sample under the loading plate (b) Applying the 5lb load on the plate (c) Removal of the plate.

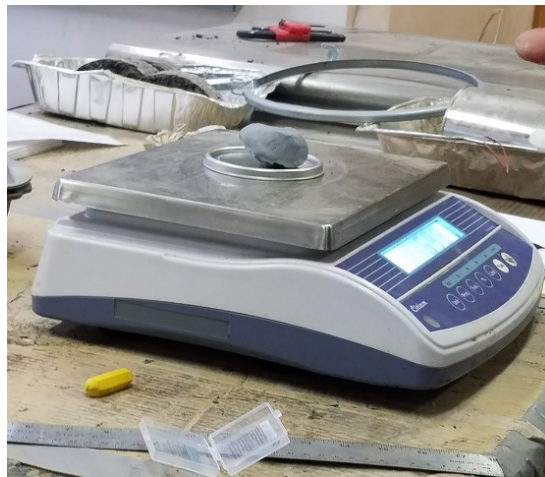
Figure 6.19: Initial weight measurement of the kneaded erasers.

1. Place the scale on a flat surface and make sure to place the transparent wind guard on it when taking weight measurements outside.
2. Open and peel plastic sheet off each eraser (make sure no residual plastic is left on the erasers).
3. Put a clean surface on the scale (this will ensure erasers do not get contaminated) and place all three erasers on the plate. Then, measure the initial weight of all three erasers together and record.
4. Knead three erasers into one eraser.
5. Weigh the single eraser to make sure no weight has changed (if weight has changed, record the final weight)

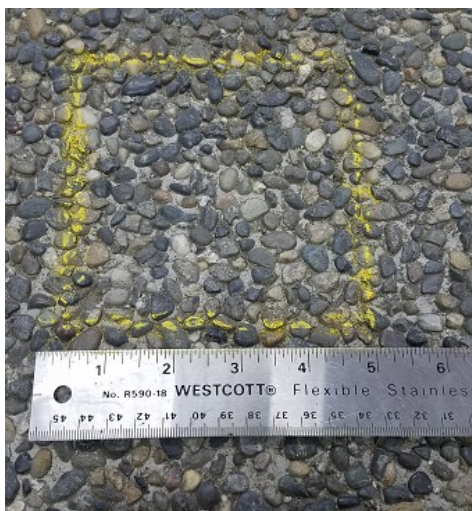
Figure 6.20: 5inch by 5inch square drawn on the pavement surface.

6. Take the weighed eraser with the clean plate to a random location in the construction lane.
7. Draw a 5 inch by 5 inch square with a ruler and a crayon.

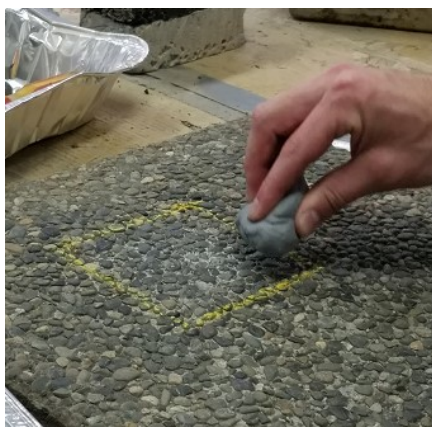
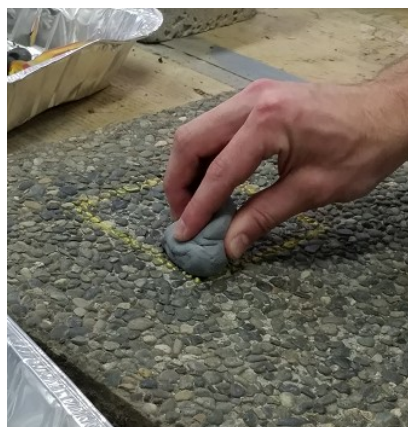
Figure 6.21: Picking up the dust from the surface (First run).

8. Take eraser and dab in square to collect surface dust. Make sure to dab the entire area of the square (This is Run 1).

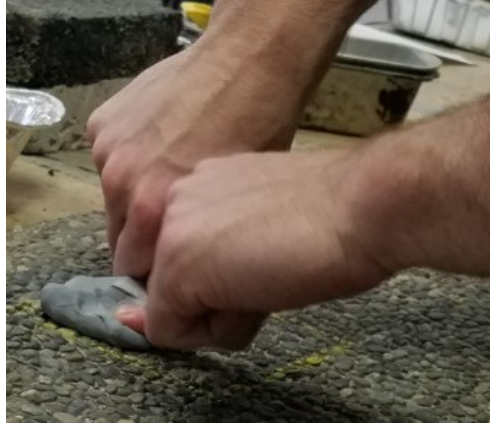
Figure 6.22: Picking up the dust from the surface (Run 2).

9. Knead the dusty side of eraser to the middle by moving the interior to the outside (pushing a dusty surface constantly into the pavement surface may reduce the stickiness of the eraser)
10. Take the eraser and push it into the texture of the pavement (this is Run 2)

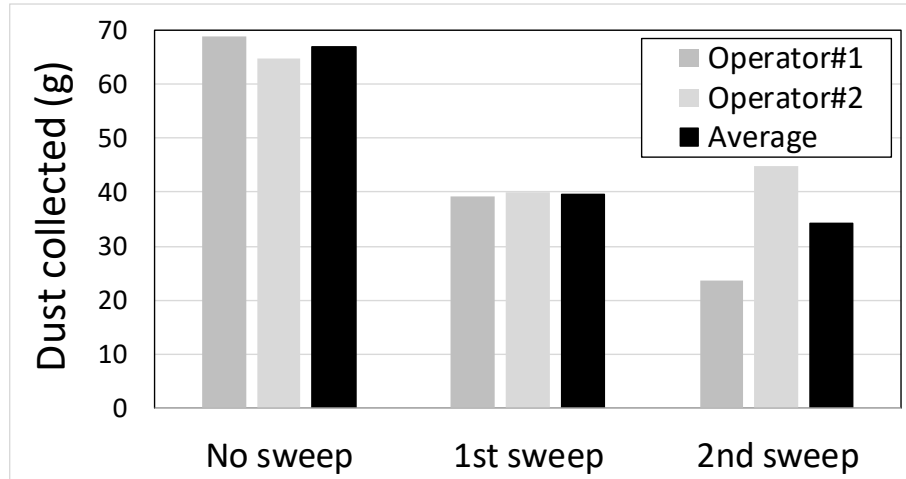
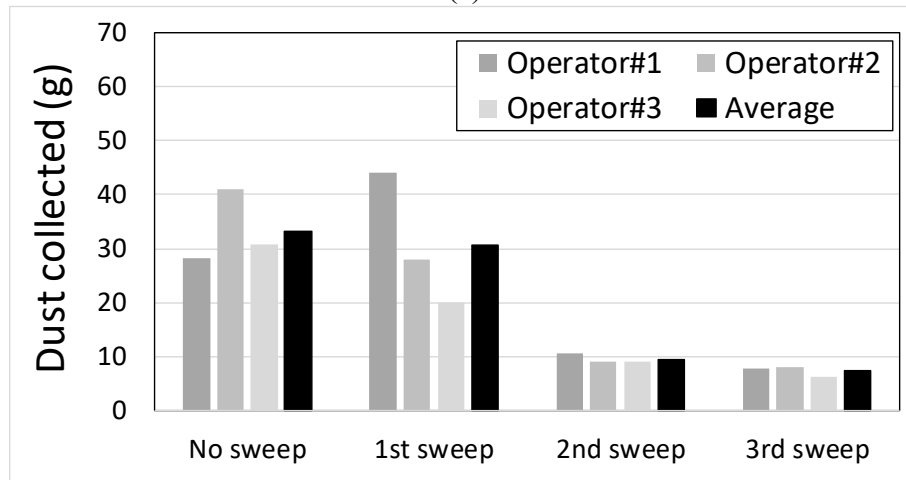
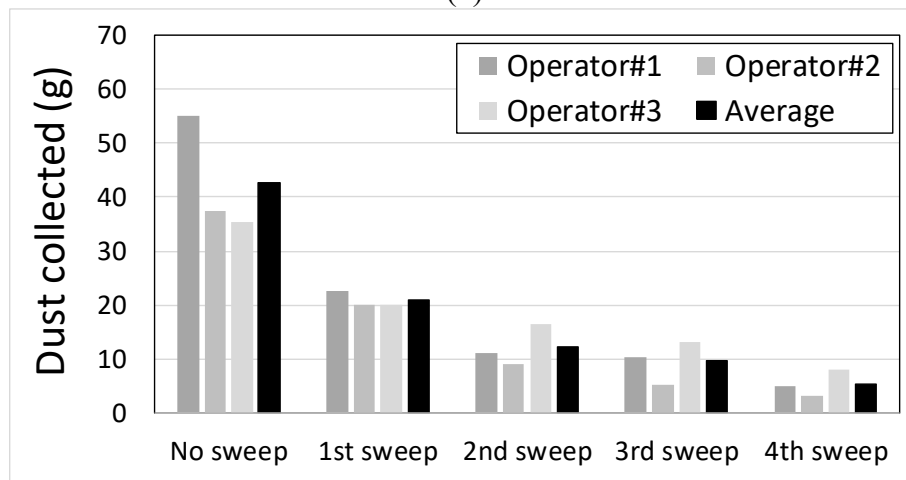
Figure 6.23: Field cleanliness test results (a) Project#5 (b) Project#6 (c) Project#7.

By following the OreTackClean process described in the previous section, field cleanliness tests were conducted at three construction projects (Projects #5, #6, and #7). Cleanliness tests were conducted by three operators at random locations along the construction lane for Projects #6 and #7. For Project#5, only two cleanliness tests were conducted. Tests were conducted after milling (before any sweeping) and after every sweep to determine the effectiveness of the developed test method for cleanliness identification. Figure 6.23 shows the field cleanliness test results. It should be noted that for some of the cases, collected dust weight might be slightly increasing after a sweep (for example: Project#5-between 1st and 2nd sweeps for Operator#2). This unexpected result is due to conducting the tests at random locations after every sweep. However, the average collected dust amount from three replicate tests is expected to represent the overall cleanliness of the pavement surface by considering the impact of spatial variability on the test results. For this reason, average collected dust from all replicate tests is always decreasing with increasing number of sweeper passes for all three projects. It can also be observed from Figure 6.23 that Project#5 had higher collected particle weight when compared to the initial weight collected for Projects #6 and #7. In addition, the amount of collected particle weight was significantly higher for Project#5 (about 5 to 7 times higher) at the end of all sweeper passes.

Excessive amount of tracking observed for Project#5 is likely to be a result of the high amount of particles on the surface of the pavement after sweeping. Additional number of sweeper passes and/or improving the effectiveness of the sweepers might have resulted in a cleaner before tack coat application for this project. On the other hand, Projects #6 and #7 had an average of 7.3g and 5.4g of particles on the surface (for the 5inch by 5inch test area), respectively. It should be noted that less than 10grams of particles on the surface always looked visually reasonable (See Figure 6.24d) while it was easier to visually see significant amount of particles on the surface when the collected average particle weight was over 20grams (See Figure 6.24c). For this reason, **a cleanliness threshold of 10grams for a 5inch by 5inch area is suggested as the acceptance criterion in this study.** Both Projects #6 and #7 pass this requirement after sweeping while Project#5 fail to meet the criterion.

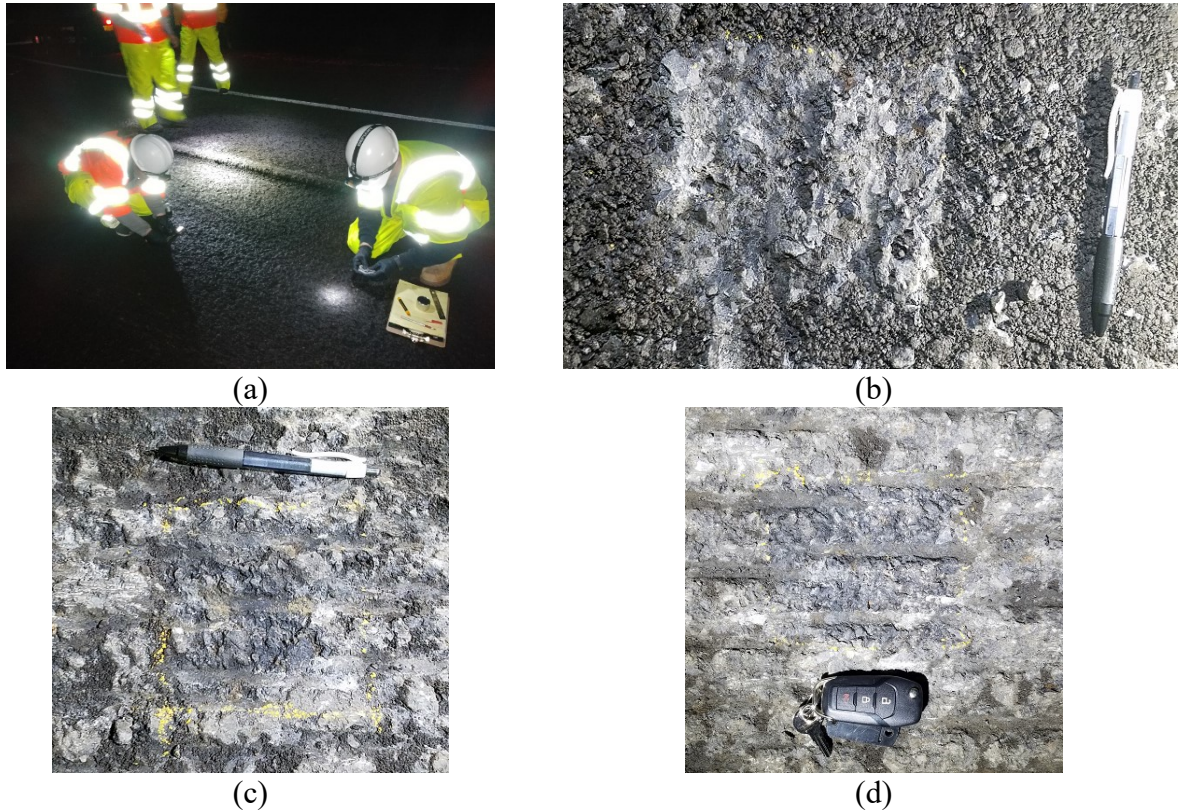
Figure 6.24: Field cleanliness testing for Project#7 (a) Two operators conducting cleanliness tests (b) Pavement surface after the cleanliness test (after milling-before sweepers – 43 grams of dust) (c) Pavement surface after the 1st sweeper pass – 21 grams of dust (d) Pavement surface after the 3rd sweeper pass – 9.5 grams of dust.
