REMOVING RESIDUAL LANE MARKINGS TO REDUCE DRIVER CONFUSION

Draft Final Report

SPR 855

Oregon Department of Transportation

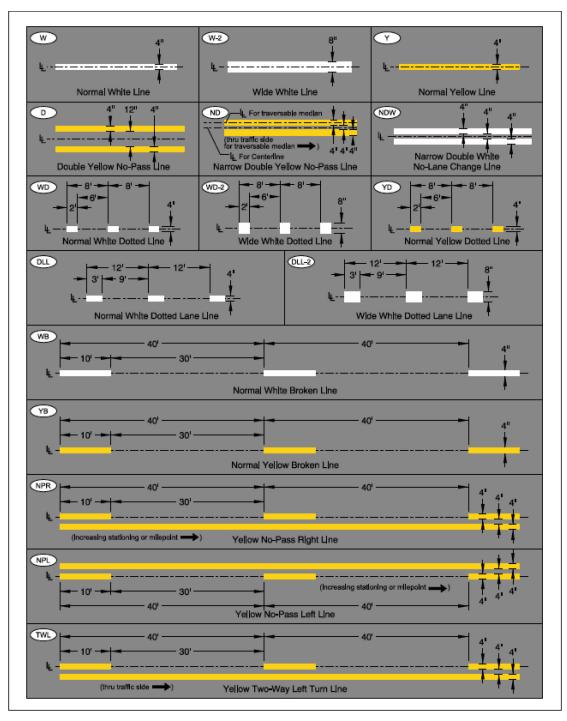
FIGURE 2.1: LONGITUDINAL LINE TYPES (ODOT, 2021)

Marking colors are required to be yellow, white, red, blue, or green depending on the application, with black only being allowed when it is used as a border color to contrast the pavement marking with the road or to cover existing markings in a temporary setting. The different pavement marking colors are necessary to convey the proper message to road users at a particular location on the roadway. For longitudinal lines, which are presented in Figure 2.1, the type of pavement markings that will be investigated in the present study, they typically are applied in a solid, double, broken, or dotted pattern and must consist of a certain width depending on the type of roadway facility and the message being conveyed. These line patterns must also maintain a width to length ratio of 1:3 (ODOT, 2021). Additional standards for other types of pavement markings and their different uses are found in the ODOT manual (ODOT, 2021).

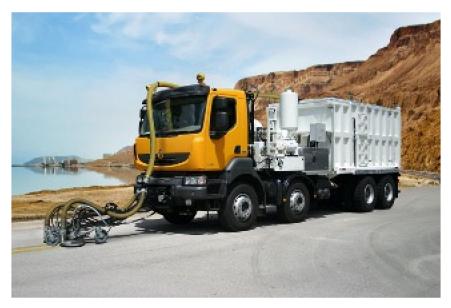
FIGURE 2.2: HIGH-PRESSURE WATER BLASTING TRUCK (GOOGLE, 2021)

Hydroblasting is different than high-pressure water blasting in that it combines sand and water rather than just water. It is effective on thin pavement markings, but the drawbacks are numerous as it can produce significant debris, scar the pavement surface, and remove the asphalt binder.

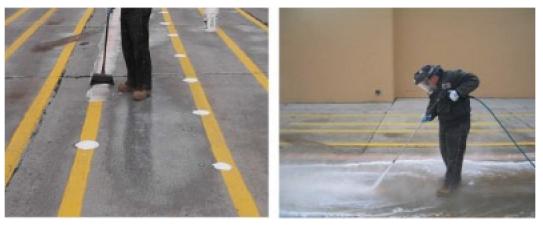
FIGURE 2.4: APPLICATION OF CHEMICAL REMOVER TO THE LEFT AND REMOVAL TO THE RIGHT (CHO ET AL., 2013)

The removal of pavement markings through chemical means has been gaining interest in the past few years as it has become more of a viable option. It is a chemical remover that, following EPA guidelines, does not contain any form of methylene chloride (MeCl) which is considered an air pollutant and hazard to public health (Cho et al., 2013). The non-MeCl chemical remover is applied to thinner pavement markings, such as waterborne paint, and is successful in removing almost all of the paint while not damaging the pavement surface. Figure 2.4 shows the application and removal of pavement markings using a chemical remover. Drawbacks to this removal method include a longer implementation time as the chemical remover needs to remain on the markings for 10 to 30 minutes to be effective and the

potential need for multiple passes over the pavement surface to remove the markings to an acceptable degree (NCHRP, 2013).

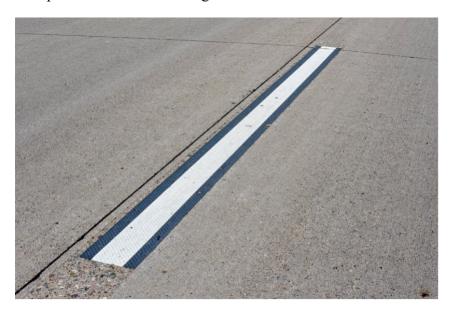
FIGURE 2.6: BLACK BORDER ON WHITE STRIPE TO INCREASE CONTRAST BETWEEN MARKING AND PAVEMENT (GOOGLE, 2019)

Contrast sensitivity is considered key when it comes to visibility as it makes it easier to discern the differences between the road and the marking with Figure 2.6 showing an example of a contrasted marking. It is stated to be, "the ability to detect small differences in brightness between an object and its background." (ODOT, 2021). As drivers increase in age, pavement markings become less visible due to changes in the eye lens and the prominence of ocular disease within the age group. Maintaining a noticeable contrast is important when considering these road users.

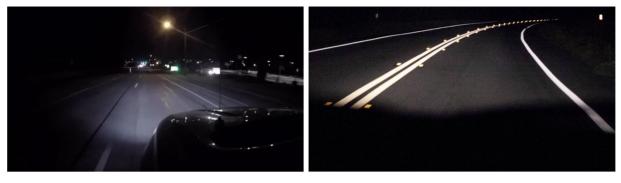
FIGURE 2.7: CONTRAST BETWEEN LOW RETROREFLECTIVITY PAVEMENT MARKINGS TO THE LEFT AND HIGH RETROREFLECTIVITY MARKINGS TO THE RIGHT (GOOGLE, 2021)

Multiple factors influence driver performance relative to the retroreflectivity of pavement markings. Factors associated with the driver include visual capabilities, cognitive processing capabilities, and motor skills (TxDOT, 2004). These factors decline with age but not all drivers will need the same amount of light to see the pavement markings. In the NCHRP study titled *Human Factors – Guidelines for Road Systems* it was found that for younger drivers a retroreflectivity value of 93 mcd/m²/lux was considered adequate for nighttime driving whereas a value of 100 mcd/m²/lux was considered the minimum adequate brightness for those 60 years or older (Campbell et al., 2012). These minimums are not to be confused with the necessary values of acceptability among all road users for retroreflectivity as it was found that a value of at least 300 to 400 mcd/m²/lux was needed for a decent user performance (Campbell et al., 2012).

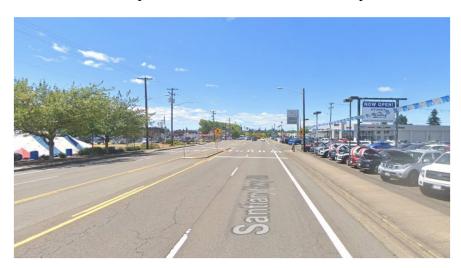
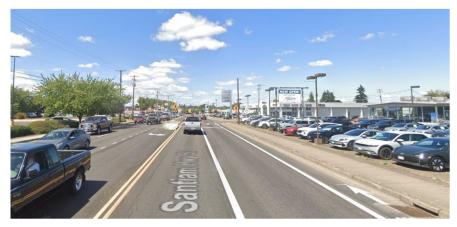
FIGURE 3.2: ALBANY – SANTIAM HIGHWAY REFERENCE IMAGE (TOP IMAGE IS PRIOR TO CONSTRUCTION AND BOTTOM IS AFTER CONSTRUCTION)

For the Santiam Highway project, the purpose was also to improve safety for this four-lane corridor. The original facility featured a painted median strip, crosswalk stripes and lane markings depicting where each lane was along with a bike lane to the right of each lane. In the updated configuration a raised median was added along with turning lanes incorporated into these medians. The speed limit for this location is 35 mph. For the Highway 99 and Airport Road project the purpose was to improve safety as it was noted to be a high crash location. The previous markings featured only one stripe for the left and right-side lane markings while the update included a double stripe for those markings as well as an added turn lane and a bike lane. The speed limit for this location is 30 mph.

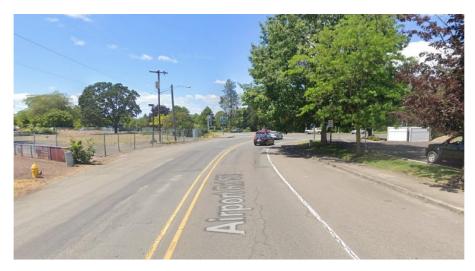
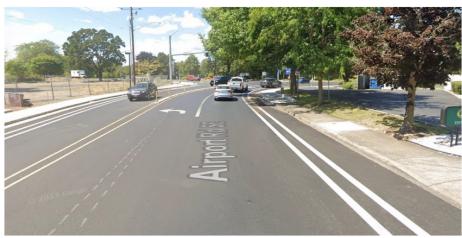
FIGURE 3.3: ALBANY – AIRPORT ROAD AND HIGHWAY 99 REFERENCE IMAGE (TOP IMAGE IS PRIOR TO CONSTRUCTION AND BOTTOM IS AFTER CONSTRUCTION)

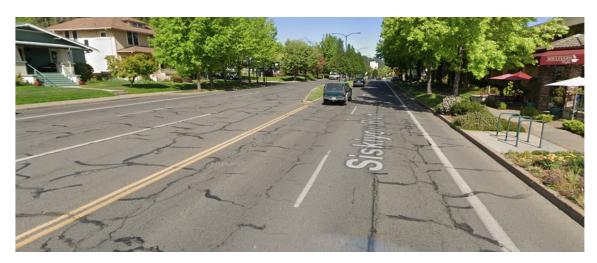
FIGURE 3.4: ASHLAND – SISKIYOU BOULEVARD REFERENCE IMAGE

The project identified in Ashland had been completed in 2012 as part of a road diet for Siskiyou Boulevard, the main roadway through the city. This roadway features four lanes, two in the northbound and two in the southbound direction along with a left turning lane, a bike lane to the right of each rightmost lane in both directions and a speed limit of 25 mph. The turning lane had been added as part of the road diet project back in 2012. While the project was older than the other featured projects in this chapter it was the only one that had removed pavement markings using the grinding removal method. Since there had been no repaving in the following years the removed markings were still visible at this location it was included as part of the sites selected for this experiment. The figure depicting the Ashland project, Figure 3.4, shows only the current facility as an image prior to construction could not be found.

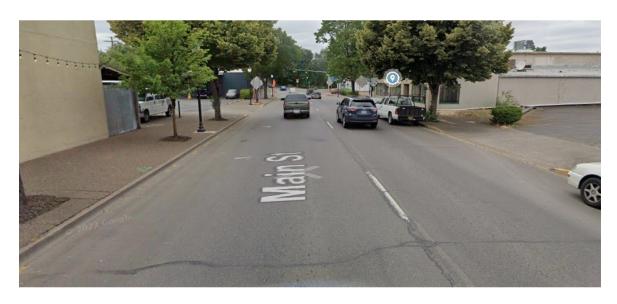
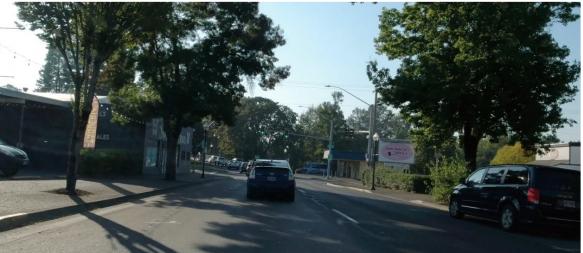
FIGURE 3.5: SPRINGFIELD – MAIN STREET REFERENCE IMAGE (TOP IMAGE IS PRIOR TO CONSTRUCTION AND BOTTOM IS AFTER CONSTRUCTION)

The Springfield project featured pavement marking removal on Main Street, shown in Figure 3.5, which is the primary street that spans the entire length of Springfield with a speed limit of 20 mph. While the project stated that it featured the removal of pavement markings along Main Street the markings were only removed in the downtown area. The removal method was identified as hydroblasting and was performed for the markings in the center of the roadway. While the other projects featured a complete overhaul of original marking placement, for this project the markings were updated to be more visible for drivers which meant placing them in the same lateral position as the previous markings. This meant that it was harder to see the difference between the before and after construction in the area.

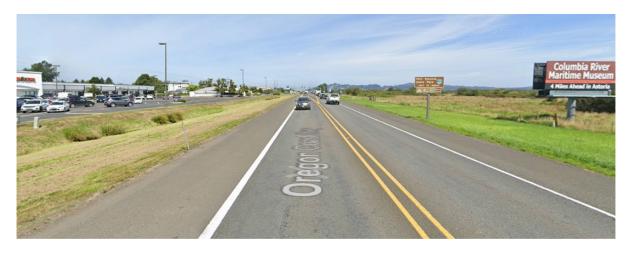
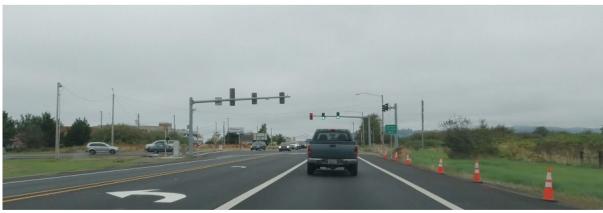
FIGURE 3.6: WARRENTON - US 101 REFERENCE IMAGE (TOP IMAGE IS PRIOR TO CONSTRUCTION AND BOTTOM IS AFTER CONSTRUCTION)

The project identified in Warrenton was along US 101 just outside of Astoria. The project featured pavement marking removal due to some issues that had occurred with newer markings that had been placed. Figure 3.6 shows the roadway which is a two-way highway with a turning lane in the middle, along with a bike lane to the right side of each lane located near a shopping area and the bridge connecting Warrenton to Astoria with a speed limit of 45 mph. Hydroblasting marking removal was used for this project, as was the case for most projects. The before condition did not feature the current left turn lane.

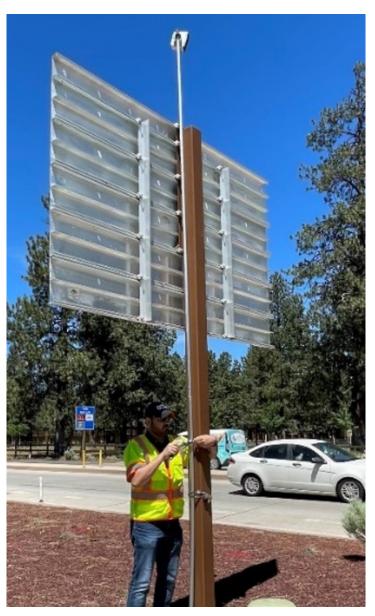
FIGURE 4.1: SETUP OF CAMERA

This method would involve data collection primarily through the temporary placement of video cameras or other sensors at the roadside without the need for directly recruiting participants or receiving Institutional Review Board approval. The project locations suggested by ODOT that feature at least one novel pavement marking removal method would be used. The research team would set up either a video camera or a drone alongside the road to capture the road users' movements as they encounter the removed pavement markings. Measures of speed, lateral position, and lane line incursions would be recorded with point sensors for comparison of the pre-post-performance between the different removal methods. Figure 4.1 shows the setup of the camera used for the project. The camera would be attached to a sign pole or stand at a height of approximately 9 to 10 feet to capture the vehicles driving on the roadway.

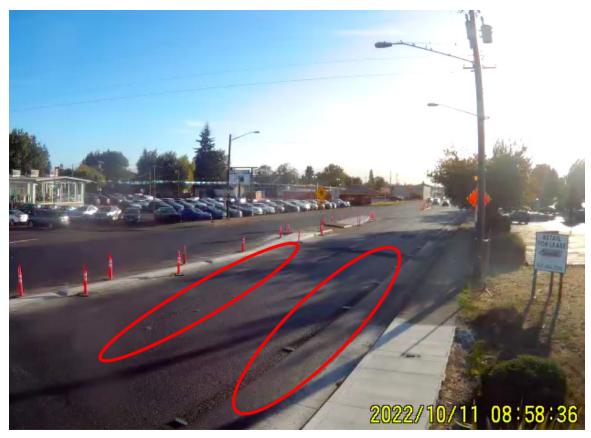
FIGURE 5.1: PAVEMENT MARKING REMOVAL ON US 20, ALBANY, OR

This study site is located on US 20 between SE Geary St and Waverly Drive SE in Albany, OR. Along this section, US 20 has two travel lanes in each direction. Video data was collected for 48 hours at this site between 11/7/2022 and 11/9/2022. The method of pavement marking removal used at this location was hydro blasting. Over six and half hours of video was watched at this location across different weather and lighting conditions encompassing dawn, day, and night, as well as wet and dry conditions. Figure 5.1 shows the pavement markings removal at this location.

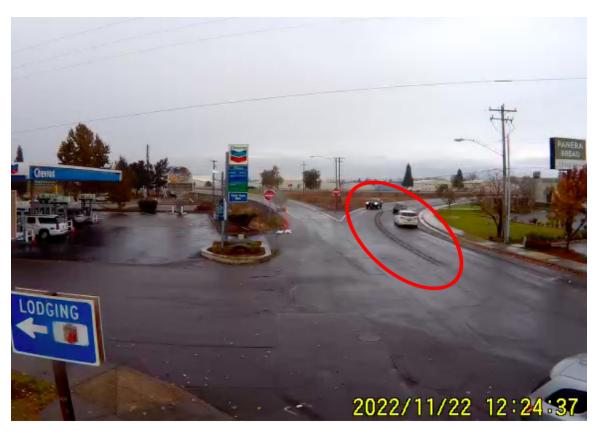
FIGURE 5.2: PAVEMENT MARKING REMOVAL ON OR 99 E, ALBANY, OR

This study site is located on 99E at Airport Road in Albany, OR. Along this section, OR 99E has one travel lane in each direction. Video data was collected for 10 hours at this site on 11/22/22. The method of pavement marking removal used at this location was hydro blasting. Approximately six hours of video was watched at this location across different weather and lighting conditions encompassing day, and night, as well as wet and rainy conditions. Figure 5.2 shows the pavement markings removal at this location.

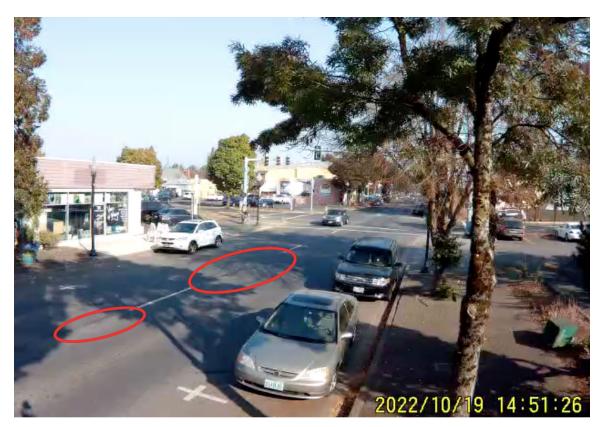
FIGURE 5.3: PAVEMENT MARKING REMOVAL ON US 126B, SPRINGFIELD, OR

This study site is located on OR 126B at Main Street in Springfield, OR. Along this section, OR 126B is one-way and has two travel lanes along with parking. Video data was collected for 48 hours at this site between 10/19/22 and 10/20/22. The method of pavement marking removal used at this location was hydro blasting. Approximately 6 hours of video was watched at this location across different weather and lighting conditions encompassing dawn, day, dusk, and night, as well as dry and foggy conditions. Figure 5.3 shows the pavement markings removal at this location.

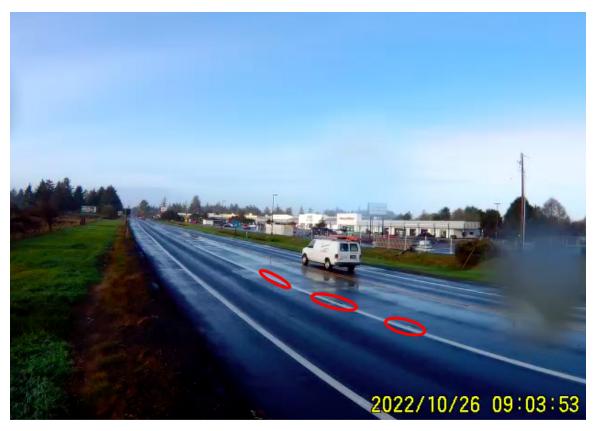
FIGURE 5.4: PAVEMENT MARKING REMOVAL ON US 101, WARRENTON, OR

This study site is located on US 101 between New Bay to Neptune in Warrenton, OR. Along this section, US 101 has two travel lanes in one direction and one travel lane in the other direction as shown in Figure 5.4. Video data was collected for 48 hours at this site between 10/24/22 and 10/25/22. The method of pavement marking removal used at this location was hydro blasting. Approximately 17 hours of video was watched at this location across different weather and lighting conditions encompassing dawn, day, dusk, and night, as well as wet and dry conditions.

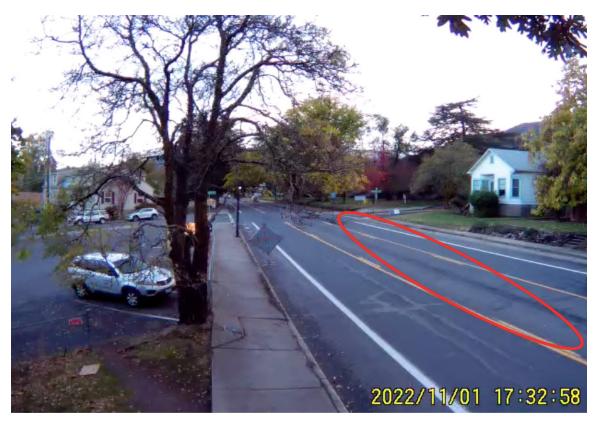
FIGURE 5.5: PAVEMENT MARKING REMOVAL ON OR 99, ASHLAND, OR

This study site is located on OR 99 on Siskiyou Blvd. northbound in Ashland, OR. Along this section, OR 99 has one travel lane in each direction and center turn lane as shown in Figure 5.5. Video data was collected for 48 hours at this site between 11/1/22 and 11/2/22. The method of pavement marking removal used at this location was grinding. Approximately 5 hours of video was watched at this location across different weather and lighting conditions encompassing dawn, day, dusk, and night, as well as rainy, wet, and dry conditions. The temporary road work sign seen in the figure was not placed by the research team, instead it was part of the construction effort at the site location during the time of video data collection.

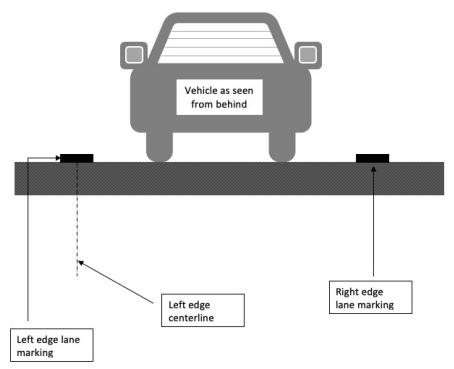
a) Vehicle in center of driving lane

For most types, A – G tires on the vehicle will be inside the lane that the vehicle is driving in but does feature types in which the tires go just beyond the lane marking. If the vehicle that is departing the lane comes to a full stop before continuing to the lane of travel, then it is also included in this section. For H – K this typically includes vehicles that are large or are a vehicle-trailer combination that needs more space to maneuver in when making turns. The bounding box looks at the entirety of the large or combination vehicle and if it needs a wider radius and is split into the body and the body plus the mirror. If the vehicle needs a wider radius to make a safe turn and goes over the pavement markings, then this is considered acceptable and not a real departure from the roadway markings. Figure 5.6 provides reference on what the vehicle lane departure can look like in different scenarios. These scenarios show the vehicle not experiencing any form of lane departure, driving on top of the lane marking, and going beyond the lane marking.

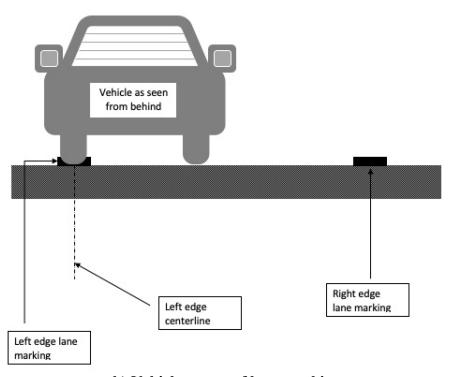
b) Vehicle on top of lane marking

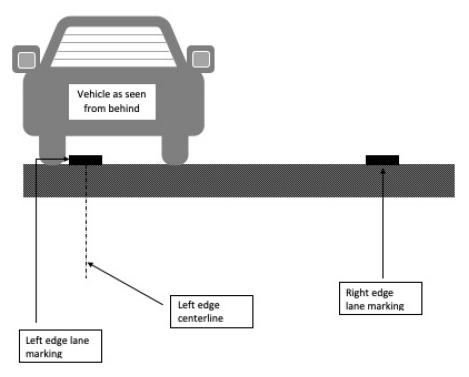
c) Vehicle crossing over lane marking

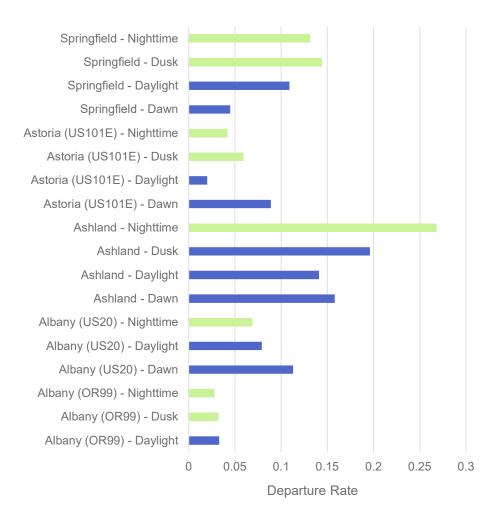
FIGURE 5.7: DEPARTURE RATE BY LIGHT CONDITION

Lighting Condition	Observations	Departures	Departure Rate
Albany	Daylight	1688	56	0.033
(OR99)	Dusk	746	24	0.032
	Nighttime	652	18	0.028
Albany	Dawn	487	55	0.113
(US20)	Daylight	2155	171	0.079
	Nighttime	524	36	0.069
Ashland	Dawn	423	67	0.158
	Daylight	4083	574	0.141
	Dusk	148	29	0.196
	Nighttime	388	104	0.268
Astoria	Dawn	180	16	0.089
(US101E)	Daylight	1780	35	0.020
	Dusk	135	8	0.059
	Nighttime	1035	43	0.042
Springfield	Dawn	287	13	0.045
	Daylight	2605	284	0.109
	Dusk	542	78	0.144
	Nighttime	411	54	0.131

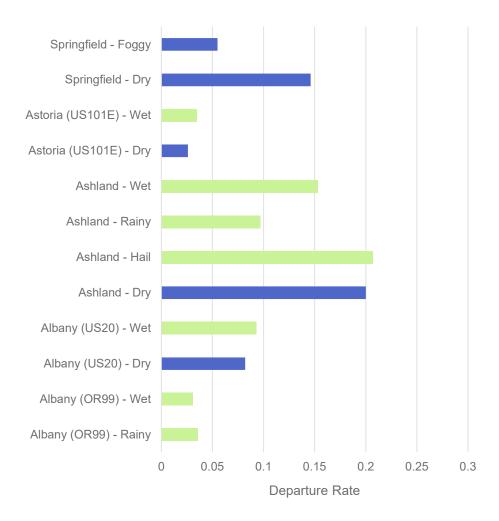
FIGURE 5.8: DEPARTURE RATE BY WEATHER CONDITION

Weather Condition	Observations	Departures	Departure Rate
Albany	Rainy	385	14	0.036
(OR99)	Wet	2701	84	0.031
Albany	Dry	2855	233	0.082
(US20)	Wet	311	29	0.093
Ashland	Dry	892	178	0.200
	Hail	87	18	0.207
	Rainy	793	77	0.097
	Wet	3270	501	0.153
Astoria	Dry	804	21	0.026
(US101E)	Wet	2326	81	0.035
Springfield	Dry	2397	349	0.146
	Foggy	1448	80	0.055

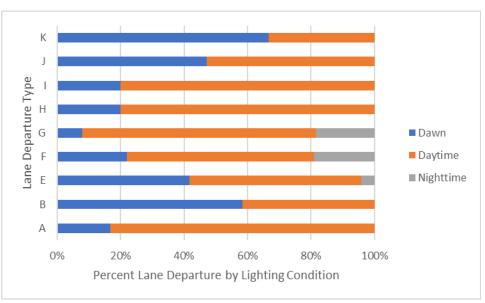
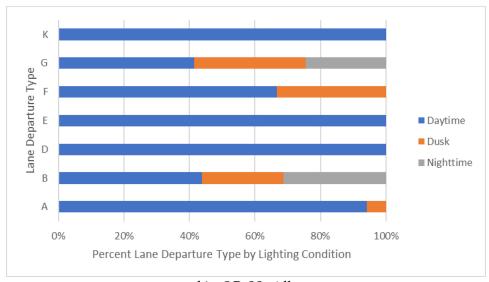
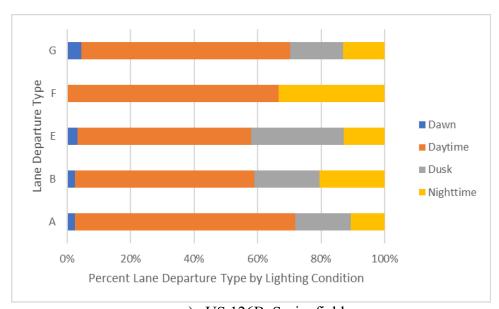
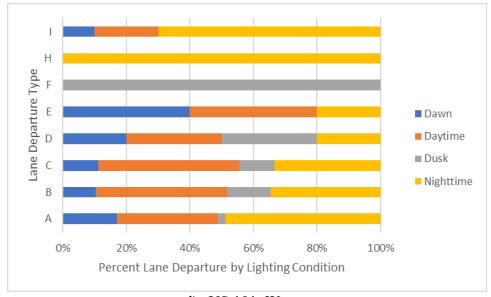
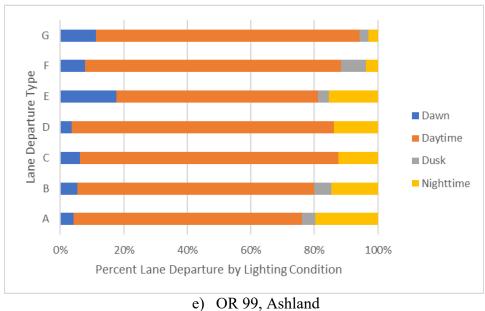
FIGURE 5.9: PROPORTION OF LANE DEPARTURE TYPE BY LIGHTING CONDITION

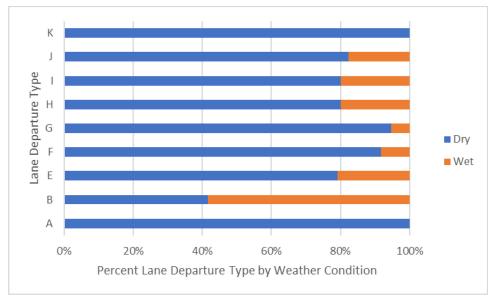
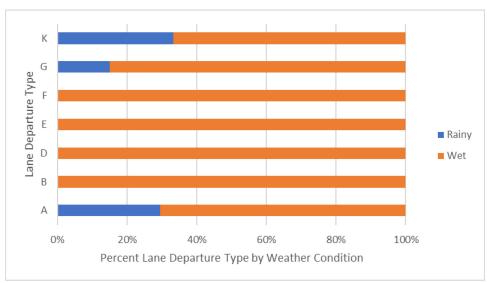
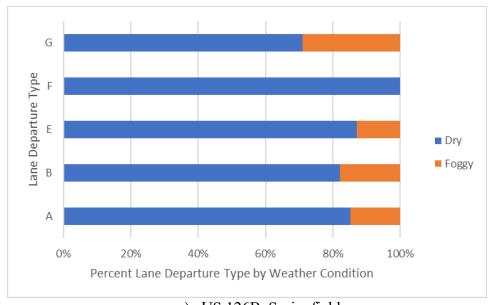
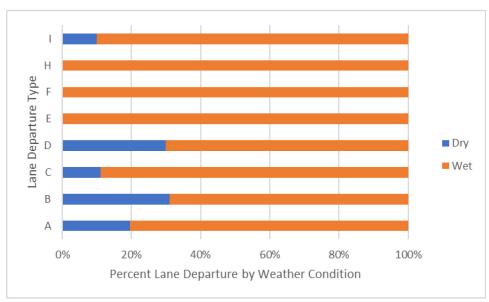
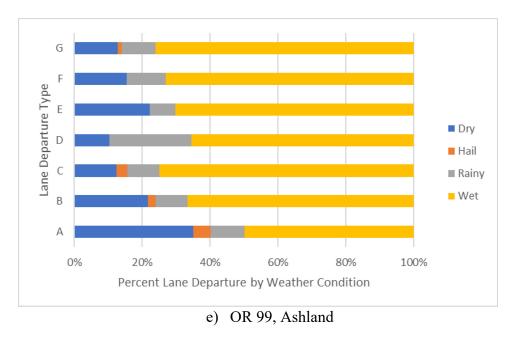
FIGURE 5.10: PROPORTION OF LANE DEPARTURE TYPE BY WEATHER CONDITION

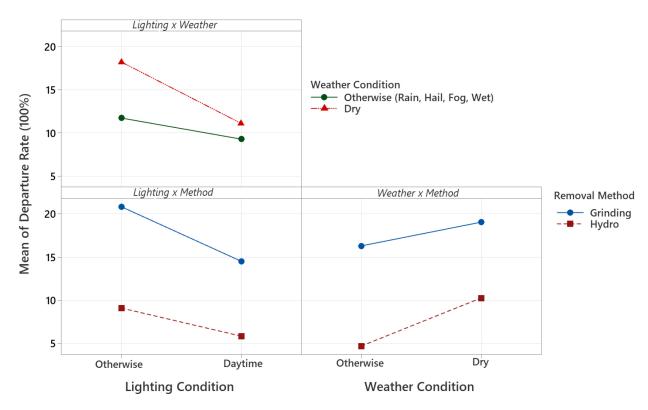
FIGURE 5.11: TWO-WAY INTERACTIONS OF INDEPENDENT VARIABLES ON MEAN DEPARTURE RATE (%)

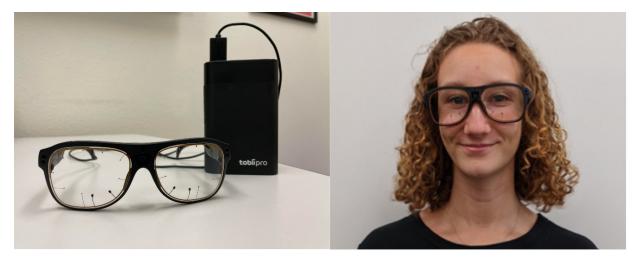
FIGURE 6.1: TOBII PRO GLASSES 3 (LEFT) AND OSU RESEARCHER DEMONSTRATION (RIGHT)

Eye movement consists of fixations and saccades. Fixations occur when the gaze is directed towards a particular location and remains still for some period. Saccades occur when the eye moves between fixations. The eye tracking system records a fixation when the participant's eyes pause in a certain position for more than 100 milliseconds. Quick movements to another position (saccades) are calculated indirectly from the dwell time between fixations. Total dwell times are recorded by the equipment as the sum of the time of fixations and saccades consecutively recorded within an area of interest (AOI) (Hurwitz et al., 2018). Figure 6-1 shows the eye-tracking equipment and an OSU researcher demonstration of how the equipment is outfitted on the participant.

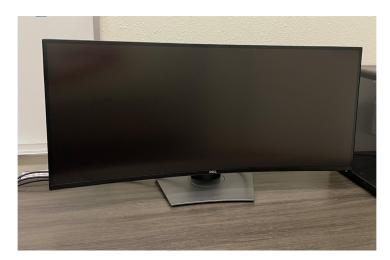
FIGURE 6.2: DELL ULTRASHARP 34-INCH CURVE MONITOR

A Dell UltraSharp 34-inch Curved Monitor was to display the videos that the participants viewed while wearing eye-tracking glasses. A curved monitor was used as it provides a more immersive experience for viewers along with improving field of vision and reducing glare. The resolution of the monitor is 3440 x 1440 which allowed for the 4K videos to show in sharp definition. Figure 6.2 shows the monitor utilized for this experiment.

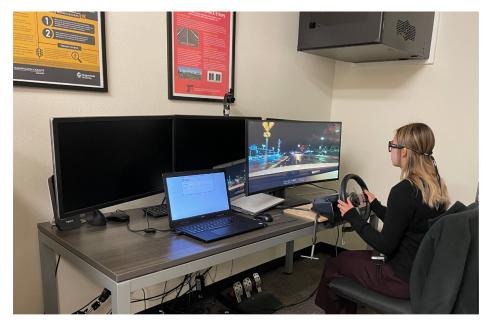
FIGURE 6.3: PARTICIPANT USING THE SETUP DURING THE EXPERIMENT.

Figure 6.3 shows the complete setup for the experiment. The monitor was placed in front of a steering wheel to provide extra authenticity to the experiment and participants were guided to hold onto the steering wheel if it felt comfortable. A laptop was set up next to the monitor for the participant to take the concurrent survey.

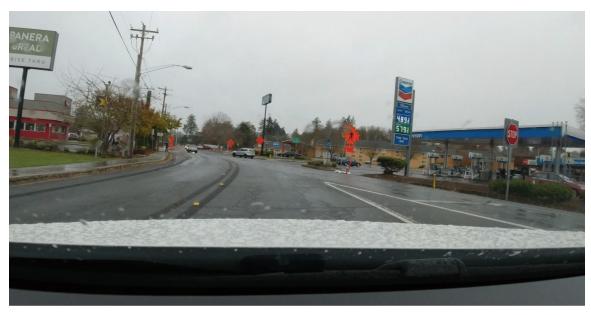
FIGURE 6.4: ALBANY - AIRPORT ROAD AND HIGHWAY 99 DURING WET DAYTIME CONDITIONS

The total length of the centerline is approximately 500 feet long while the right-side pavement marking in the westbound direction is approximately 200 feet long and the right-side pavement marking in the eastbound direction is also approximately 200 feet long. All weather conditions and lighting conditions were captured which were rainy, wet, dry for the weather types and daytime and nighttime for lighting. During the daytime portion there was no glare as there was a cloud cover.

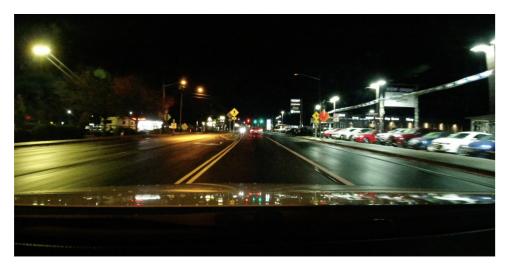
FIGURE 6.5: ALBANY - SANTIAM HIGHWAY DURING WET NIGHTTIME CONDITIONS

At this location hydroblasting was also used to remove multiple markings for a significant portion of the highway as it was a major project in upgrading the location. Figure 6.5 shows the roadway which are two lanes in either direction of the highway with a concrete divider separating the lanes. For the initial videos reflective road markers were used to designate the individual lanes while in the later videos freshly painted markings were evident. The removed markings were the centerlines, right-side pavement markings and left-side pavement markings. The total length of the different markings is a total as there was an intersection that split the project. As the markings were generally lined up together the total length for the centerline, right-side pavement markings and the left-side pavement markings are similar in length. The length for each type of pavement marking is approximately 1250 feet long. All weather and lighting conditions were captured at this location with the daytime conditions also featuring no glare due to the cloud cover.

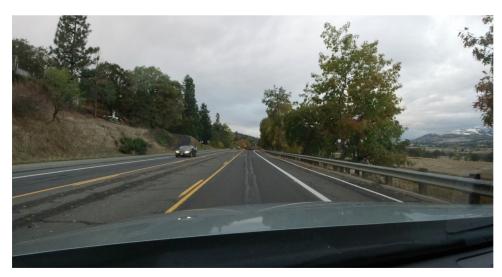
FIGURE 6.6: ASHLAND - SISKIYOU BOULEVARD DURING DRY DAYTIME CONDITIONS

For this location it featured grinding as the removal method from a road diet project performed a few years ago. Figure 6.6 shows the project location with two lanes in either direction and the location of the removed markings being in-between the two lanes with yellow paint designating the new lanes. This was to the left of the driving lane with the video capturing it in the northbound direction. The length of the removed markings that were featured in the different scenarios is around 4600 feet long. As with the other two locations a combination of different weather and lighting conditions were captured but due to the late in the year season there was no sunshine.

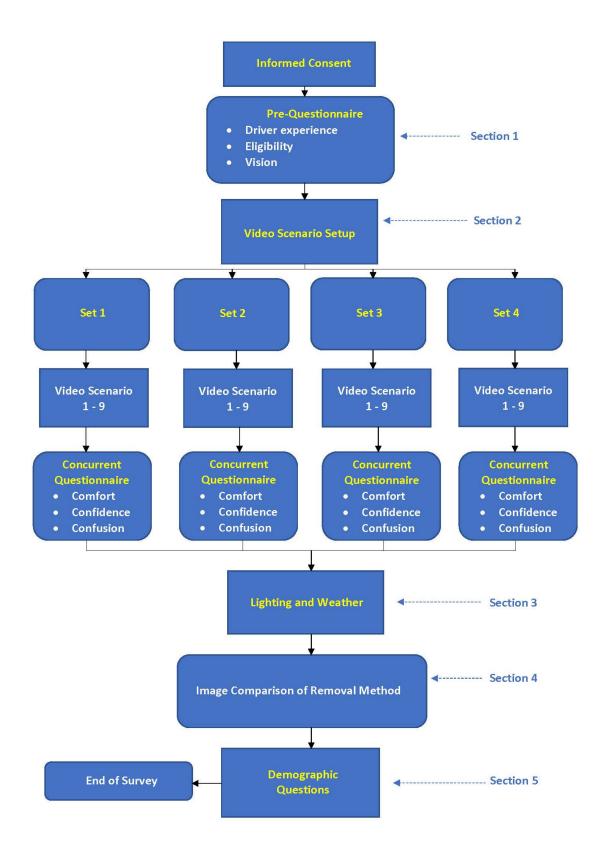
FIGURE 6.8: FLOW OF THE SURVEY USED IN THE EXPERIMENT.

The survey consisted of 32 questions, which included a mix of open-ended, close-ended questions. The survey design was created so that open-ended questions could be presented in an unbiased manner. Figure 6.8 illustrates the flow of the survey.

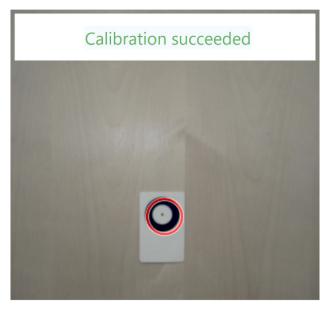
FIGURE 6.9: EYE-TRACKING CALIBRATION IMAGE

The Tobii Pro Glasses 3 eye-tracker was calibrated for each participant after the participant met the inclusion experiment criteria. The participant was asked to wear the glasses and look straight at a target card. The eye tracking recording could proceed if the calibration was successful. Figure 6.9 shows a view from the eye tracking glasses of a successful calibration.

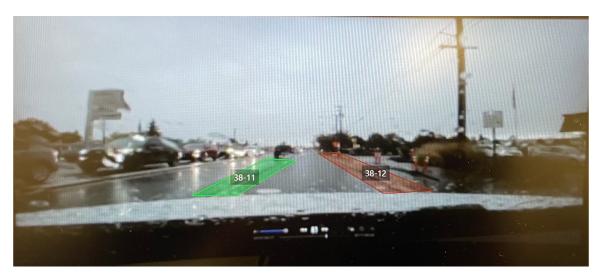
FIGURE 6.10: AOIS EXAMPLE

The interest period of each scenario started approximately 10 feet before the removed marking line started on the roadway and lasted until the scenario finished. This resulted in 30 seconds to 1.5 minutes of clip length per scenario depending on the location. Researchers manually coded polygons over the AOIs, and the polygons were adjusted incrementally to fit the AOIs frame by frame. The two AOIs defined in this study were removed markings to the left of the lane the video capturing vehicle was in and removed markings to the right of lane. Figure 6.10 is the screenshot of the AOIs during the reduction process. For scenarios in which only one removed marking line was featured, only one AOI was captured.

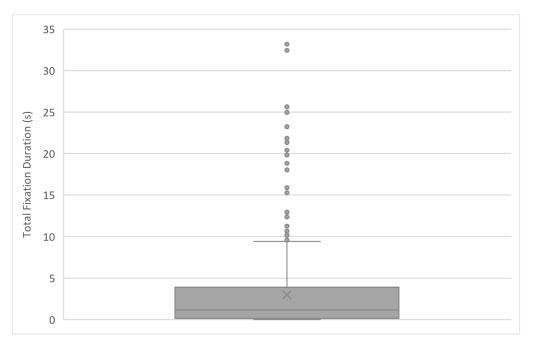
FIGURE 6.11: TOTAL FIXATION DURATION (TFD) IN SECONDS

The total fixation duration (TFD) of the participants for each scenario was used to compare the three independent variables and combinations of the variables to understand what caused the participants to focus on the pavement markings most frequently. In Figure 6.11 the total fixation duration is shown with the average amount of time focused on a pavement marking being approximately 2.9 seconds with the longest amount of total time spent fixating on an area at 33 seconds.

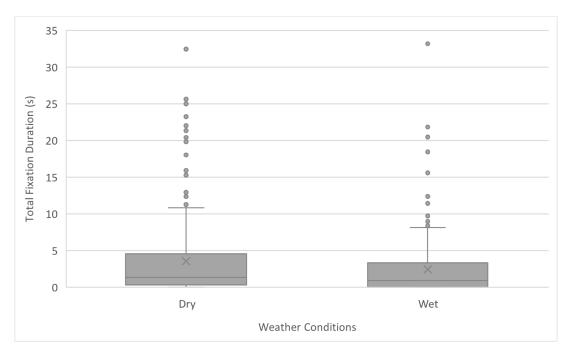
FIGURE 6.12: TFD BY WEATHER CONDITIONS

When looking at weather conditions the total fixation duration was used to compare the difference between both dry and wet/rainy conditions overall for the three different locations. It was found that participants fixated for a longer amount of time in dryer conditions on average rather than in wet/rainy conditions. Figure 6.12 shows the results between the two weather conditions.

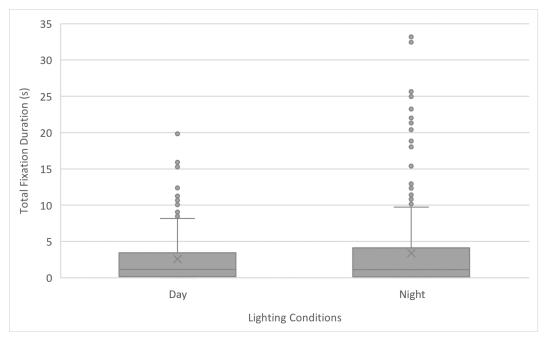
FIGURE 6.13: TFD BY LIGHTING CONDITIONS

For lighting conditions, the total fixation duration was compared between daytime and nighttime conditions at the three locations. It was found that the participants focused significantly more on the pavement markings during nighttime conditions over daytime conditions. The average duration of focus on the markings for nighttime is 3.37 seconds whereas for the daytime conditions it is 2.57 seconds. Figure 6.13 displays the results for the two different lighting conditions.

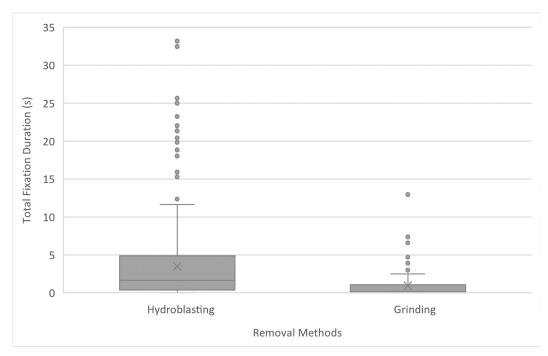
FIGURE 6.14: TFD BY REMOVAL METHOD AT STUDY LOCATIONS

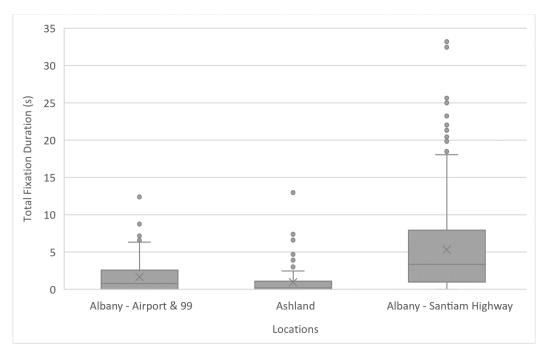
FIGURE 6.15: TFD AT STUDY LOCATIONS

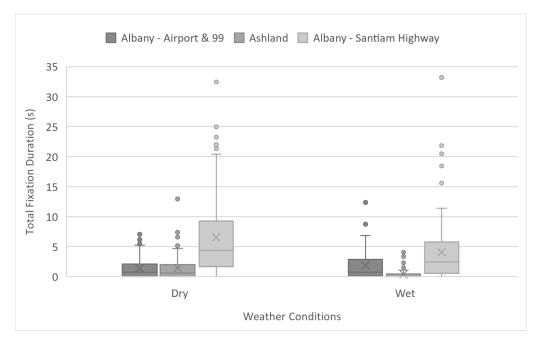
FIGURE 6.16: TFD BY WEATHER AT STUDY LOCATIONS

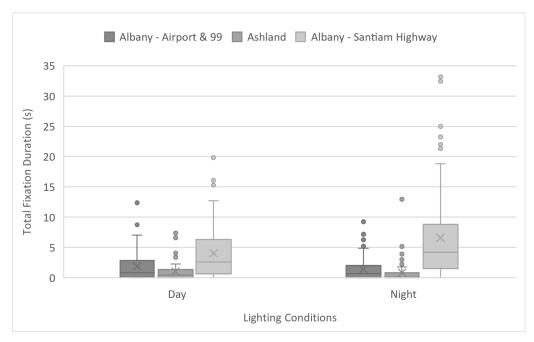
FIGURE 6.17: TFD BY LIGHTING AT STUDY LOCATIONS

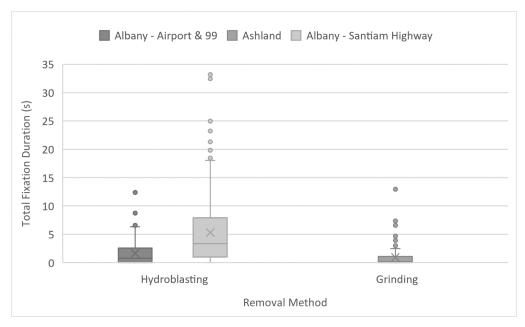
FIGURE 6.18: TFD BY REMOVAL METHOD AT STUDY LOCATIONS
