Preserving Wood in Historic Cemeteries

CASE STUDY: WOODEN OBELISK REPAIR IN WILLAMETTE VALLEY

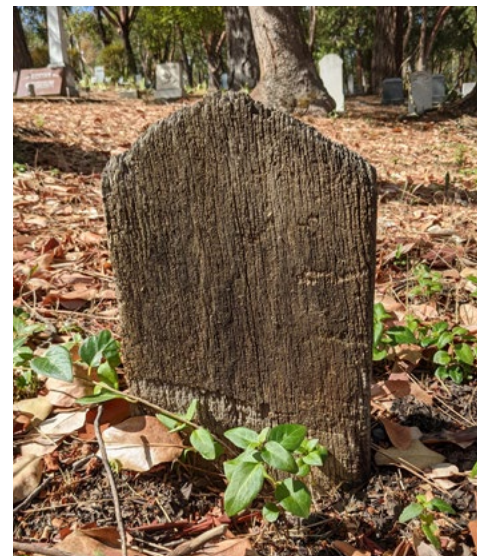
Jacksonville Cemetery, in relatively dry Southern Oregon, has recreated several of their wooden markers in wood. They’ve done an accurate recreation of the original wooden marker in shape, information, and font; however, they have mounted the new wooden marker on a post to separate the wood from the ground. A naturally rot-resistant wood like cedar or redwood does a good job of shedding water if it is vertical, but if

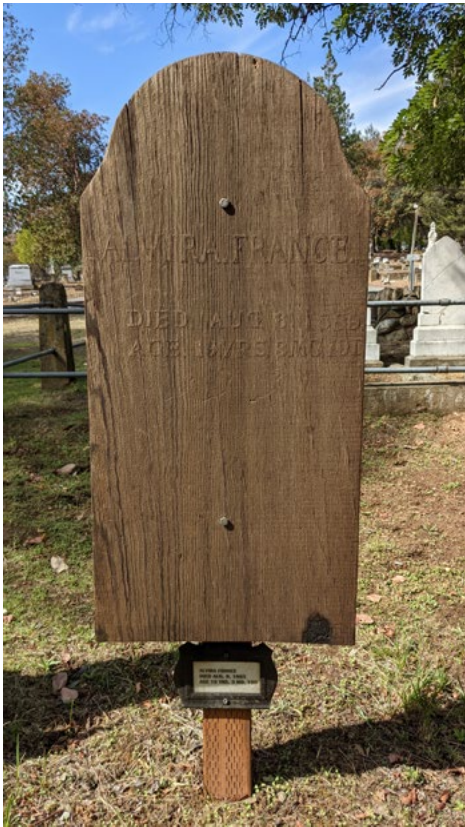
The recreated wooden marker is mounted to a pressure-treated post. Pressure treating helps resist rot but it is not a cure all. An old-grown cedar post placed in the ground will likely do equally as well if packed in with gravel within a well-drained soil.

Whatever wood is used for the post, the post should never be encased in concrete or foam – packed gravel works best to allow water to drain away from the wood.

Jacksonville Cemetery recreated their wood markers using a thick plank of old-growth cedar and then mounted the plank to a “sacrificial” post. They then repeated the information on the wooden marker within an enclosed metal marker on the same post. It’s a clever way to show what the original marker looked like, in the same format, but also slowing down the marker’s eventual decay by mounting it to a post. Even the relatively recently recreated marker has eroded to the point that the carved letters are almost in relief rather than incised.

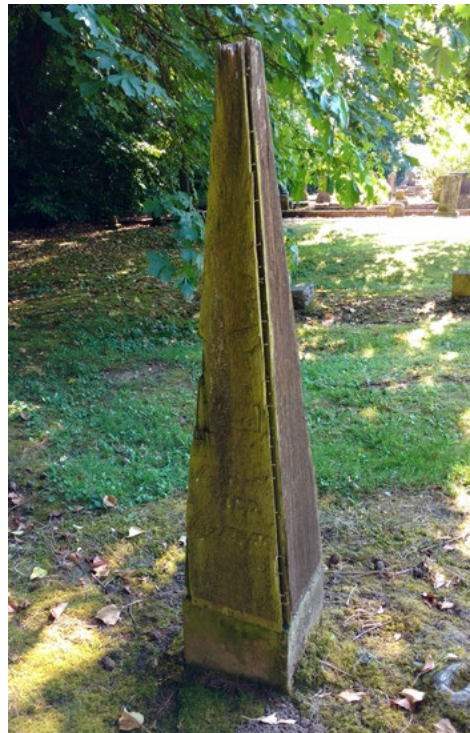
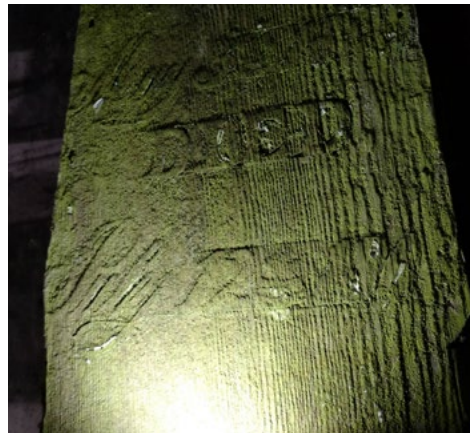
Lena Crosby’s wooden obelisk in Brookside Cemetery, Dayton, is a rare original wooden marker that is mostly intact and dates between 1900 and 1909.

Under a raking light, the ornate carving can still be discerned.

The high-quality wood and shape of the maker have helped the marker survive approximately 120 years in the wet Willamette Valley.

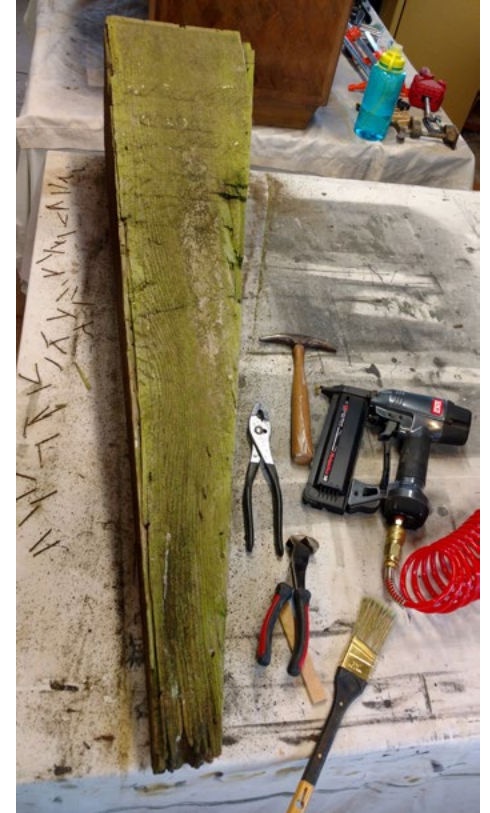
The corner was found to have been repaired over the years with 45 finish nails. A finish nailer coupled with water-based glue and clamping was the answer to repairing the fragile wood corner.

One corner of the marker had opened up noticeably, so Historic Preservation Northwest took the marker to their shop for examination in 2019.

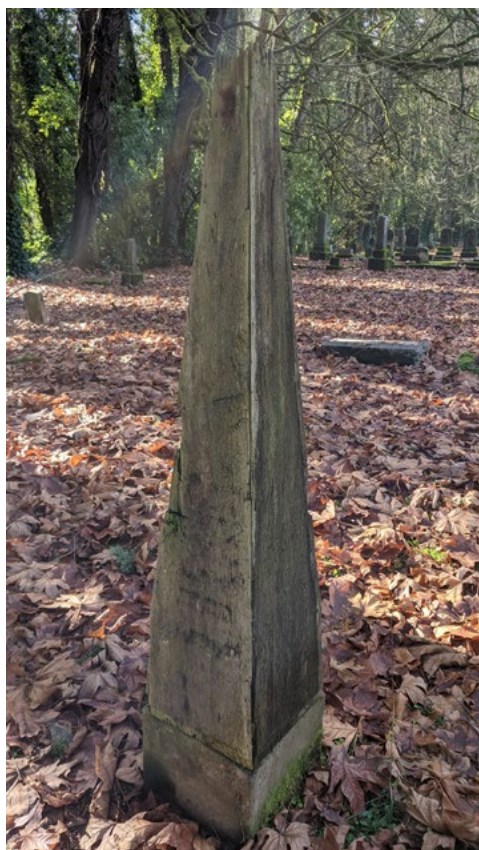
a concrete pedestal that the obelisk fits over and holds the obelisk about six inches off the ground. We believe the old wooden base was used as the form work for the concrete pedestal and for awhile was used to hide the concrete. In fact, it's arguable that the concrete was there from the very beginning hidden behind a wood skirt. Whatever the case, the wood was kept away from direct contact with the soil and helped in the obelisk's preservation.

The shape and material are important contributors to the survival of the obelisk but so is an early alteration to the monument. It originally had a wooden base of some sort but early on the base was replaced with
