National Register of Historic Places Registration Form

1. Name of Property				
historic name Cahill-Nordstrom Farm				
other names/site number Big Bend Farm				
Name of Multiple Property Listing <u>N/A</u>				
(Enter "N/A" if property is not part of a multiple property listing)

2. Location				
street & number 85926 Cahill Road	not for publication			
city or town Clatskanie	X vicinity			
state Oregon code OR county Clatsop	code 007 zip code 97016

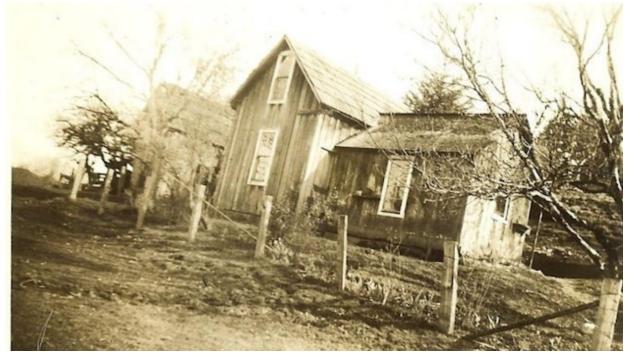
Figure 22. Second Cahill house built 1897, Spring 1940. The one-story kitchen wing was moved and repurposed as the shop (see Photos 15 and 16). Cahill-Nordstrom Family Collection.

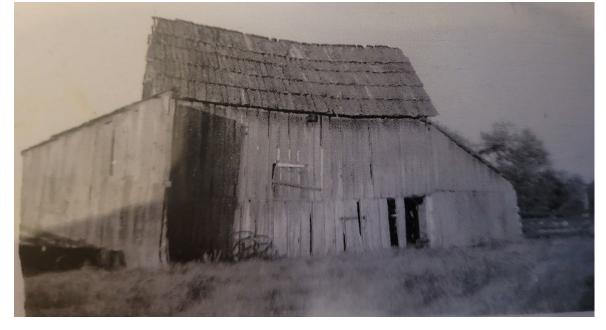
Figure 23. First barn (demolished in mid-1950s), no date. Cahill-Nordstrom Family Collection.

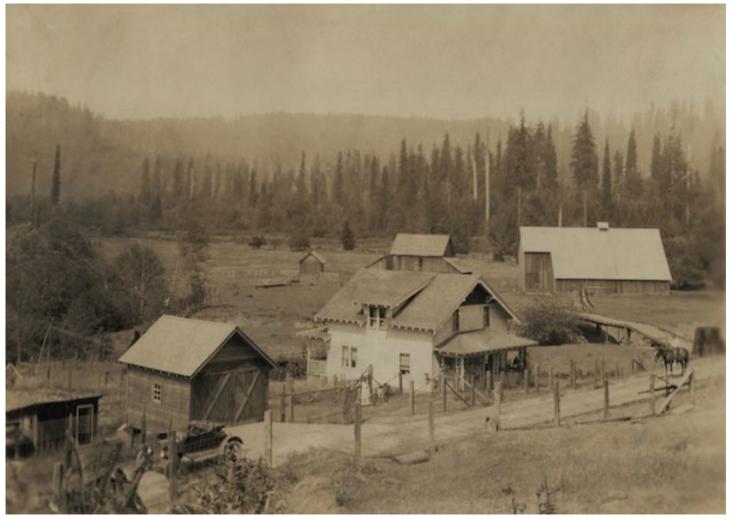
Figure 27. Overview of Cahill-Nordstrom Farm, view looking northeast from hillside above today's Highway 202, circa 1918.

Buildings in foreground, left to right: chicken house, garage, 1914 house built by John Larson, bridge. Buildings in background, left to right: unknown, old barn, new 1911 barn. Courtesy Carol Sullivan Colletta.

- Garage A single-car garage stood to the west of the house and was accessed from the Nehalem Highway/Highway 202 (Figure 27). It remained in place until the 1950s when it was dismantled.¹³

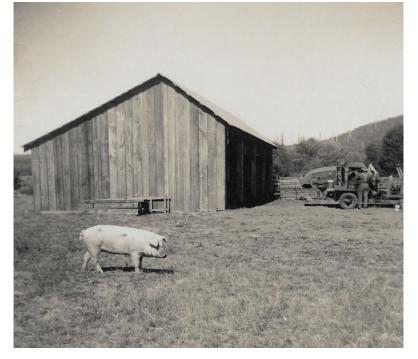
Figure 35. Machine shed, circa 1952. Courtesy Carol Sullivan Colletta.

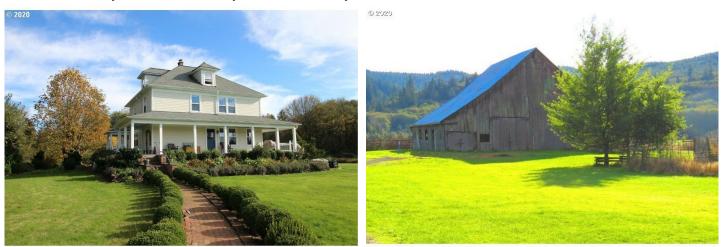
Figure 40. David and Margaret Van Volkinberg Freeman Farmhouse and Barn, 10640 Freeman Road, Birkenfeld vicinity, Columbia County, 2020. Courtesy Redfin.

- Freeman, David and Margaret Van Volkinberg, Farmhouse and Barn, 1900-1915 (10640 Freeman Road, Birkenfeld; Figure 40) - The Freeman farm today includes the c. 1915 house, c. 1900 barn, c. 1925 garage, and c. 1970 machine shed as well as a newer greenhouse and R.V./boat storage.⁹⁹ The house has been altered and updated, most obviously by an addition and installation of vinyl windows, but is in good condition. The property does not retain as many of the smaller outbuildings seen at the Cahill-Nordstrom Farm (which are helpful in conveying the history and function of the farm), but overall the property is in excellent condition, and retains sufficient integrity to convey its period of construction.

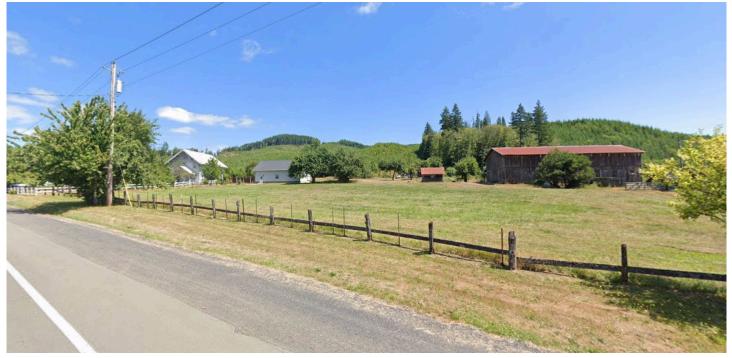
Figure 41. Anton and Julianna Birkenfeld House and Barn, 11164 Highway 202, Birkenfeld, Columbia County, July 2019. Courtesy Google.

- Birkenfeld, Julian (?), House and Barn, c. 1915 (11164 Highway 202, Birkenfeld; Figure 41) Though listed in the Statewide Inventory as the Julian Birkenfeld House and Barn, Anton and Julianna Birkenfeld were the original owners of these buildings.¹⁰⁰ The circa-1915 Birkenfeld property includes the house and barn, as well as two older but undated outbuildings, a new detached garage, and a number of mature orchard trees. The house was built by local builder John Larson, and has been altered by at least one addition and vinyl windows. The barn retains reasonably good exterior integrity. The property overall appears to be in excellent condition, and retains sufficient integrity to convey its period of construction, but lacks the smaller outbuildings that help describe the history and function of the farm.

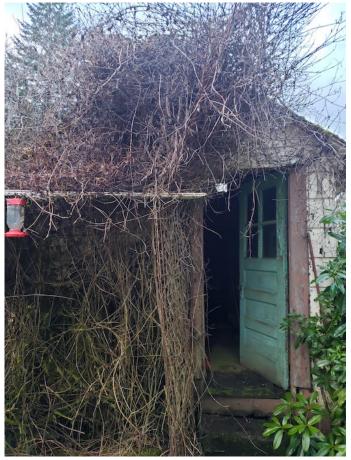
Photo 23. Francis and Helen Nordstrom fruit cellar, front wall and entrance (east end), looking west.

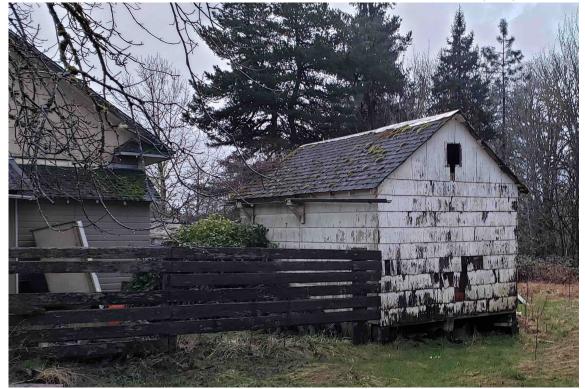
Photo 24. Francis and Helen Nordstrom fruit cellar, north side and west (rear) elevations, looking southeast.
