National Register of Historic Places Registration Form

historic name Pallay Apartments

street & number 631 SE Taylor Street not for publication

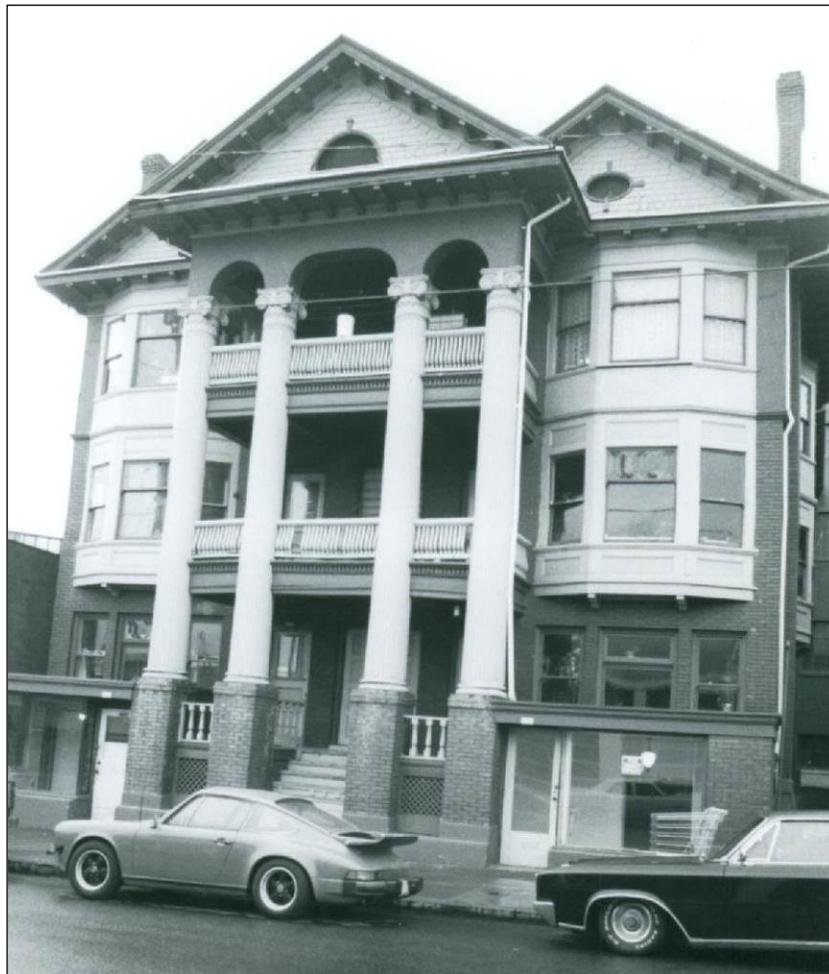
Figure 12: Stokes & Zeller Flats at 525 NE Couch Street, completed in 1909.⁶³ Demolished.

Development activity made a perceptible uptick in 1908 and the first buildings beginning to exhibit some, but not all, characteristics of the modern apartment house opened their doors on the east side. Possibly the first was a stately Neoclassical building by Stokes & Zeller at 525 NE Couch Street as seen in Figure 12 (demolished). On a parcel comprising 1/8th of a city block, the building had just six units, all accessed via a single building entry.⁴⁶ While on the scale of a modern flat for multiplex building, the use of brick and the rich architectural detail made it very much in keeping with some of the luxury apartment houses being constructed on the west side.

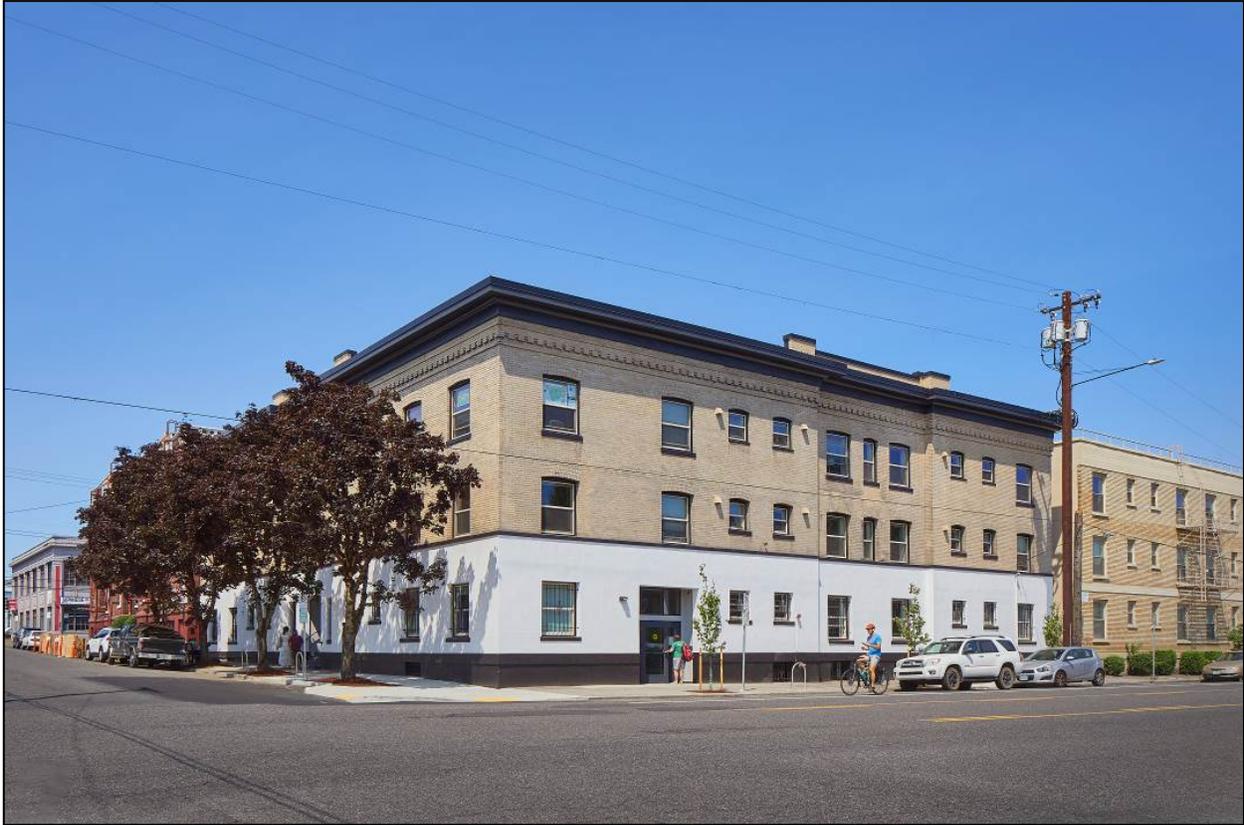
Photo 1 of 12: South and east elevations, camera facing northwest.

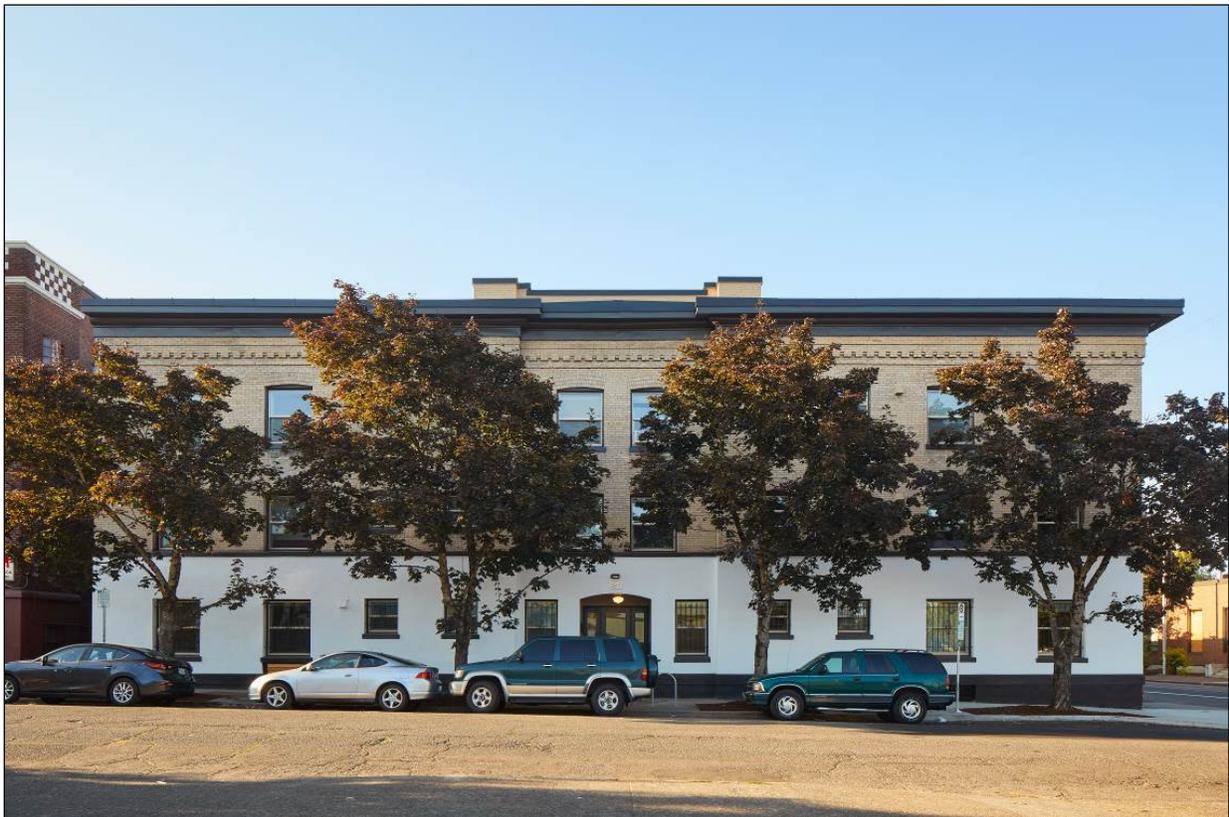
The south façade is arranged symmetrically with the primary entry in the center of the façade, as shown in Photo 2 and the elevation drawings in Figure 8. There are several steps up to the recessed entry door. Shown in Photo 3, the primary entrance is a non-original wood door with a single light in the door panel and side lights on either side of the door. On the south façade, the windows are arranged in an alternating rhythm of two large windows followed by two smaller windows.

Photo 2 of 12: South elevation, camera facing north.

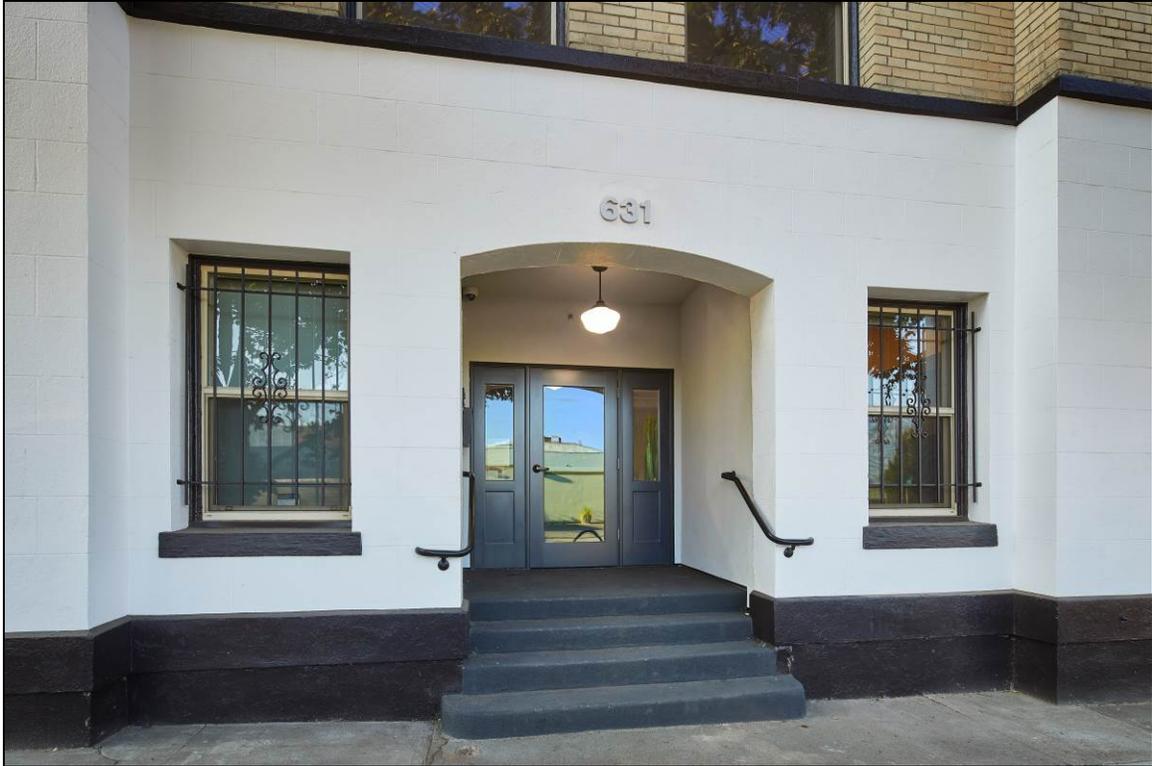
Photo 3 of 12: Main entry, camera facing south.

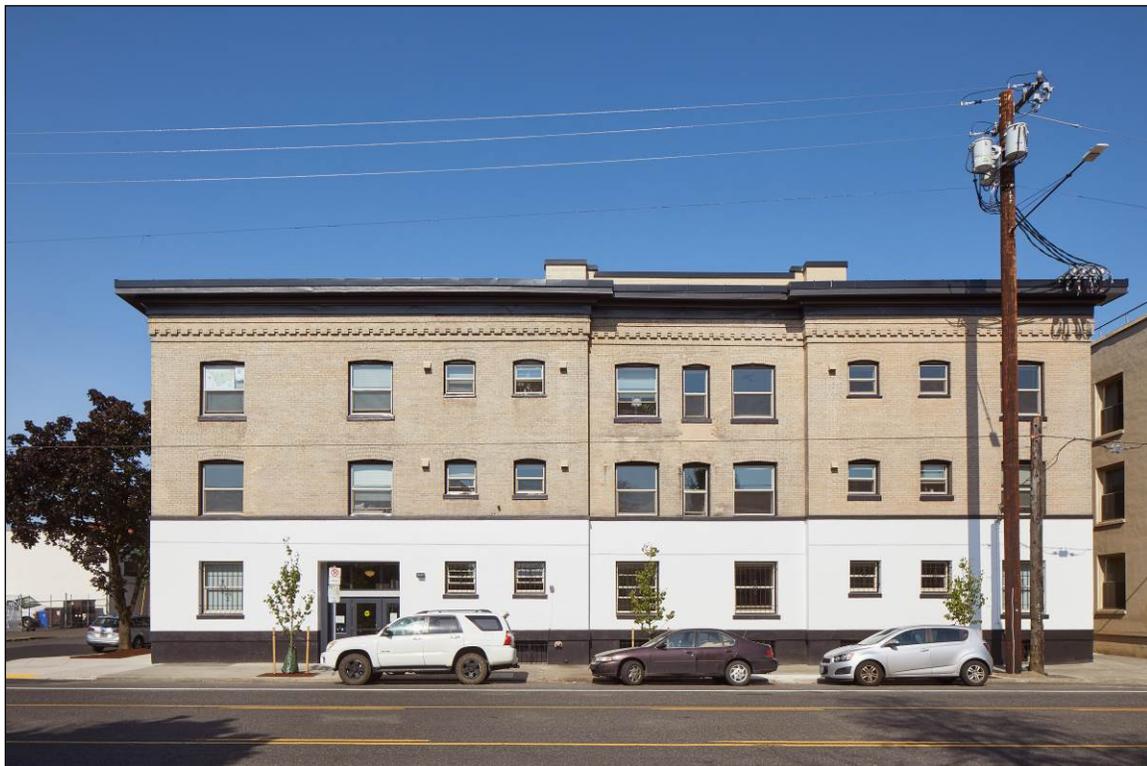
The building's east façade is shown in Photo 4 and in Figure 8. As originally designed, the façade was nearly symmetrical except for an additional bay of windows at the south end. A secondary entry was added in a window opening at a date unknown, but likely within the last 30 years. This was further modified in 2020 to make the building ADA accessible. The opening was enlarged and there is a wood door with relites, providing at-grade access to an elevator. The windows follow the same pattern as the south façade, alternating two large windows followed by two small windows.

Photo 4 of 12: East elevation, camera facing east.

- A secondary entry was added at an existing window opening on the east elevation at a date unknown, but sometime in the last 40 years. This entry was further modified for ADA accessibility in 2020. While this entry creates a change in the design and fenestration pattern of the east elevation, it does not disrupt the primary façade and the centrally-place main entry.

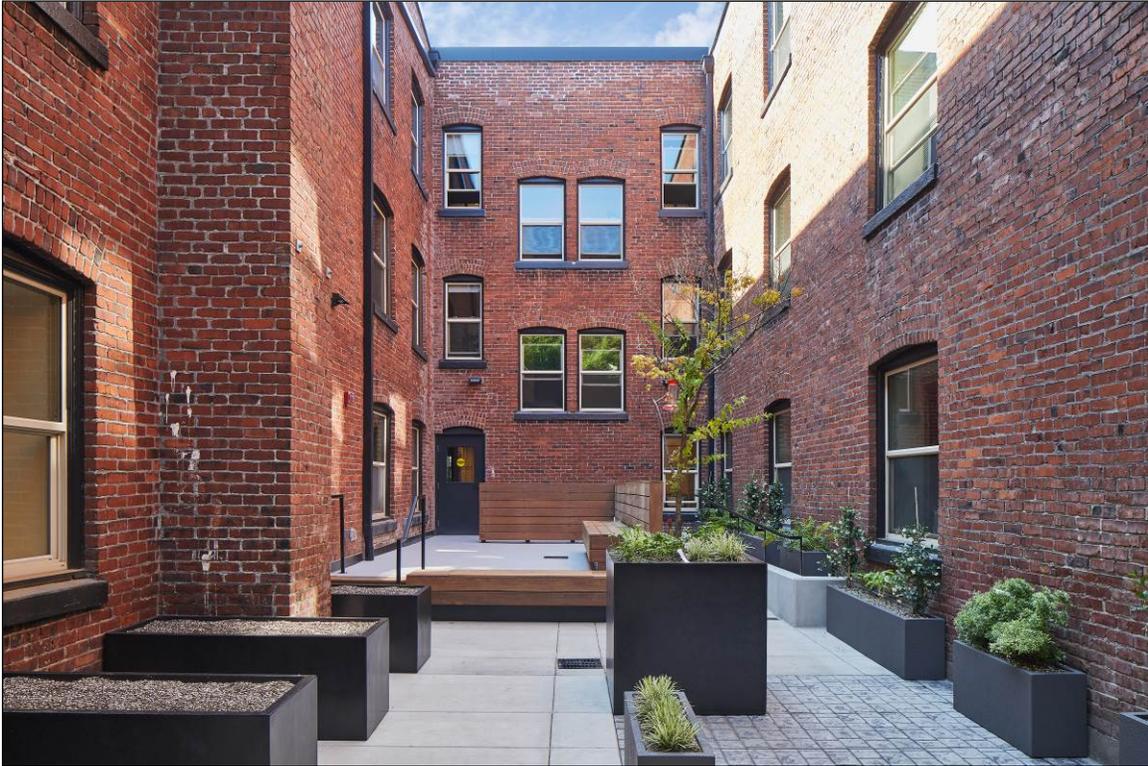
A large light court that opens to the north is shown in Photo 5. The light court was historically utilitarian to allow light into all parts of the building. The walls within the courtyard are red brick and all window opening are topped with segmental arches. The windows are the same one-over-one vinyl windows with concrete sills. There are no other decorative brick features. The courtyard includes a garbage enclosure, raised planters, a patio deck area, and ADA ramp that leads to a door at the southeast corner. These nonoriginal features were updated in 2020.

Photo 5 of 12: Light court, camera facing south.

- The light court has had accessibility improvements and other outdoor amenities such as benches added. Because the light court is not visible from the exterior and its purpose has always been utilitarian in nature, the changes that have been made do not negatively affect the building's historic character.

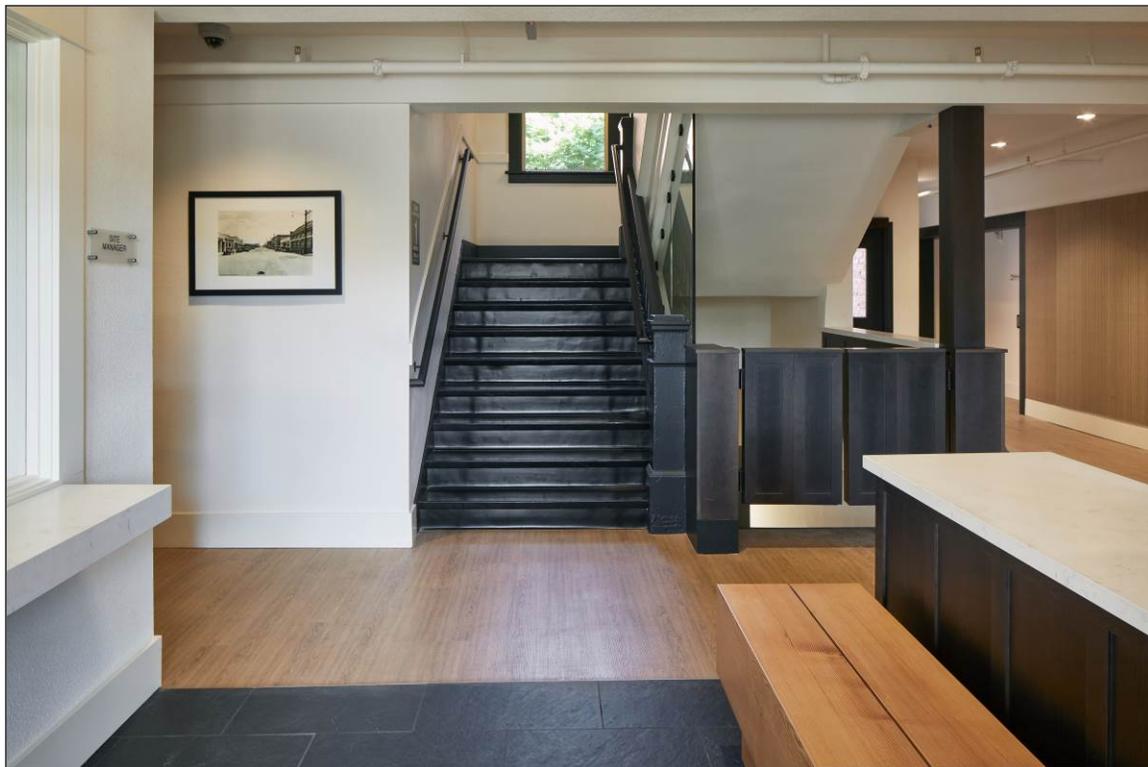
Arriving in the building through the main entry, the first space is a lobby with the primary historic feature being the main staircase. This is shown in Photo 6. The wood stair treads have had rubber added for slip-protection. The original painted wood newel posts and bannisters are intact, as shown in Photo 7. Modifications for safety include a glass guardrail and a gate at the stairs leading to the basement. The lobby has been reconfigured several times. Most recently in 2020, a mailroom was added to the east of the entry and a window to the west looking into the manager's office.

Photo 6 of 12: Entry lobby, camera facing north.

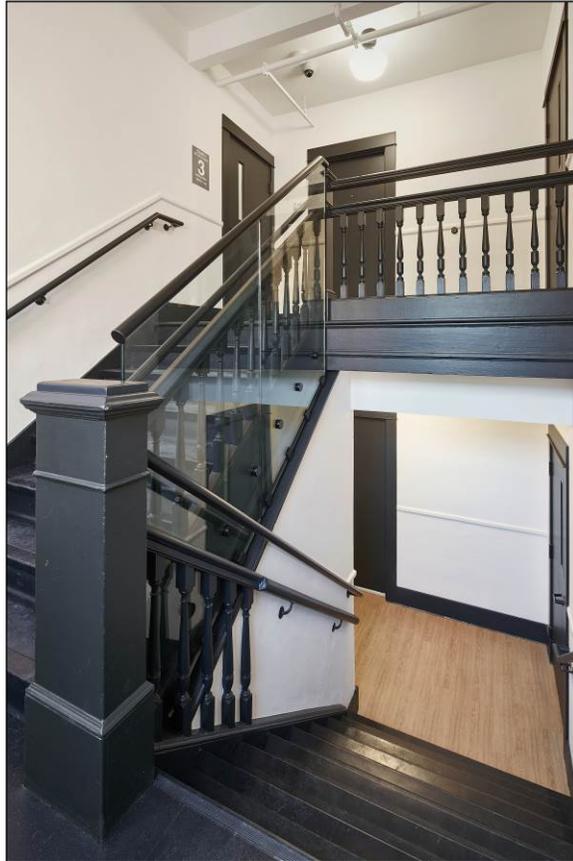
Photo 7 of 12: Main stair, camera facing south.

- Rubber treads were added to the main staircase at a date unknown, but probably c. 1980. The addition of rubber treads covers the original wood treads, causing a reduction of integrity at the staircase. However, the loss is not significant.

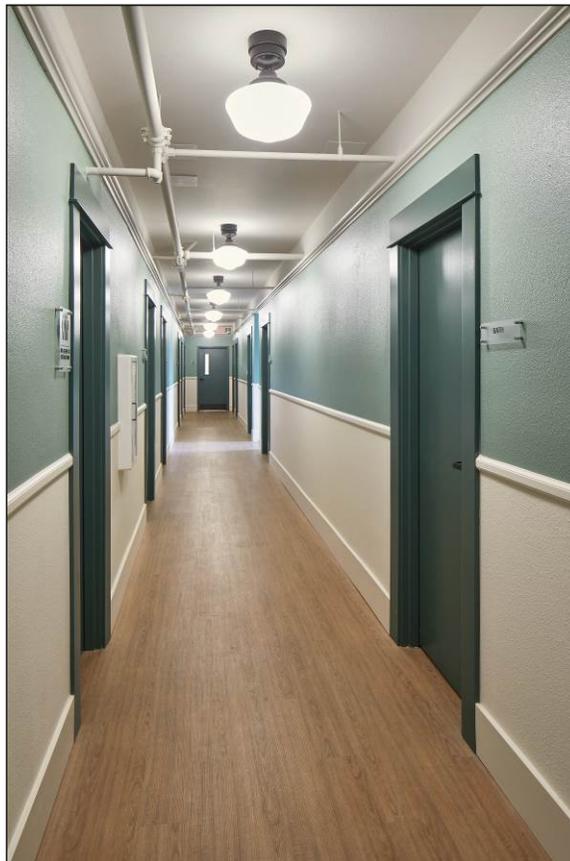
The three-story building with partial basement has a U-shaped double-loaded corridor from which studio apartments are accessed, as shown in Photo 8. There are more utilitarian secondary staircases at each end of the U-shaped plan. These were enclosed behind doors for fire safety early in the building's history, if not originally. The corridors feature picture rail mouldings. All original corridor doors, which were likely five-panel wood doors, have been replaced with flush doors with lever door hardware. The removal of the original doors was likely done in c. 1980 and they were replaced again in 2020. Each corridor door casing is comprised of flat-stock wood trim and a parting bead. The corridor flooring is carpet.

Photo 8 of 12: Typical corridor, camera facing north.

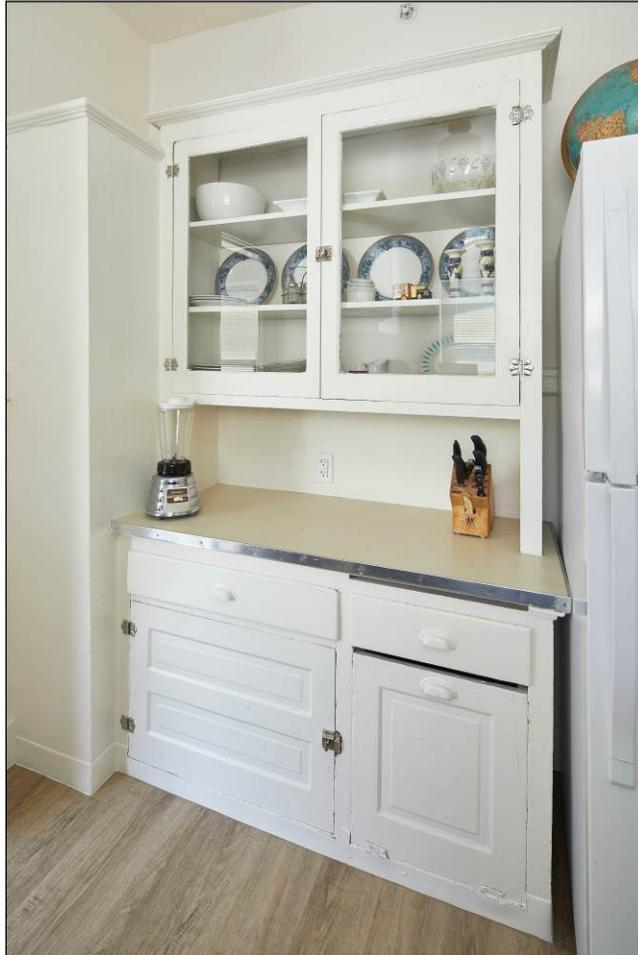
Photo 9. The walls and ceilings are painted plaster with painted fire sprinkler lines. Some units have original five-panel closet doors with original door hardware.

Photo 9 of 12: Original kitchen casework, camera facing east.

- The apartment kitchens were remodeled in c. 1980 and again in 2020. Some kitchens retain their historic cabinetry with wood-and-glass cabinet doors and under-counter storage. Some kitchens have been fully remodeled. The retention of these built-ins provides a direct link to the past and indicates the original character of the apartments.

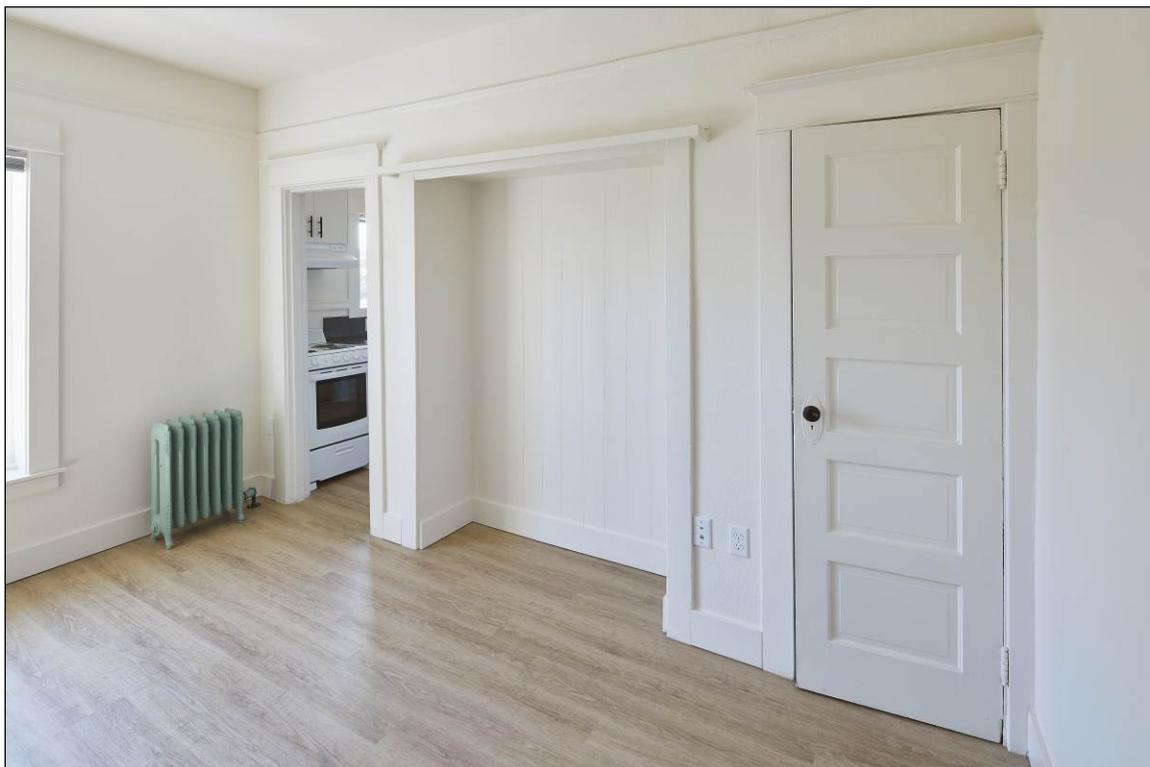
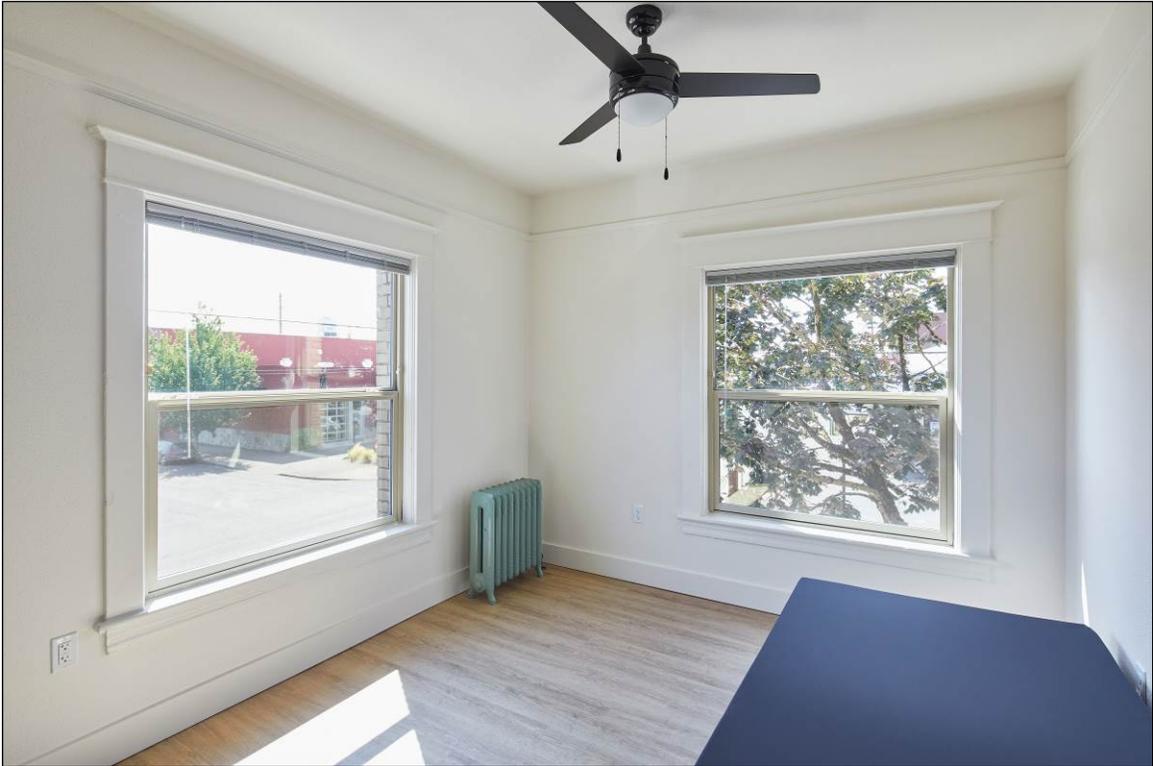
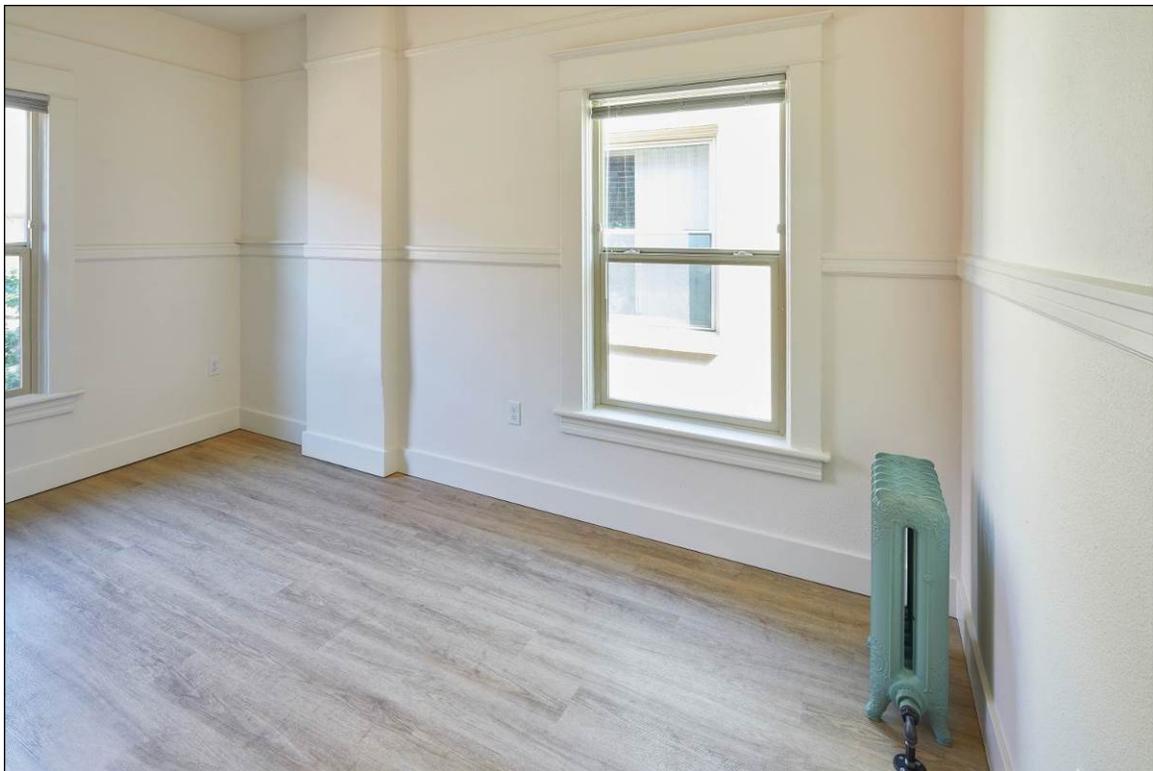
The residential units feature their original window trim, baseboard trim, and picture rail trim, as shown in Photos 10-12. The window trim is made from flat trim stock and features a parting bead and a cornice molding at the top of the window. The wood baseboard trim is flat without decorative features. The picture rail features a standard profile. Many units have original Murphy Bed alcoves and decorative cast iron radiators. Some have original built-in kitchen hutches with glass upper cabinet doors, as shown in

Photo 10 of 12: Typical residential unit, camera facing east
