**DEBRIS FLOW ASSESSMENT
EILERTSEN CREEK/WOODSON
December 2007 Storm
T 7N, R 5W, Sections 5, 8, & 17**

April 10, 2008

This report presents the results of a geologic/geotechnical assessment of the causes and slope movement mechanisms that led to the railroad fill failure which occurred on the morning of December 11, 2007 in the Eilertsen Creek drainage (T 7N, R 5W, Sections 5, 8, and 17, Figure 1). The failure sent a debris flow through the hamlet of Woodson, across Highway 30, and into Westport Slough, destroying several residential structures and covering the highway with mud and large woody debris. Due to warning of the impending failure by ODF personnel prior to the event, the effects were limited to property damage. This report was completed at the request of the Oregon Department of Forestry's Policy Unit. The assessment was completed in its entirety by Gunnar Schlieder, Ph.D., an Oregon Certified Engineering Geologist.

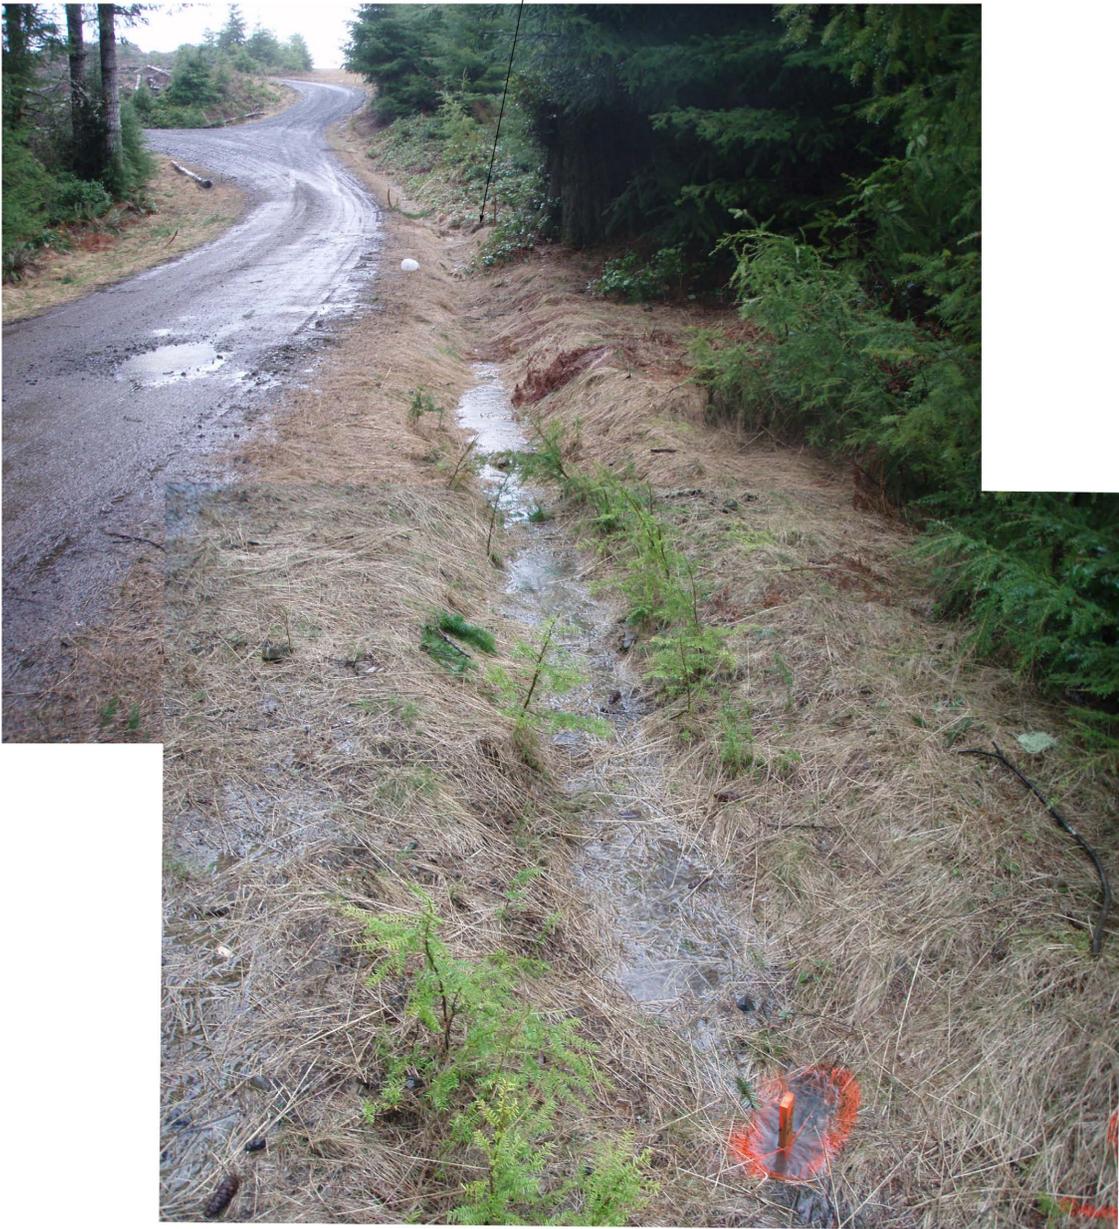
Roadside ditch segment at point "A" on Figure 5. View W. Head scarp of Slide 1 is a couple of feet to right of lower right corner.

Discharge point of ditch from road to N. Slide 1 deposit below. View NE. →

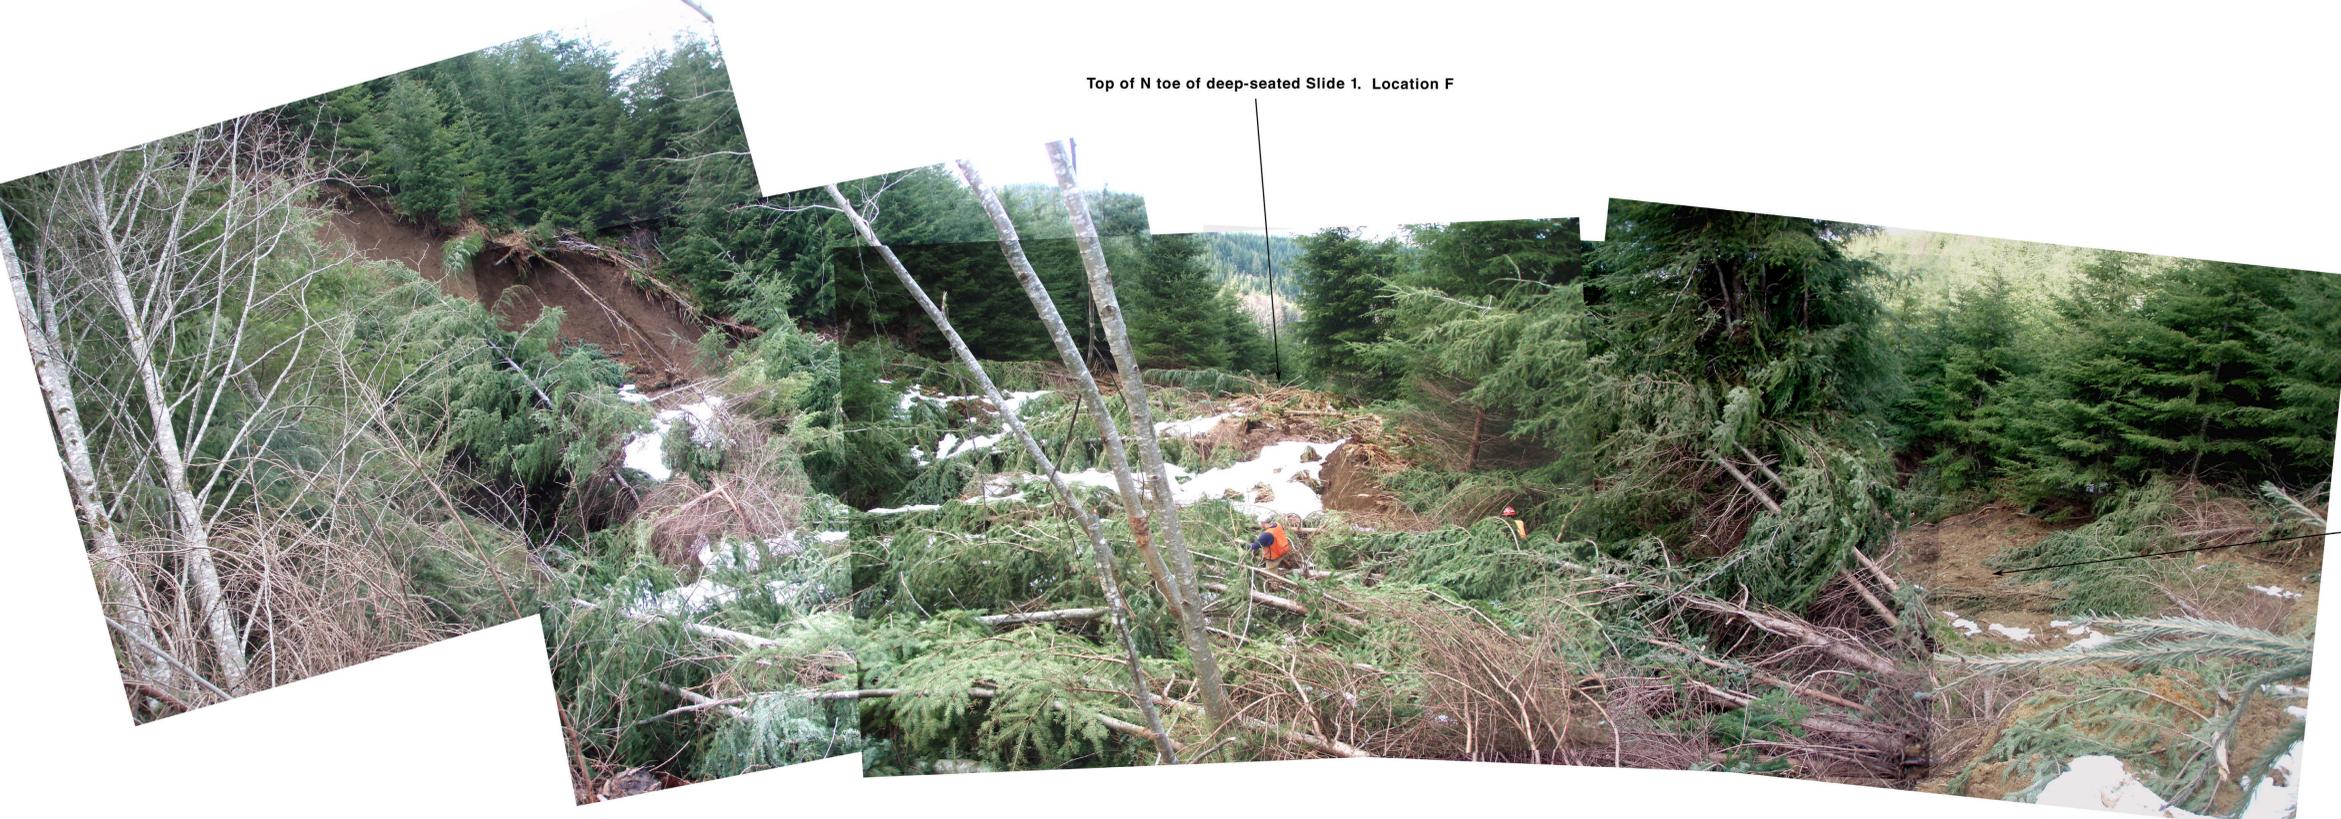
Top of N toe of deep-seated Slide 1. Location F

Head of Debris Flow 1, upper deposit. Location D

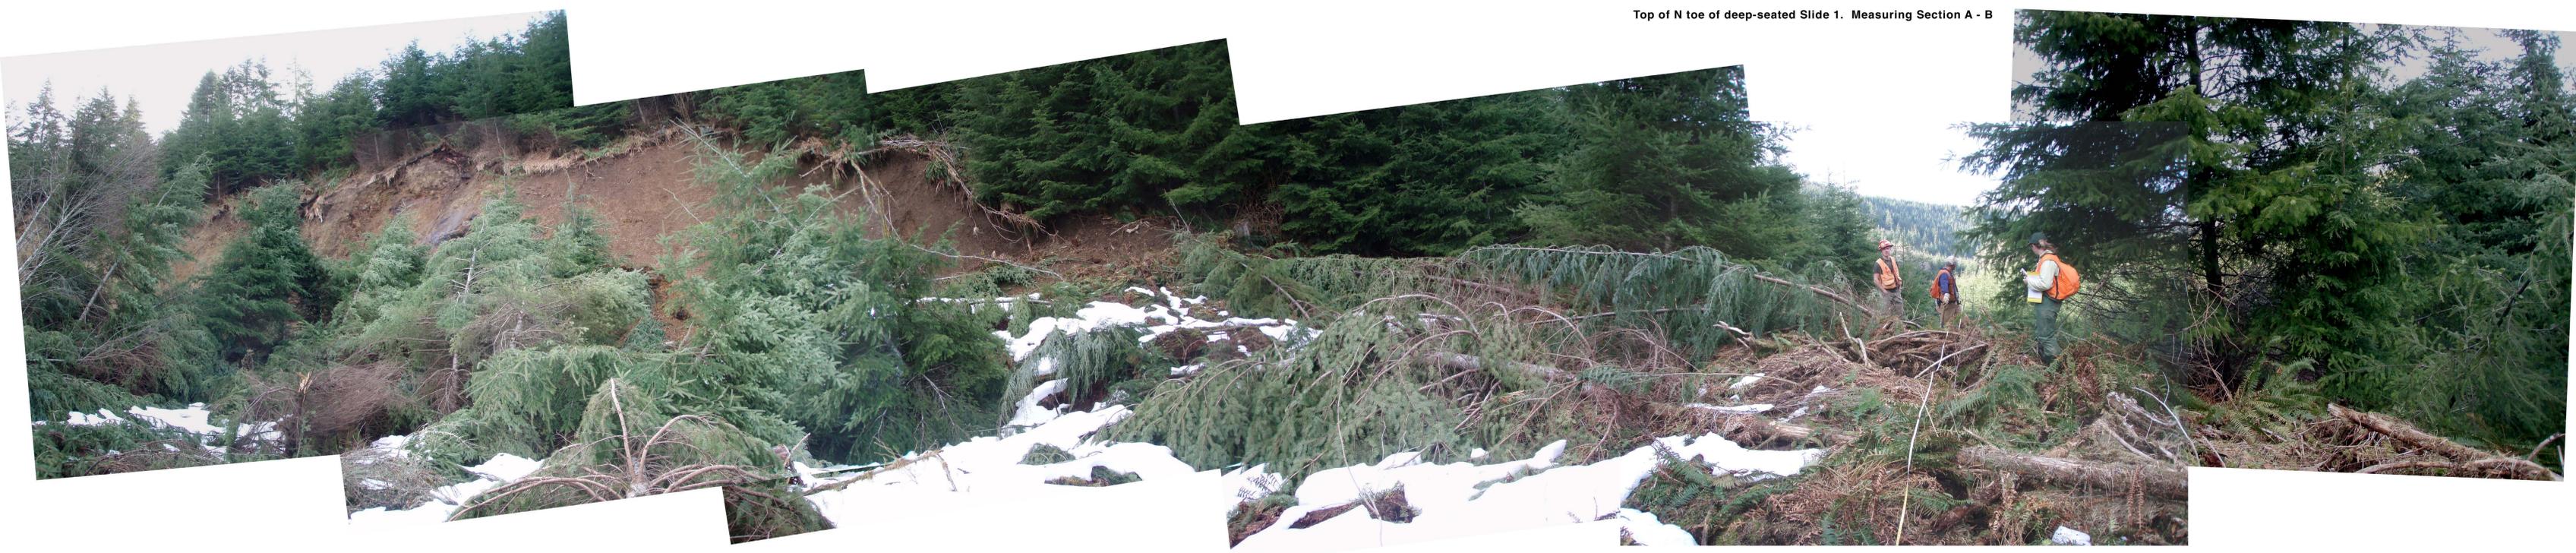
Top of N toe of deep-seated Slide 1. Measuring Section A - B

View from central portion of Slide 1. S is to left and N to right. Note back-rotated fir trees in left middle ground and to right.

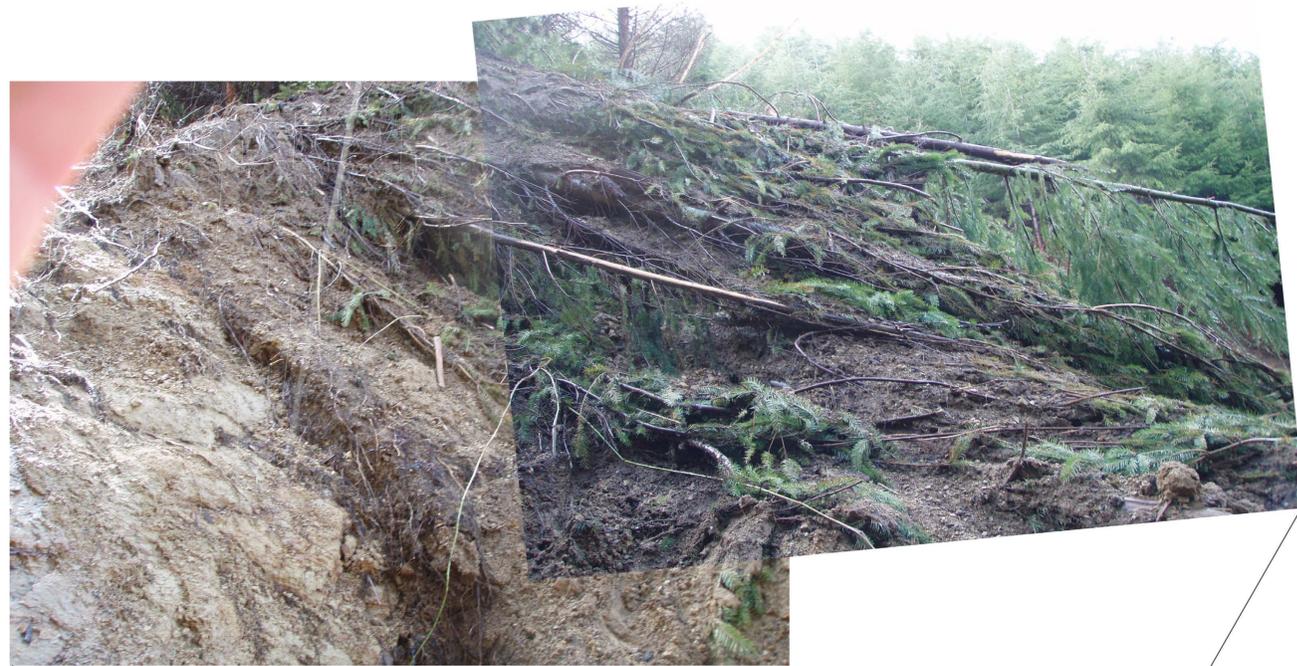
Location E: In-place rock (left lower corner) and trees which have been stripped and arranged parallel to debris flow direction. View SW to NW in area indicated by lines.

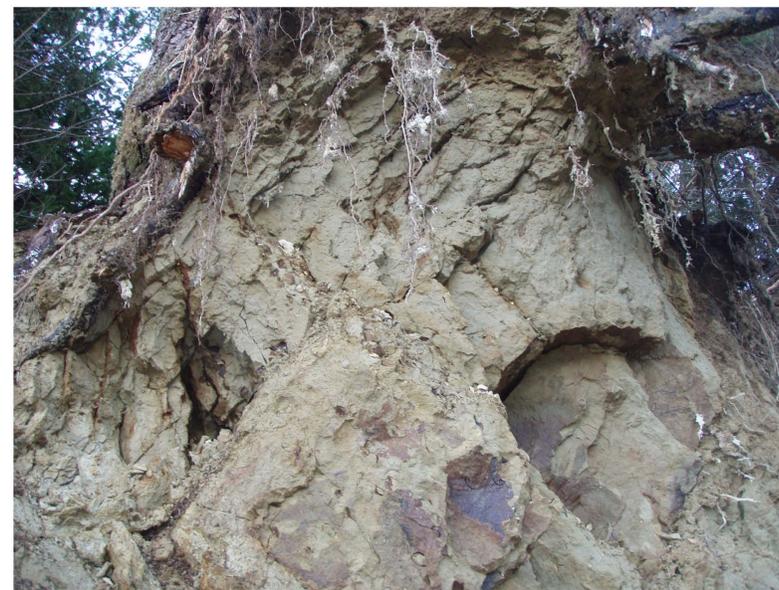
With the exception of minor blocks of surficial material which have collapsed down the slope, the toe of Slide 1 is completely devoid of vegetation and exposes a stratigraphy ranging from the top soil at the top to CDS rock to PDS rock, and finally, near the bottom, to blocks of a poorly cemented siltstone. At one location near the top of the toe, a bed with numerous pelecypod (clam) fossils imprints was noted (see site photos).

Back-rotated shell bed in partly to completely decomposed near-shore marine sedimentary rock.

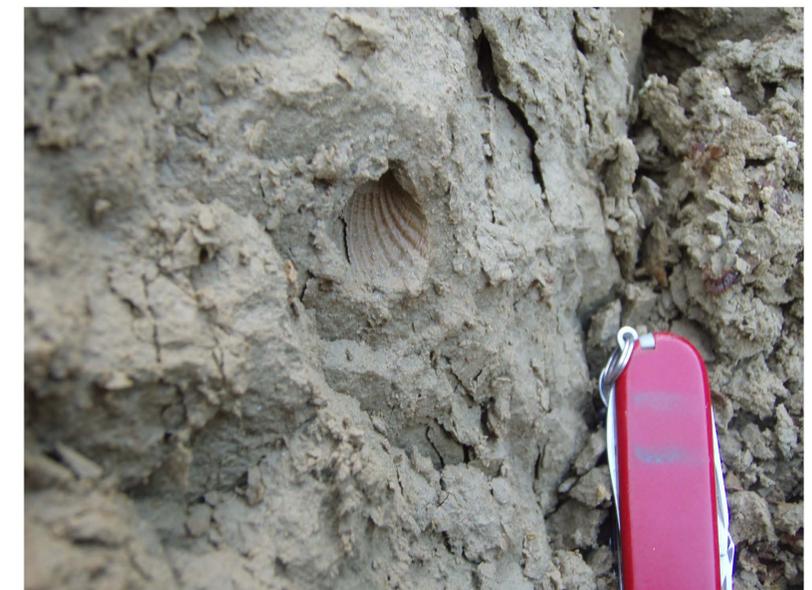
Closer view of pelecypod imprint in completely decomposed sandstone. Swiss Army Knife for scale.

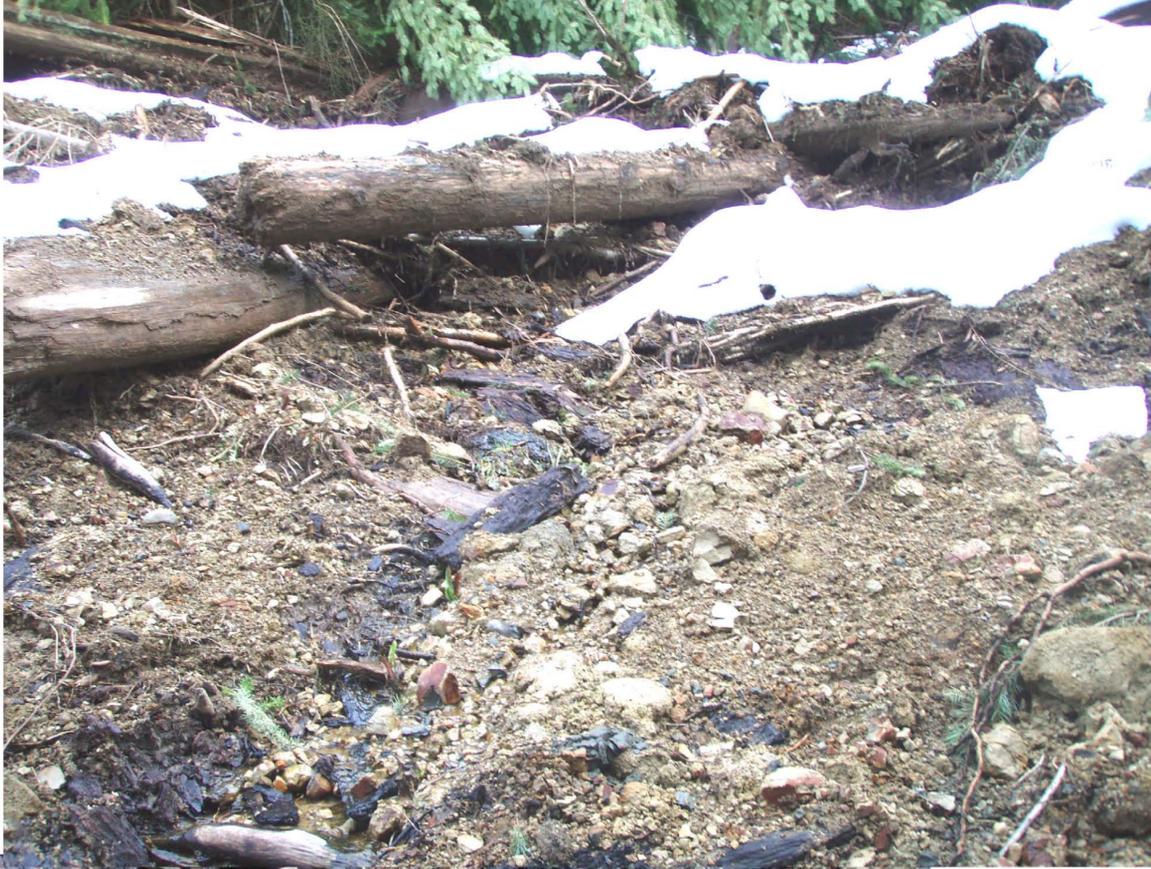
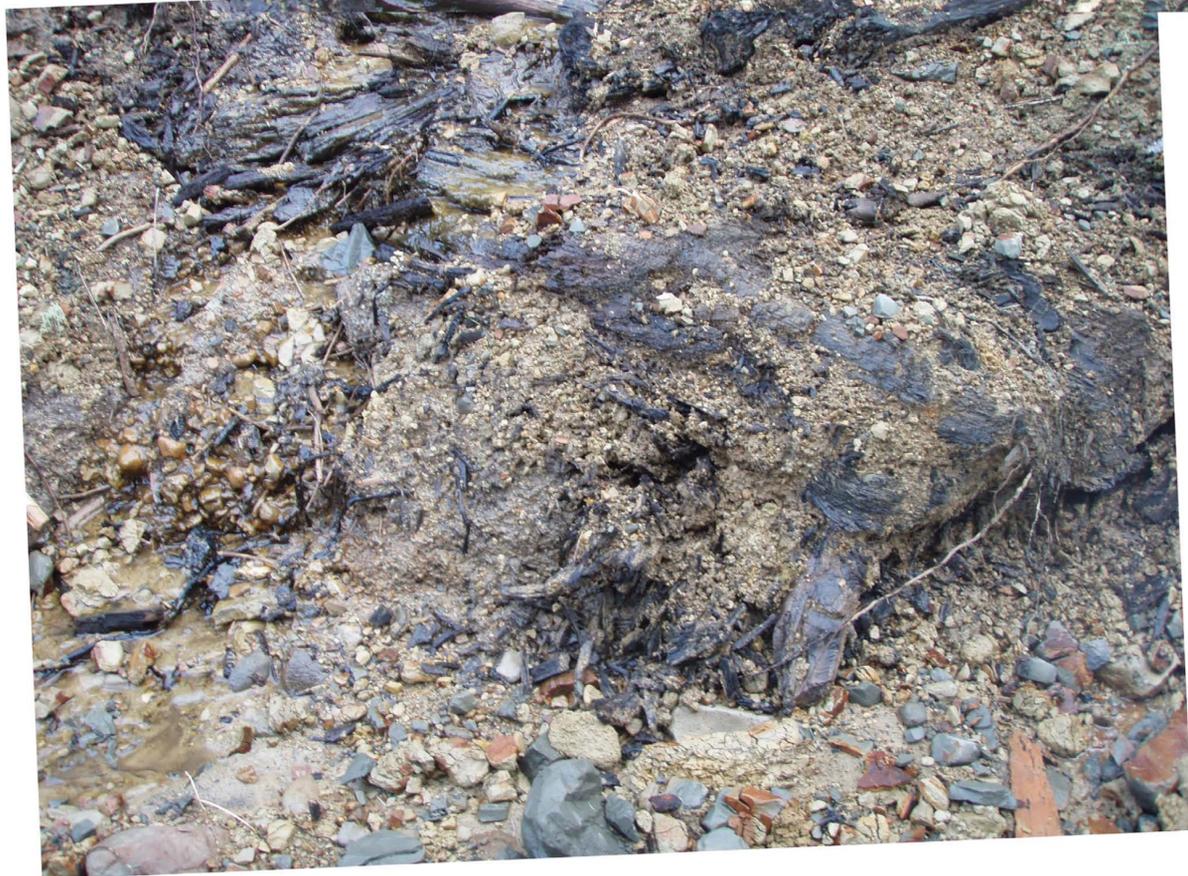
At the confluence of combined Creeks 1b/c with Creek 1d, a deposit containing significant quantities of wood which appears to have been buried for some time, is present in the eastern sidewall of the channel. The wood is black and the soil material around the wood is reduced. The soil in the deposit consists of variably weathered siltstone and fine-grained sandstone fragments in a silty sand matrix which is plastic at natural moisture content. The material appears to be an older slope movement deposit. It is not known whether the deposit is the toe of the deep-seated slope movement noted during the air photo interpretation, or represents a debris flow deposit originating in Draw 1d.

Woody debris in previous slide deposit at confluence of Creek 1d with combined 1b/c (Location H). View E.
This may be the toe of the deep-seated slide in Draw 1d..

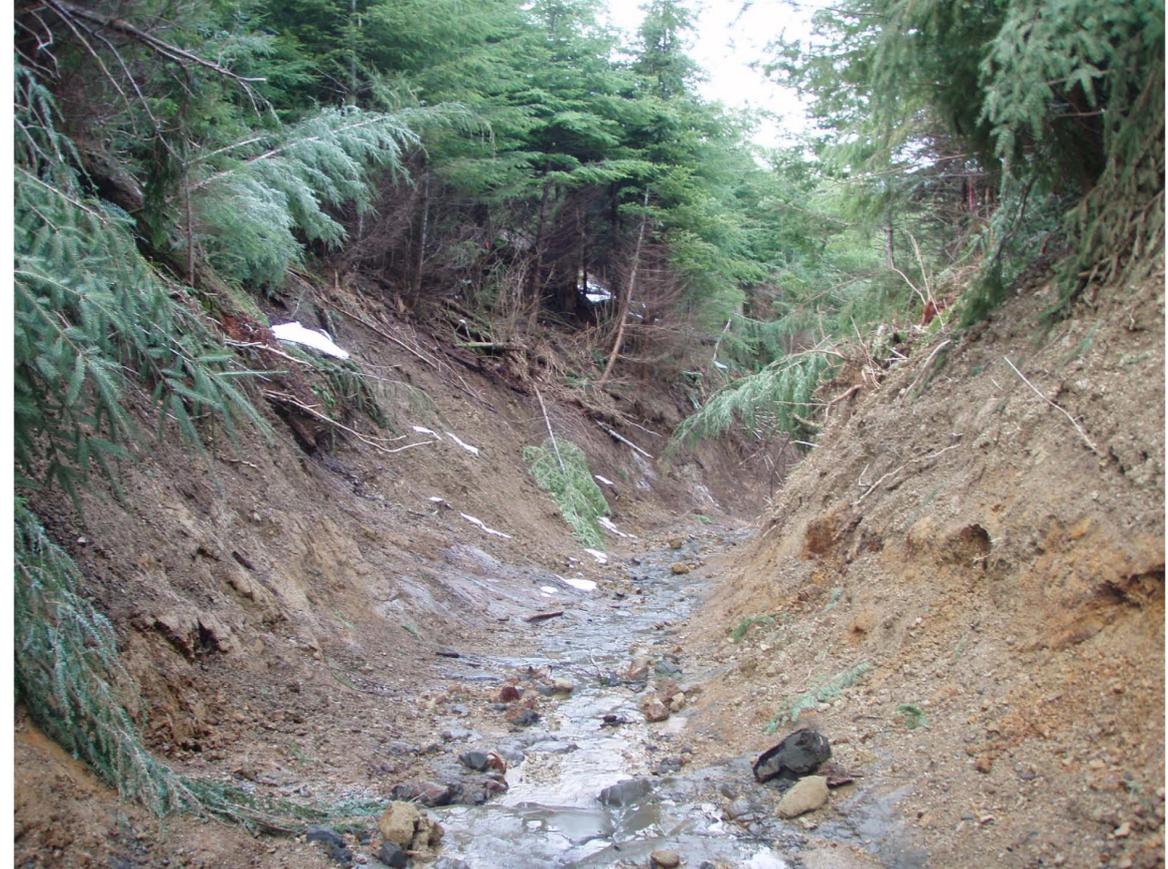
Channel scoured to partly decomposed rock downstream from Location "H" on Figure 5.

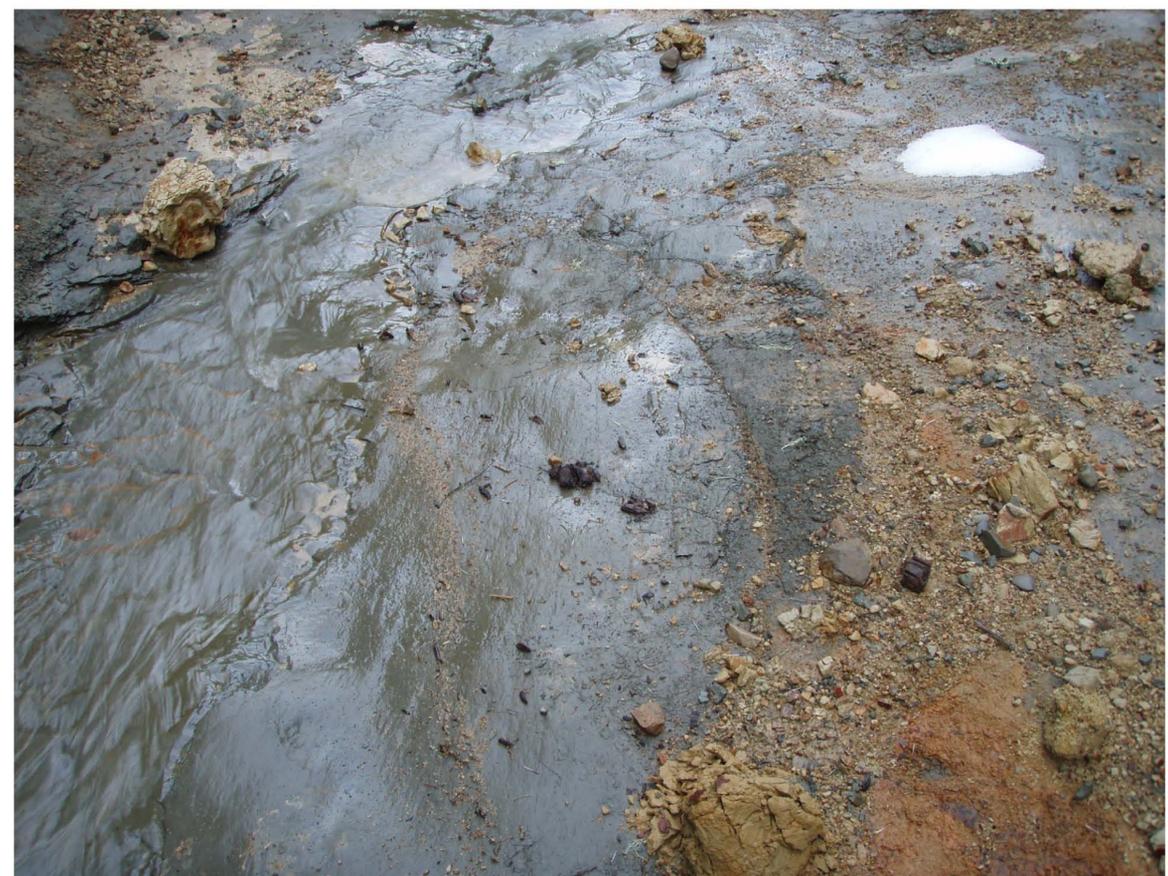
Scour marks on channel floor downstream from Location "H". View SE.

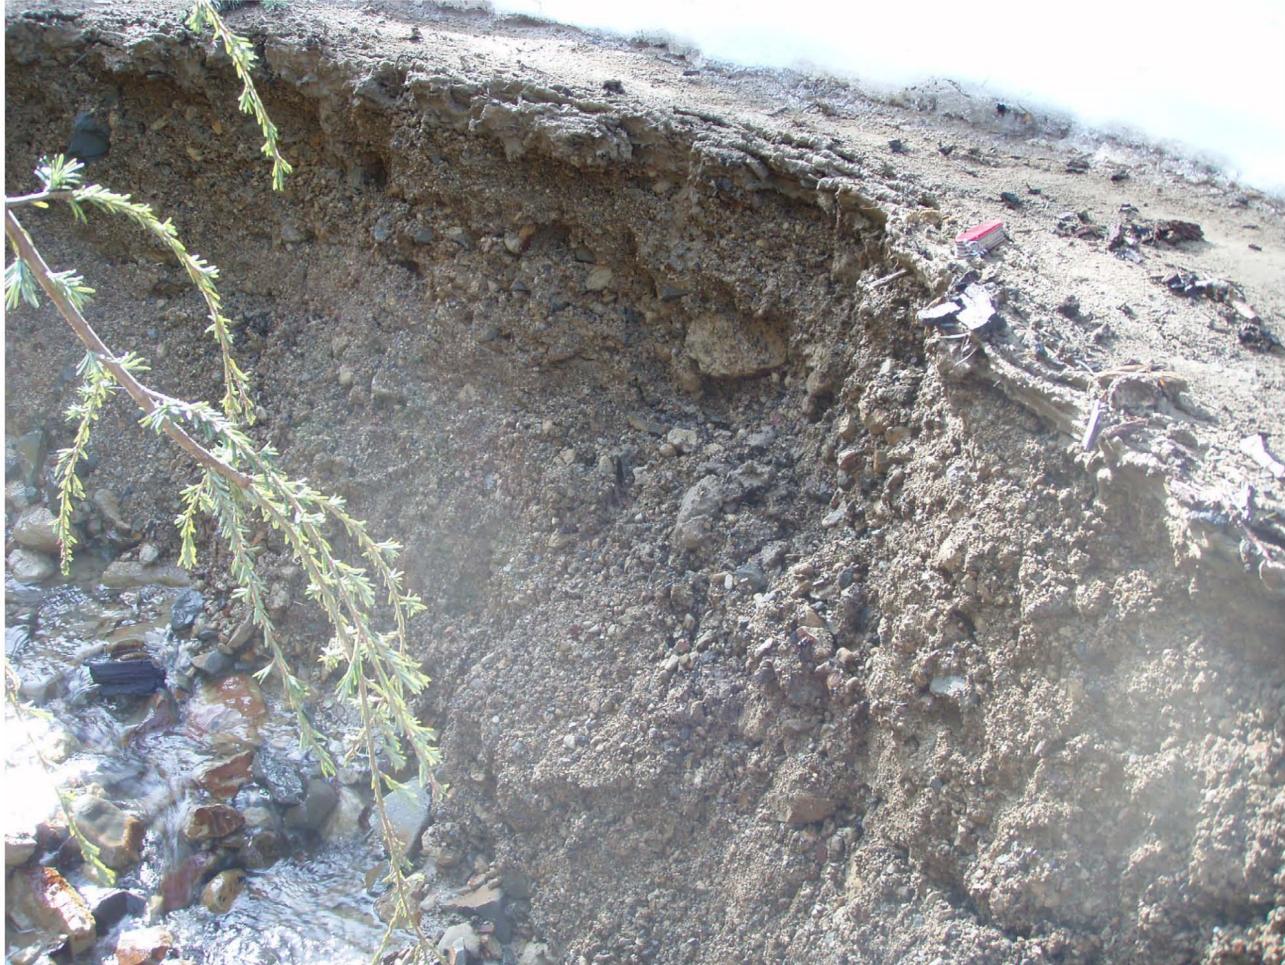
Closer view of delta deposit at creek 1. Swiss Army Knife for scale. Deposit consists mostly of top-set beds, indicating rising water level during deposition. Uppermost fine-grained deposit formed from settling out of muddy water entering the pond.

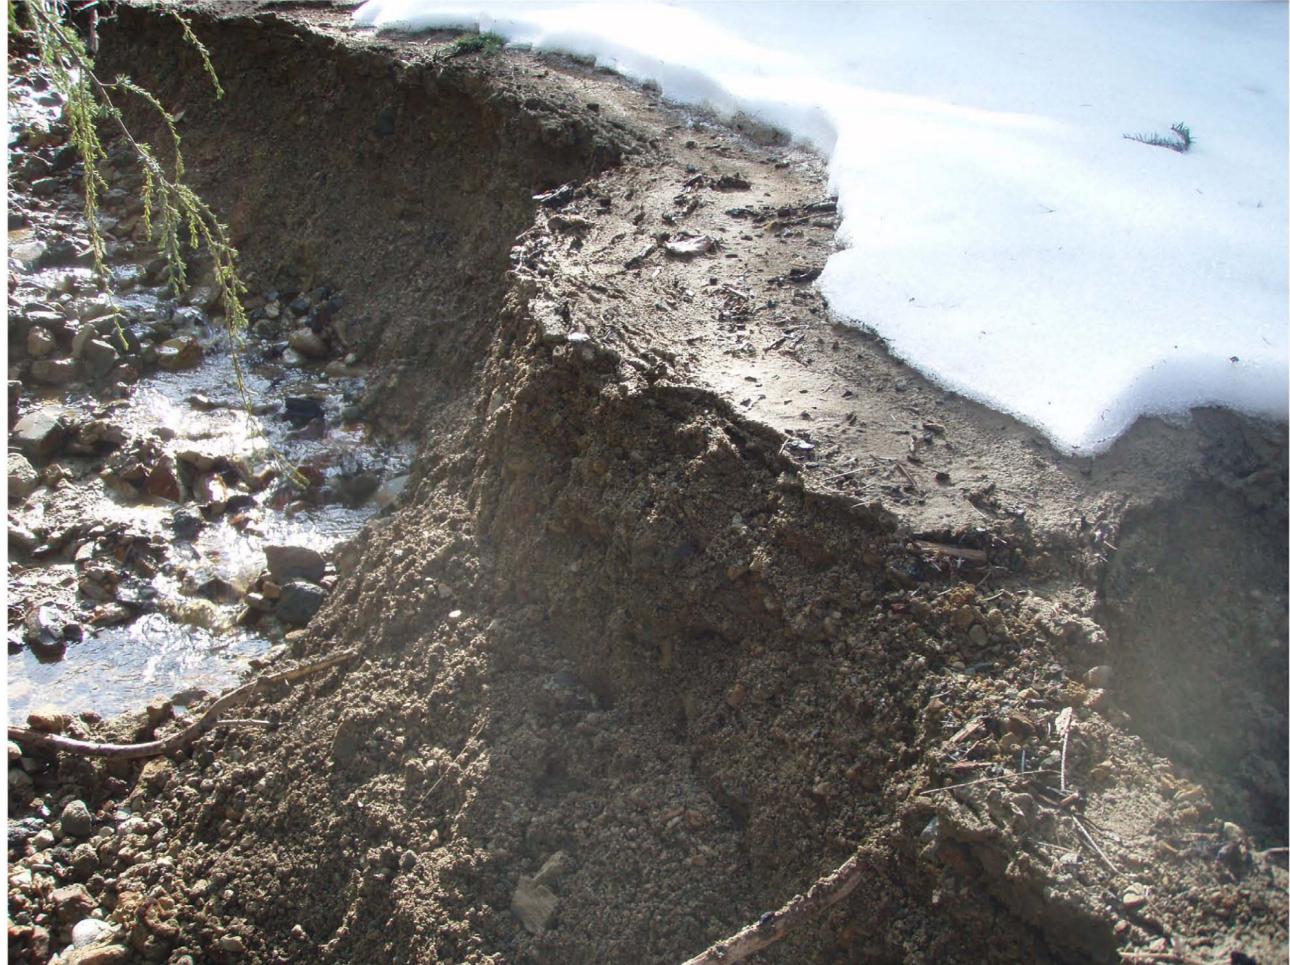
Another view of thin fine-grained (silty very fine-grained sand) deposit formed on top of the delta by settling from muddy water entering the pond.

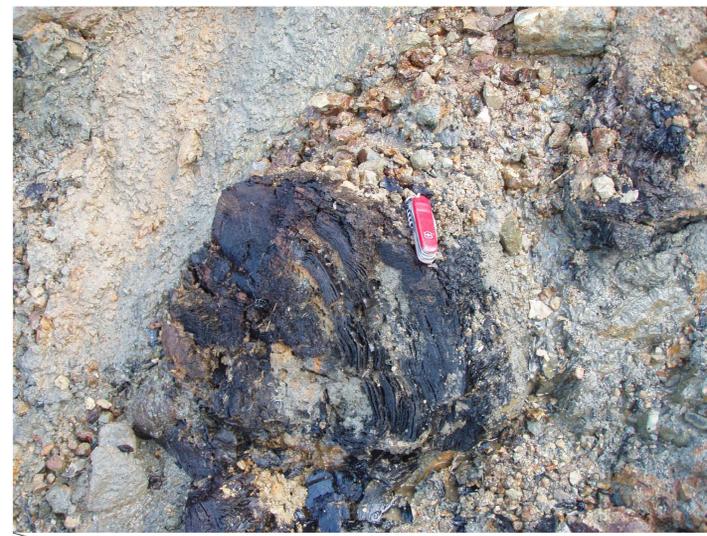
Piece of wood exposed under 15 feet of old slope movement deposit in E scarp.

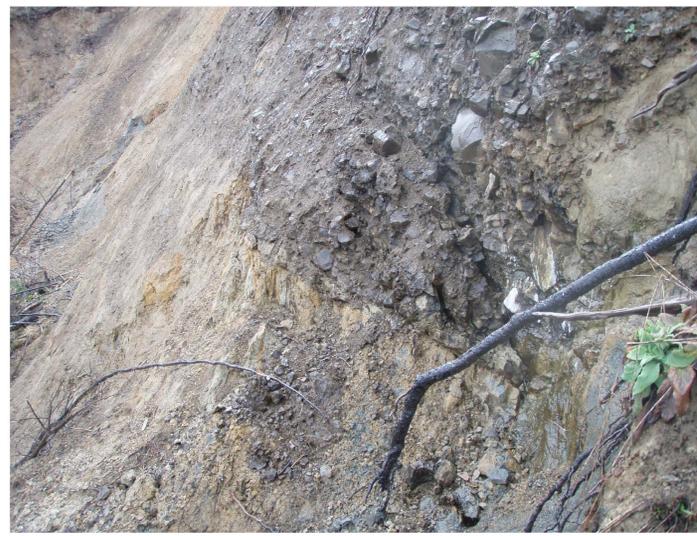
Contact flowing water between CRB (?) unit above and completely decomposed sandy marine sedimentary rock below

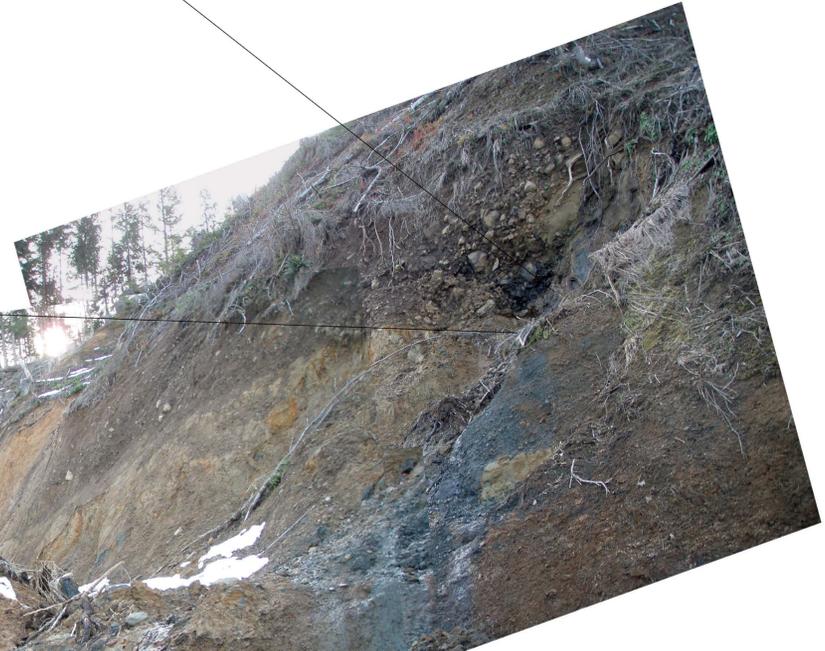
View of Slide 2 from NW. NNE is to left and SW is to right. Note in-place rock (siltstone?) in bench in right foreground. Deep-seated rotational sliding slope movement spills over this bench and turns into viscous flow type failure. Section B - C indicated in yellow.

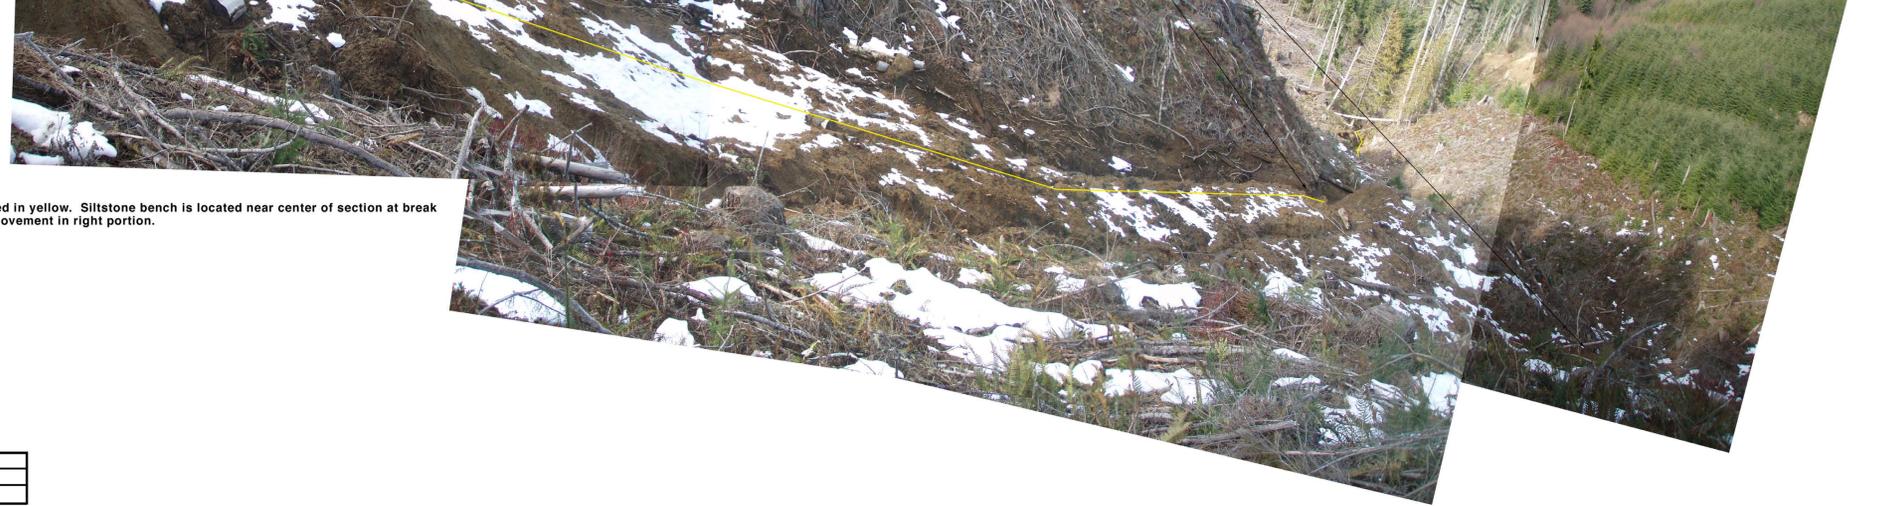
Debris Flow 2 initiation sites.

East side of failed railroad embankment.

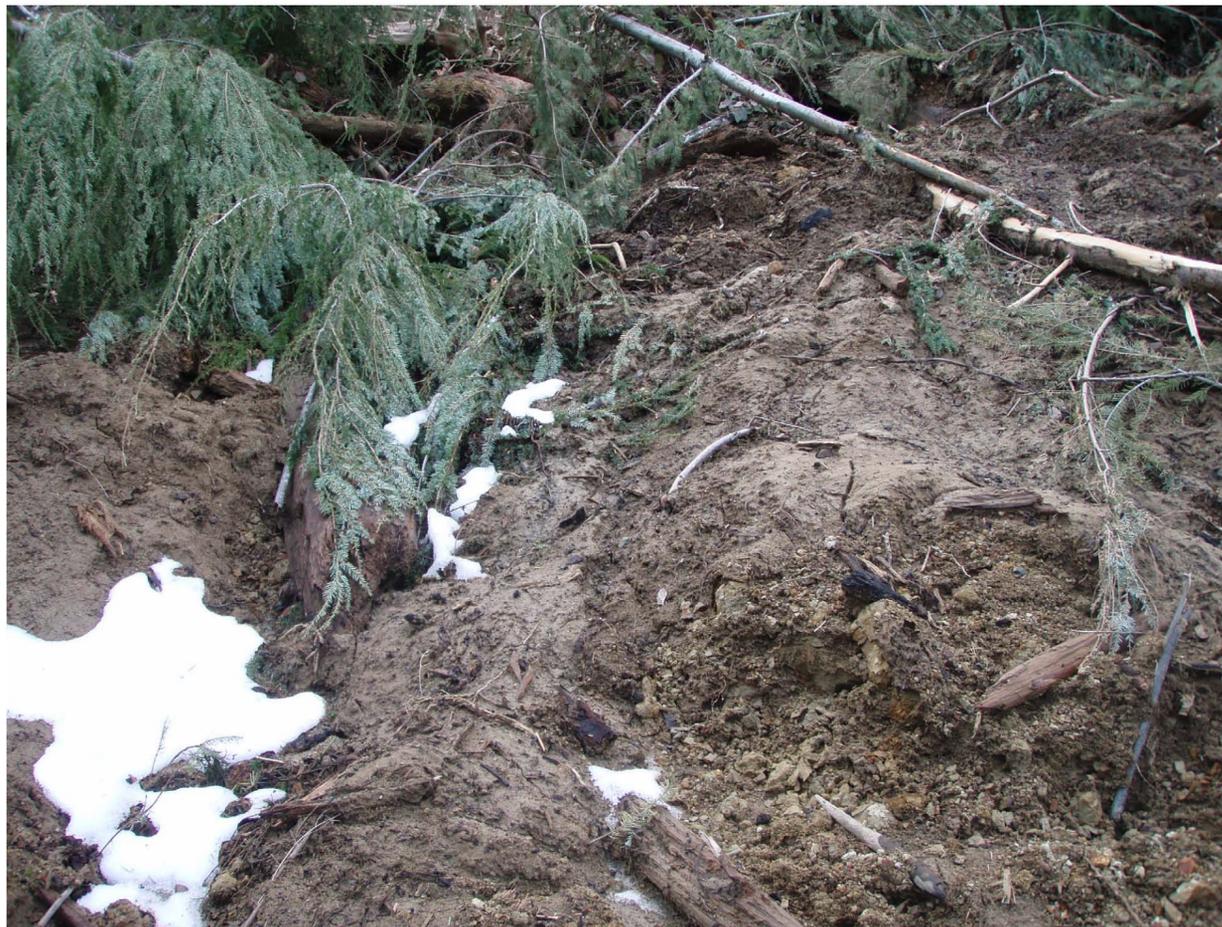
Contact between Debris Flow 1 deposit (rockier in lower right corner) and overlying Debris Flow 2 deposit (darker, finer grained in central right and lower left corner)

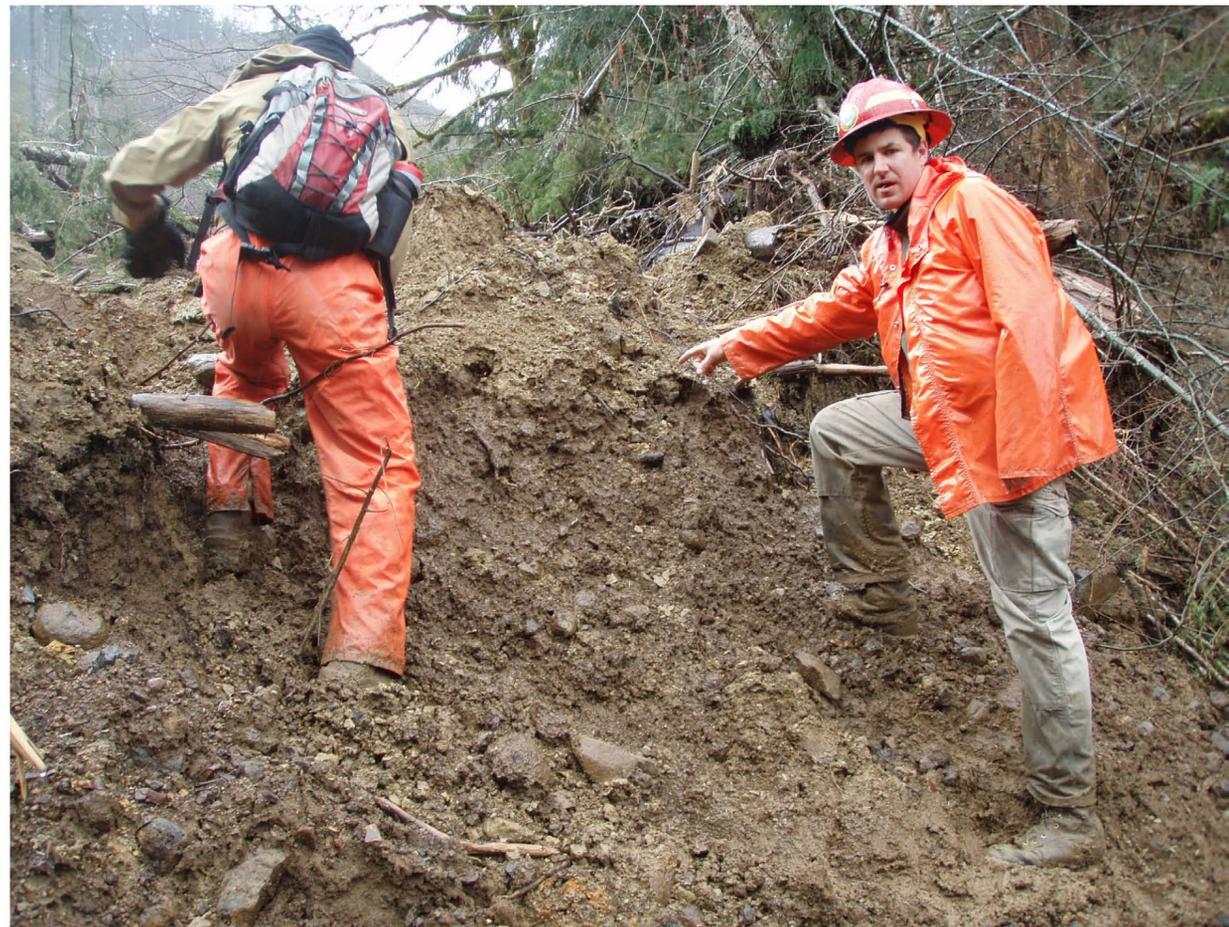
At the easternmost end of the scarp of the railroad fill failure, deposits from Debris Flow 1 were observed to be overlying remnants of the railroad fill (site photos). At this location, the railroad fill consists of angular igneous rock fragments (some vesicular) in a dark brown to dark reddish-brown clayey sand matrix. Similar material is found in the failure scarps on both the west and east sides a short distance below the road. The material appears to have been part of the ballast for the railroad tracks. By contrast, the deposits of Debris Flow 1 consist of yellowish-brown silty sand with numerous yellowish to tan CDS to STS sedimentary rock fragments up to 12 inches in diameter.

Contact between Debris Flow 1 deposit (lighter yellowish-brown above pointing finger) and railroad embankment fill material (below pointing finger, darker brown).

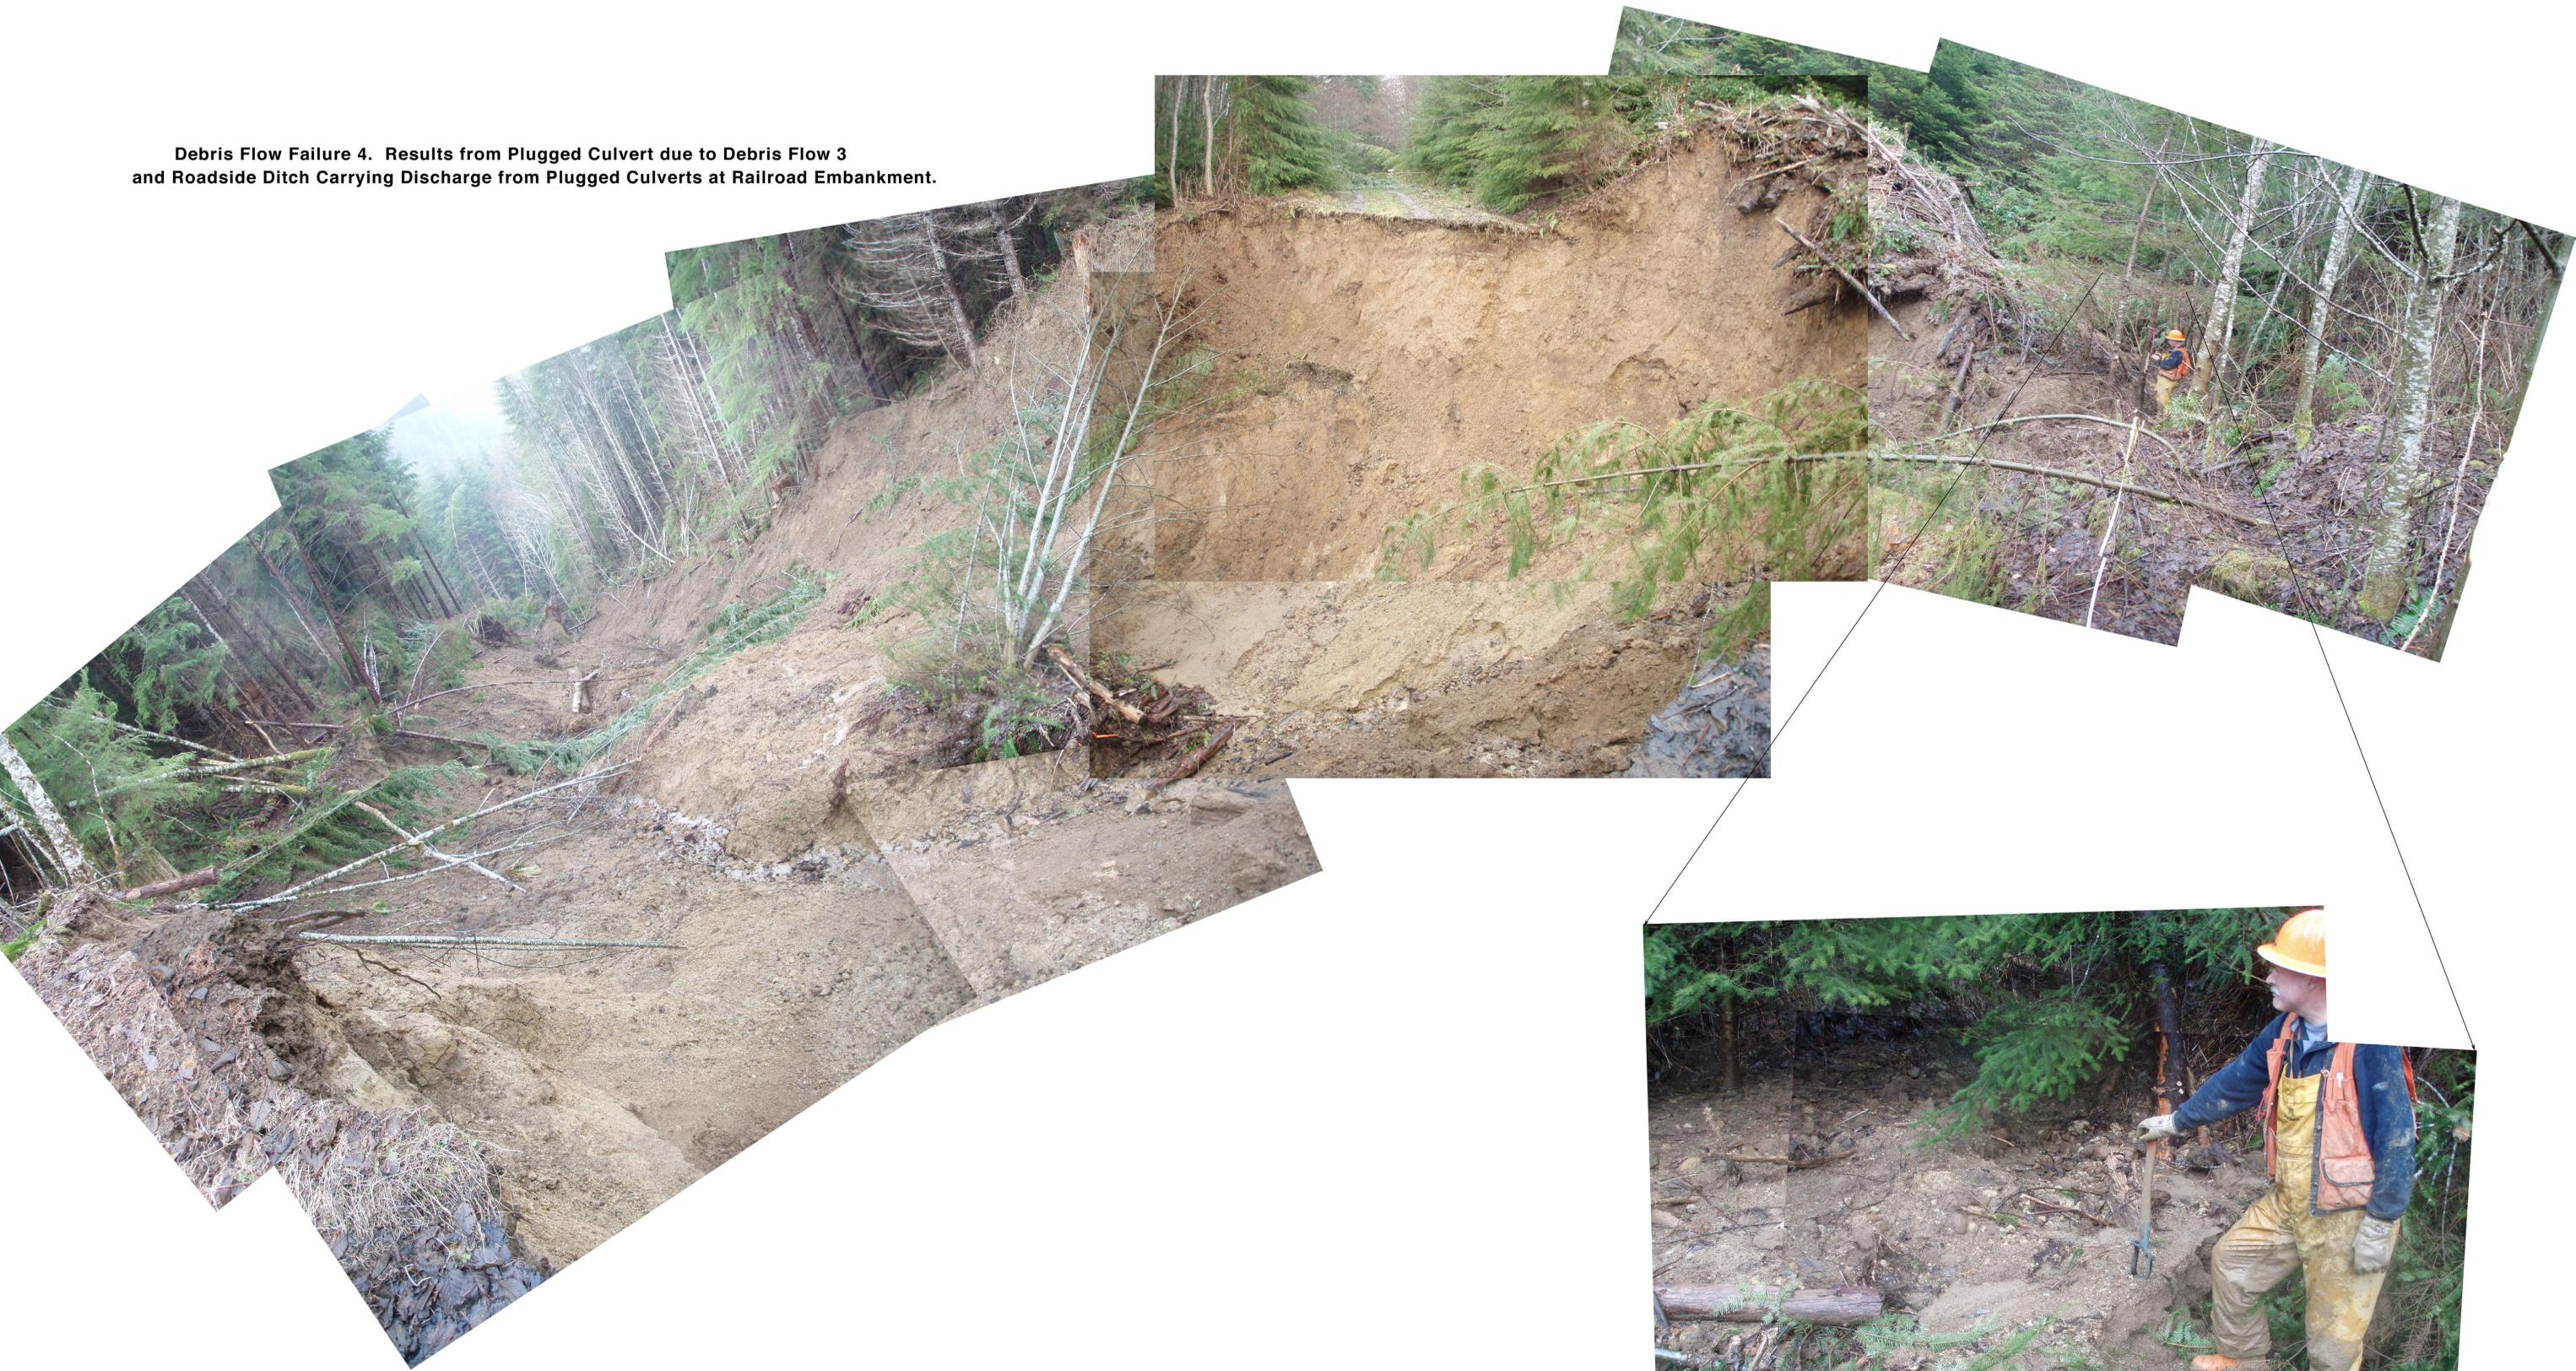
Debris Flow Failure 4. Results from Plugged Culvert due to Debris Flow 3 and Roadside Ditch Carrying Discharge from Plugged Culverts at Railroad Embankment.
