**DEBRIS FLOW ASSESSMENT
EILERTSEN CREEK/WOODSON
December 2007 Storm
T 7N, R 5W, Sections 5, 8, & 17**

April 10, 2008

This report presents the results of a geologic/geotechnical assessment of the causes and slope movement mechanisms that led to the railroad fill failure which occurred on the morning of December 11, 2007 in the Eilertsen Creek drainage (T 7N, R 5W, Sections 5, 8, and 17, Figure 1). The failure sent a debris flow through the hamlet of Woodson, across Highway 30, and into Westport Slough, destroying several residential structures and covering the highway with mud and large woody debris. Due to warning of the impending failure by ODF personnel prior to the event, the effects were limited to property damage. This report was completed at the request of the Oregon Department of Forestry's Policy Unit. The assessment was completed in its entirety by Gunnar Schlieder, Ph.D., an Oregon Certified Engineering Geologist.

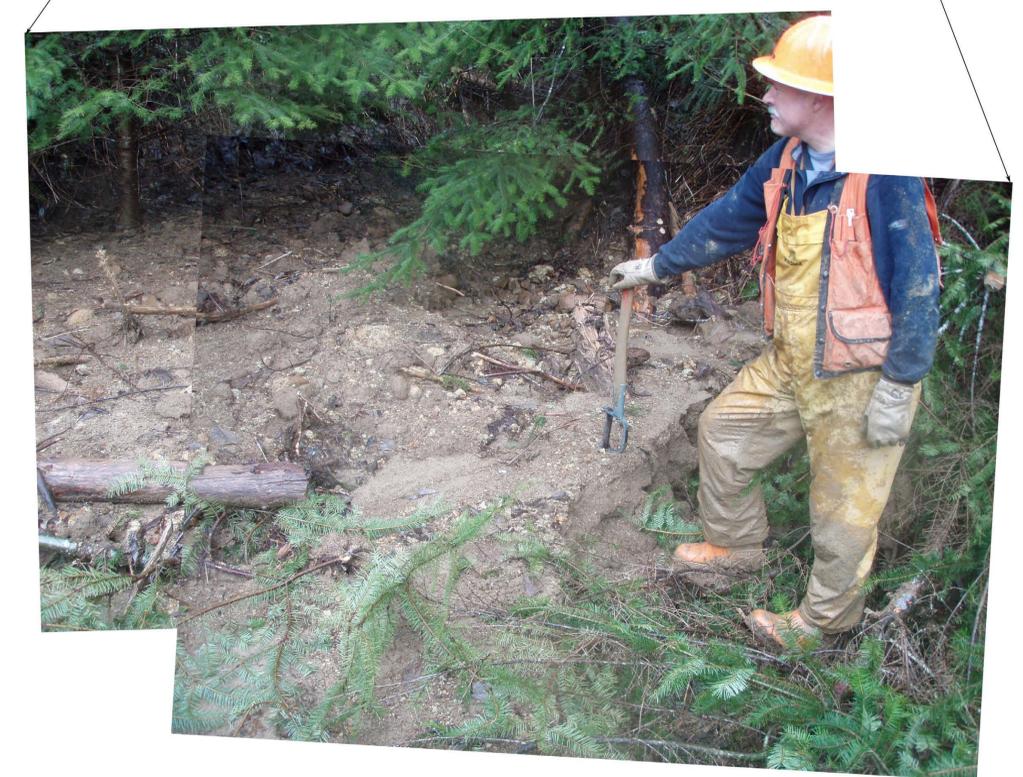
plug the culvert located where the draw crosses the Kerry Road (the old railroad grade). Well-stratified alluvial sediments were deposited in the resulting pond upslope of the road, to a level matching the elevation of the road crown at this point. These deposits are located at the mouth of the draw and do not extend to the road. Therefore, the deposits clearly originated from erosion occurring at the toe of Debris Flow 3.

Debris Flow Deposit 3 and Delta resulting from Deposition in Small Pond due to Culvert Plugging

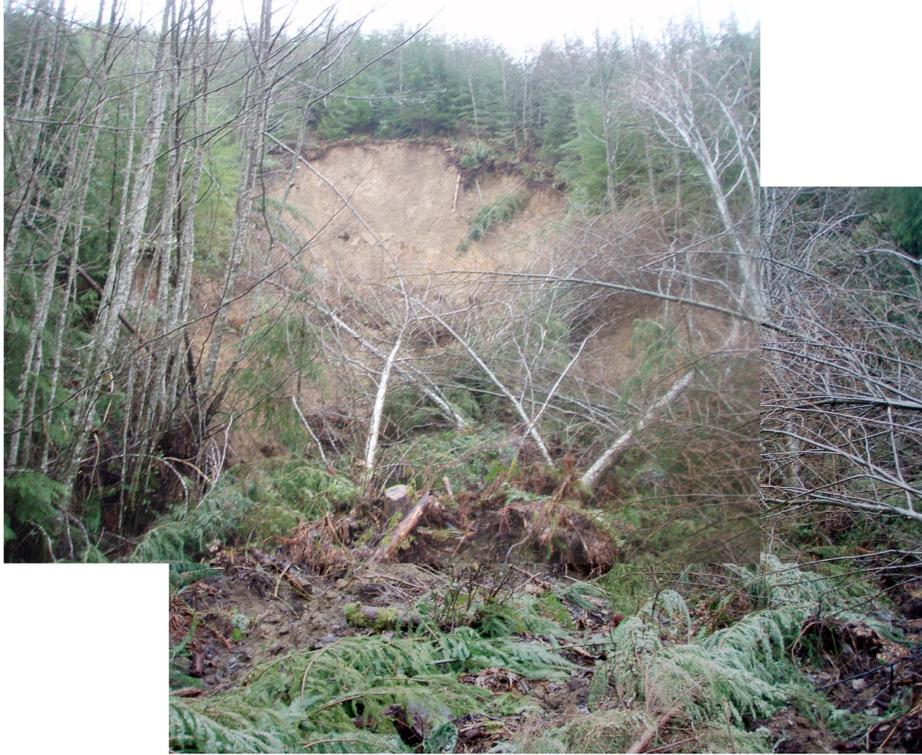
Initiation Area. View SE from Road.
Deposit in Foreground.

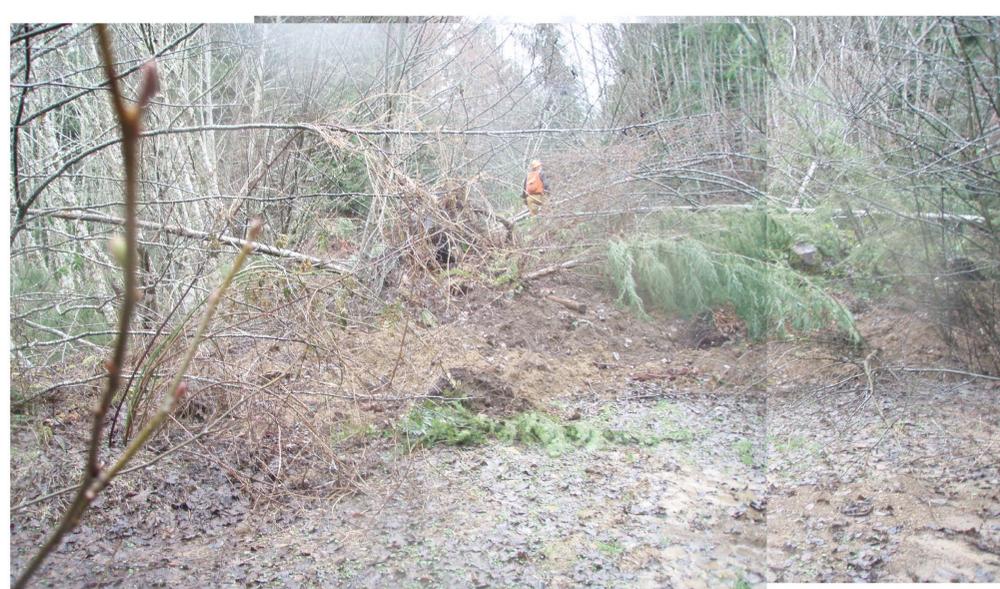
Deposit on Road, View NE.

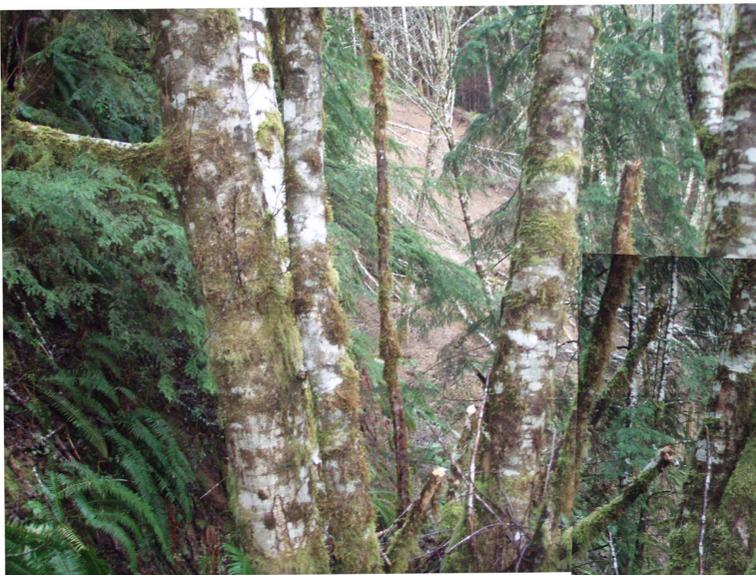
Lower Portion of Path and Depositional Area of Debris Flow 5.
Debris did not reach main stem of Ellertsen Creek (bare area visible through trees in R background).

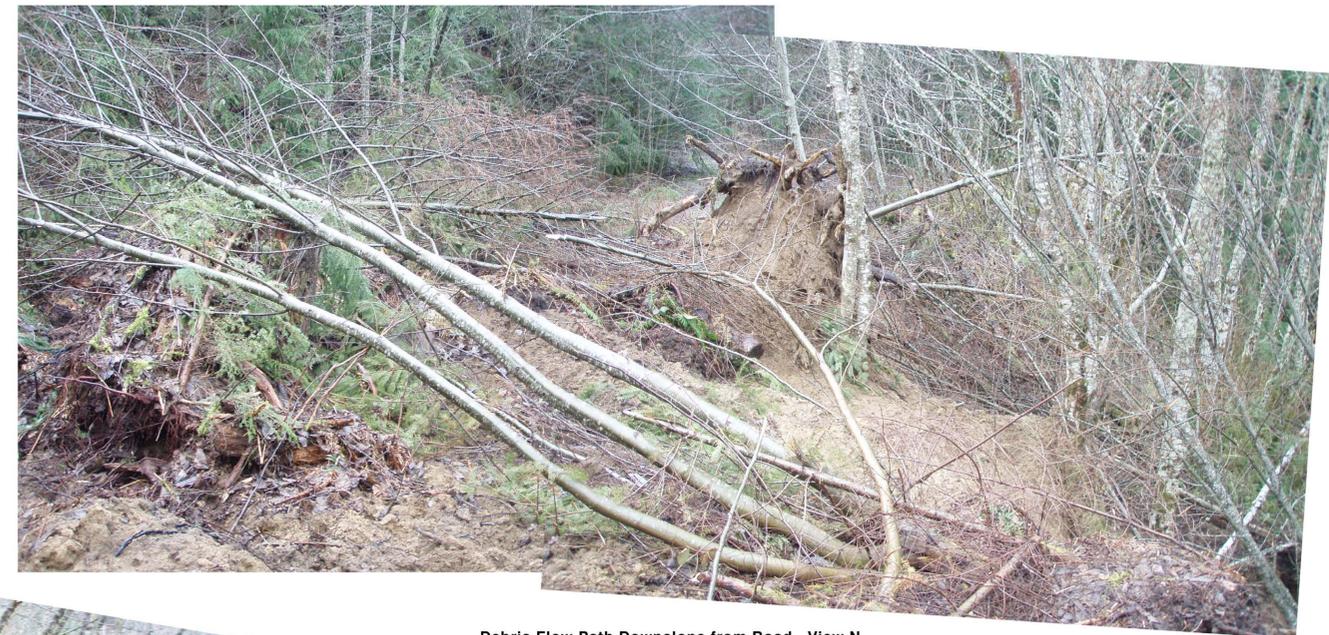
Debris Flow Path Downslope from Road. View N.

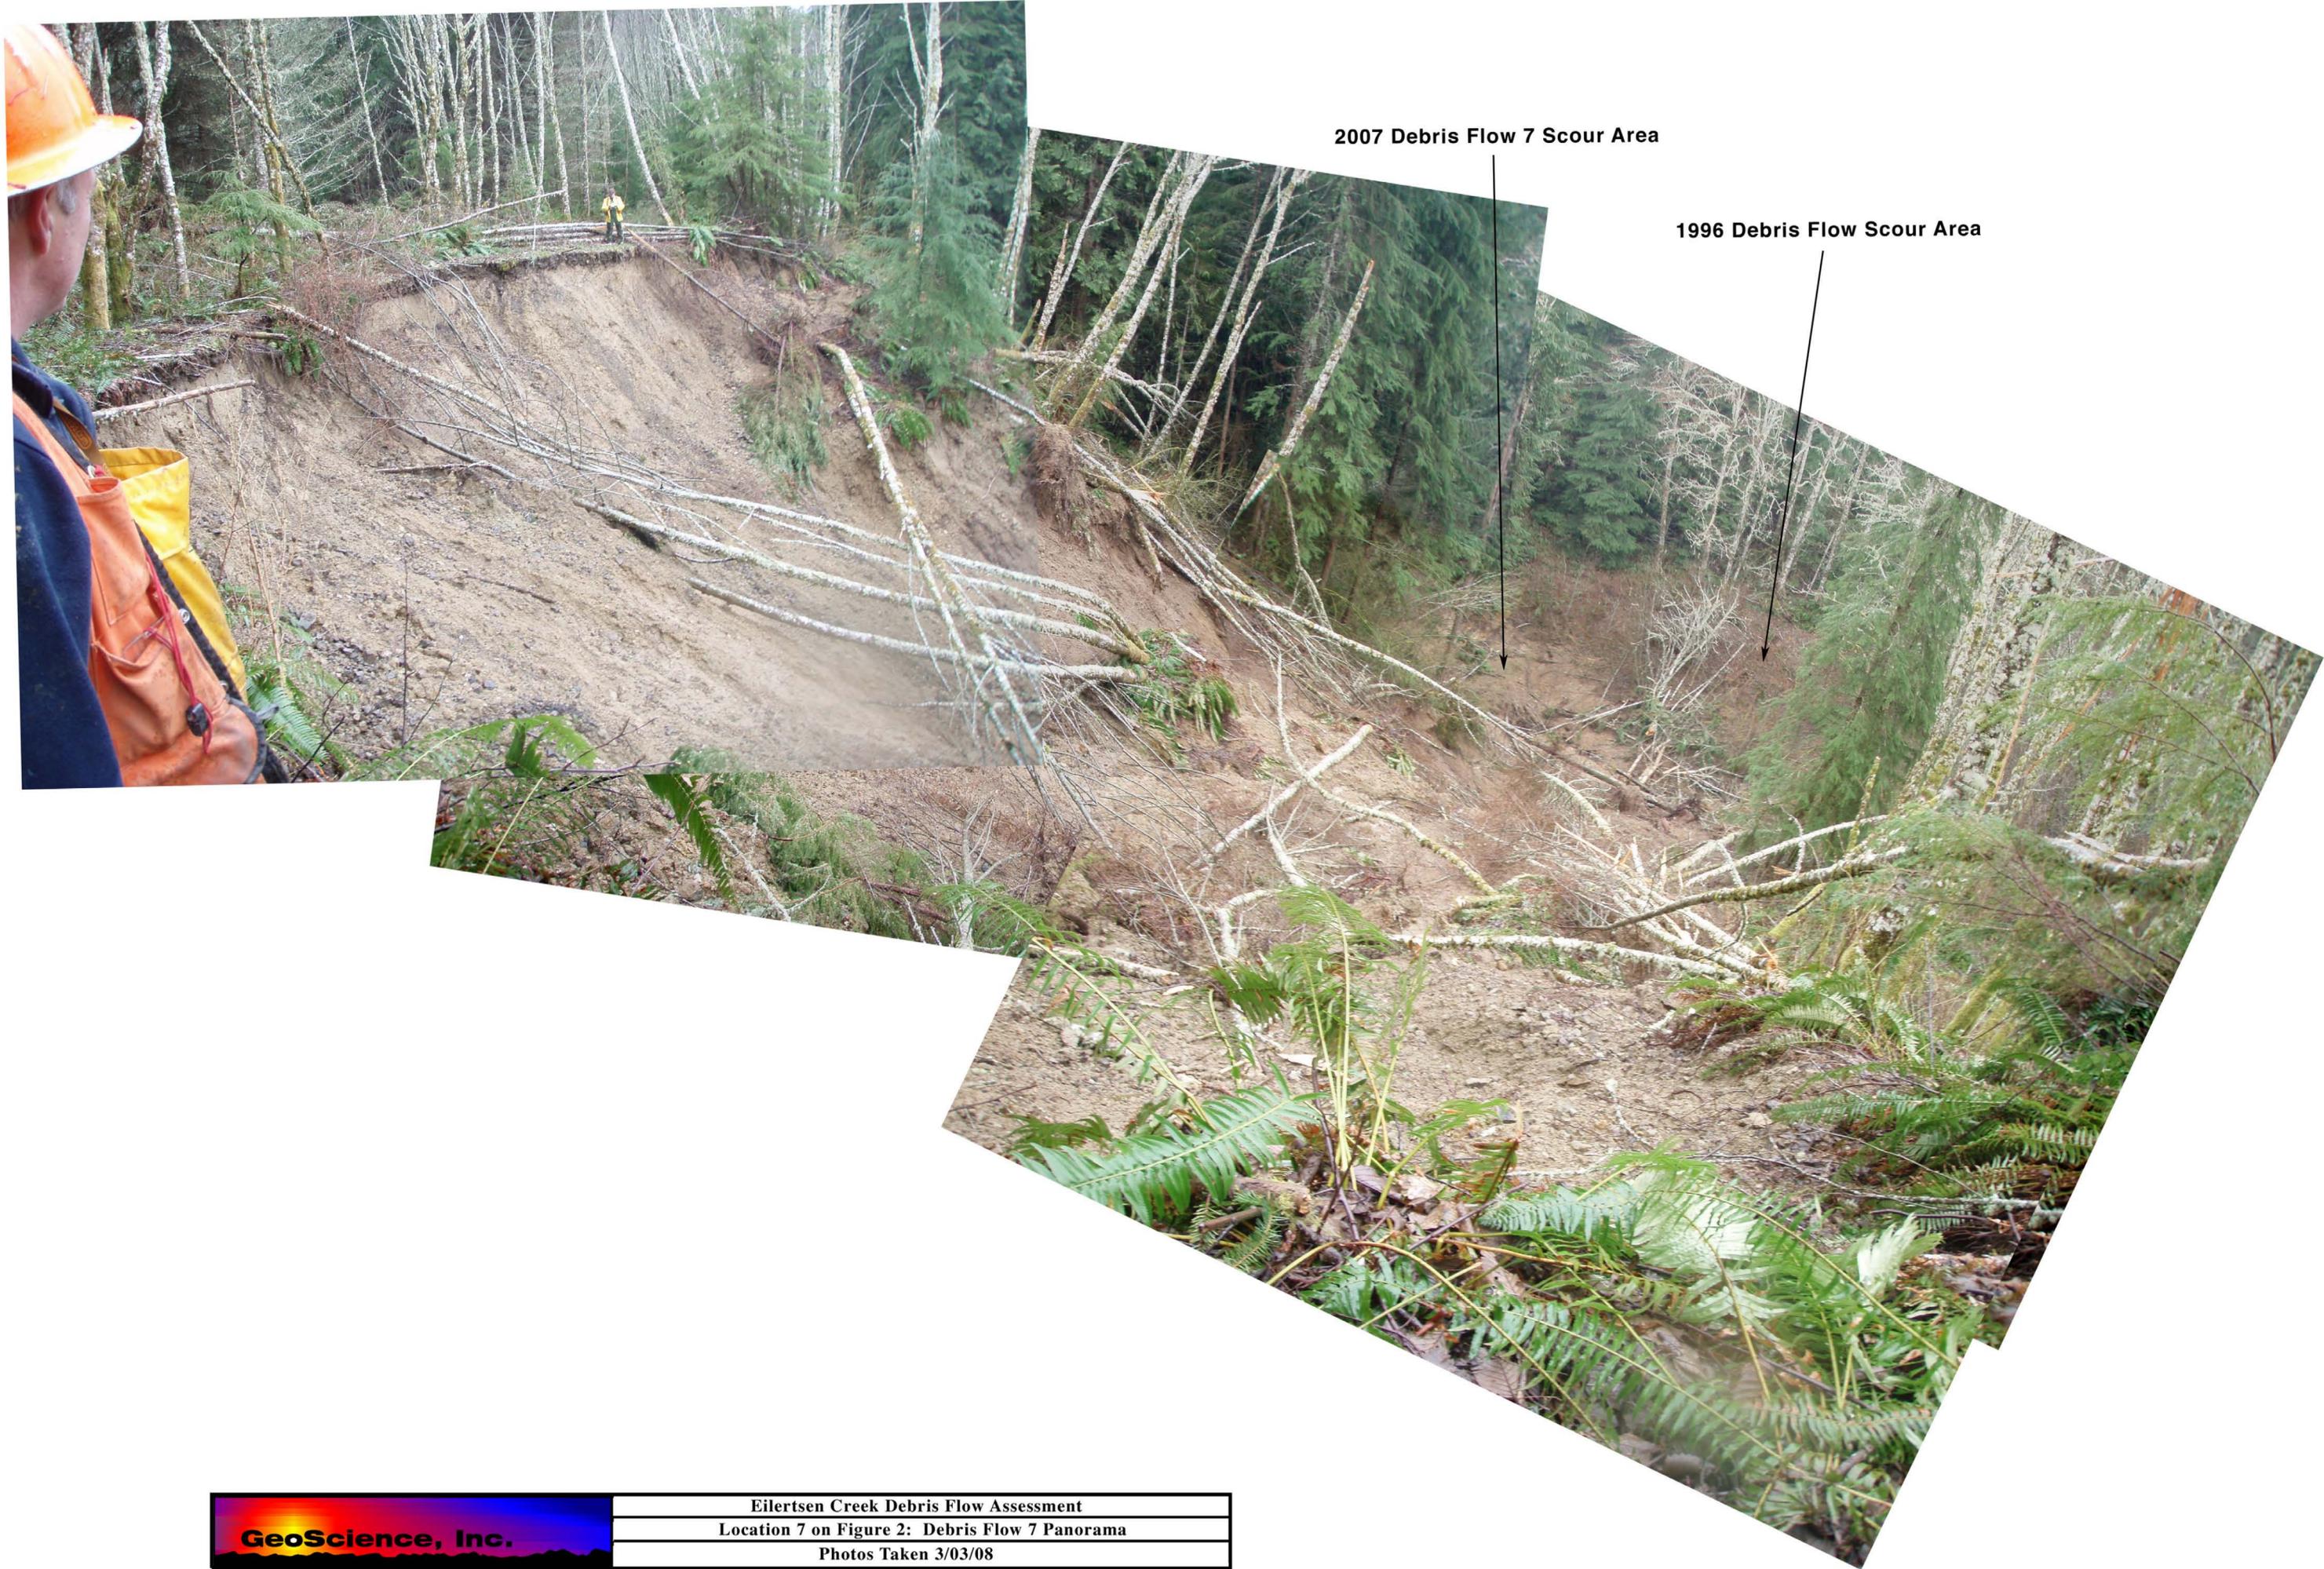
2007 Debris Flow 7 Scour Area

1996 Debris Flow Scour Area

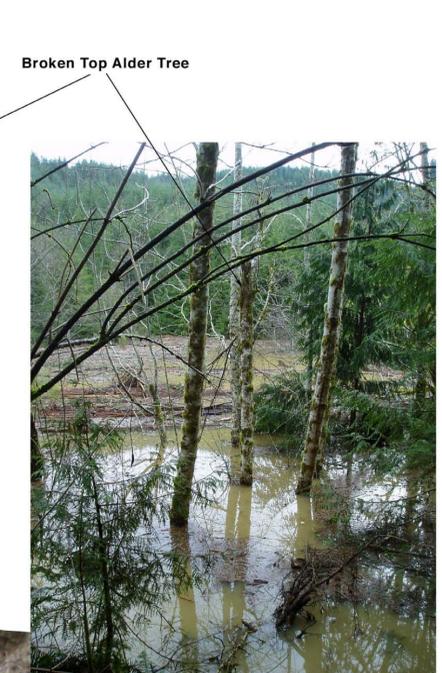
Pond 12/10/07. Photo Jason Hinkle, ODF

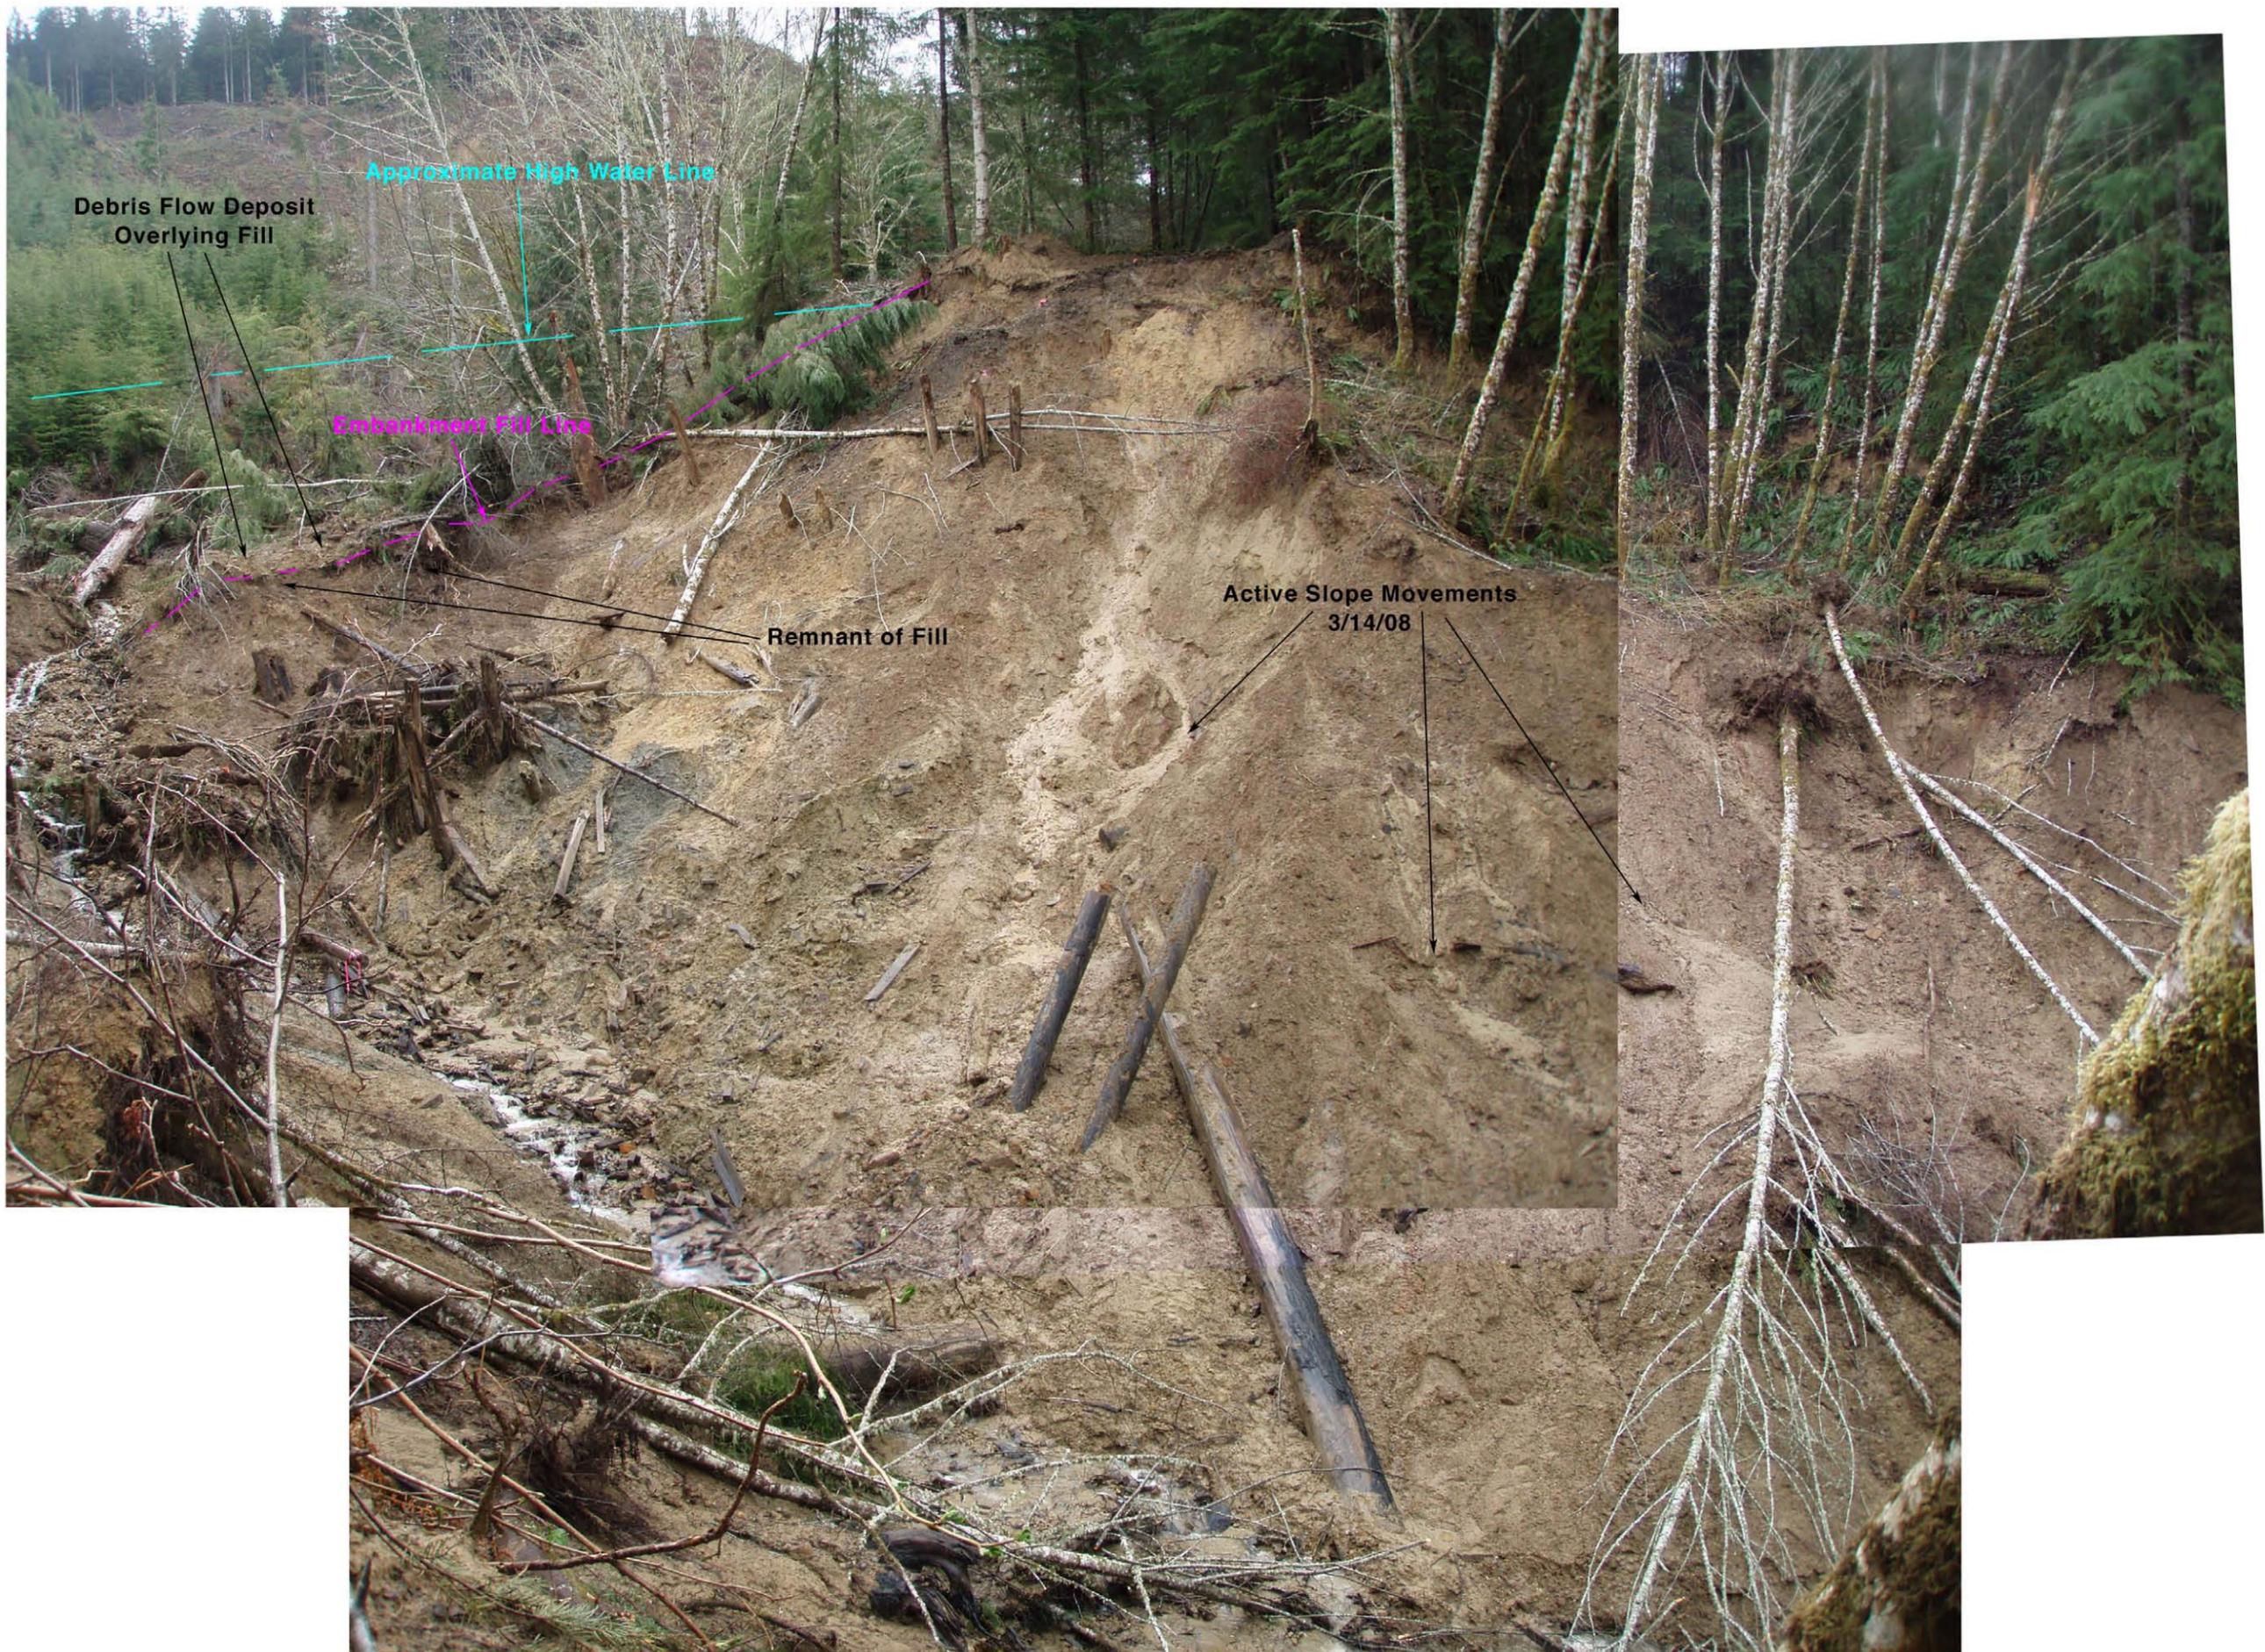
Debris Flow Deposit
Overlying Fill

Approximate High Water Line

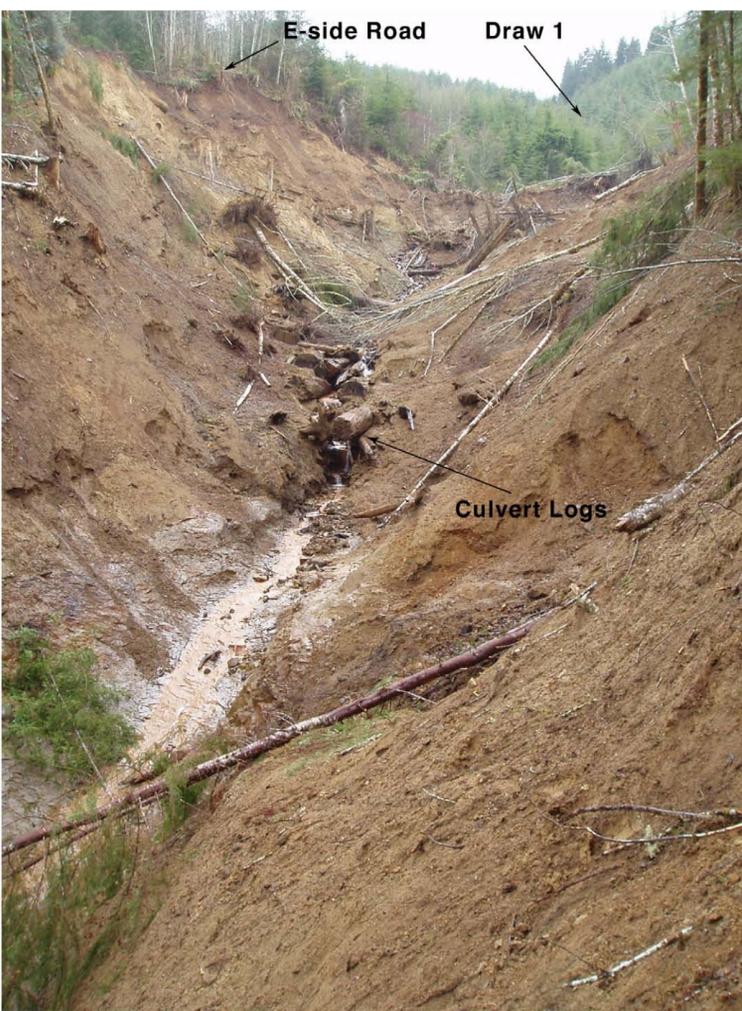
View upstream in Reach "B". Lower end of puncheon culvert.

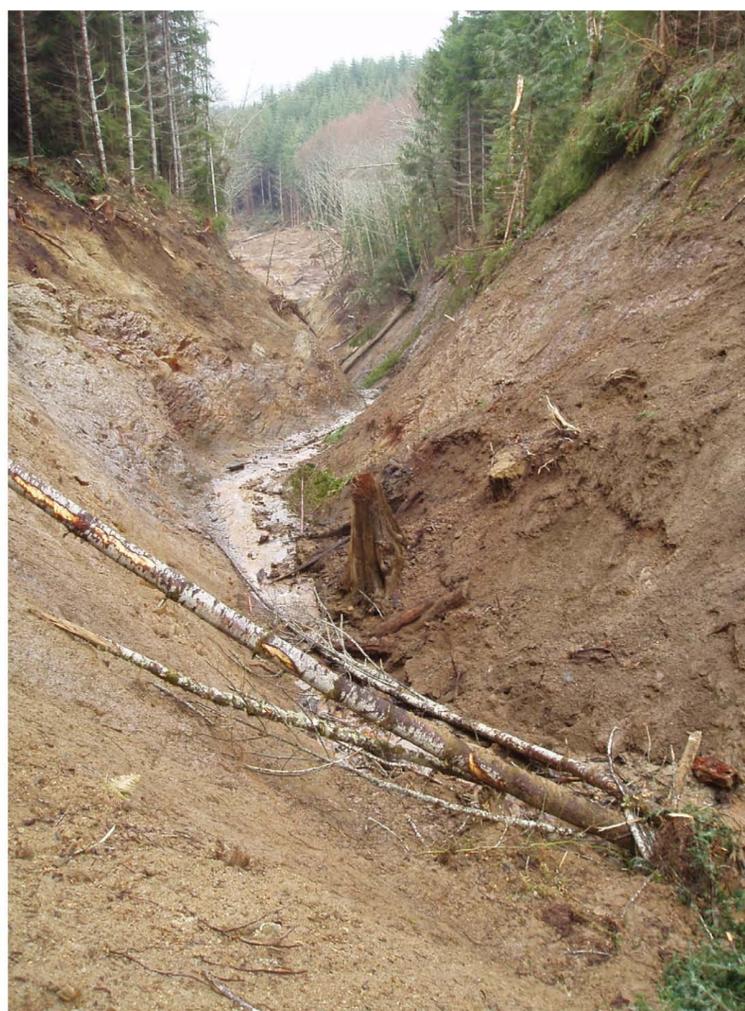
View downstream in Reach "B". Note scouring on left bank.

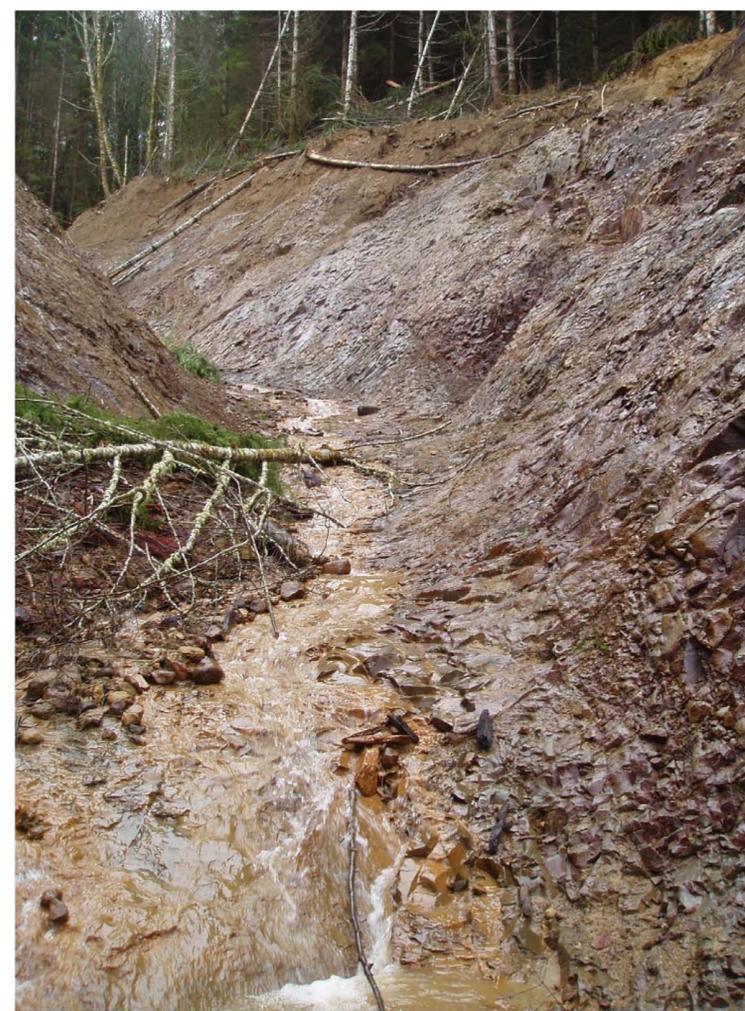
Closer view of scoured in-place rock in Reach "B". View upstream

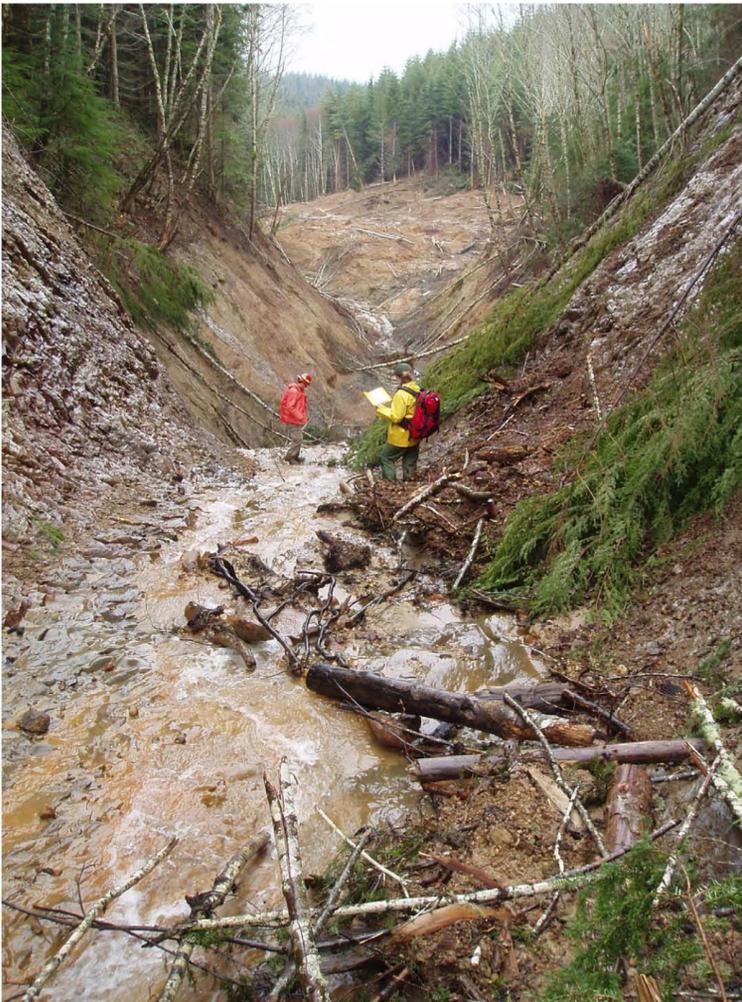
Near "knick-point" in Reach "B". View downstream.

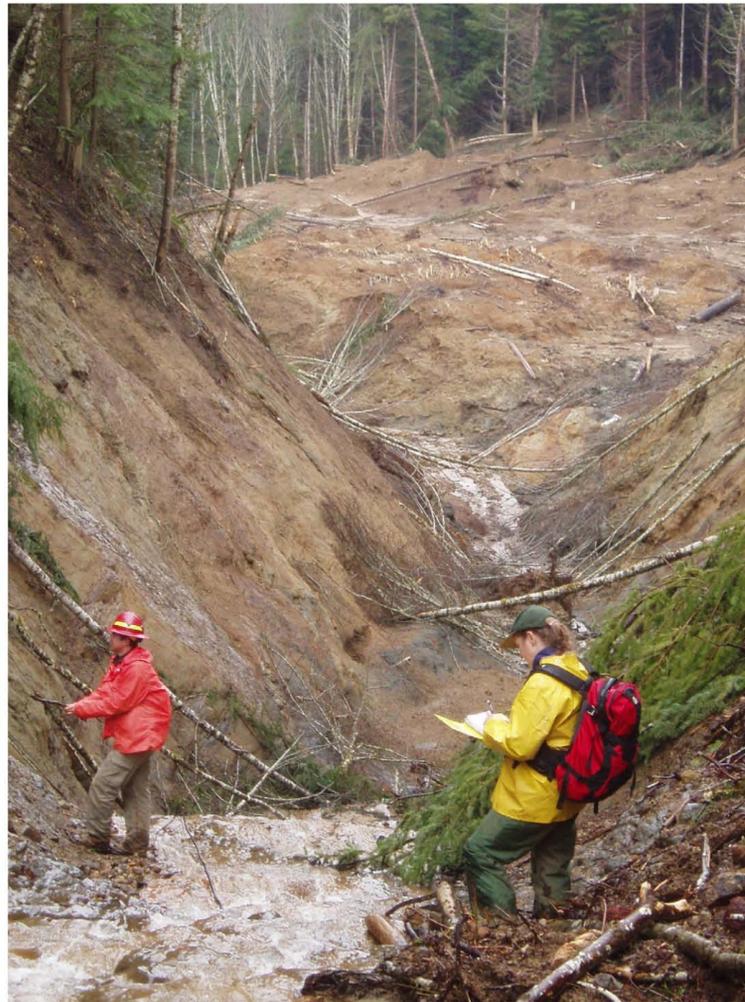
At knick-point (waterfall) in Reach "B". View downward onto "Alder Flat" (Location "C").

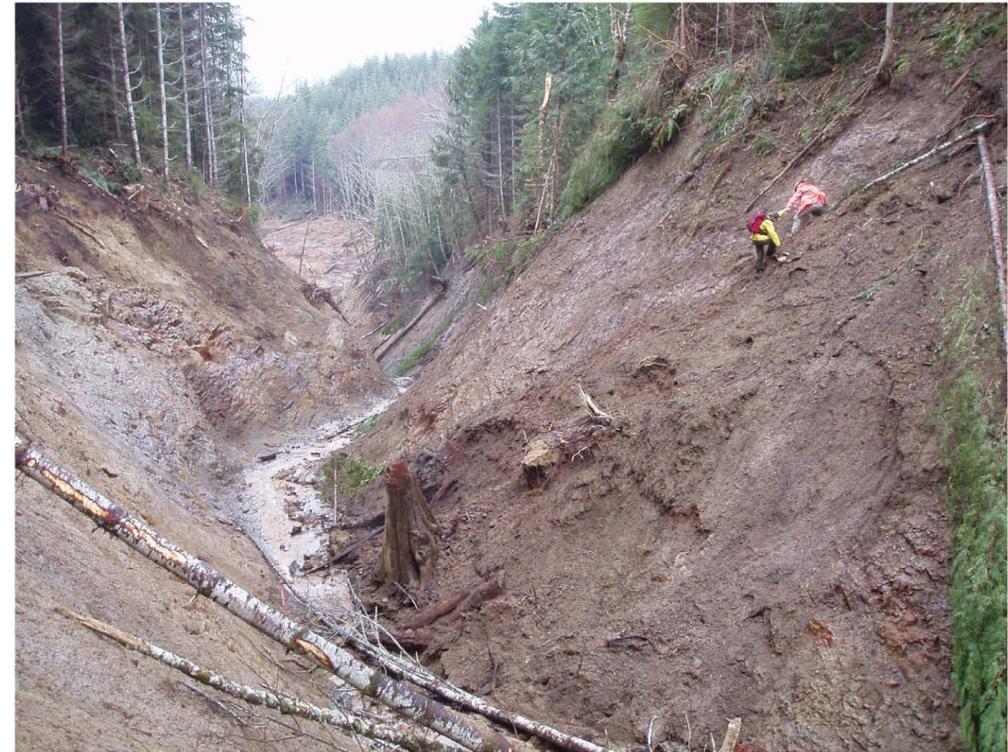
Reach "B", view downstream, with ODF personnel for scale.

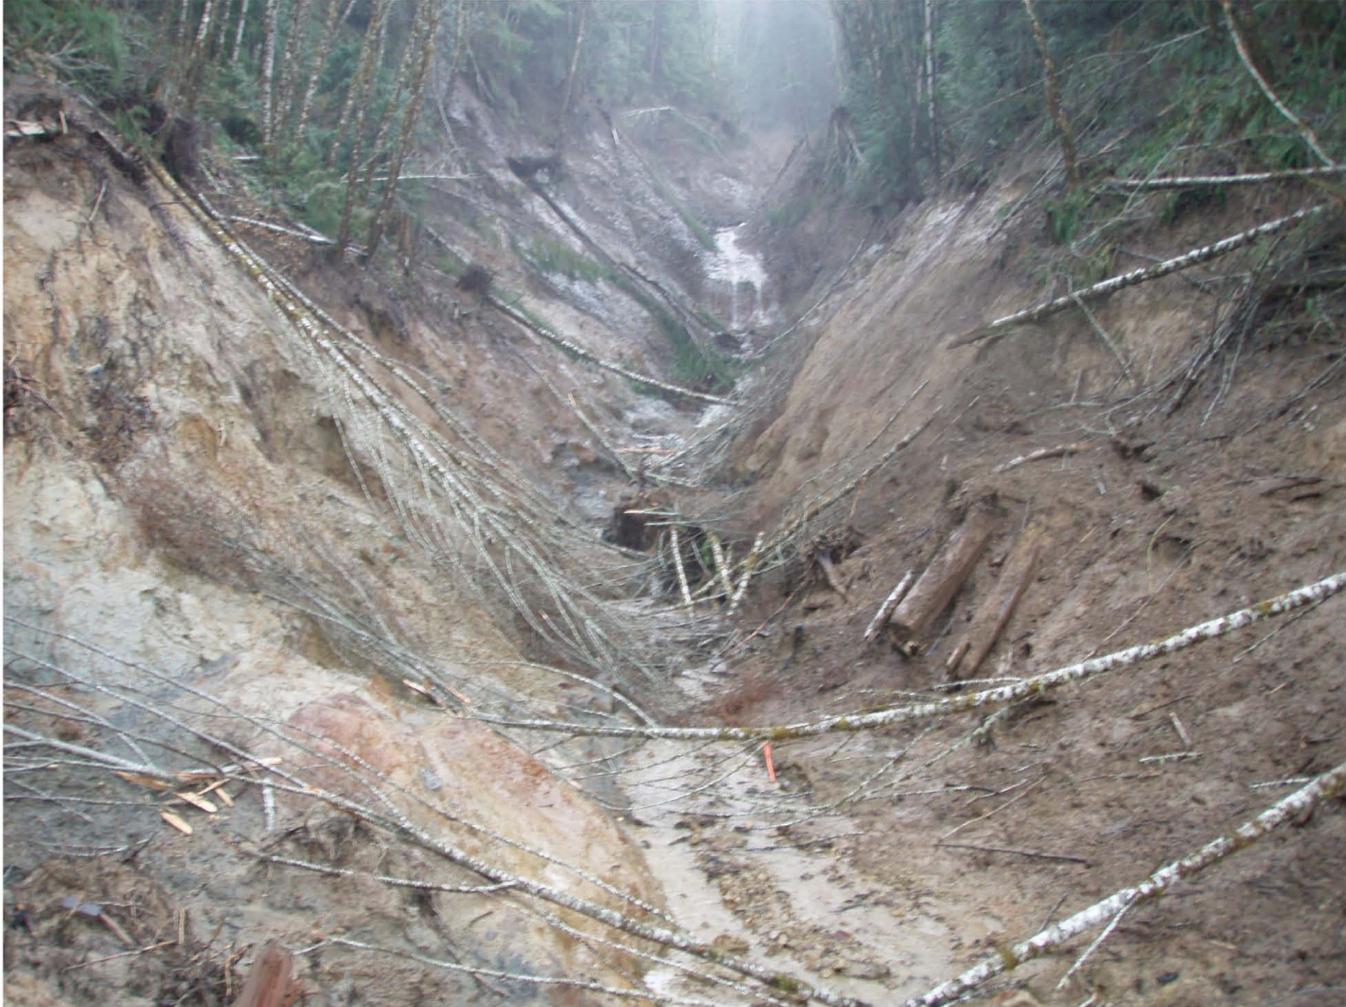
View upstream (SW) from "C" into reach "B". Waterfall is visible in middle ground. Note transition from scouring on both sides to deposition on W side (right).

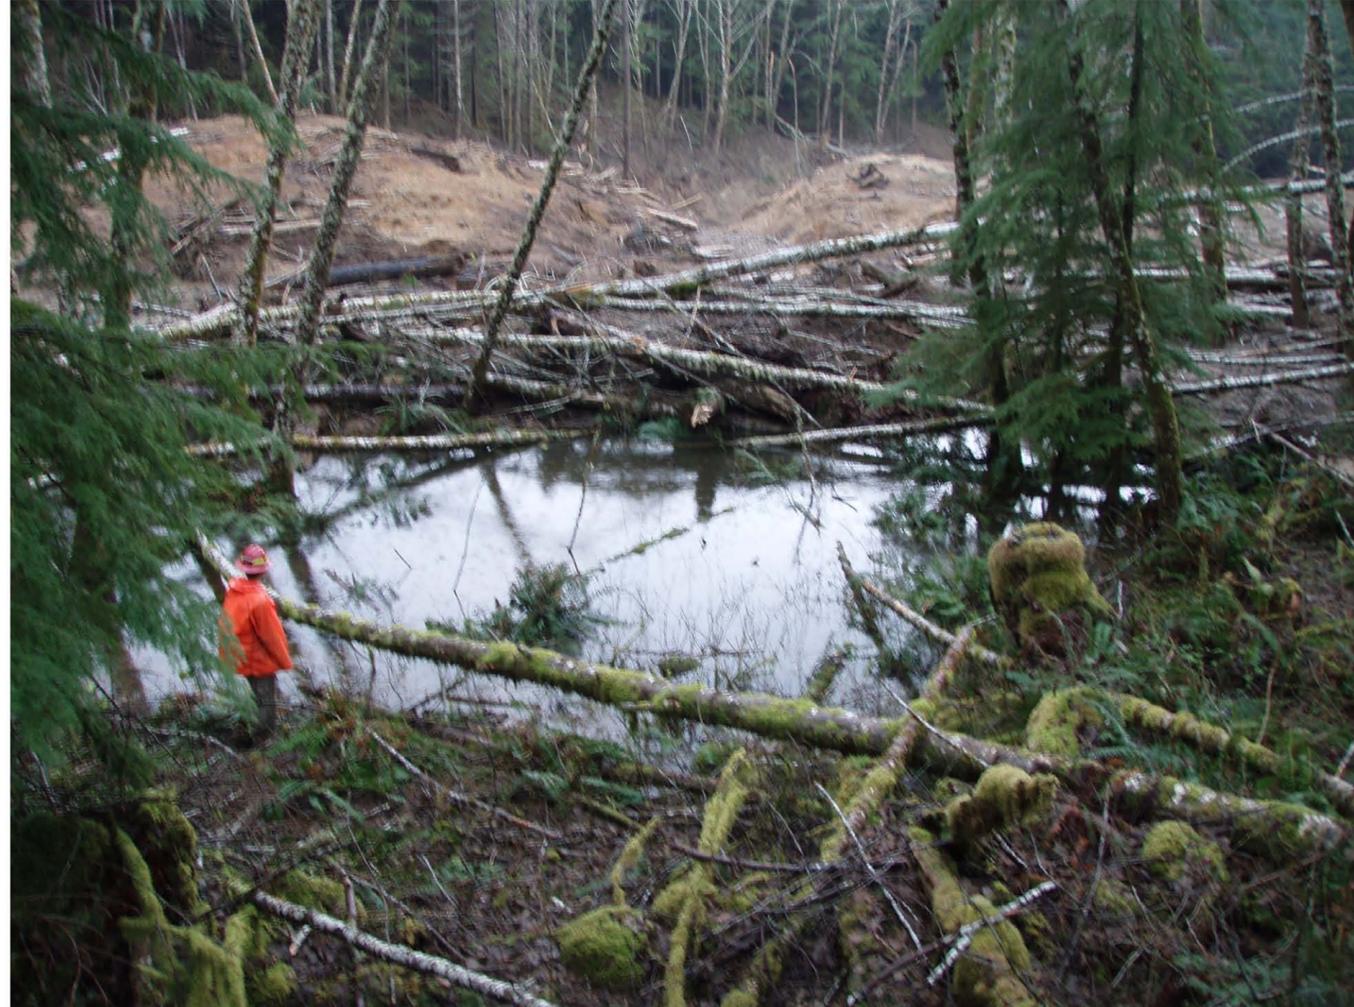
This reach includes the upper and central portions of the “Alder Flat”, a very gently sloping area several hundred feet wide at the base of a much steeper slope. It is possible that the “Alder Flat” represents the top of a large rotational slope movement block. The channel of Eilertsen Creek is located along the western margin of the wide flat area. The channel is incised into the flat by 10 to 15 feet. However, for an event of the magnitude of the December 11, 2007 railroad fill failure, this area represents a significant loss of confinement. As a result, the debris flow spread out to a width of 200 to 300 feet or more, depositing a natural levee of trees and mud along the low-sloping eastern margin. In at least one area, below Debris Flow 5, this linear mound of debris has resulted in a shallow (less than 2' deep) impoundment of water.

Deposition of "natural levee" along E side in upper portion of "Alder Flat" (Location "C" on Figure 2). View NW. Levee has resulted in formation of pond. Area is directly below Debris Flow 5.

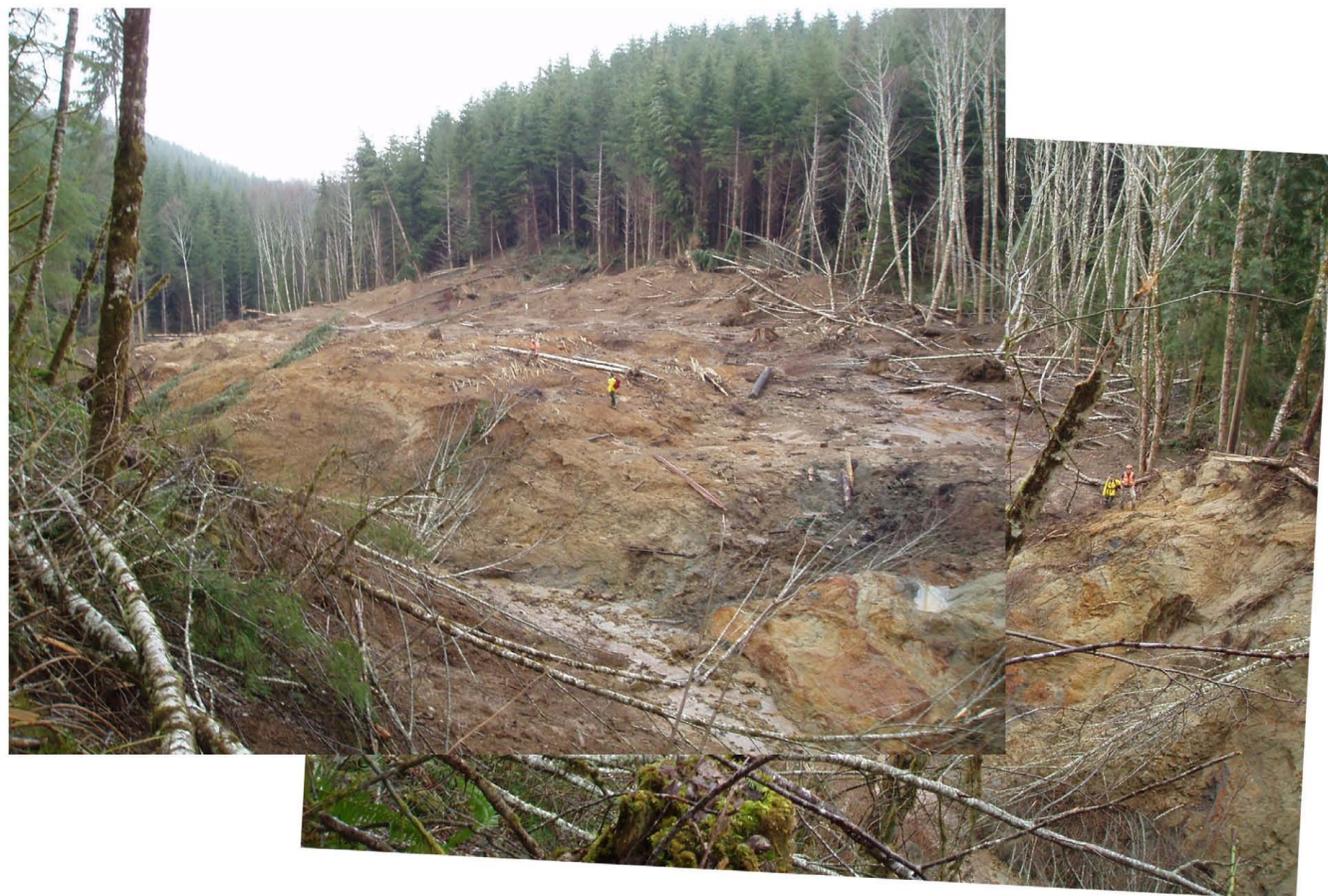
Upstream portion of "Alder Flat". View N. Debris lost confinement at this location, resulting in partial deposition, likely from the rear portions of the flow. However, the front of the debris flow removed vegetation and most of the top soil during its passage through this area. Transition from scour only to partial deposition near people in right part of picture.

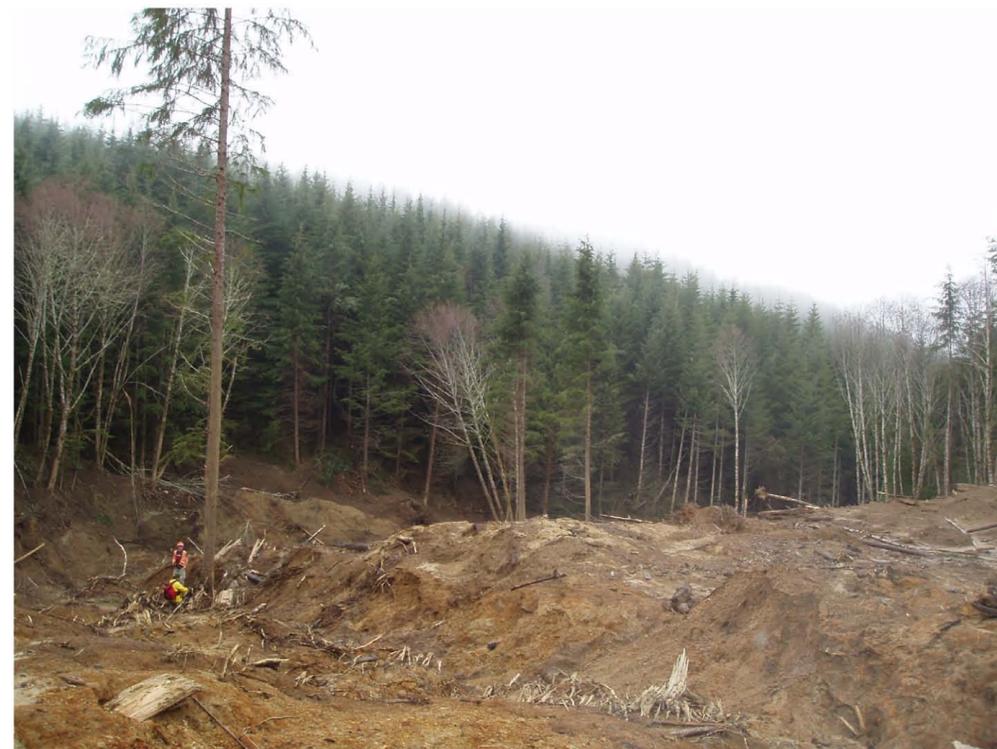
Central W portion of "Alder Flat". Note scoured original ground with roots aligned with flow direction and lone fir tree let standing. Original ground is mostly covered to depths of several feet with debris from 12/11/07 event.

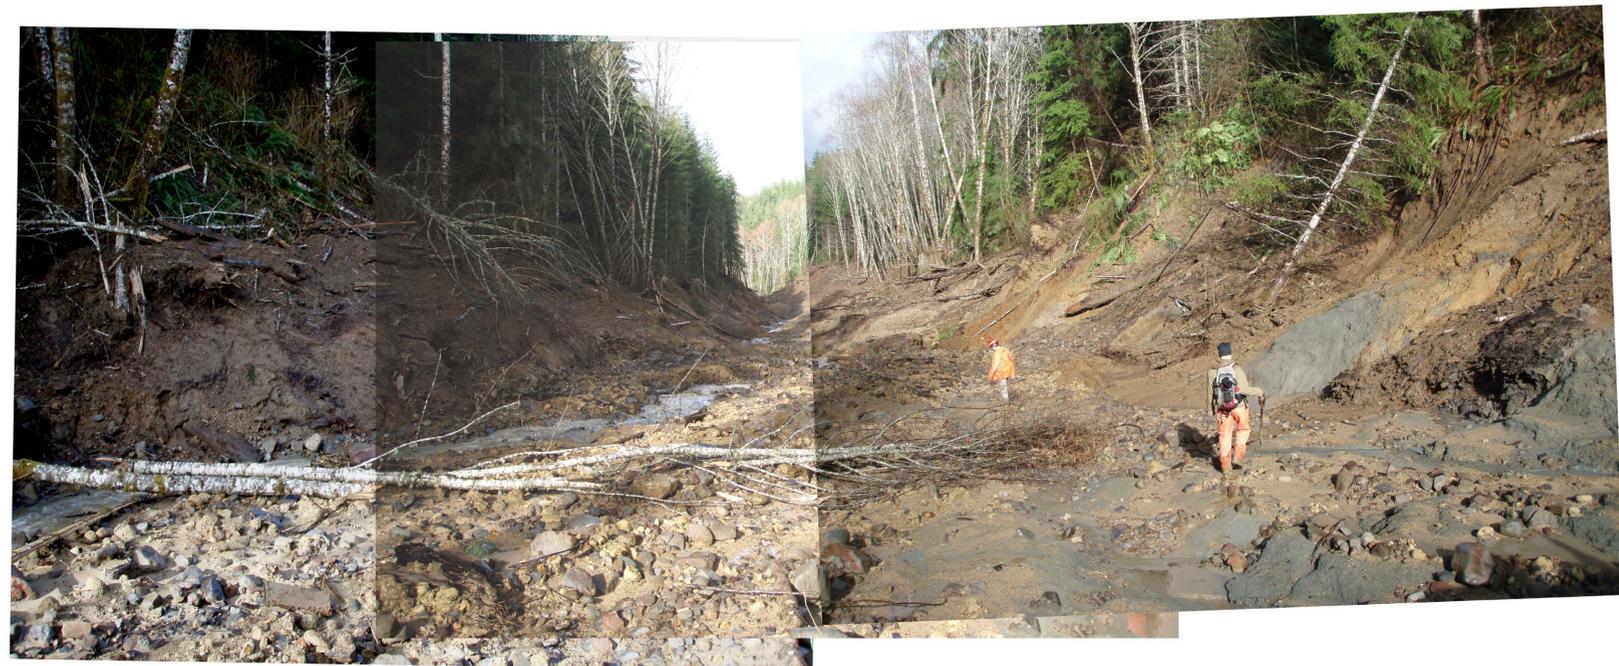
Channel in Reach "H", view NNE. Note slump (with small fir) along right bank as a result of 12/11/07 event.
