**DEBRIS FLOW ASSESSMENT
EILERTSEN CREEK/WOODSON
December 2007 Storm
T 7N, R 5W, Sections 5, 8, & 17**

April 10, 2008

This report presents the results of a geologic/geotechnical assessment of the causes and slope movement mechanisms that led to the railroad fill failure which occurred on the morning of December 11, 2007 in the Eilertsen Creek drainage (T 7N, R 5W, Sections 5, 8, and 17, Figure 1). The failure sent a debris flow through the hamlet of Woodson, across Highway 30, and into Westport Slough, destroying several residential structures and covering the highway with mud and large woody debris. Due to warning of the impending failure by ODF personnel prior to the event, the effects were limited to property damage. This report was completed at the request of the Oregon Department of Forestry's Policy Unit. The assessment was completed in its entirety by Gunnar Schlieder, Ph.D., an Oregon Certified Engineering Geologist.

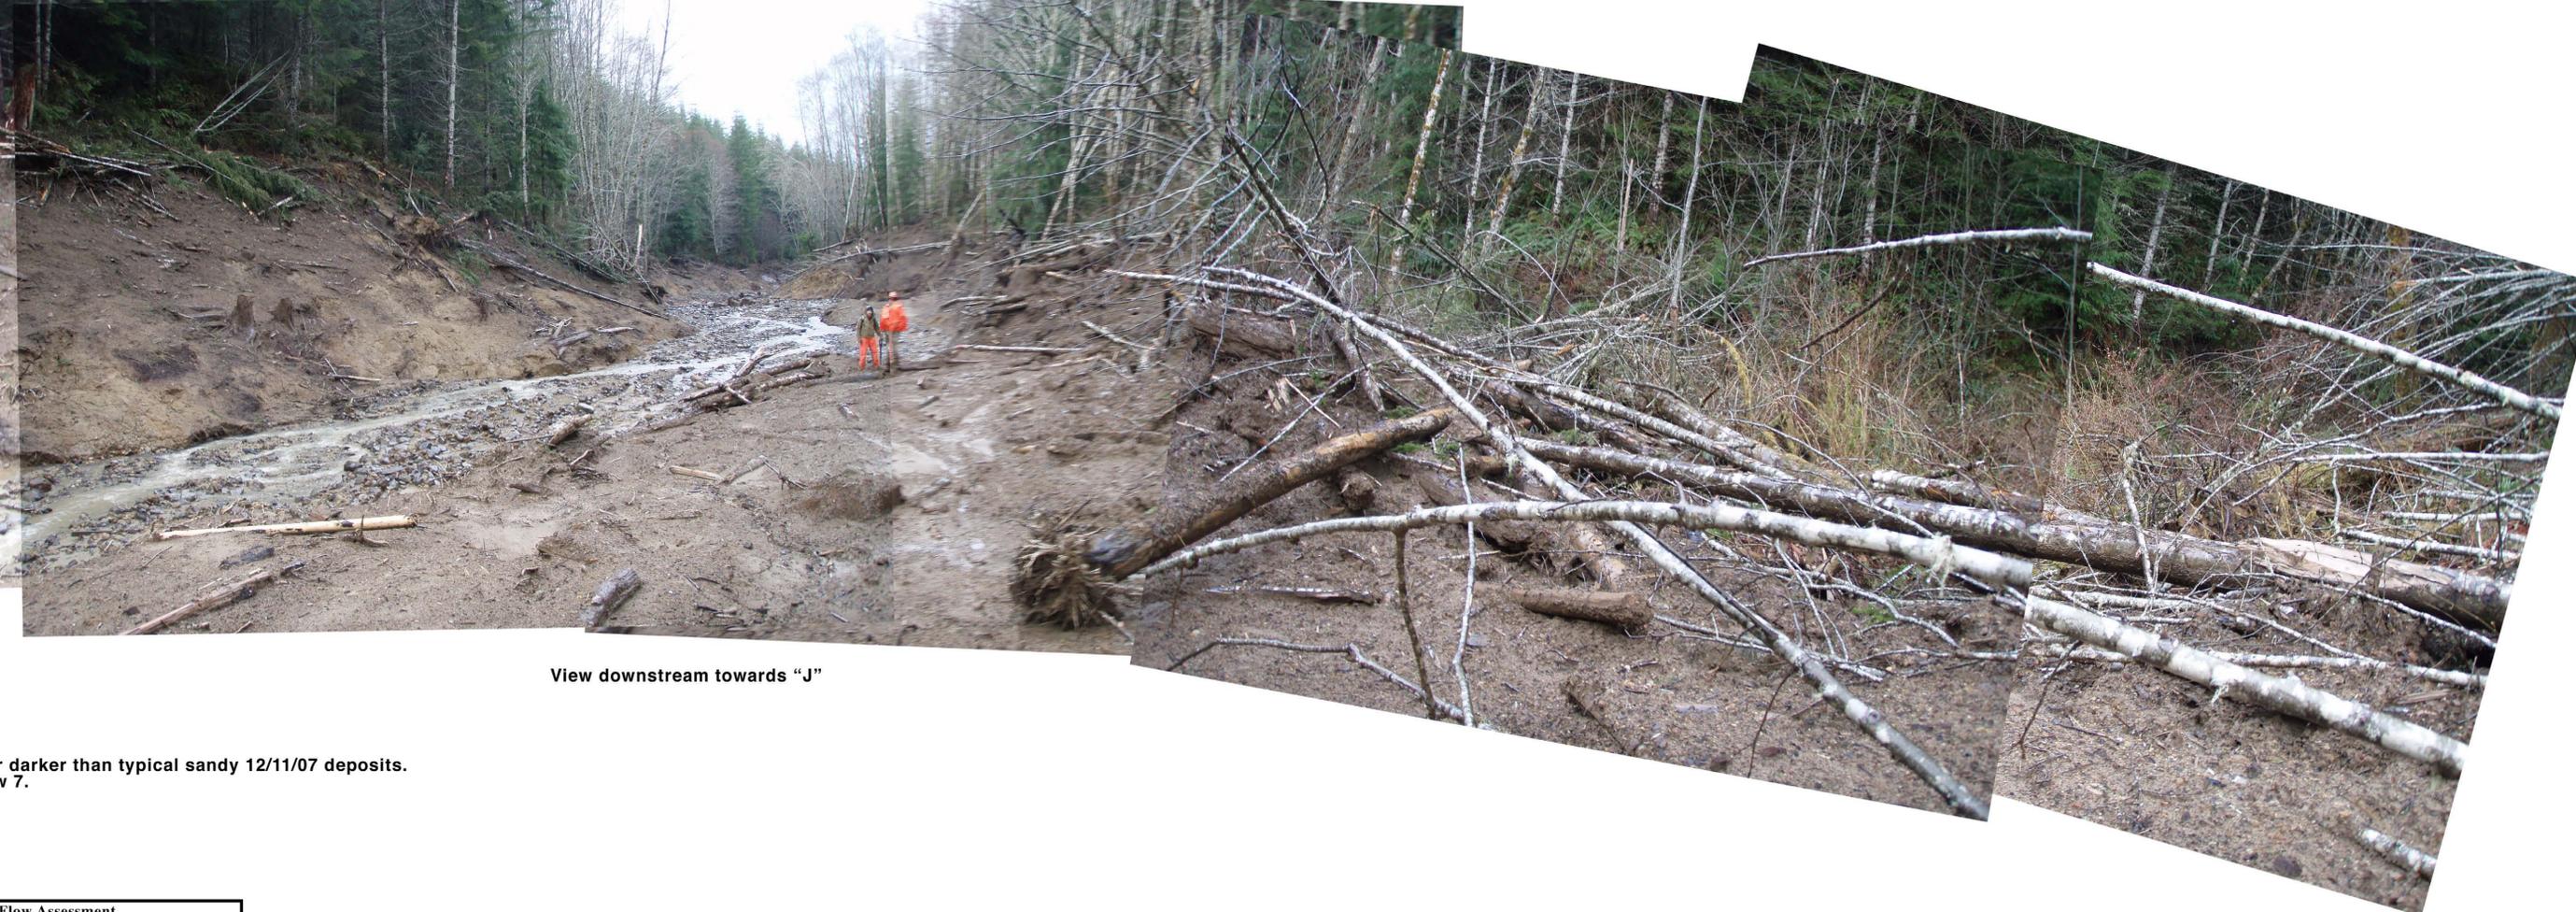
View downstream towards "J"

View upstream into Reach "H". 12/11/07 debris flow deposit on left bank off ridge spur forming divide between Eilertsen Creek and draw containing debris flow 7.

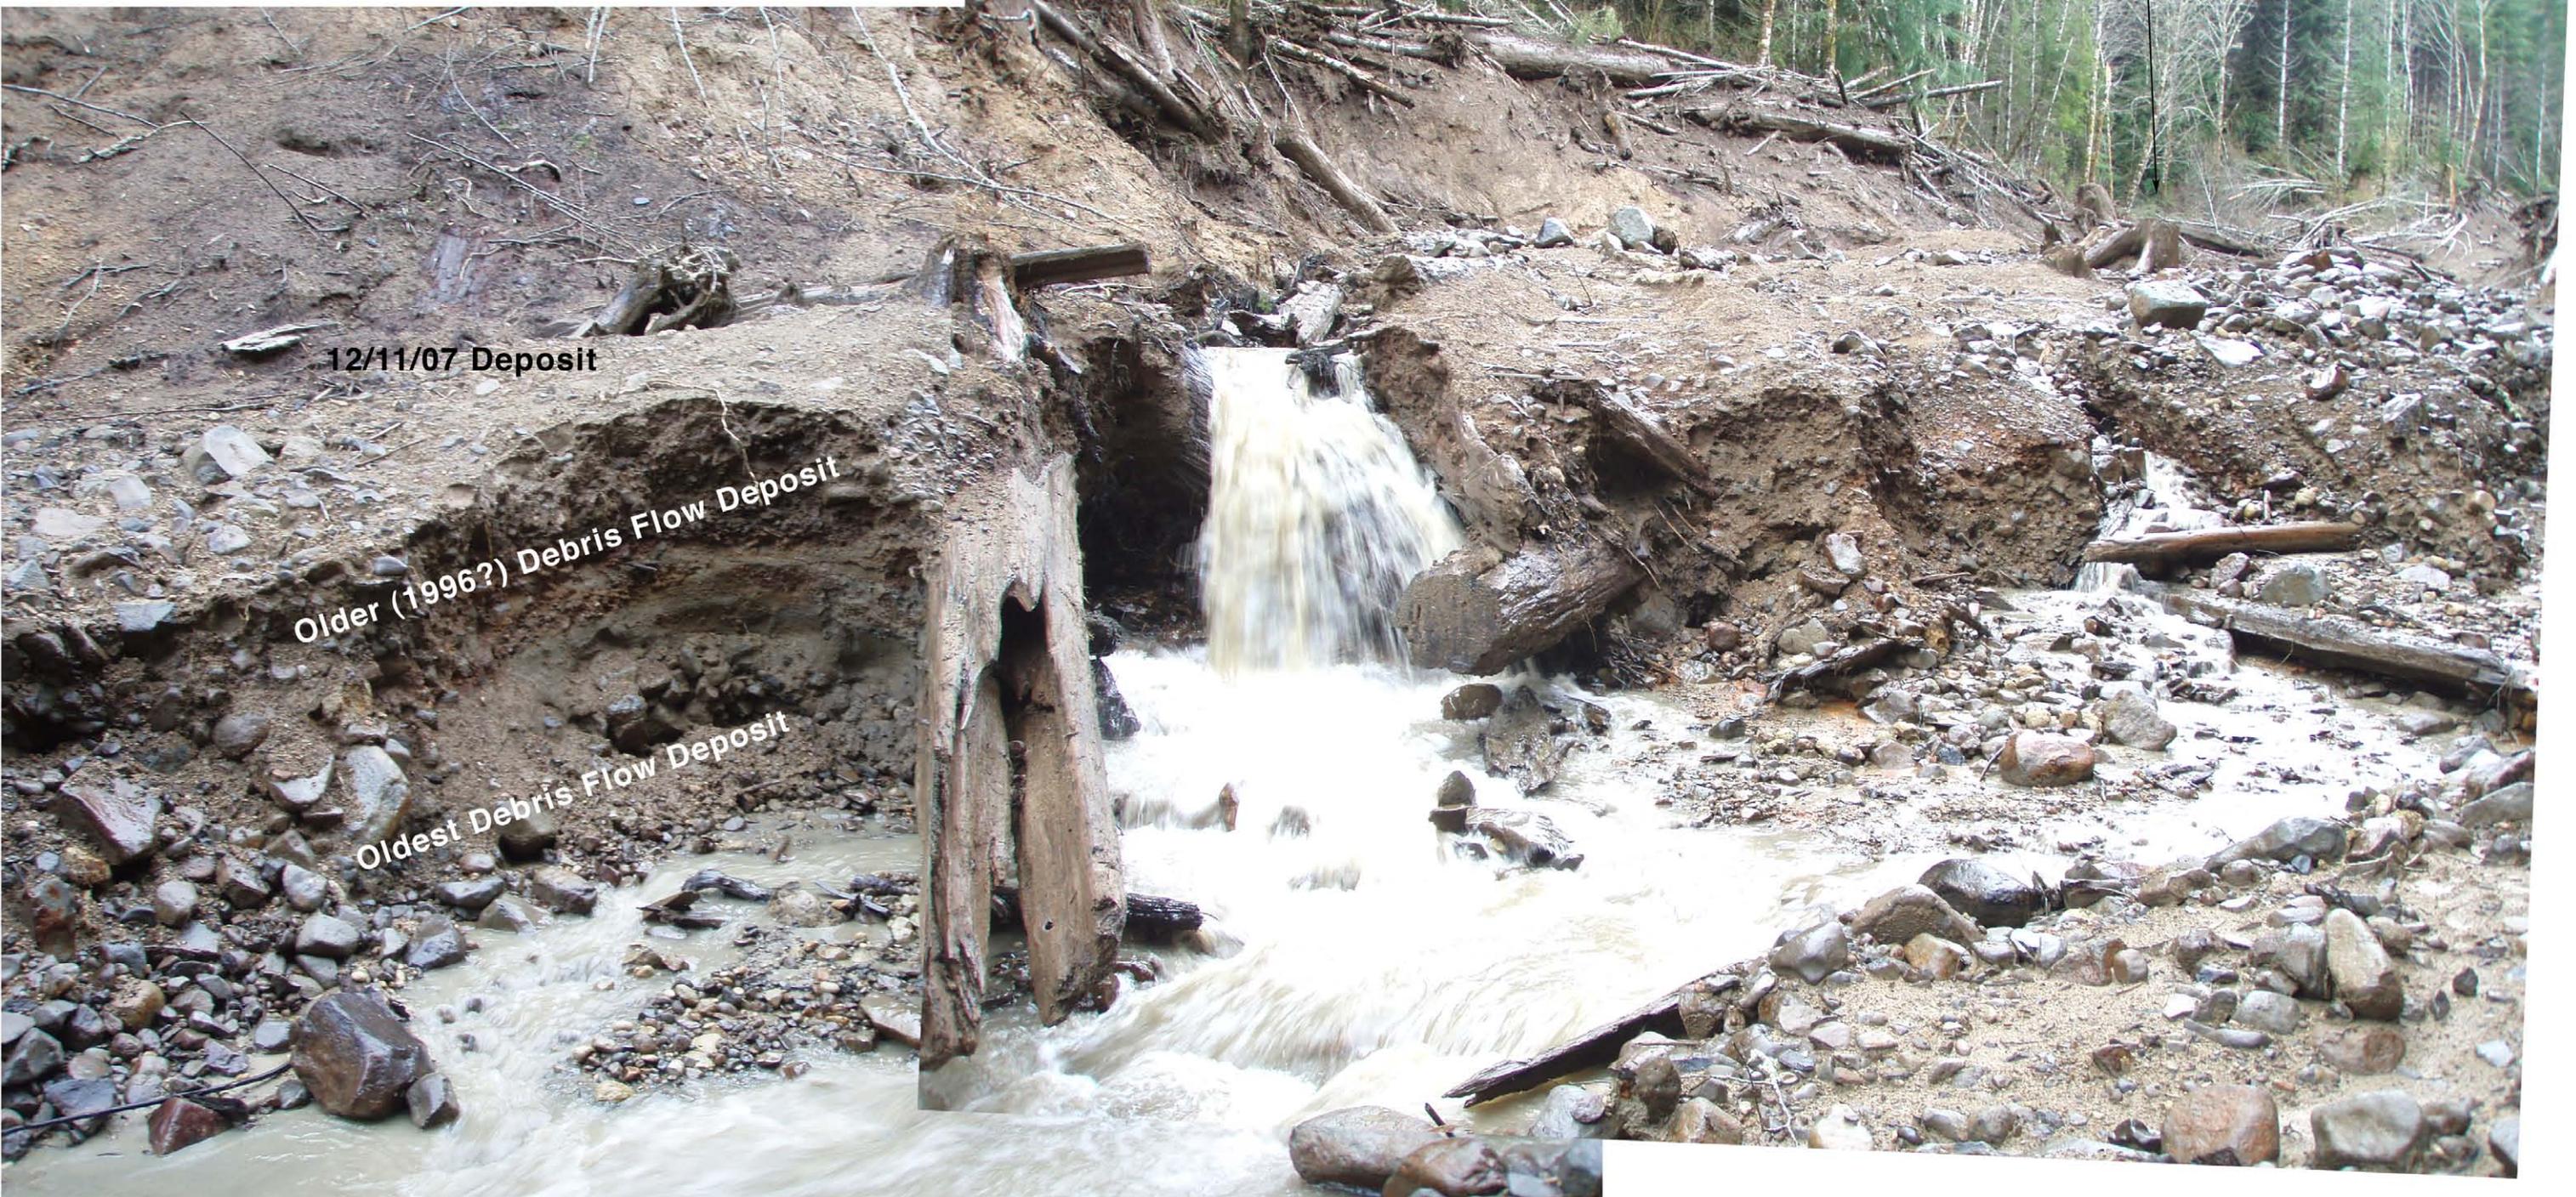
In Reach “L”, portions of an old road bed formed of roughly hewn planks remain on the west side of the channel. The old road has been covered by a couple of feet of the recent debris flow deposit and possibly, by the 1996 event also. Based on the good preservation of the wood forming the road, it is likely that the road bed had been covered by soil and remained wet most of the time. It is also probable that this system of road bed was placed there due to the presence of soft, muddy or boggy soils. This reach is located at the upslope end of another very flat area which, to the northeast includes a sizeable pond. It has not been determined whether this shallow impoundment is the result of the old railroad grade or if the pond is a natural sag pond resulting from slope movement. If the old road predates the railroad grade (constructed in the early 1900s), then it is probable that the flat, poorly draining area is the result of slope movement.

12/11/07 Deposit

Older (1996?) Debris Flow Deposit

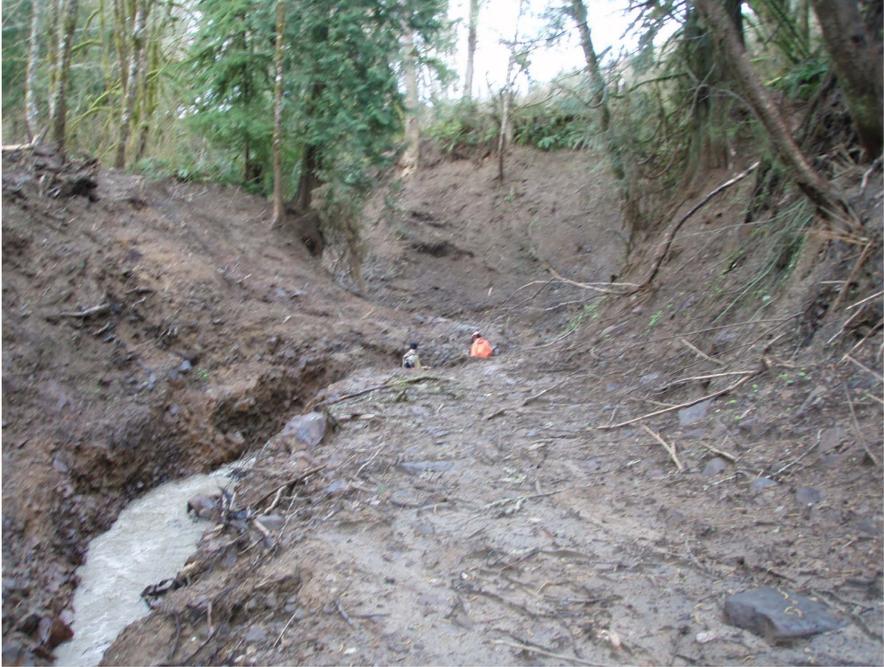
Channel incision and increase in gradient downstream of "N". View NE. Note CRB in place.

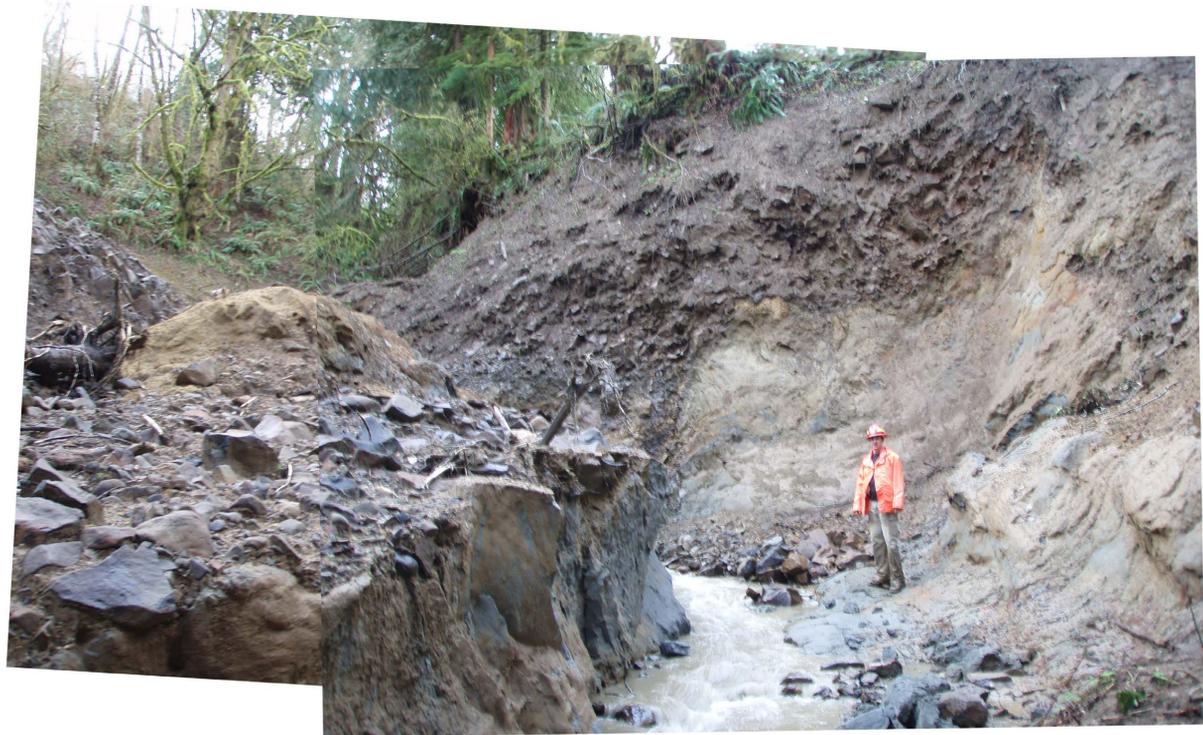
Contact between CRB and underlying sedimentary rock at upstream end of "O"

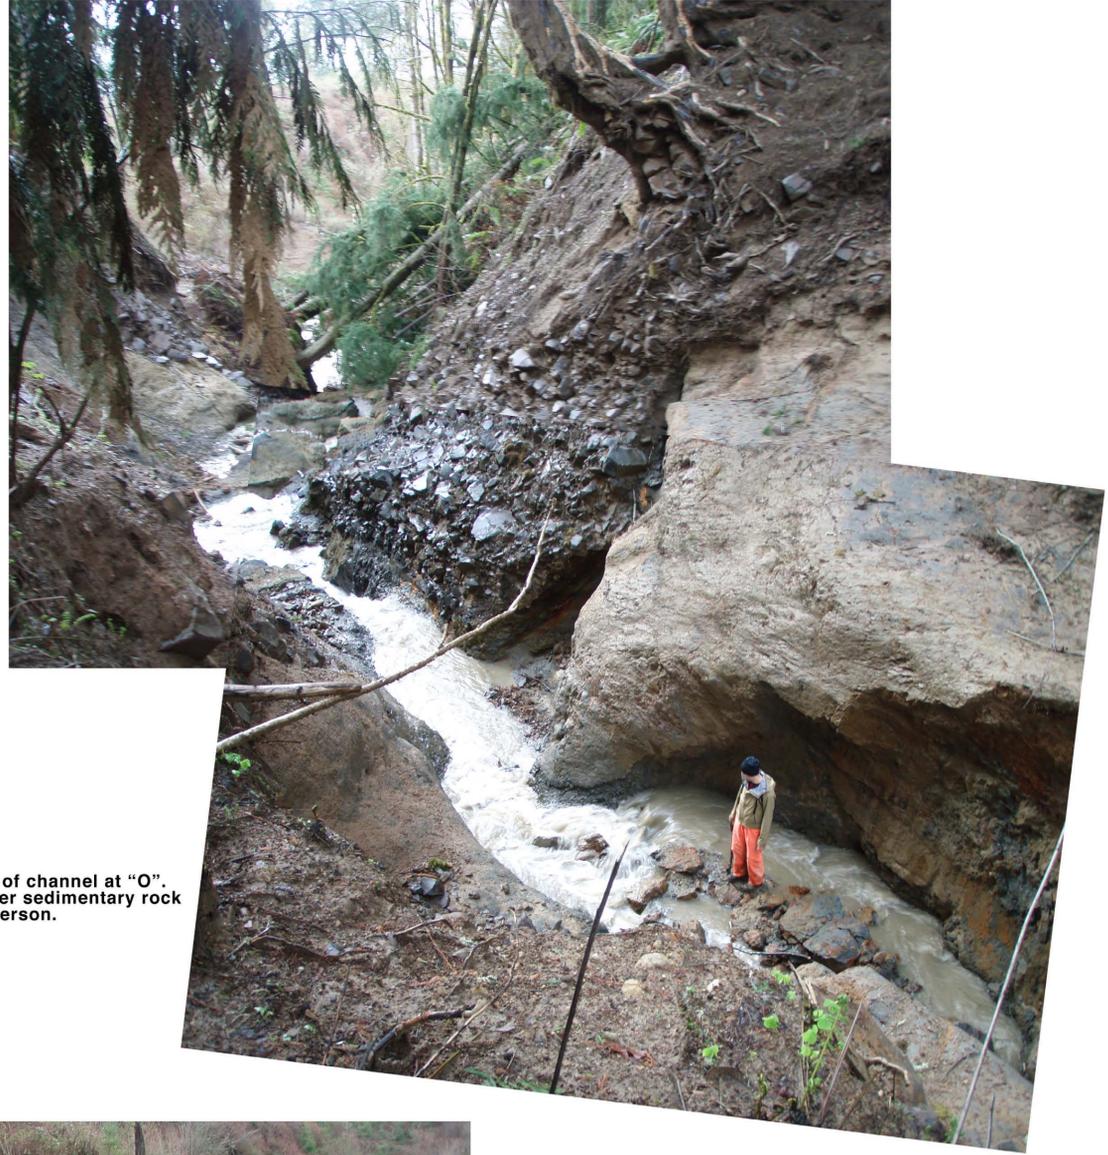
Significant incision of channel at "O". Note grooving of softer sedimentary rock above person.

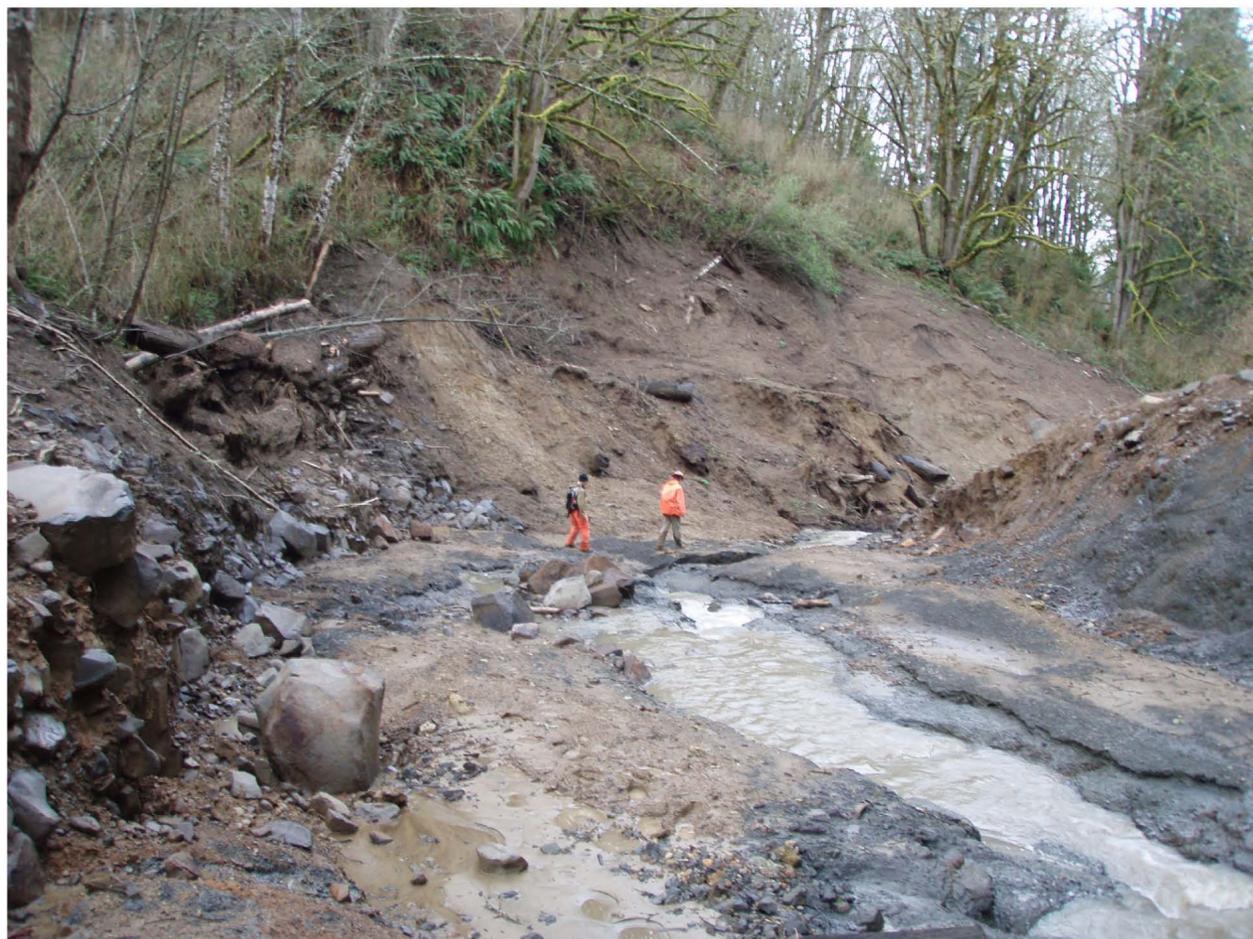
Slight right curve at "Q". Terrace deposits terminate upstream from the curve.

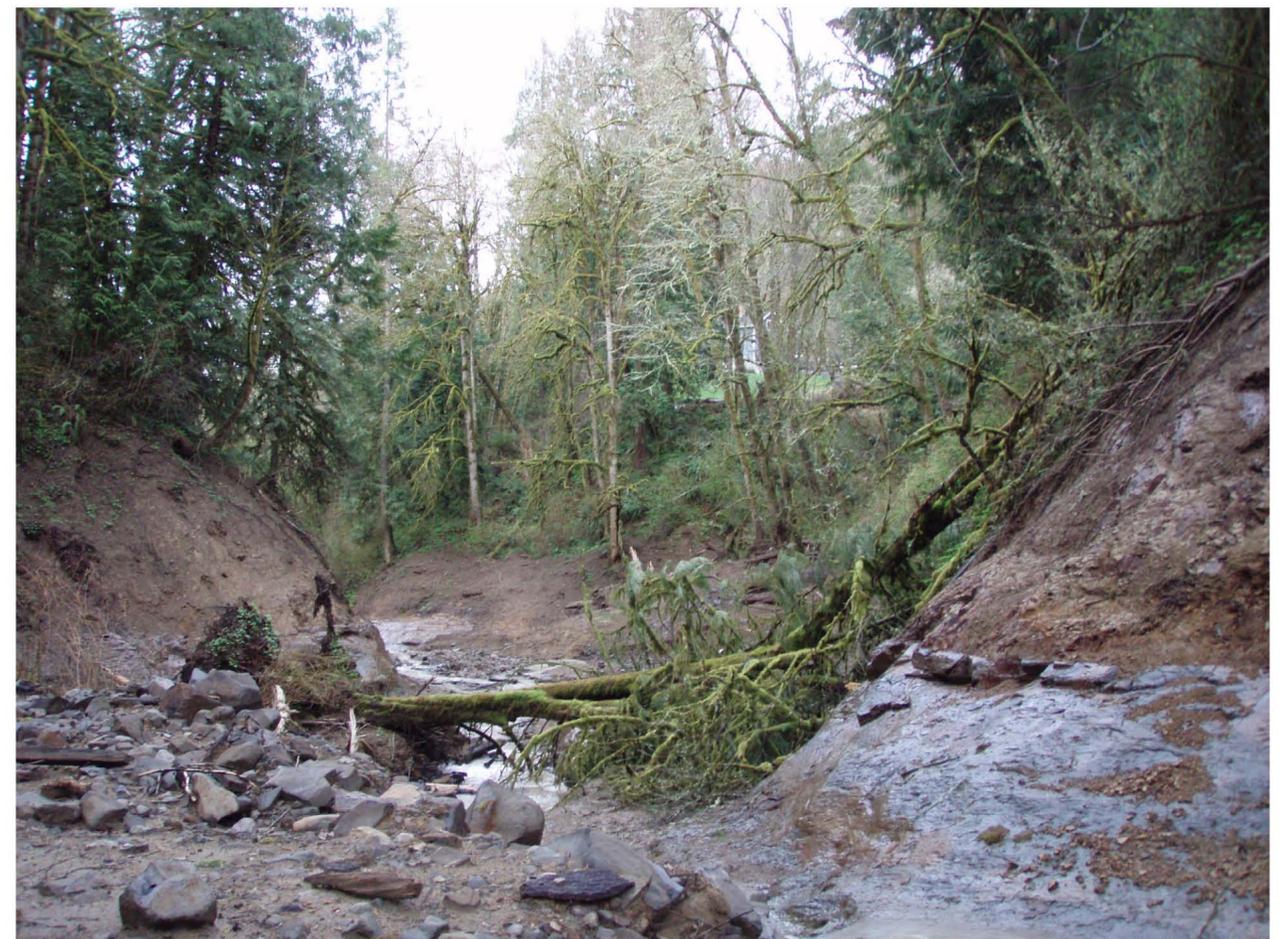
View from "Q" to "R". House is visible in the trees above center of photo.

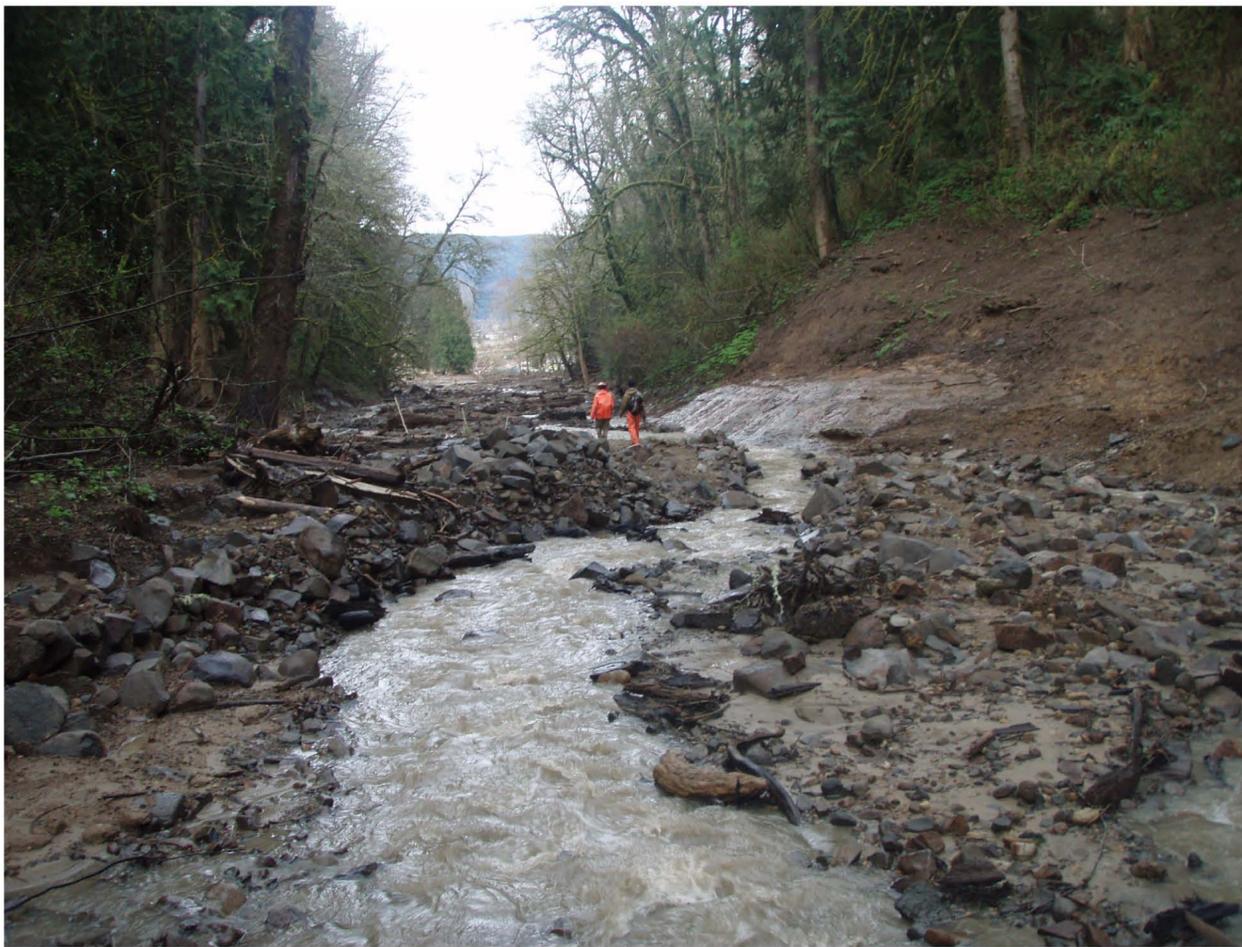
From Reach "R" to Highway 30, both the confinement and gradient of the channel and surrounding area decrease significantly. Confinement is essentially completely lost at Point "U" and the debris flow margins are located along the valley sides extending to the NE and NW from there. Several structures which are located in this triangular area were either inundated or surrounded by debris from the failure.

Channel near "R", view N. Confinement decreasing as valley widens.

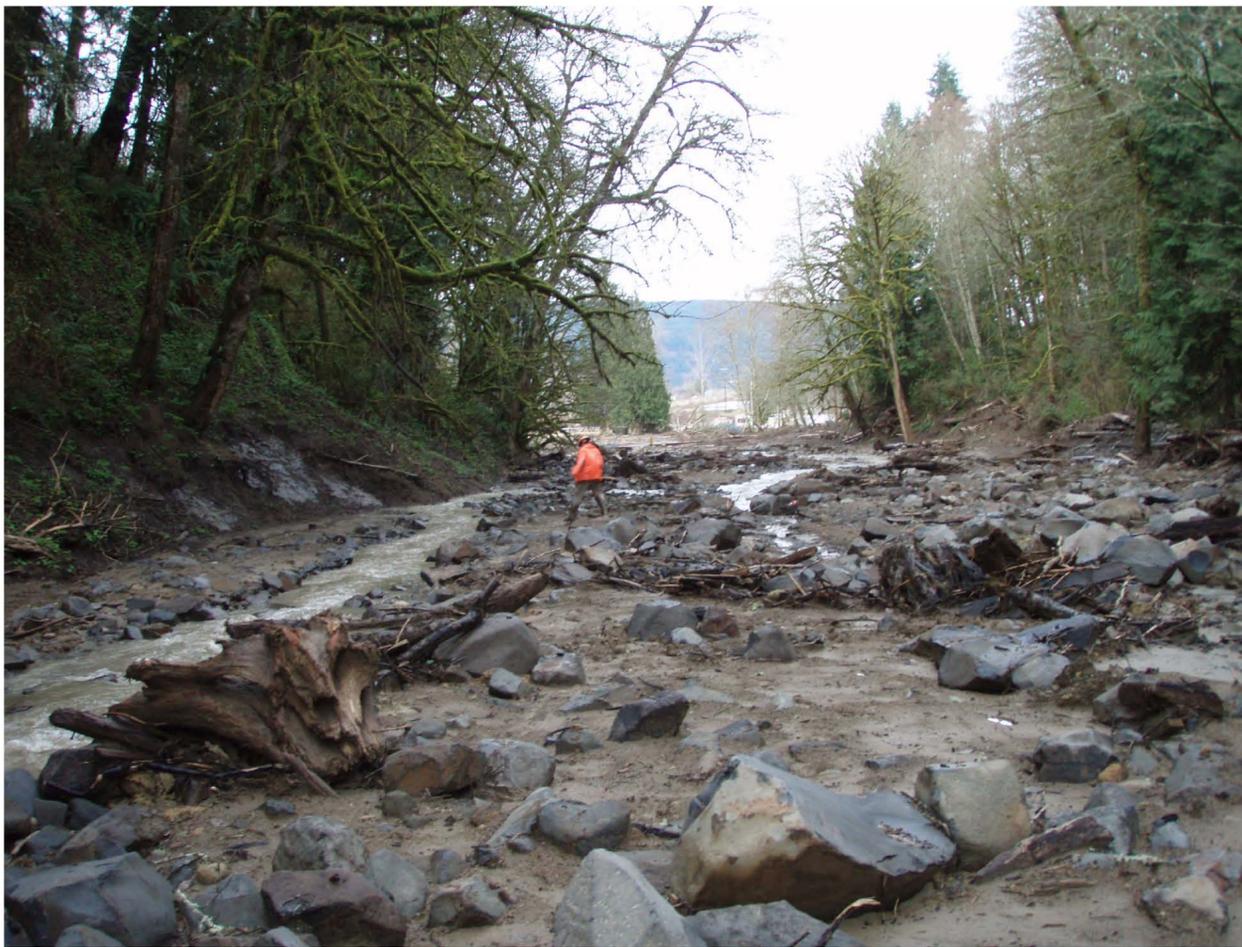
View downstream at approximately "S" on Figure 2.

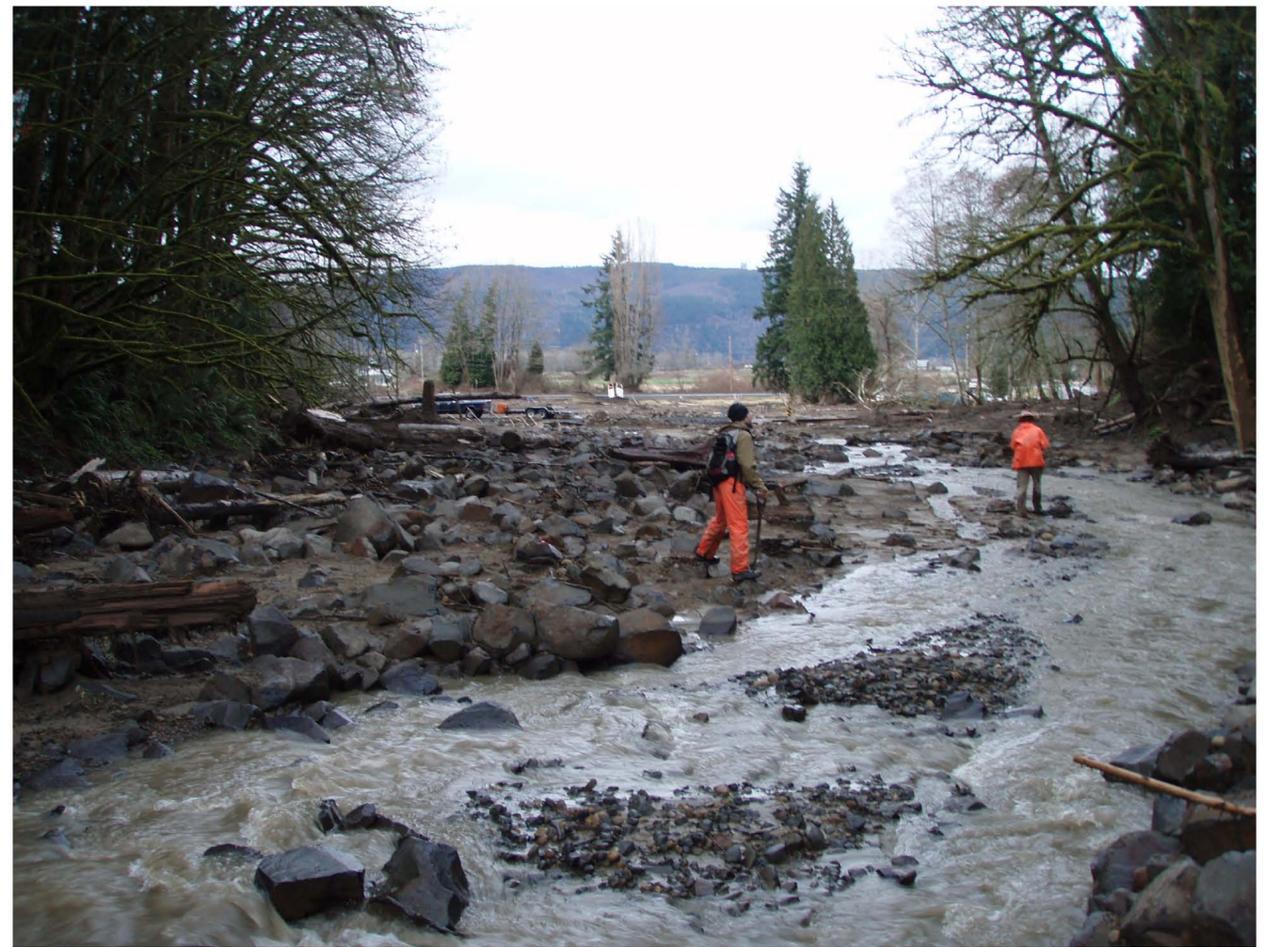
View downstream at approximately "T" on Figure 2.

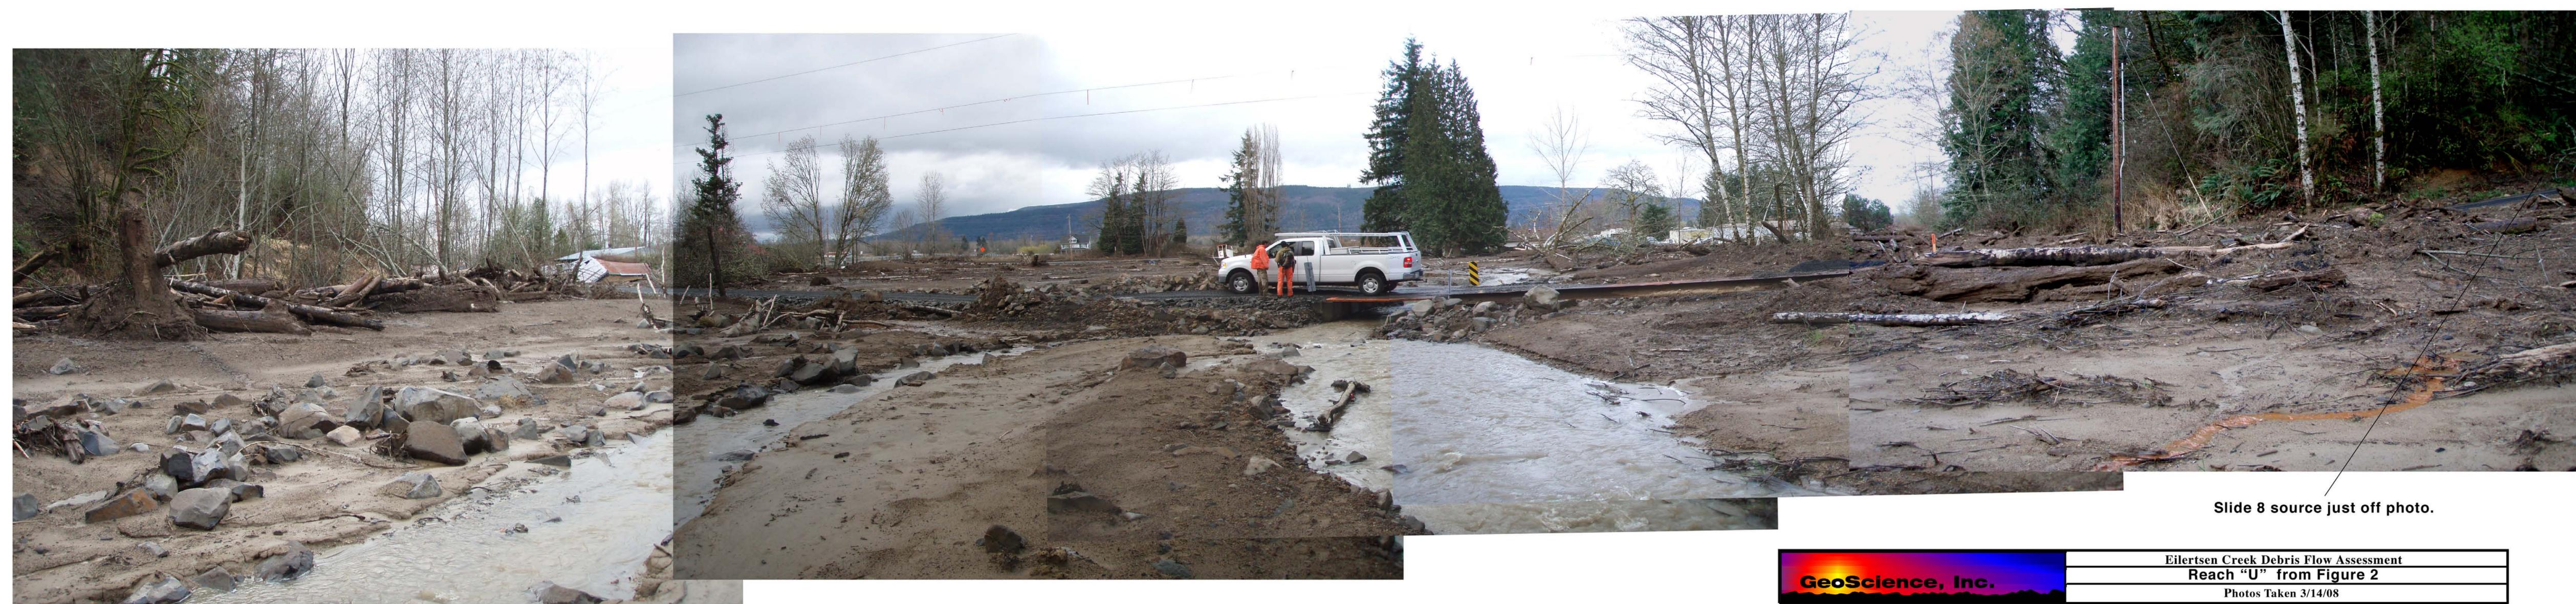
Eilertsen Creek Debris Flow Assessment
Reach "U" from Figure 2
Photos Taken 3/14/08

Slide 8 source just off photo.
