OREGON DEPARTMENT OF TRANSPORTATION

AGGREGATE SITES

DISTRICT 4

JUNE 2002

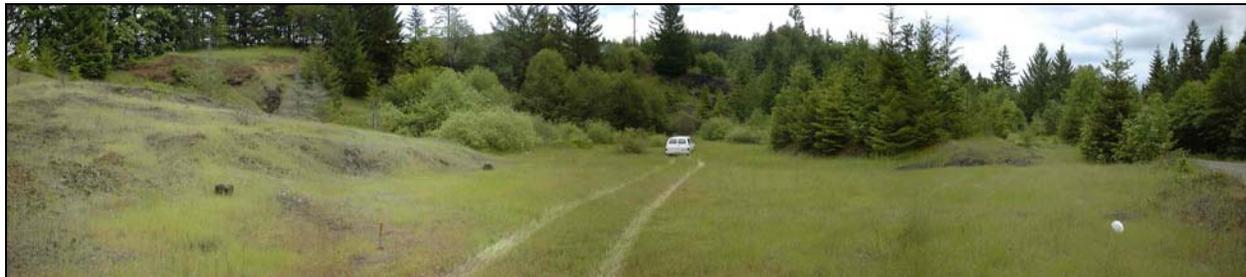
View to the east looking at the pit.

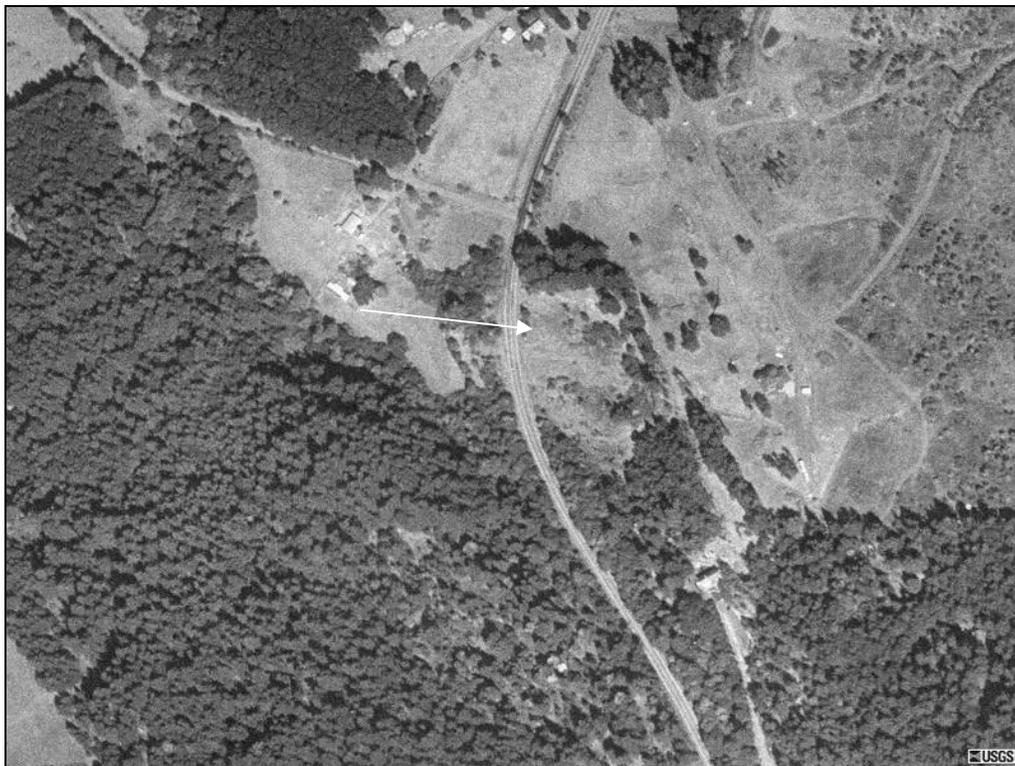
Aerial view of the site along Highway 223.

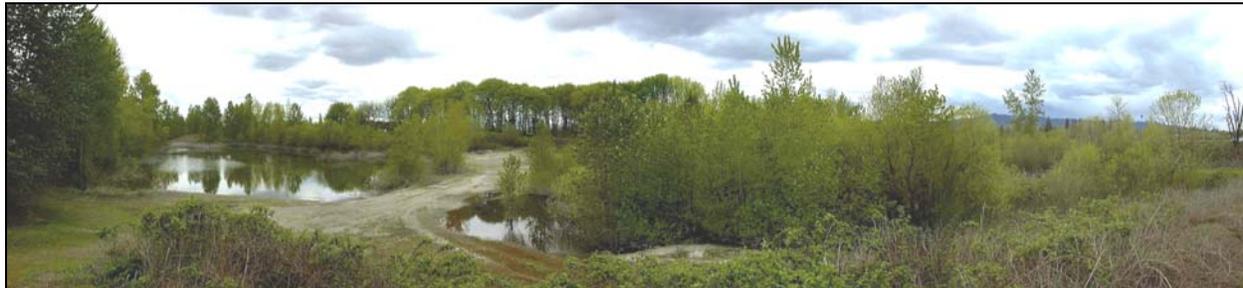
View of the borrow site looking west.

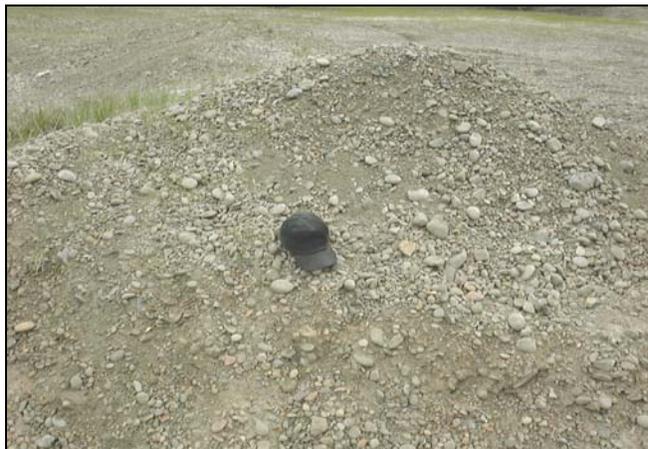
Close-up view of the gravel size.

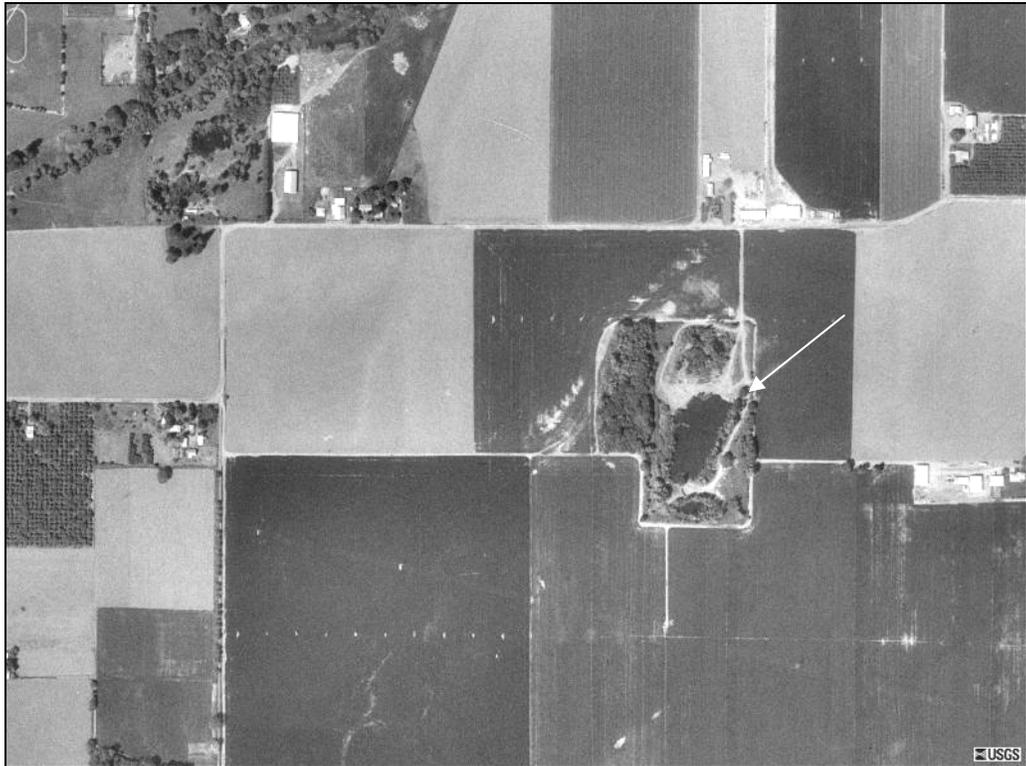
Aerial view of the gravel site and surrounding farm land.

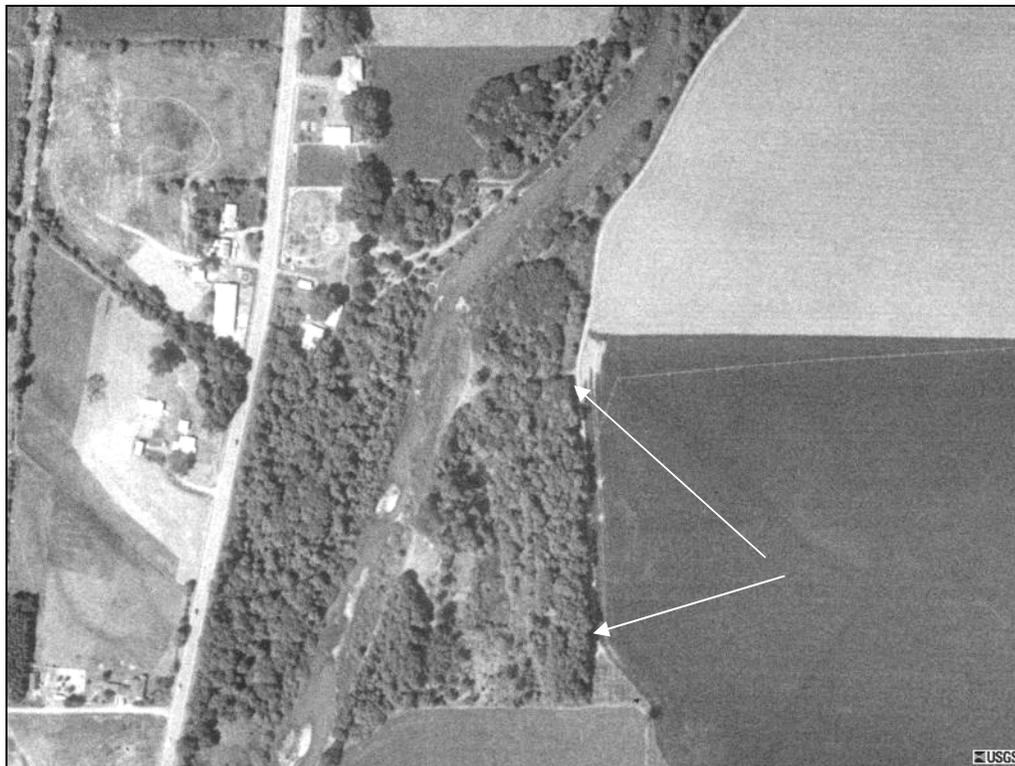
Aerial view (lower center) of the site along the Long Tom River. Upper arrow is the access road.

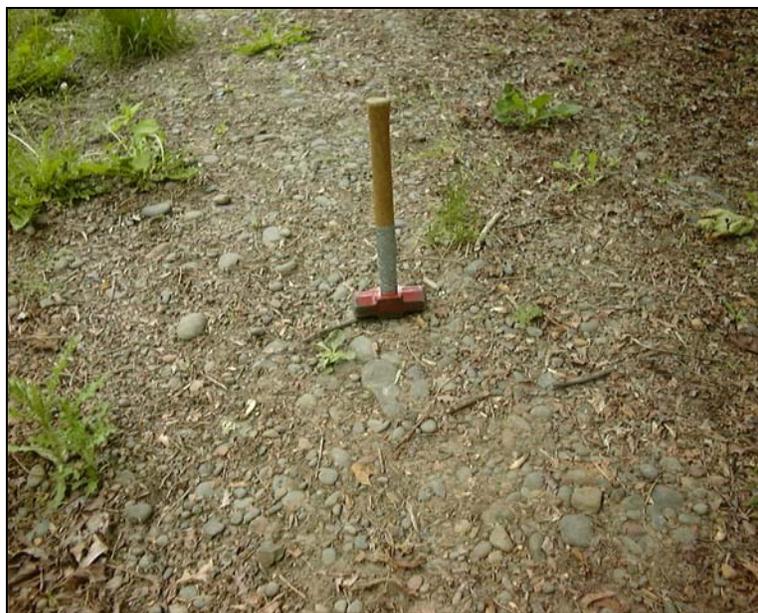
Close-up view of the gravel along the river.

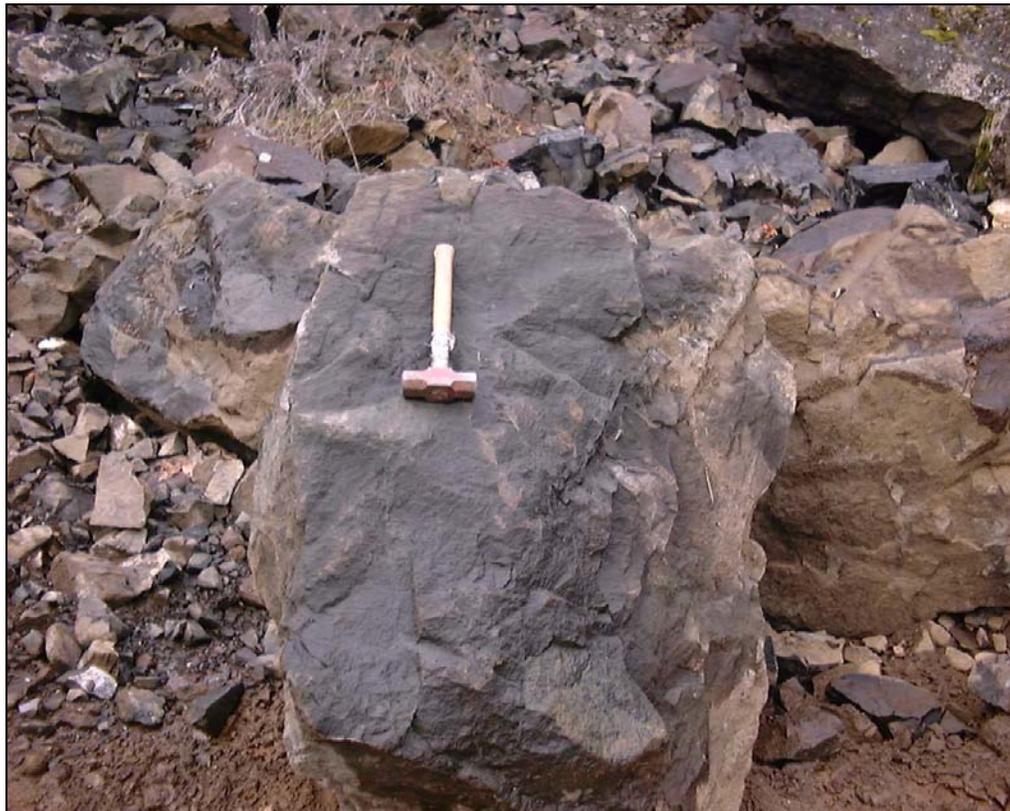
Close-up view of the rip rap in the lower pit.

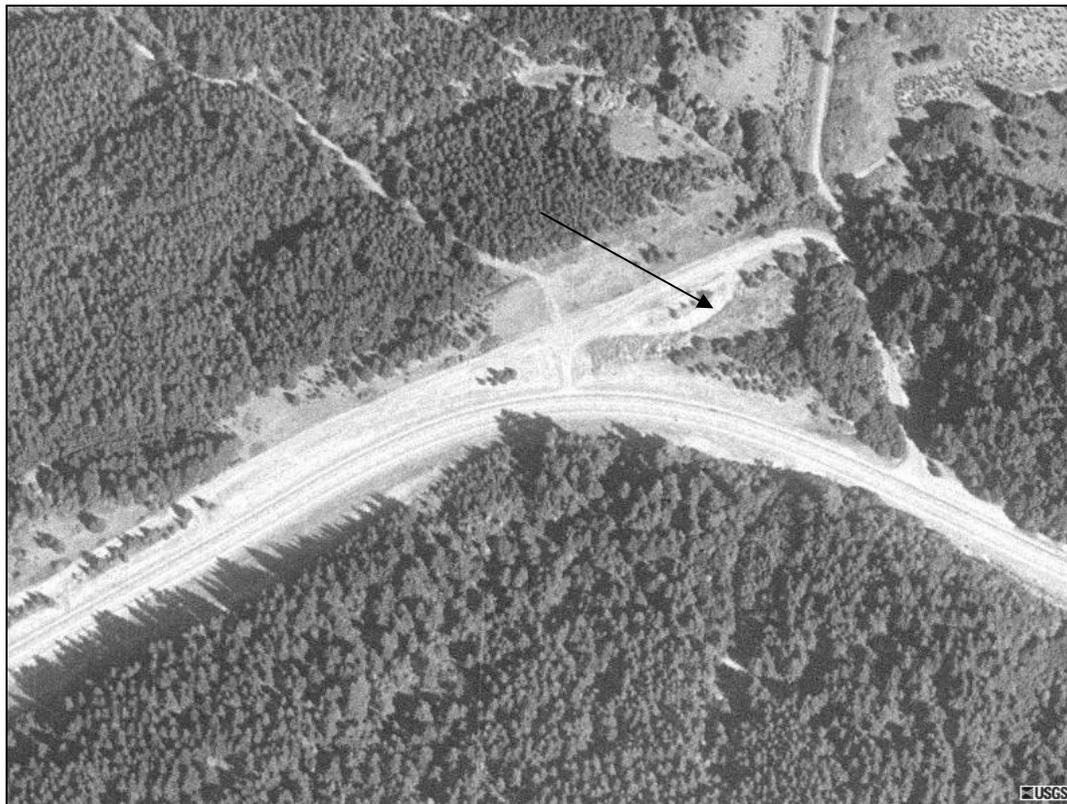
Aerial view of the stockpile site along the old highway alignment.

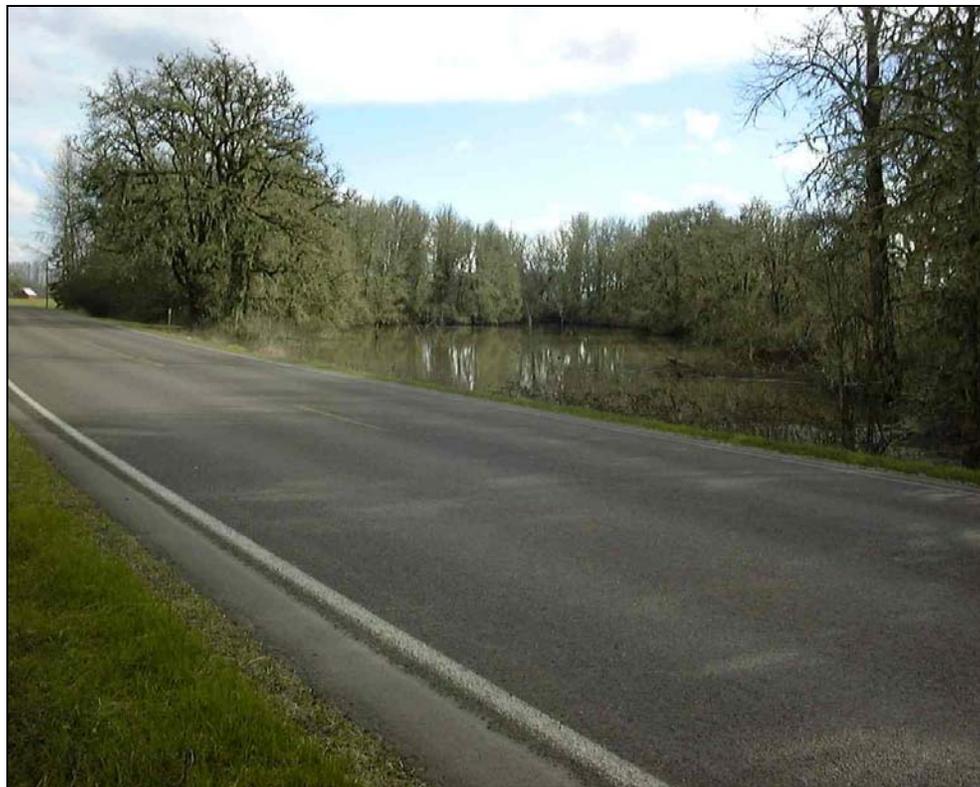
View of the pit looking south along Highway 99.

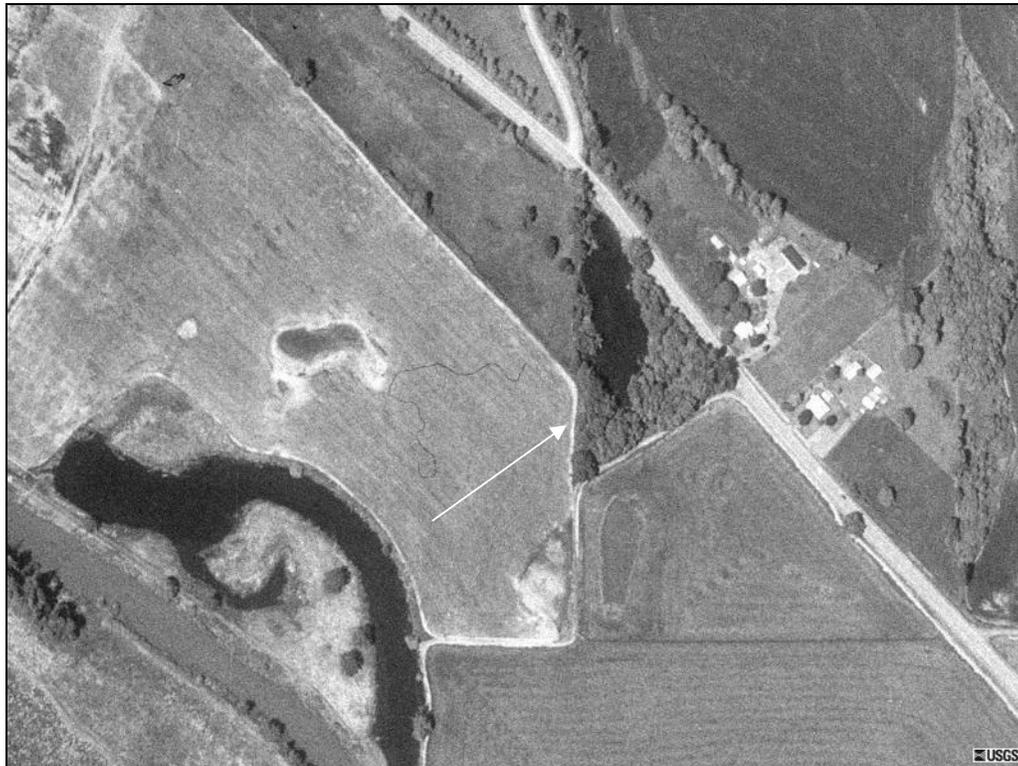
Aerial view of the site in relation to Highway 99.

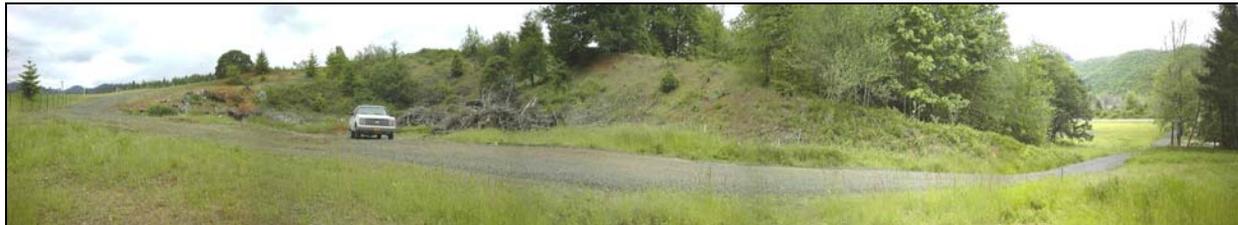
View to the north looking at the pit and the local terrain.

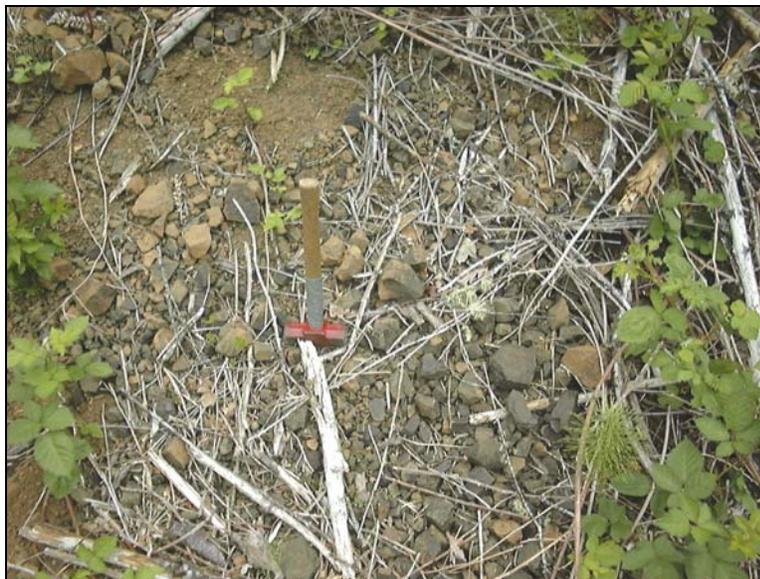
Close-up view of the basalt on the surface.

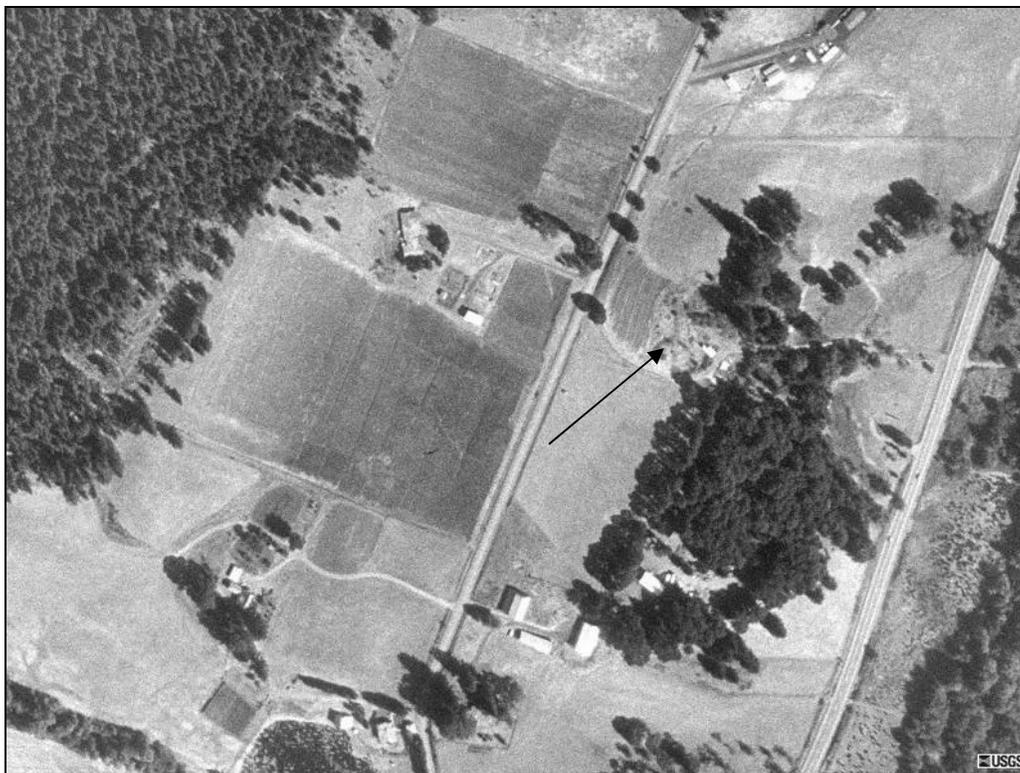
Aerial view of the site along Highway 34.

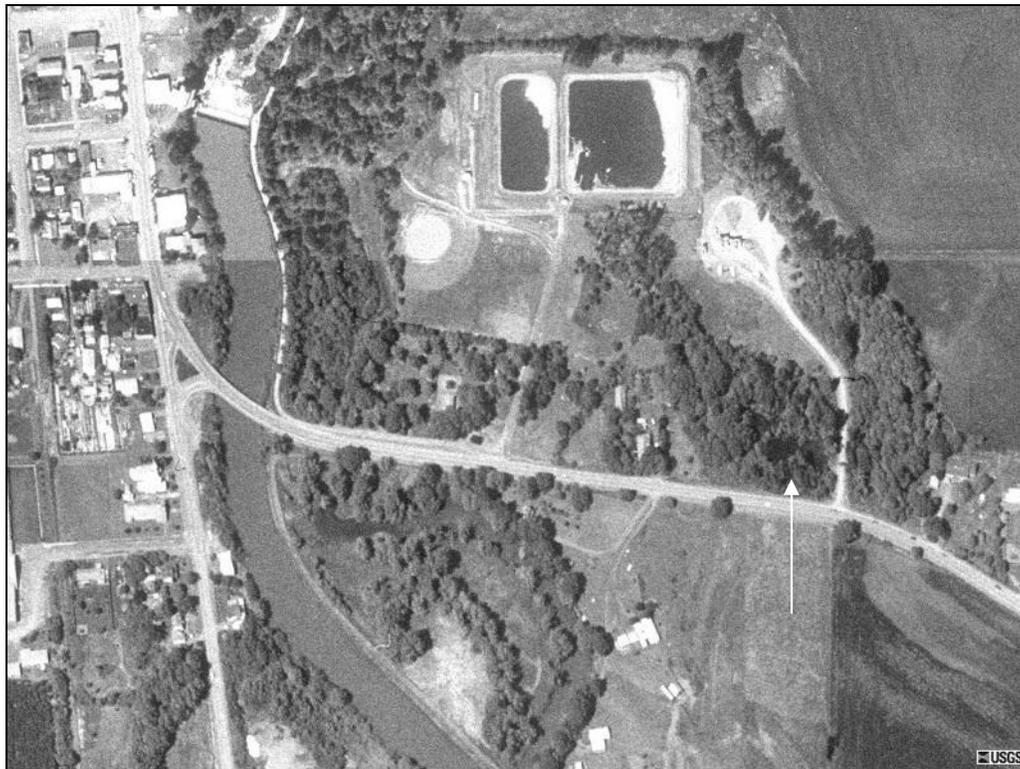
Aerial view of the site and surrounding area along Highway 99.

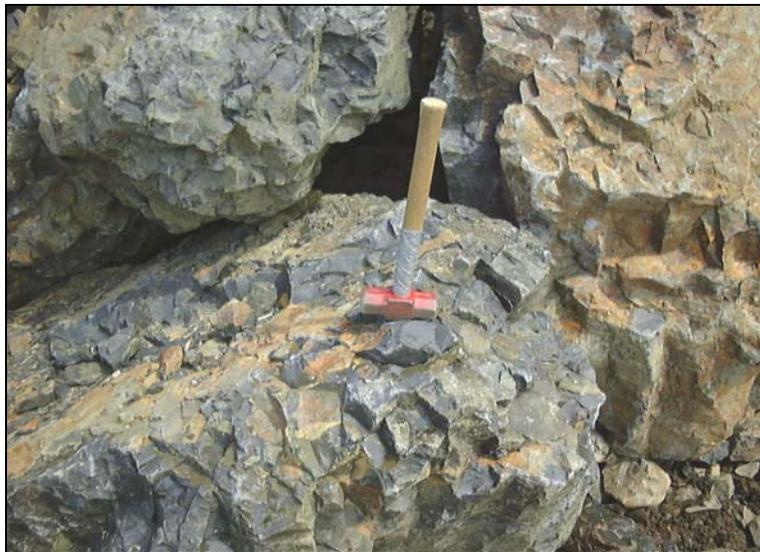
Close-up view of some rip rap in the pit. Notice the jointing pattern.

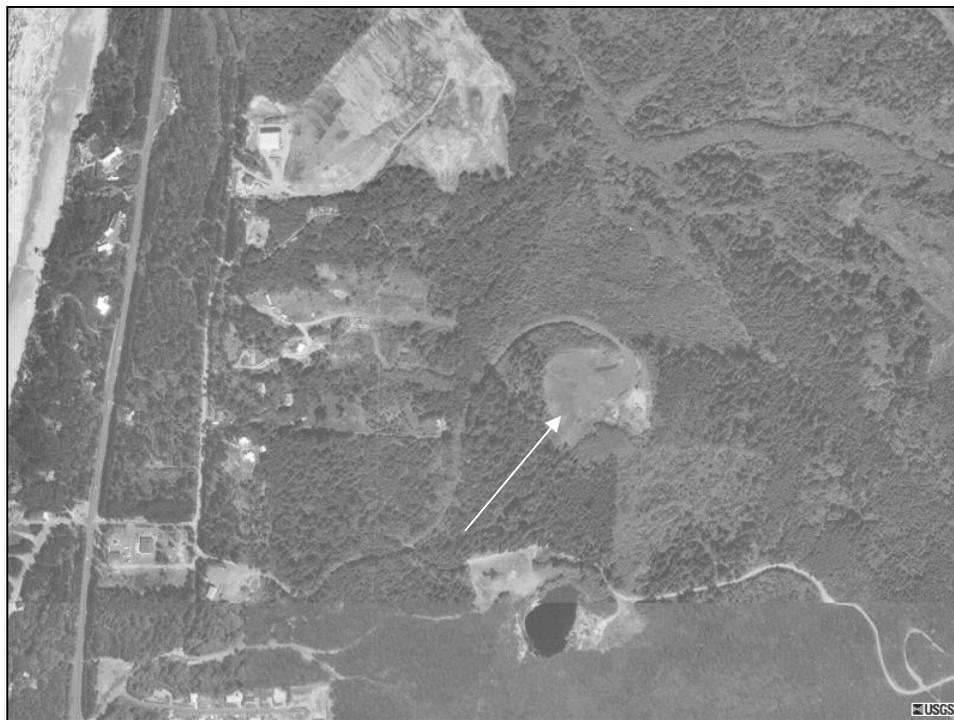
Aerial view of the site, taken in 1994.

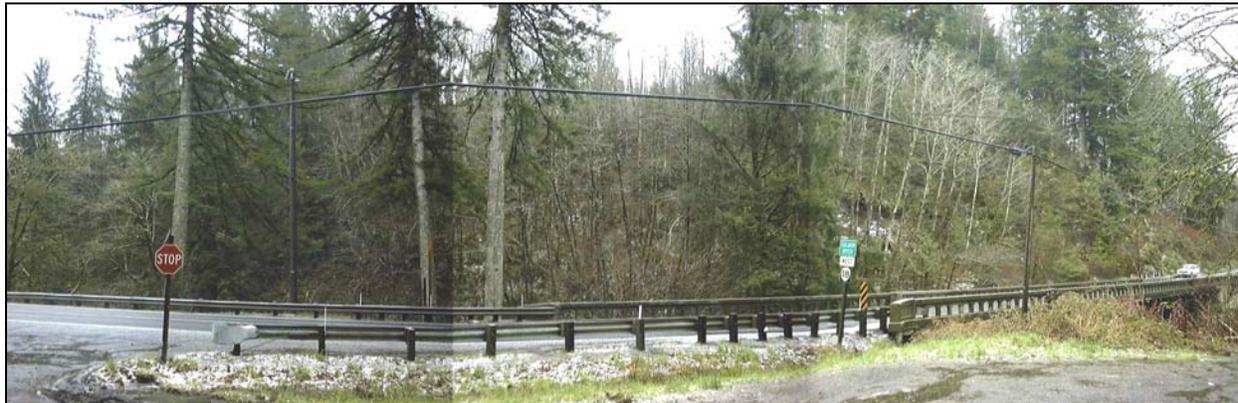
View to the south looking across Highway 18 at the site. The bridge to the right crosses over the Salmon River.

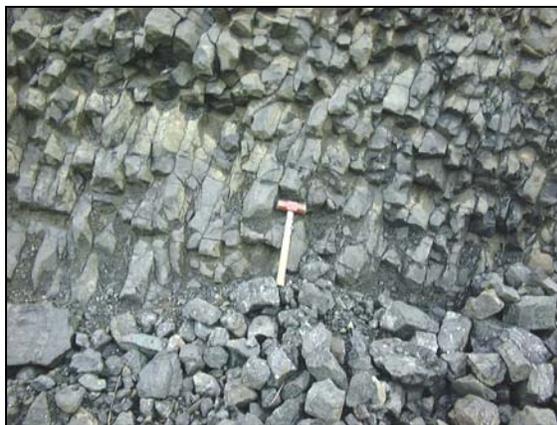
Close-up view of the jointing pattern in the adjacent quarry.

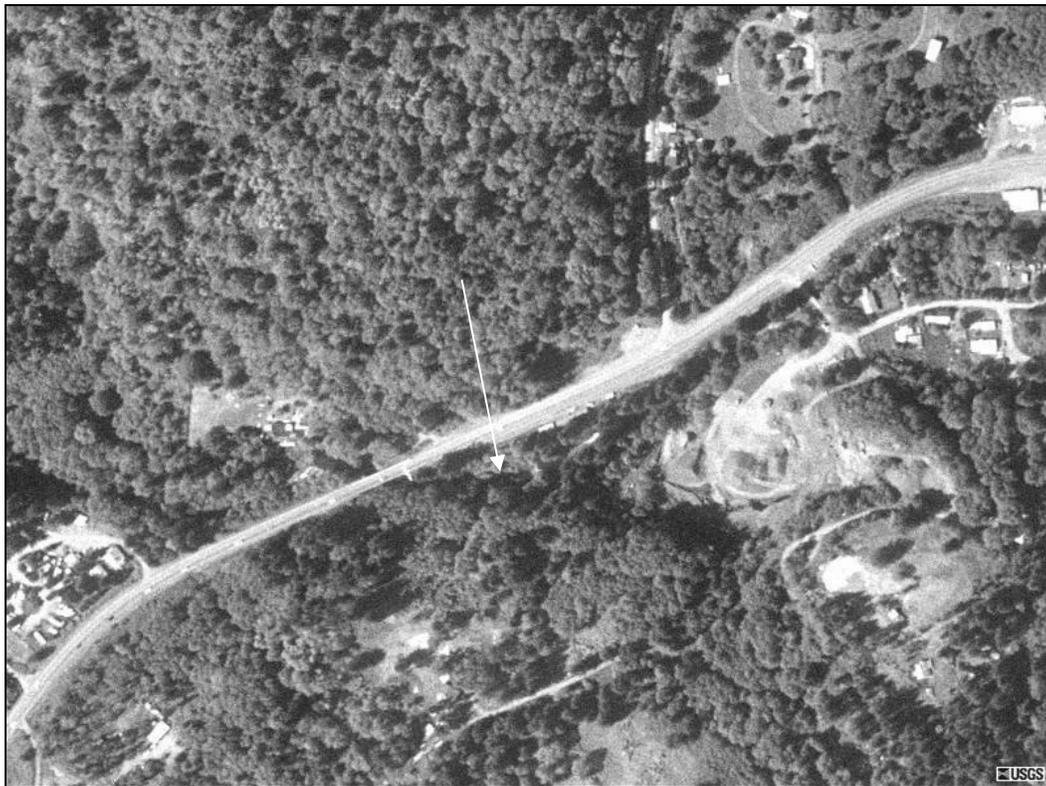
Aerial view of the site (arrow), and the adjacent quarry to the east.

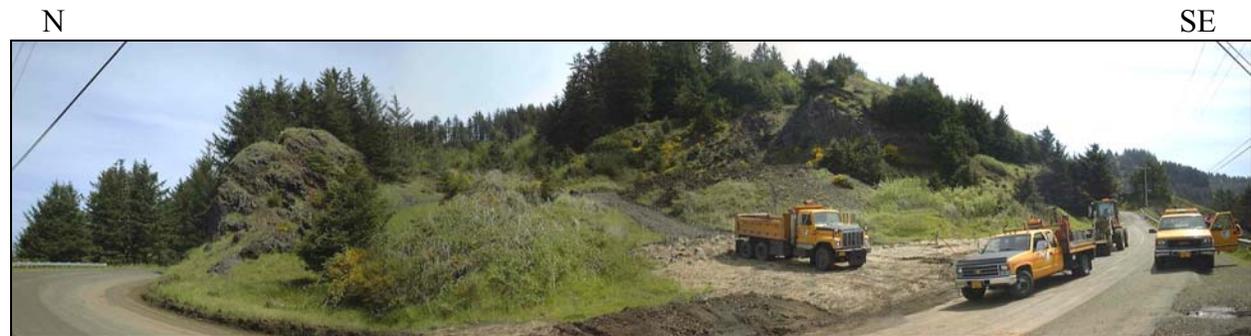
Looking east at the quarry site along the old highway alignment.

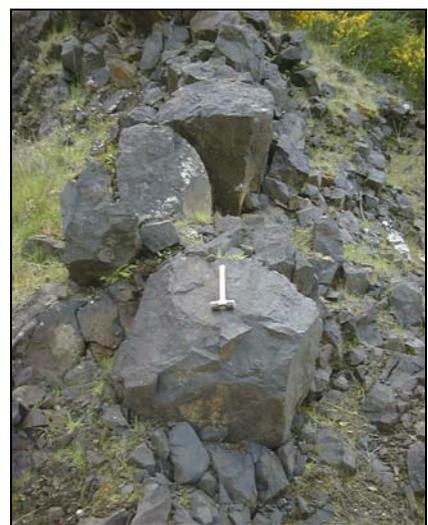
Close-up view of some of the rip rap at the site.

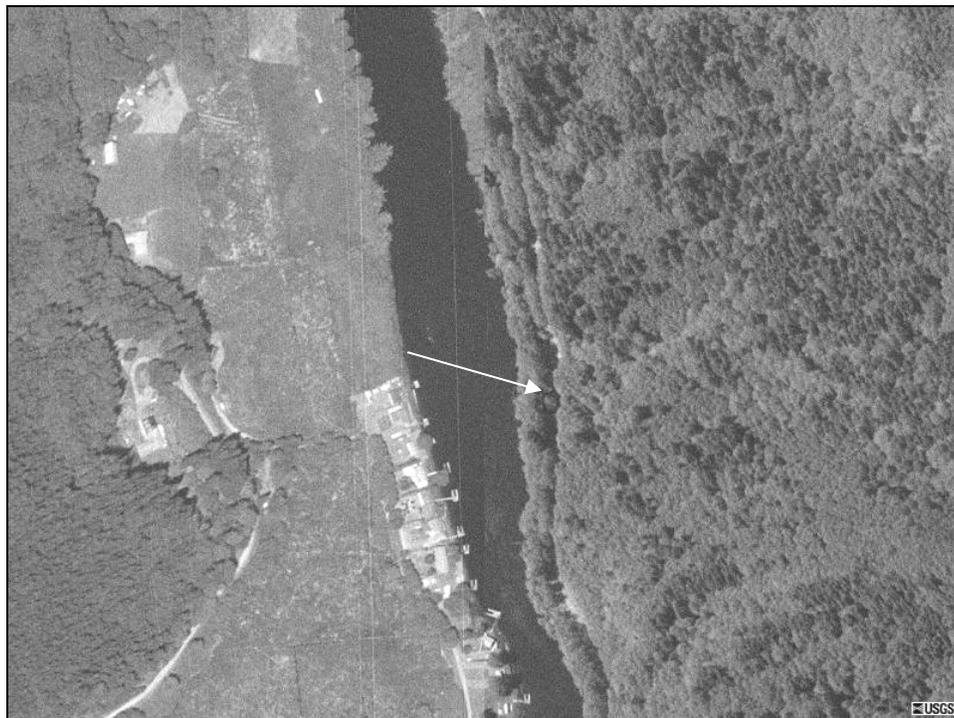
1R-2-458

Aerial view of the property.

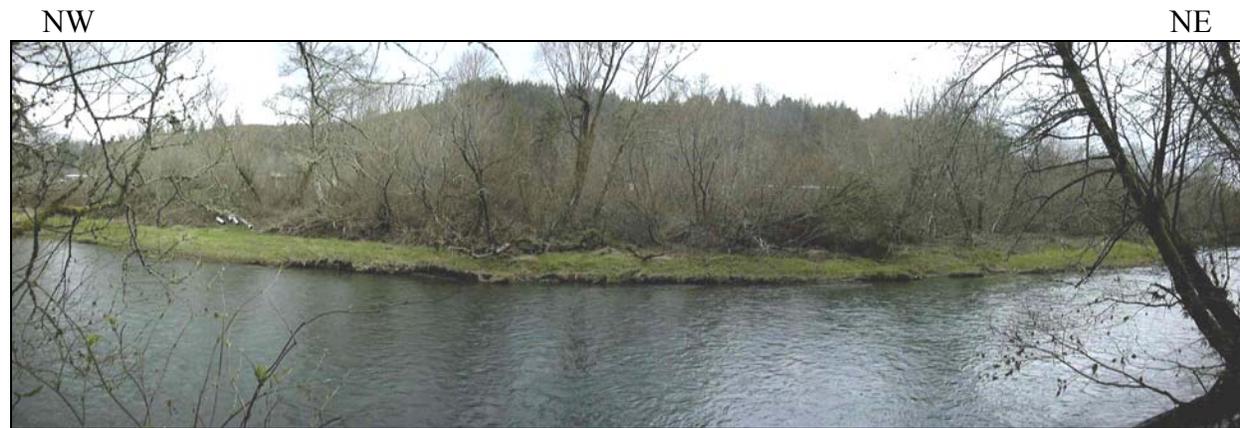
Looking north across the Salmon River at the gravel site.

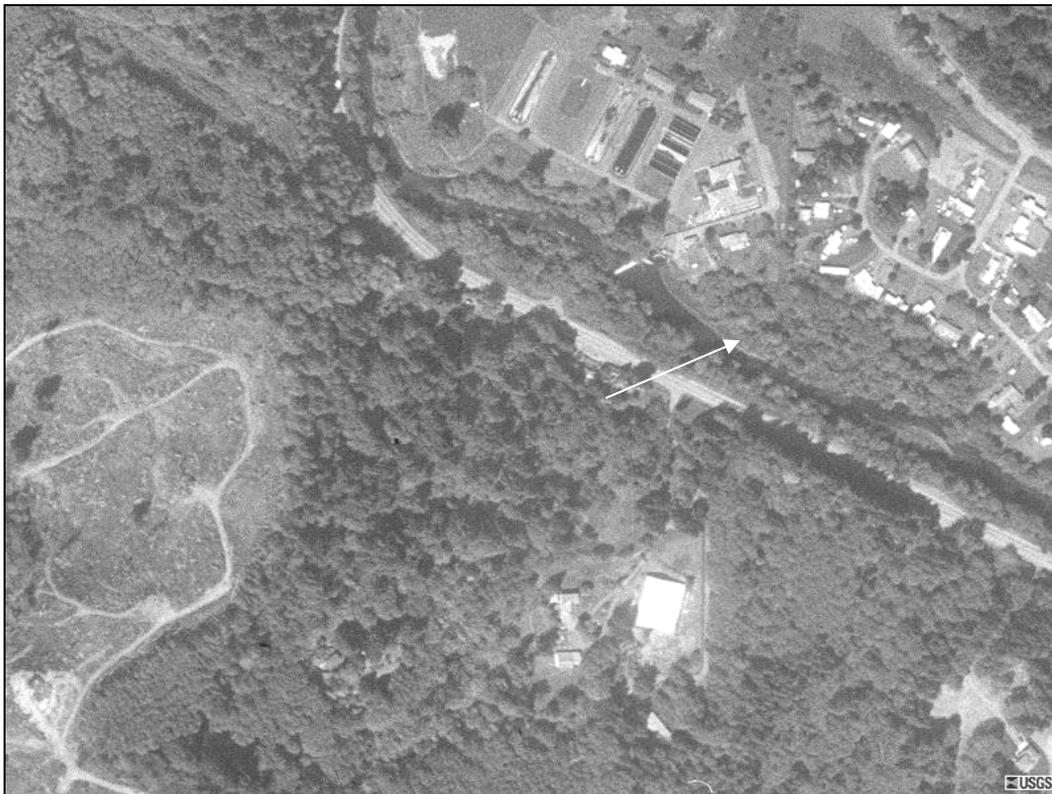
Aerial view of the gravel bar along the Salmon River.

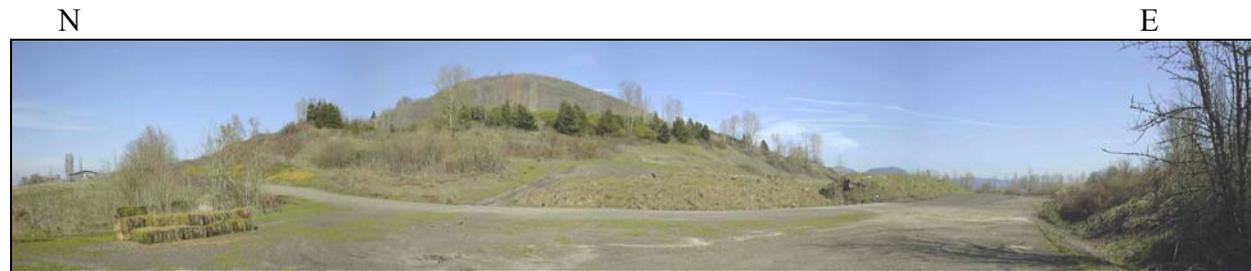
Farming/Gun Club									
Remarks									
This site is located east of I-5 about 200 meters. The basalt at this location is composed of a heterogeneous mix of igneous flows that produce some soft rock. The lithology is variable, depending on which lava flow you analyze. Some of the basalt at this location is a fine-grain good quality rock. Then you get other flows that are brecciated and very vesicular. This type of a site is difficult to work with in picking and choosing the good rock within poor rock. The terrain is moderately steep and past work has over steepened the south facing bench. If we wish to remove rock in the future you would need to develop a site plan for removal from the top down. The south facing bench is too tall (approximately 70 feet) and should be cut to a height of about 30 feet. You would need to drill and blast at this site. There is no screening from Interstate 5 unless you work on the eastside of the Butte. There is ample room to work. This site has a locked gate, and is used predominately for a waste site now. The northern 26 or so acres is leased to the Albany Gun Club and should pose no problems. The southern 40 or so acres are wetland and could be used for mitigation. The latitude and longitude for the access point is 44 27 24.94306, 123 03 34.37543. There has been approximately 115,000 cubic yards removed to date.

Looking northeast at Saddle Butte, the pit is just beyond the tree line.

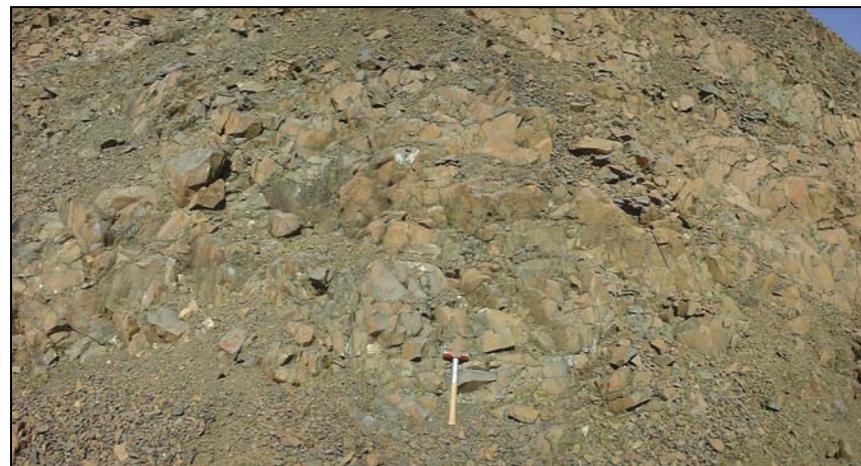
Close-up view of the fracture pattern in the pit.

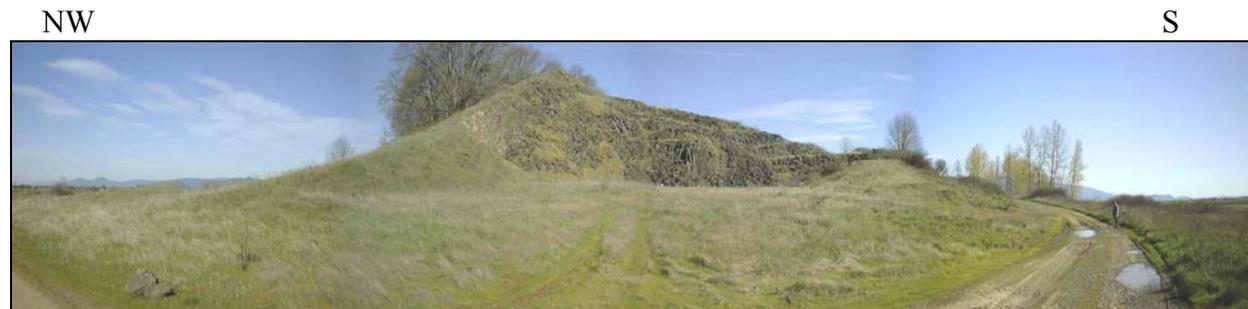
Looking east at the pit area at Bond Butte.

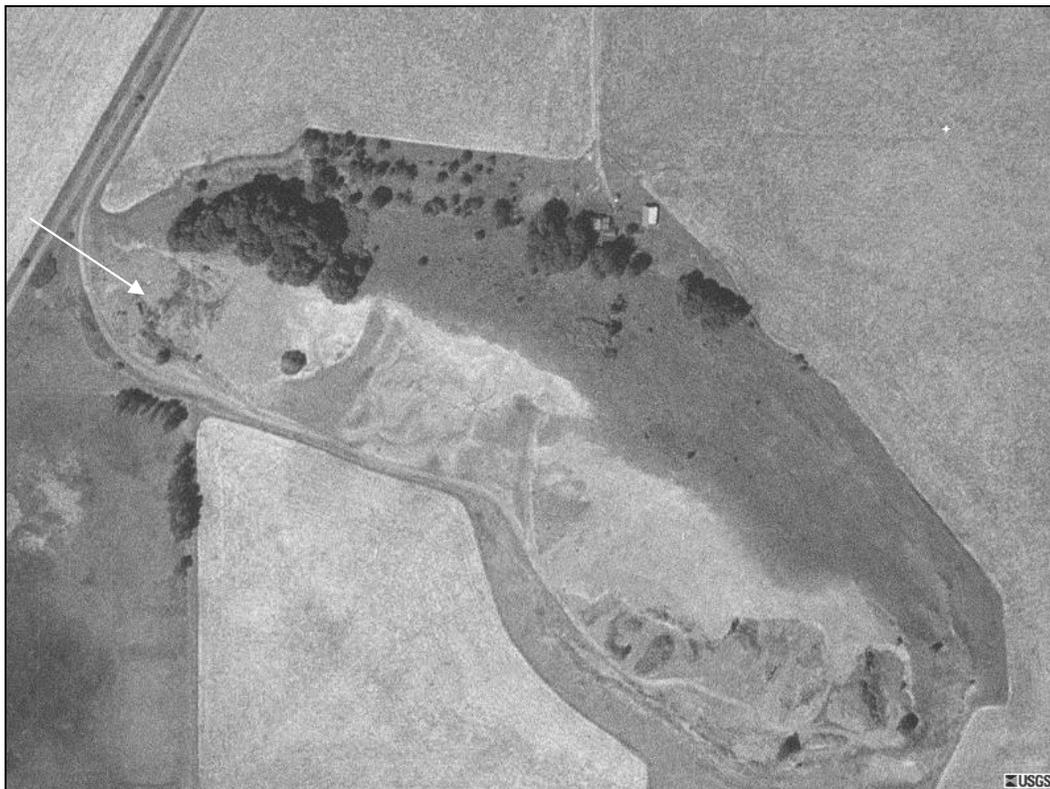
Aerial view of Bond Butte, arrow points to the pit on the west side.

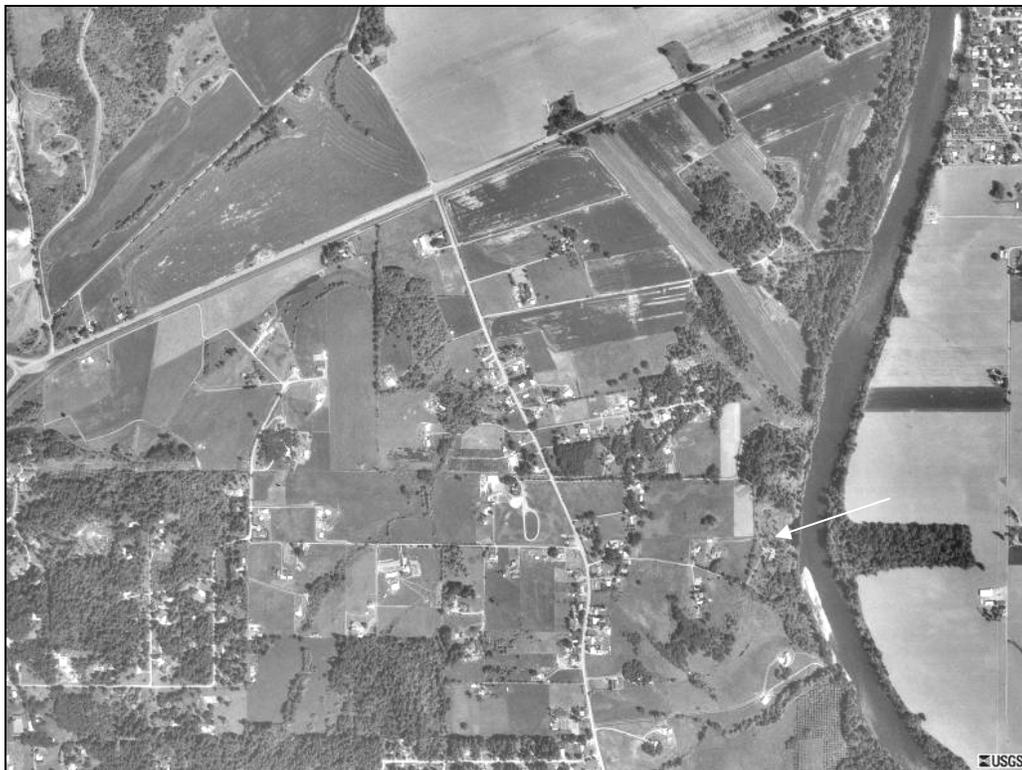
Aerial view of the quarry site along the Santiam River.

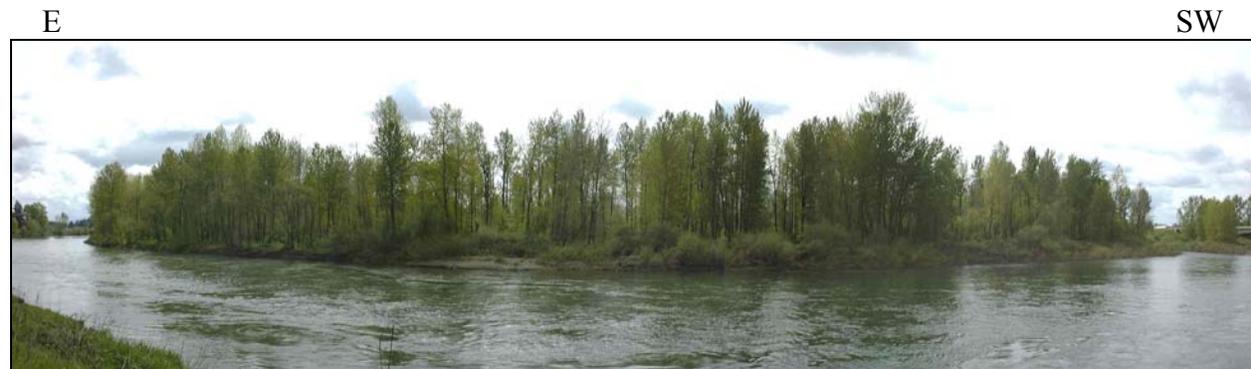
County	Site Name				Dist	Hwy	Mile Pt	TWP	RGE	Sect
Linn	Santiam River Gravel Pit				04	0001	241	10S	03.0W	03
File ID		Source #	Date Visited	Map #		Type of Site				
24539, 24540		22-029-2	4/20/1999	1R-2-1590		Gravel				
Latitude	Longitude	Elev. (m)	Acreage	Pit Size	DOGAMI Permit #					
44 44'03.59000"	123 02'33.73000"	61	67	NA						
Comments										
Lat. and Long. acquired using Terrain Navigator Software										
Rock Type	Unit	Color	Weathering			Jointing				
Volcanic Gravel	NA	NA	NA			NA				
Quality			Hardness	lbs./cu ft.	Reserve (cy)	Reserve (Tons)				
NA			NA	120	300,000	486,000				
Potentially Significant Site	Why			Open/Closed	Direction					
No	No access, in the river, land use issues.			Closed	In and adjacent to the Santiam River					
Adjacent Land Use										
Farming										
Remarks										
This site is located in the Santiam River. It is south of the north bound I-5 rest area. The easement was from I-5 and is now landlocked. If we ever want to develop this property for rock production we will need a new way to get to the ground. The property is on the inside radius of the river. In the winter time the property becomes an island and access would be restricted. This site has no visible disturbance and is over grown in vegetation. There are some ownership questions with the Division of State Lands. They think that they own the property in question and have leased out part of the ground for 10 years. This site would be good for wetland mitigation.

Looking south across the Santiam River at the gravel site.

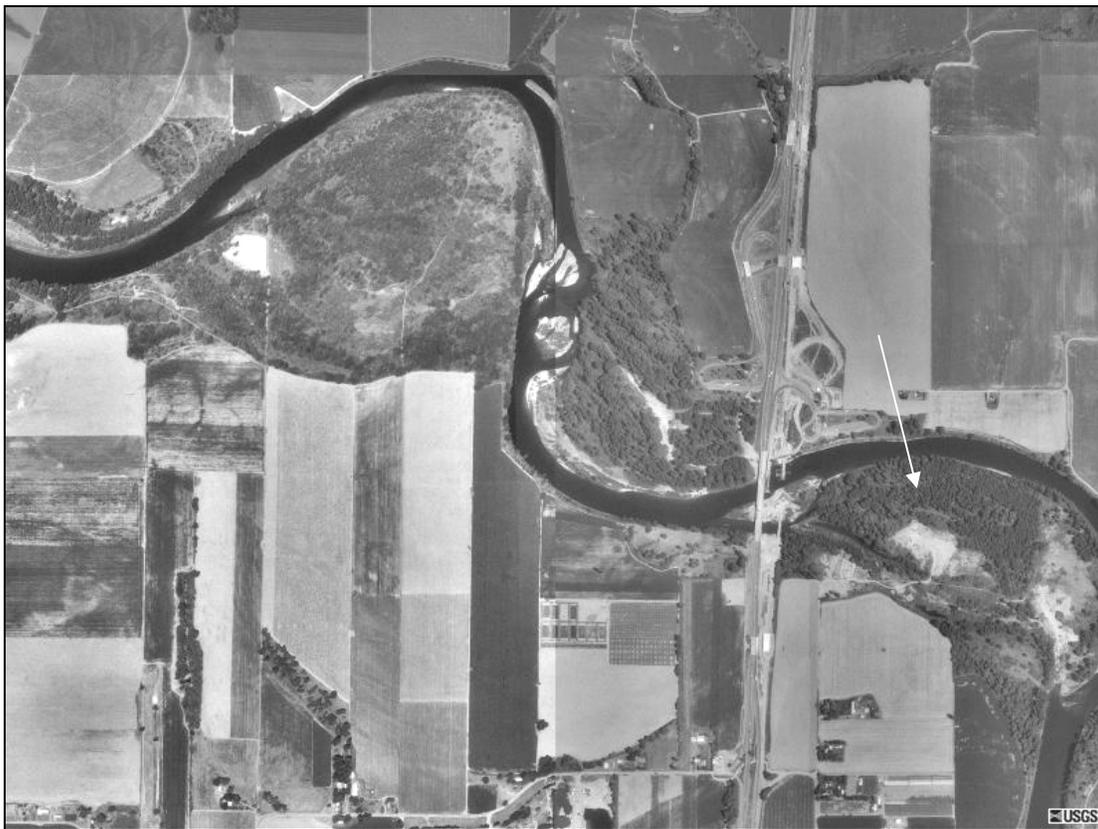
Aerial view of the gravel bar along the Santiam River.

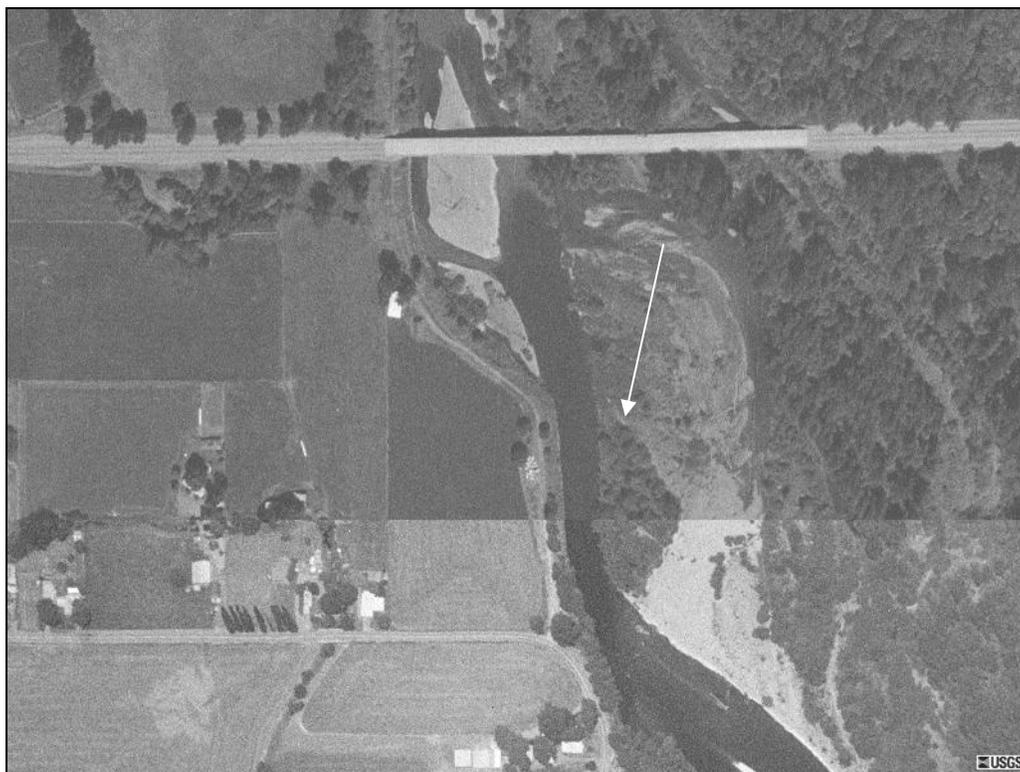
Aerial view of the site and surrounding area.
Sanderson Bridge and Highway 226 are in the upper portion of the image.

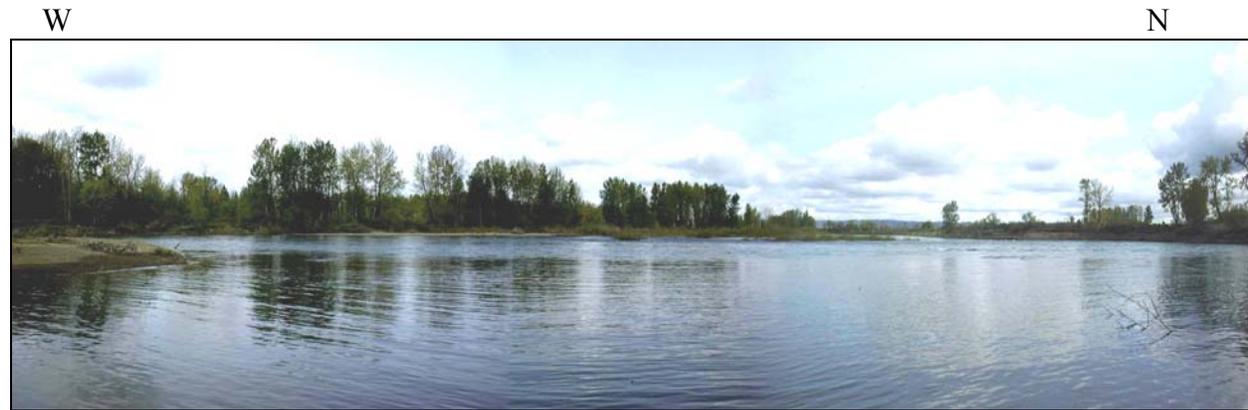
Farming										
Remarks										
This site is located west of I-5 about 300 meters. The gravel is well-rounded cobble size and less with pockets of sand. There could be up to 40% sand/organics at this location. The property is on the inside of the river radius. You could scrap 3 to 6 feet of material from this site. There is some hummocky terrain within the site due to the flooding of the river during the winter of 1998. This property is in both Marion and Linn Counties. The access to the property in Linn County is from the county road just south of the river. I saw no evidence of the easement through the fields. The access to the site in Marion County is adjacent to the southbound I-5 rest area. This is a large amount of acreage within this area for potential wetland mitigation.										
202B	203B	211	206 Fine	206 Coarse	208 F	208 F Ht.	208 C	208 C Ht.		
Material Use

Looking northwest at the gravel bar along the Santiam River.

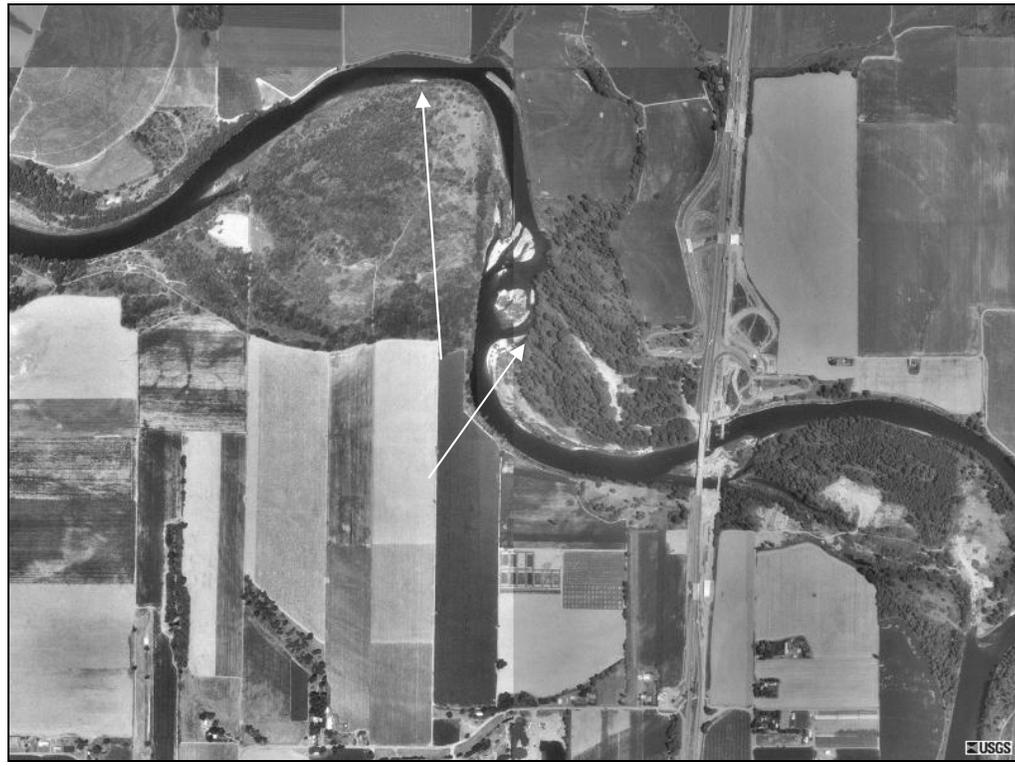
Aerial view of the gravel bars along the Santiam River.
Interstate 5 and the rest areas are in the right center of the image.
