OREGON DEPARTMENT OF TRANSPORTATION

AGGREGATE SITES

DISTRICT 4

JUNE 2002

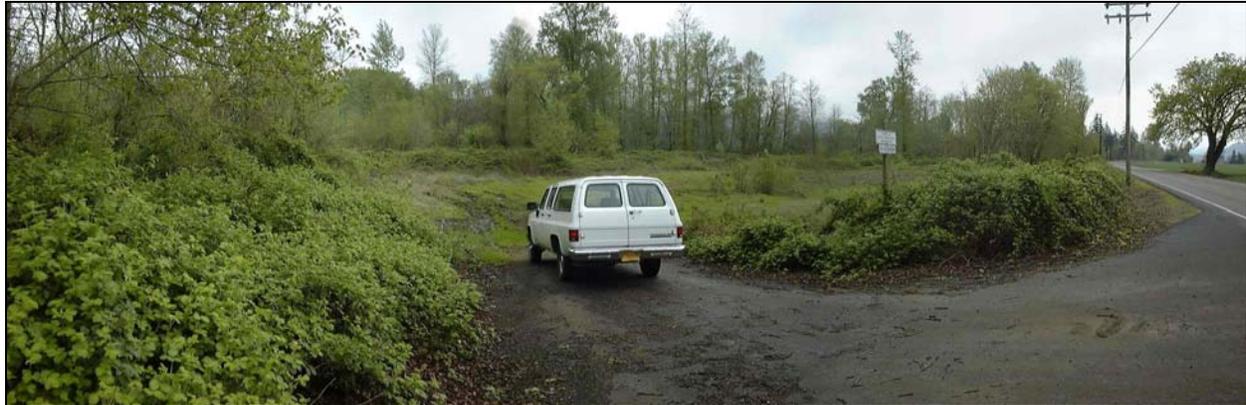
County	Site Name			Dist	Hwy	Mile Pt	TWP	RGE	Sect
Linn	Sayer Pit			04	0212	0	14S	02.0W	03
File ID		Source #	Date Visited	Map #			Type of Site		
12524		22-037-2	1/22/1999	1R-2-1582			Gravel		
Latitude	Longitude	Elev. (m)	Acreage	Pit Size		DOGAMI Permit #			
44 22'37.12876"	122 55'24.39977"	117.653	9.05	NA					
Comments									
GPS acquired at the access point to the site.									
Rock Type	Unit	Color		Weathering			Jointing		
Volcanic Gravel	NA	NA		NA			NA		
Quality			Hardness	lbs./cu ft.	Reserve (cy)	Reserve (Tons)			
Good			NA	120	65,000	105,300			
Potentially Significant Site	Why			Open/Closed	Direction				
No	Limited amount of rock. Site used as a waste/bone yard now.			Closed	Calapooia River is adjacent to the north.				
Adjacent Land Use									
Farming									
Remarks									
This site is about 4 miles east of Brownsville. The pit floor of the site is approximately 8 feet below Highway 228. There is no gravel exposed at the surface. The site has been used as a minor waste site. The property is all over grown with blackberries and I was not able to evaluate all of the ground. There is no screening from the highway. The property is not fenced nor is there a gate to restrict access. The site has plenty of room to work. Possible wetland/salmon recovery site. This is the only site along this stretch of the highway.

Looking east at the gravel site along the Calapooia River.

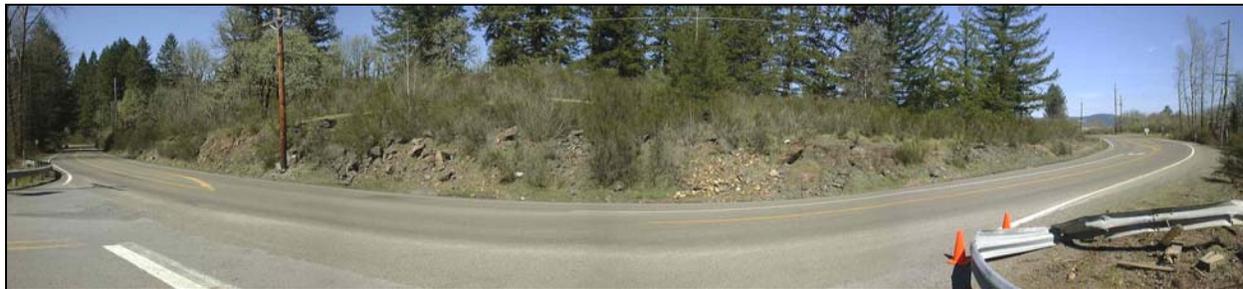
View to the northwest of the site along Highway 226.

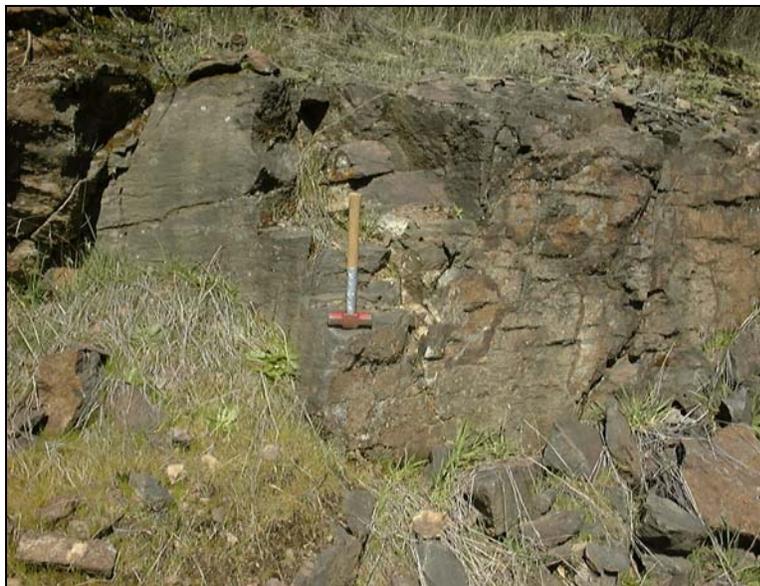
Close-up view of the fracture pattern of the basalt along the highway.

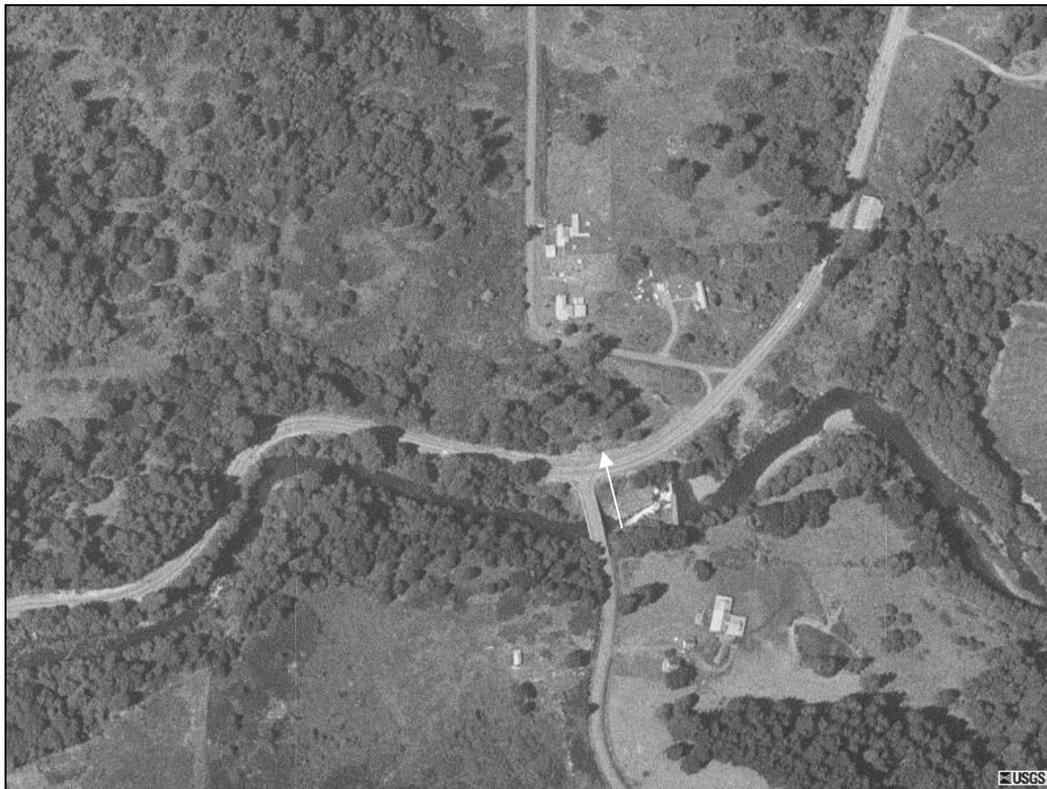
Aerial view of the site in relation to the surrounding property.

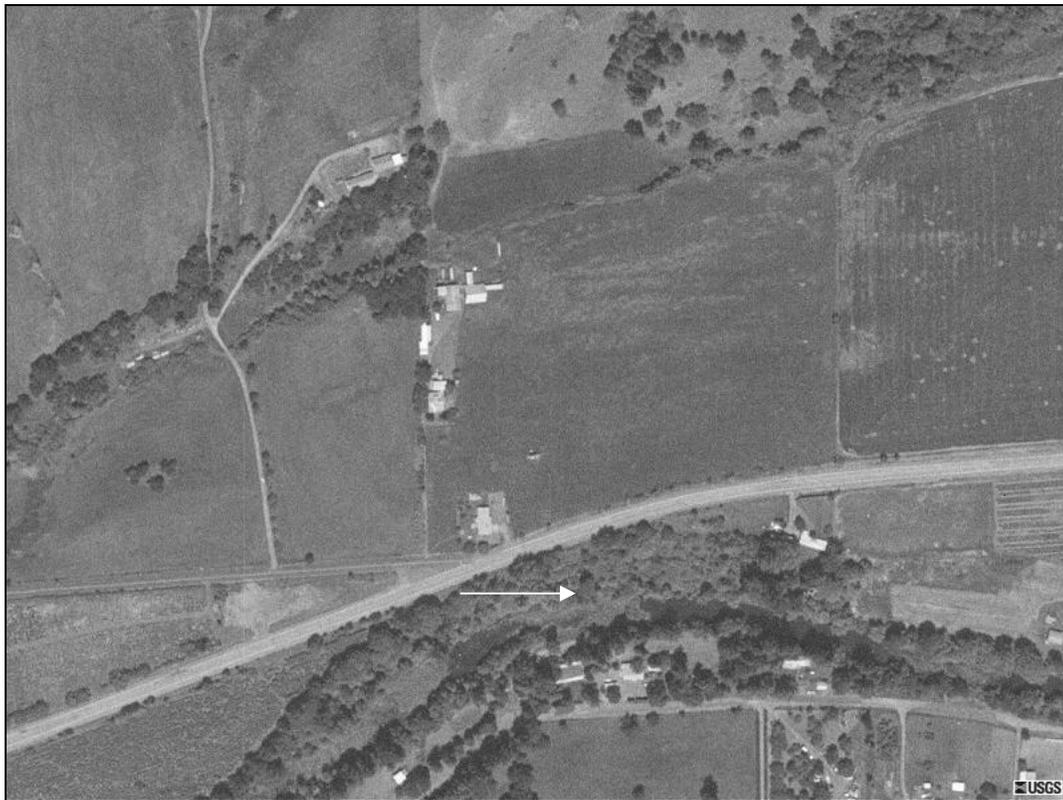
Aerial view of the site and surrounding property.

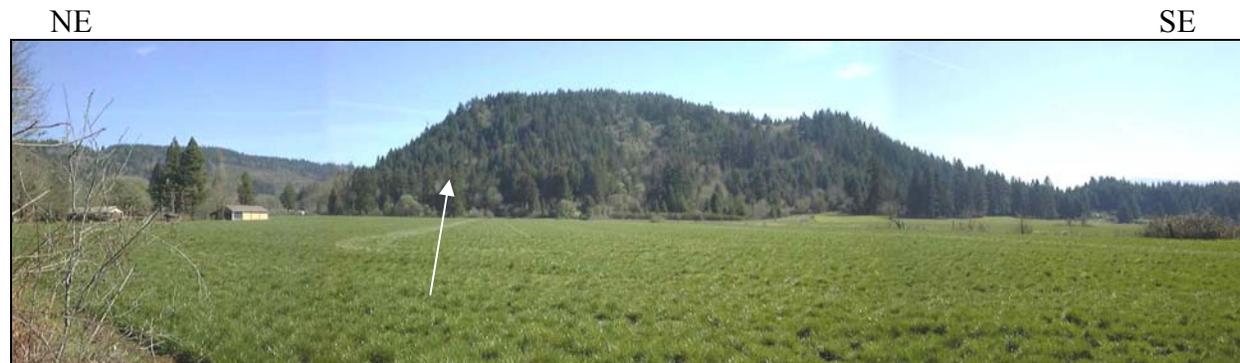
Looking east at the site.

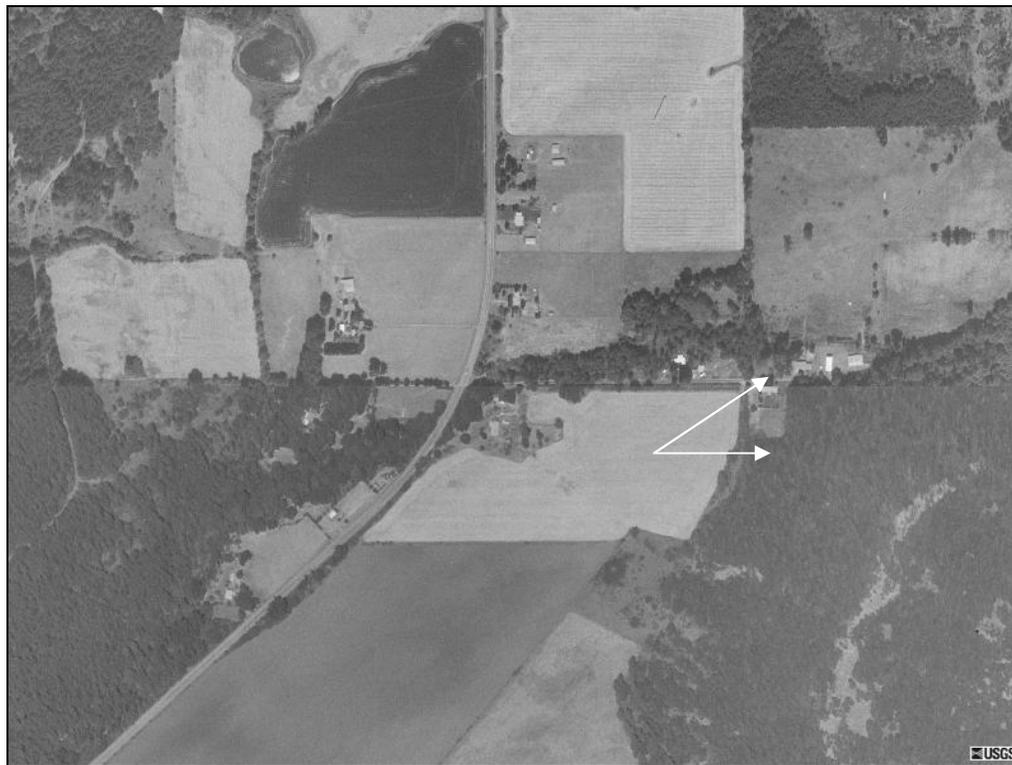
Aerial view of the surrounding ground.
The site and access road are highlighted by arrows.
