CULTURAL LANDSCAPE INVENTORY:
SHELLROCK MOUNTAIN TO RUTHTON POINT

HISTORIC COLUMBIA RIVER HIGHWAY

Prepared For:
Oregon State Department of Transportation

January 2010

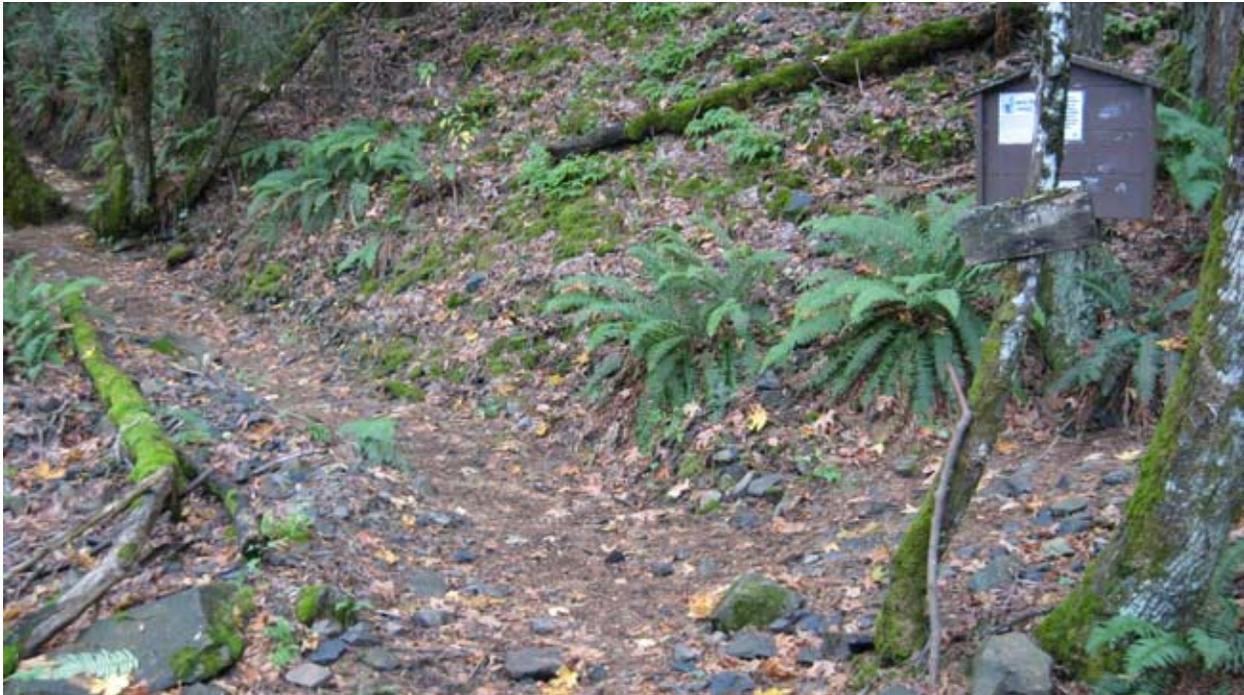
Broken Pavement, Mitchell Creek diversion, Mitchell Point 2

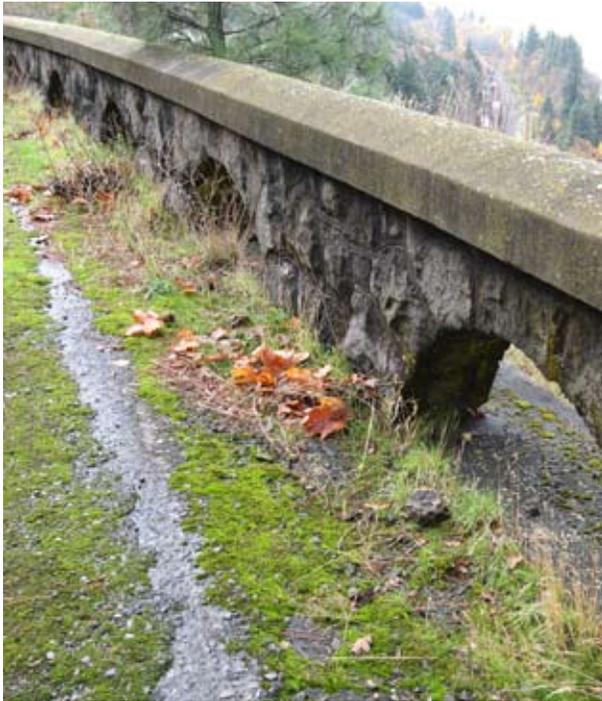
Restored Masonry Parapet, Ruthton Point

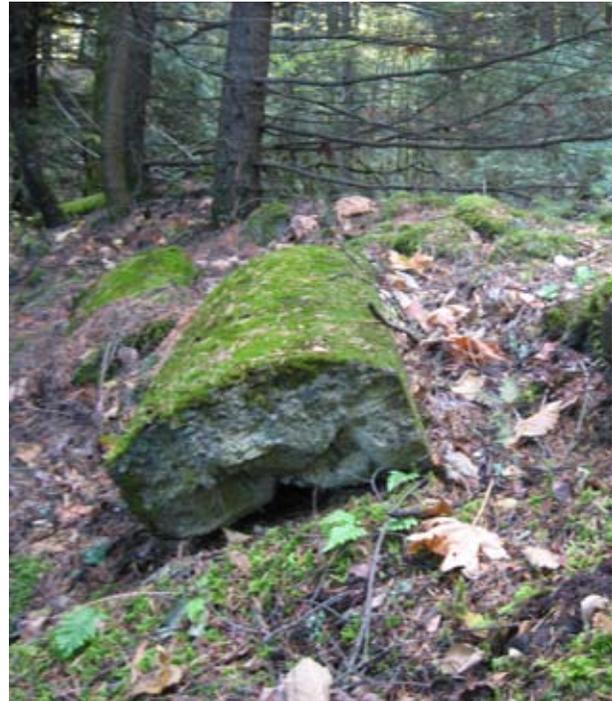
Collapsed Masonry Parapet, Lindsey Creek

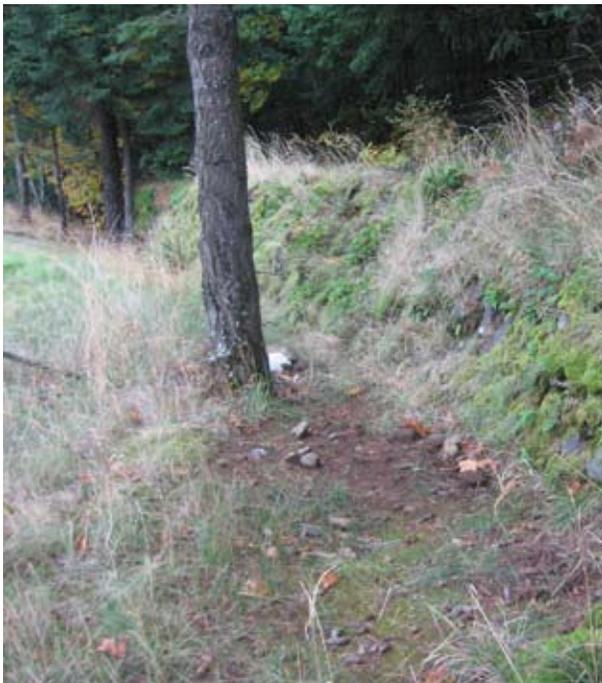
The inventory recorded a 270-foot long retaining wall in below the road on the north side of the highway, in the area of Cabin Creek. It is a typical coursed, dry laid stone retaining wall, with a mortar cap. The wall is in poor condition, with a crumbling mortar, some missing stones, and missing chink stones. It is overgrown with vegetation. The mortar cap may be a later addition.

Retaining Wall, Cabin Creek Area

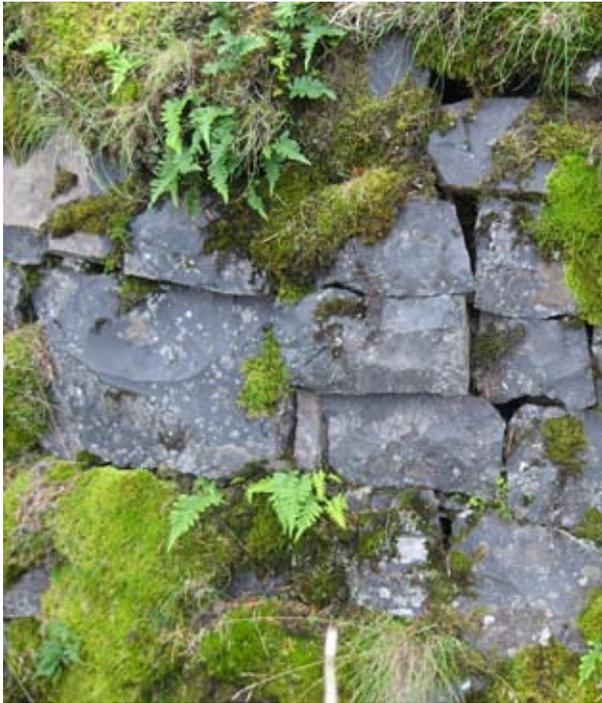
Detail, Cabin Creek retaining wall

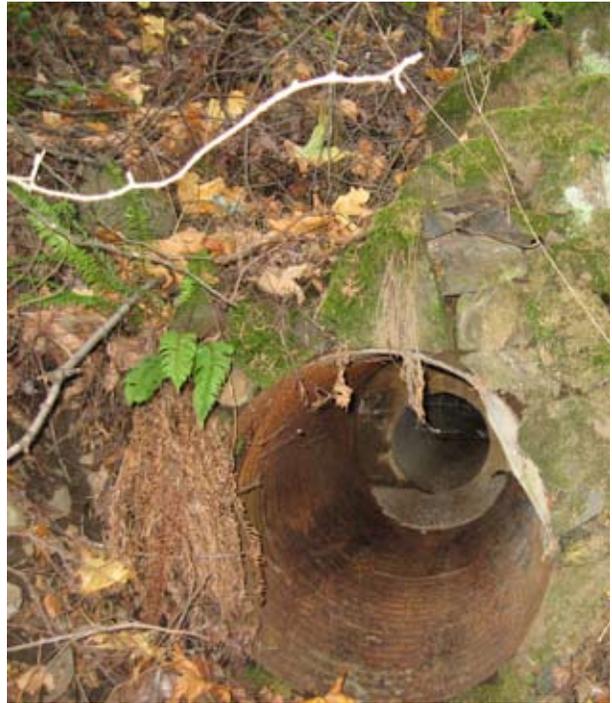
Culvert, rubble wall, Mitchell Point 2

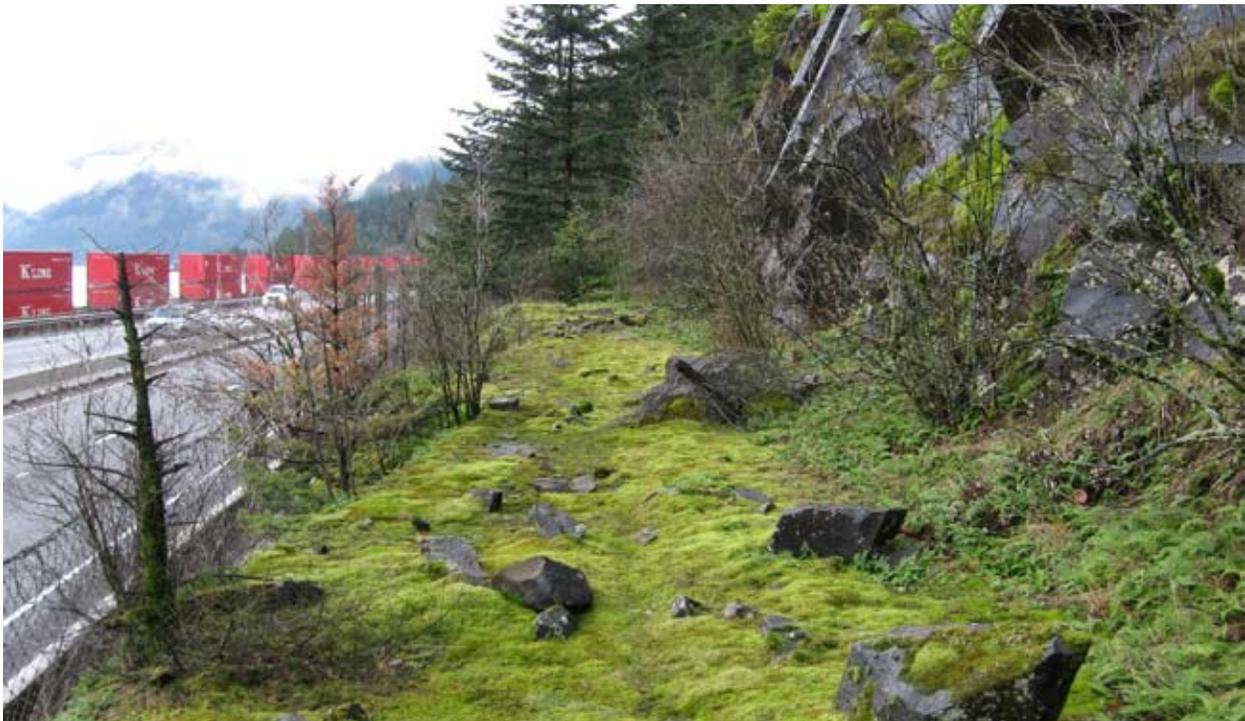
HCRH roadbed and rock cut, Shellrock Mountain

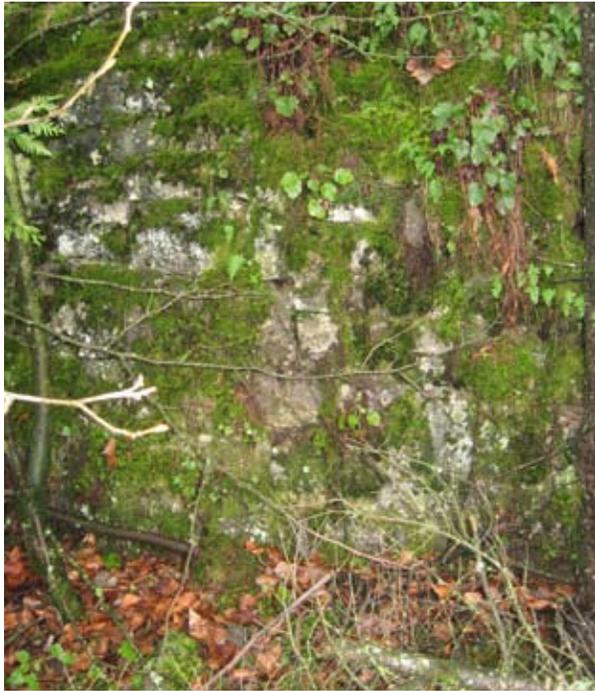
Retaining wall, Shellrock Mountain

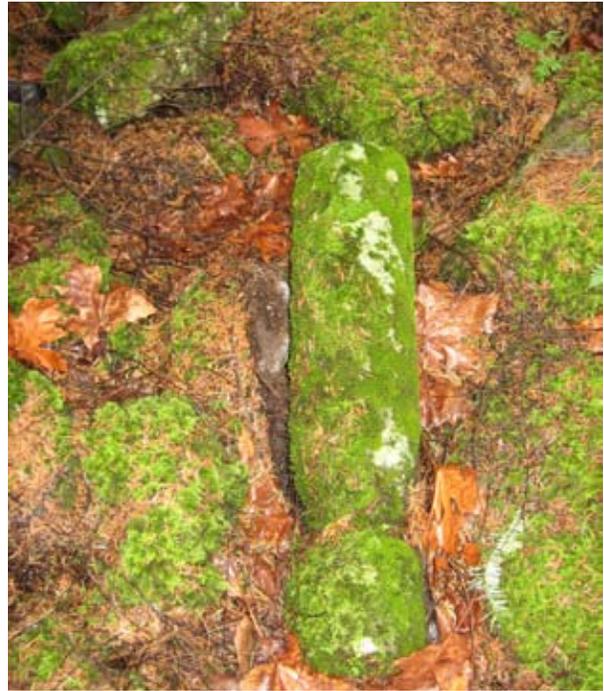
Concrete guard post, Shellrock Mountain

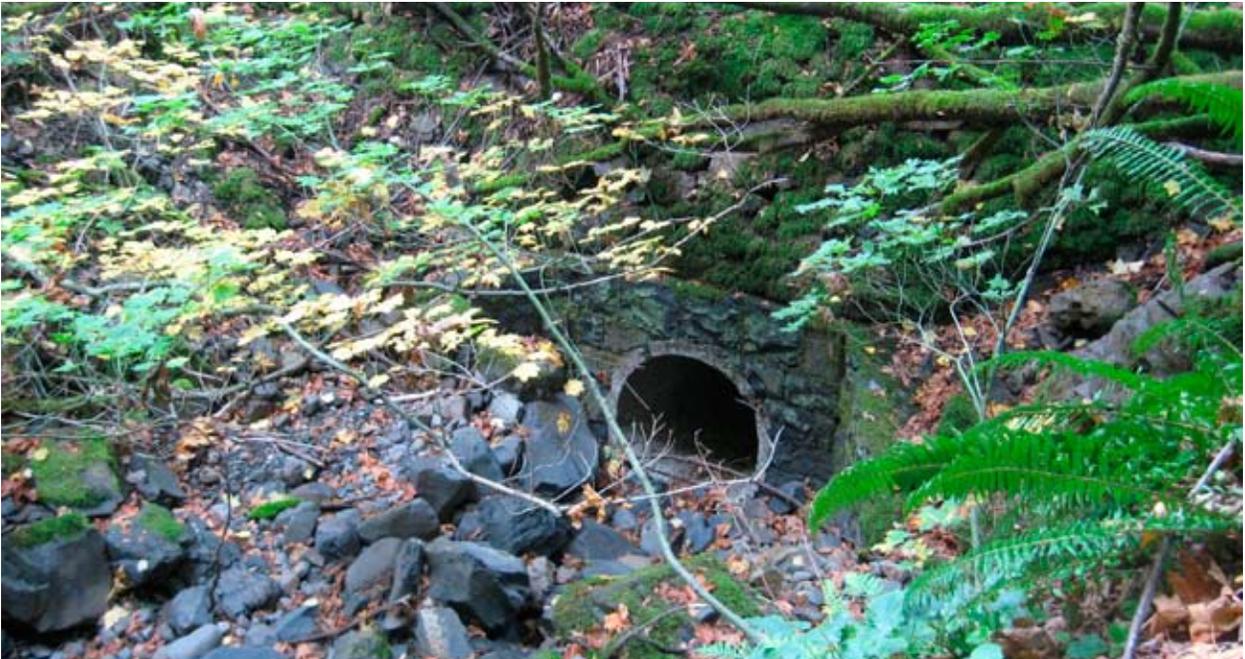
segment. The Cabin Creek culvert was designed to be seen from the trail to the Falls, and consists of 36" concrete culvert set in a six foot wide headwall of coursed basalt stones that have been hewn and bossed, laid with mortar. Above and to the sides of the mortared headwall is a continuation and wing walls of unhewn, dry laid rubble wall. This rubble wall appears to have been repaired or modified at some time. Because of these modifications and some missing stones, the culvert is considered to be in poor condition. A second concrete culvert with basalt stone detailing around the mouth is in poor condition because it is almost entirely buried and clogged.

Cabin Creek culvert. The style of this culvert suggests it was meant to be seen from a path to the fall.

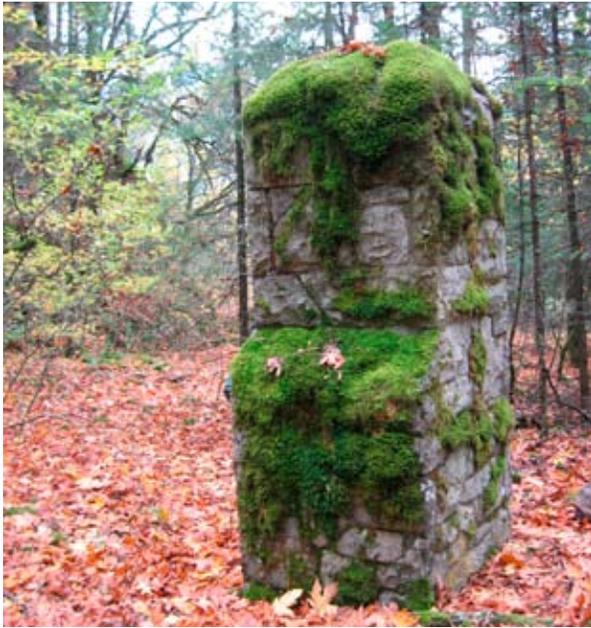
CCC sign post, Perham Creek

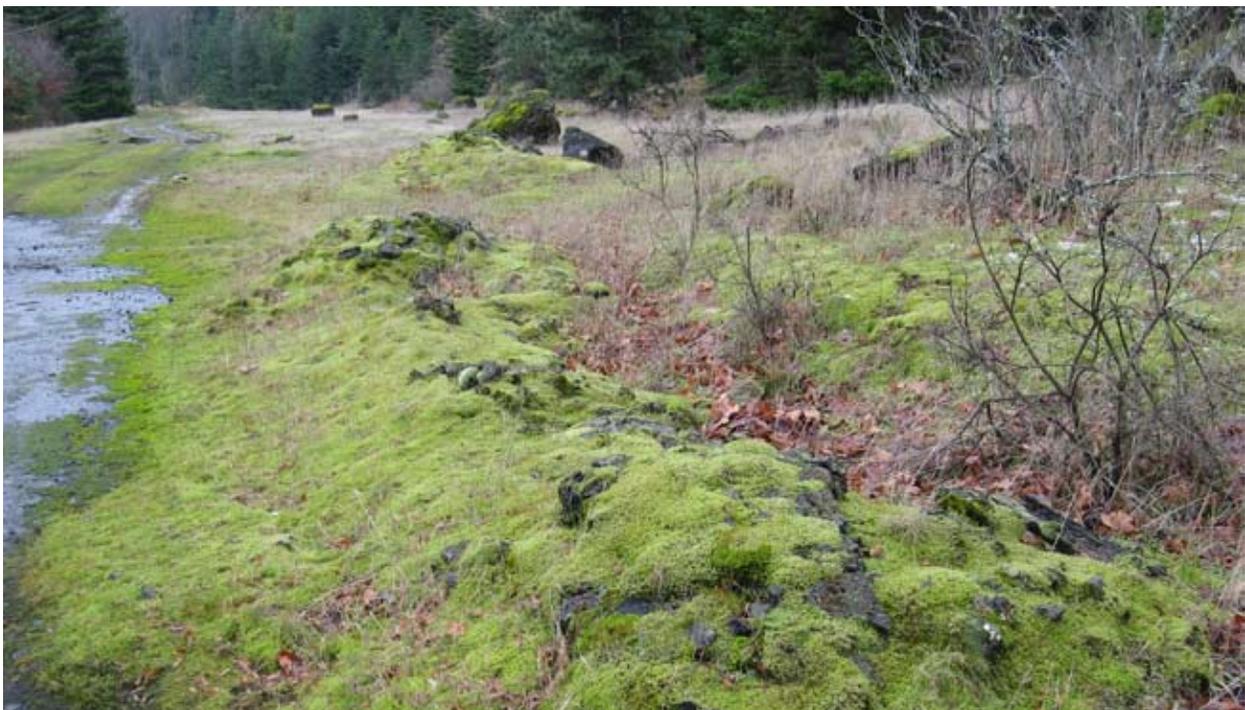
Asphalt heap, roadbed and disused quarry site, Mitchell Point East.

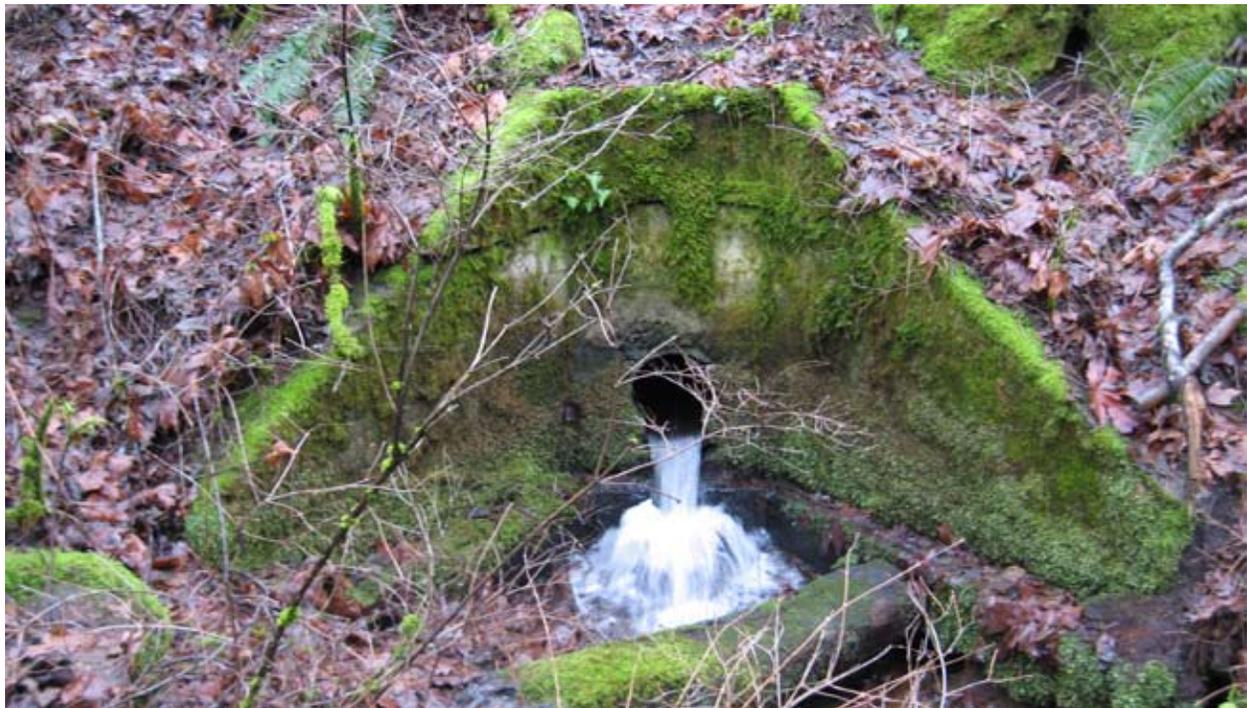
Concrete culvert headwall, Mitchell Point East.

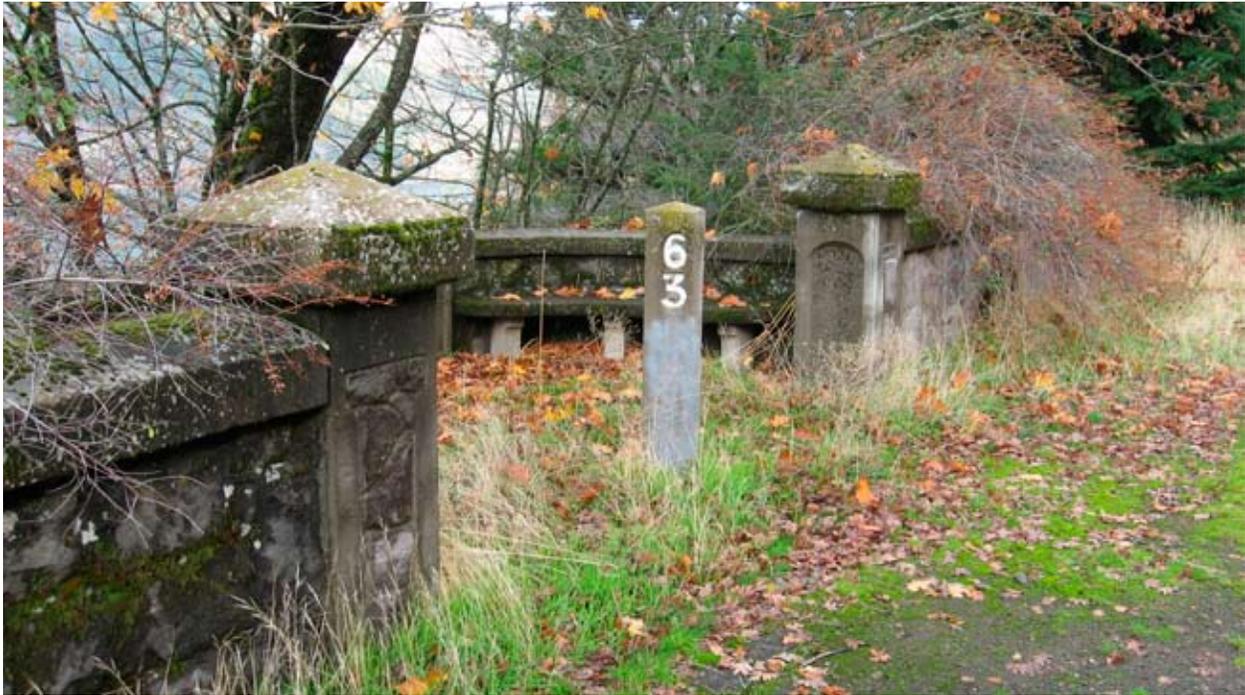
Reconstructed viewpoint, Ruthton Point

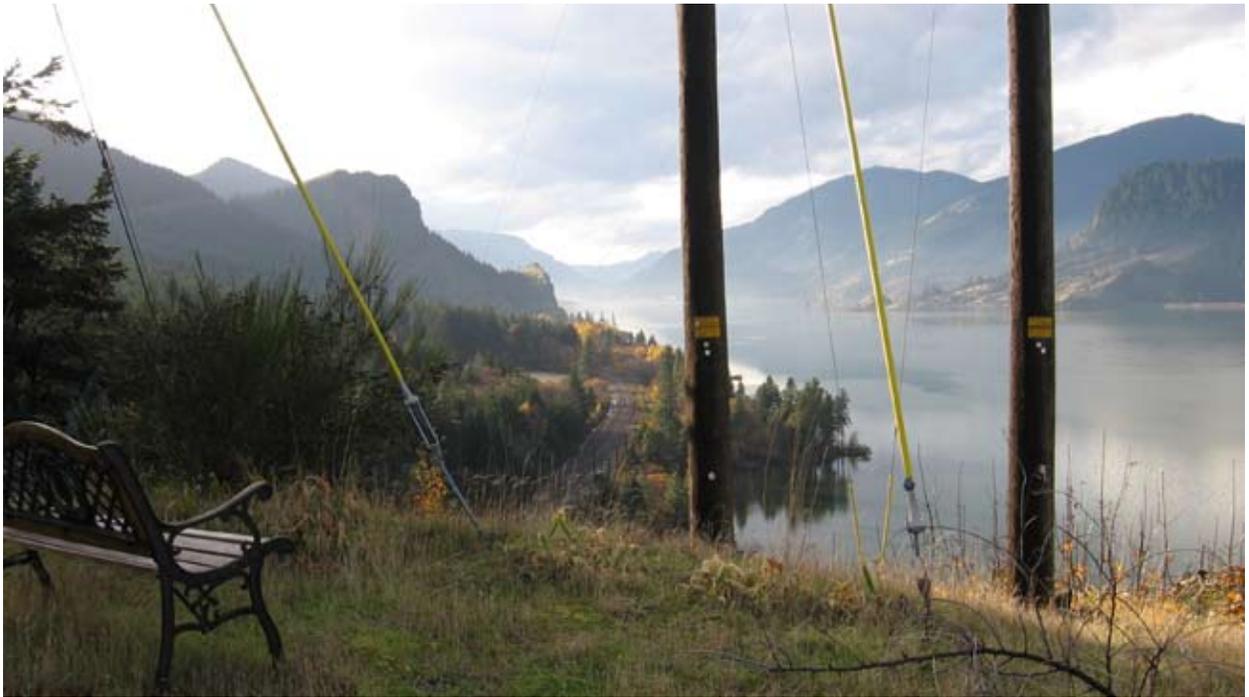
There is a distant panoramic view of the Gorge to the west from the first section of Ruthton Point. This is a moving view, seen while travelling along the road. The 1939 aerial photograph shows a series of lens-shaped turnouts along the cliff edge in this area. The built viewpoint is a recent reconstruction or addition. It corresponds to a lens-shaped shoulder widening on the 1939 aerial, partly obscured by tree canopy. The historic aerial also shows a large space, perhaps for parking, opposite this area across the road. The built viewpoint is in fair condition, with one of its benches broken off. The oaks surrounding it partially block the view. There is an informal view point equipped with a garden bench on the east end of the Ruthton Point fragment. It is a panoramic distant view of the gorge, obscured by the power line.

Viewpoint, with powerlines in foreground. Ruthton Point

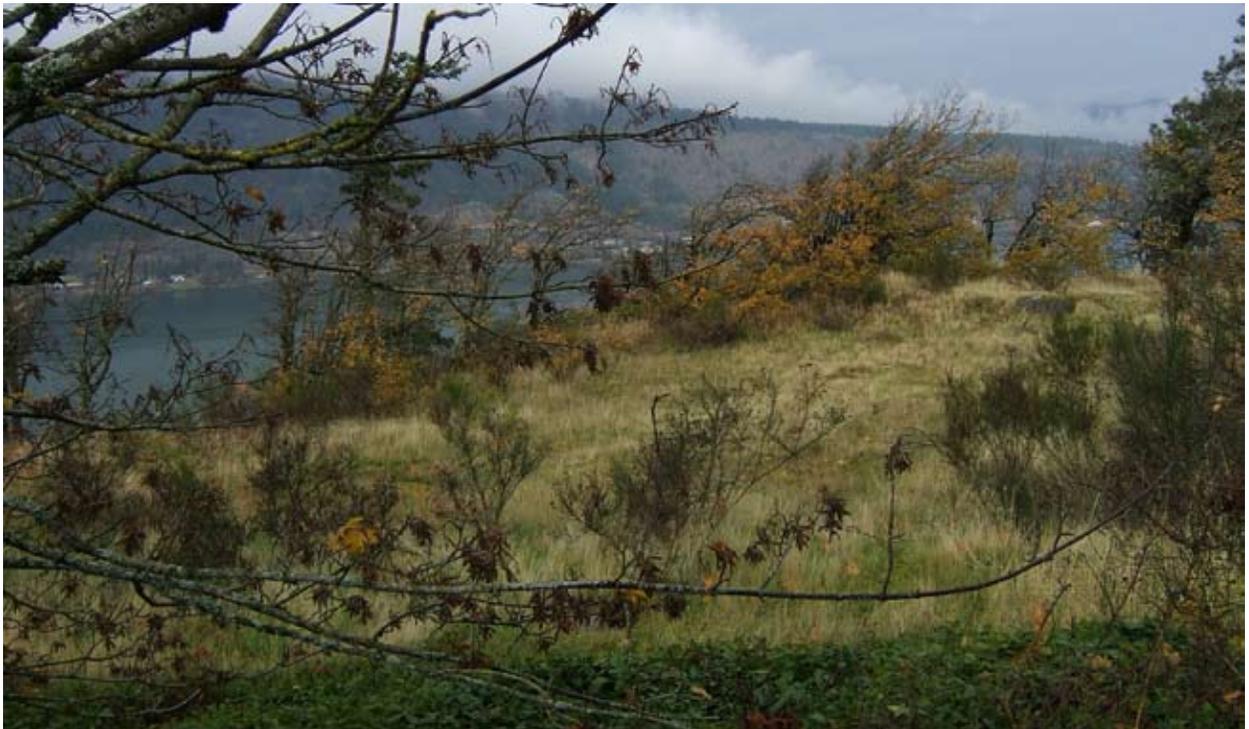
The cliff top adjacent to the Ruthton Park fragment has a rectilinear space and stone remnants that may reflect a previous development. The 1939 aerial shows a building to the east, so this may have been parking or a garden area. There is a stone structure in the drainage between Ruthton Park and the road fragment that may have been a structure associated with the highway, or with the development

Archaeology, former building site, Ruthton Park, Ruthton Segment 2

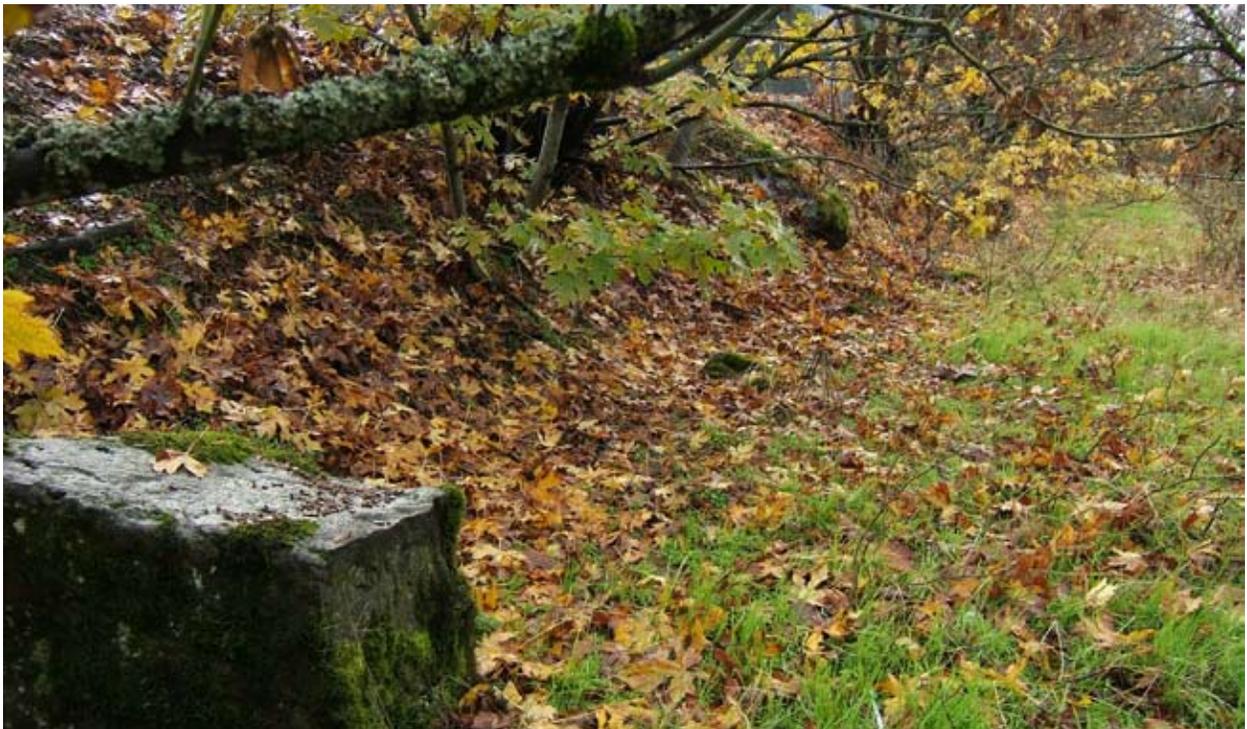
The Ruthton Park segment pavement is in poor condition. It is overgrown with moss, shrubs and trees. The edges of the roadbed are buried or have been lost to the construction of the frontage road immediately above it. This segment ends in trees and rock at just before a small seasonal drainage cuts across it, at the fenced boundary of Ruthton Park itself.

Edge stone, roadbed, Ruthton Park, Ruthton Segment 2

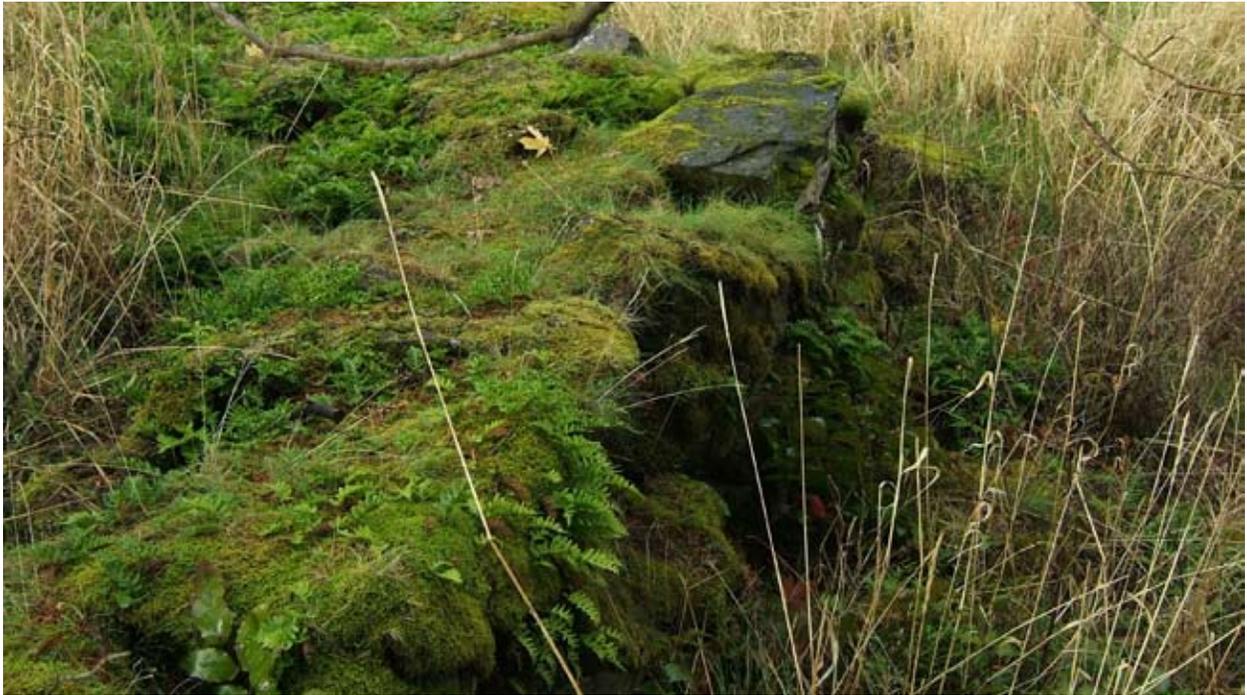
Stonework, drainage area, Ruthton Park
