## **PHASE I ENVIRONMENTAL SITE ASSESSMENT REPORT**

**Oregon State Hospital – North Campus  
2575 Bittern St. NE, 2575-2600 Center St. NE  
Salem, OR 97301**

May 14, 2013  
185750103

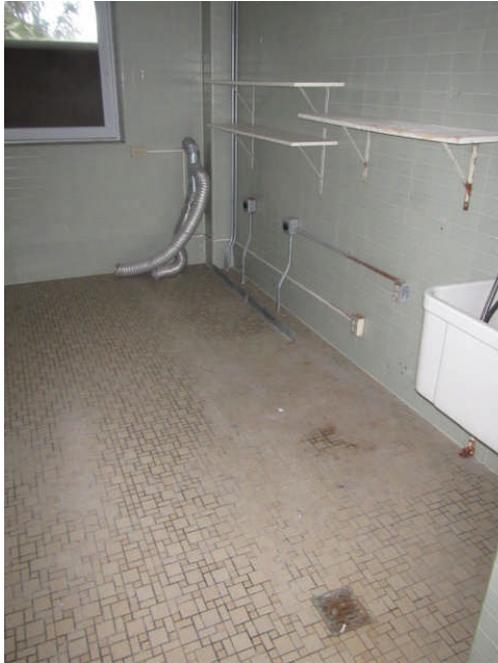
**PHOTO No. 7, February 19, 2013**

- Floor drains in rest rooms and wash areas throughout the buildings (see Breitenbush Hall, Photos 7 and 9, 10 and 16; Santiam Hall, Photos 9 and 10).
- Floor drains in basement storage areas (see Breitenbush Hall, Photos 27, 28, 40 and 55; Other, Photos 19, 20 and 21; Santiam Hall, Photo 3).
- Sumps in basement areas (see Breitenbush Hall, Photos 29 and 46).

1<sup>st</sup> Floor, West Wing – Common Wash Area

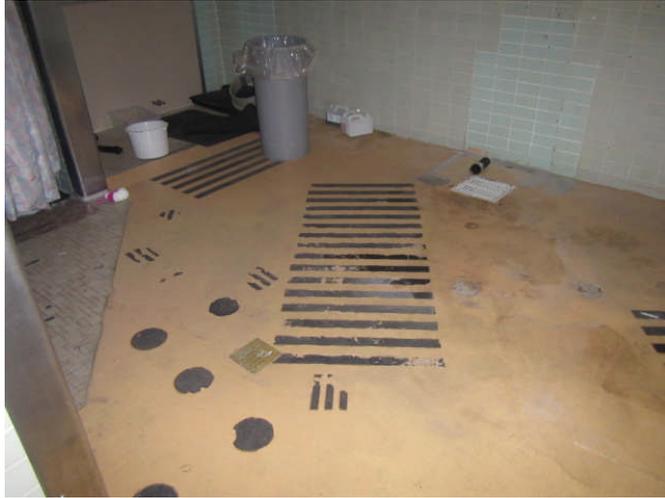
**PHOTO No. 9**

1<sup>st</sup> Floor, West Wing – Common Wash Area

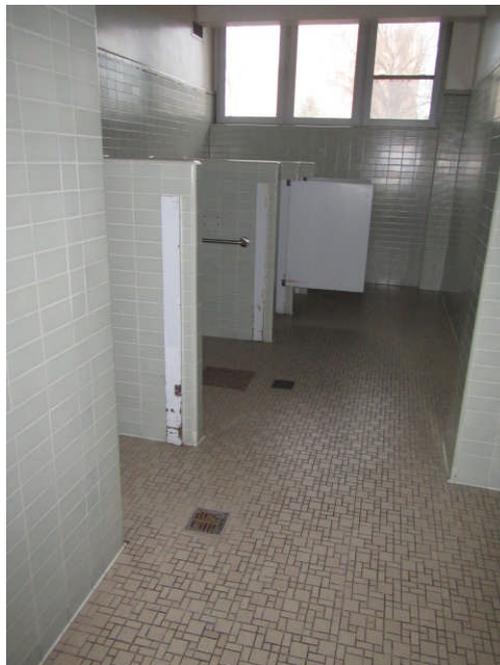
**PHOTO No. 10**

1<sup>st</sup> Floor, West Wing – Wash/Restroom Area

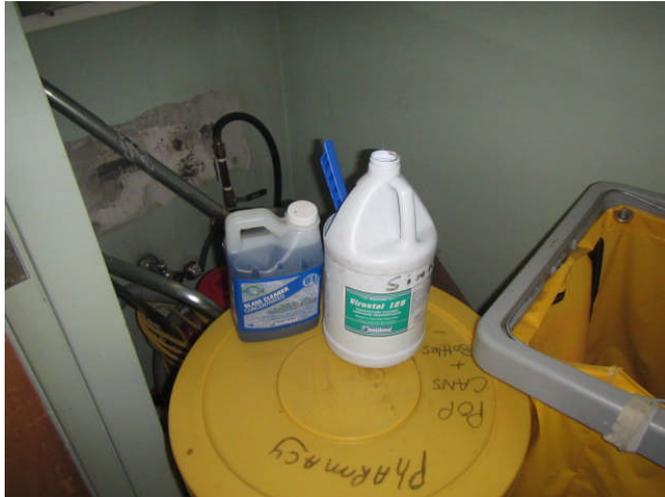
**PHOTO No. 15**

**3<sup>rd</sup> Floor – Cleaning Supplies**

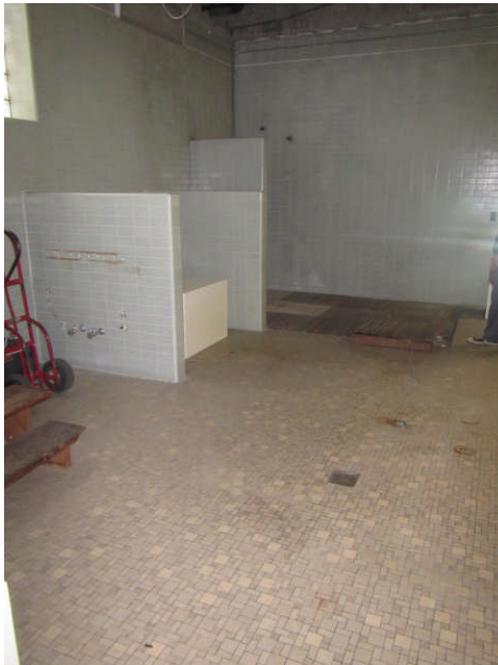
**PHOTO No. 16**

**3<sup>rd</sup> Floor – Former Common Wash Area**

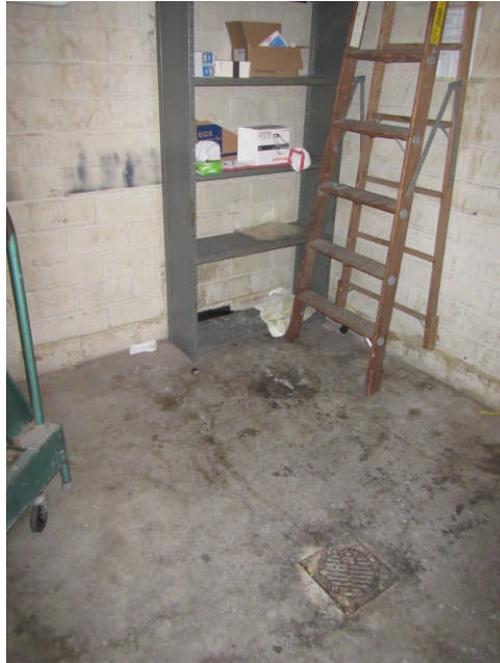
**PHOTO No. 27**

**Basement – Floor Drain in Storage Room**

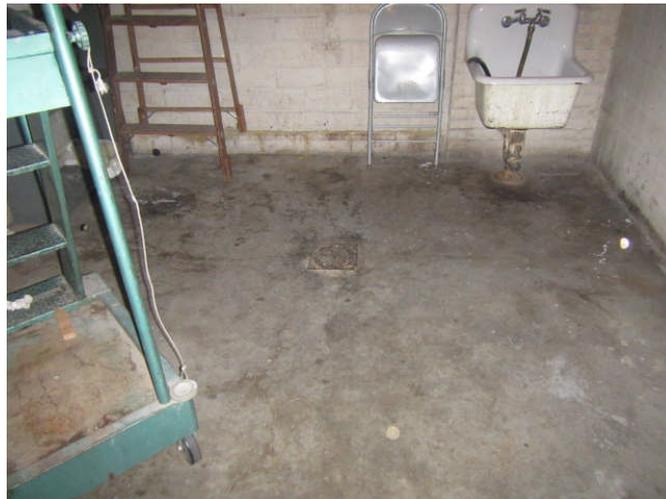
**PHOTO No. 28**

**Basement – Floor Drain in Storage Room**

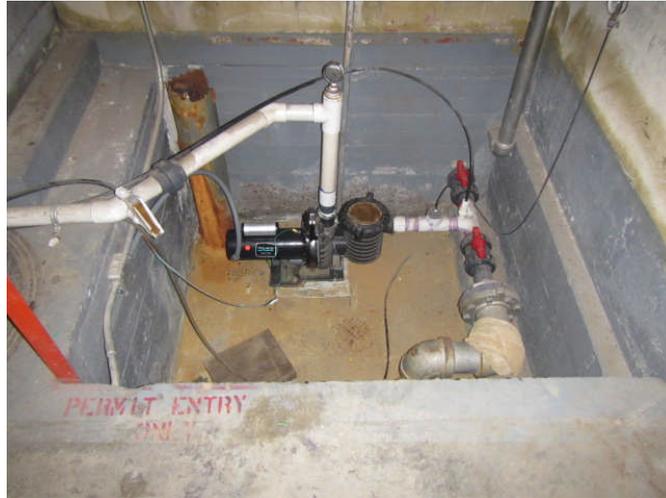
**PHOTO No. 29, February 19, 2013**

Basement – Sump Pit

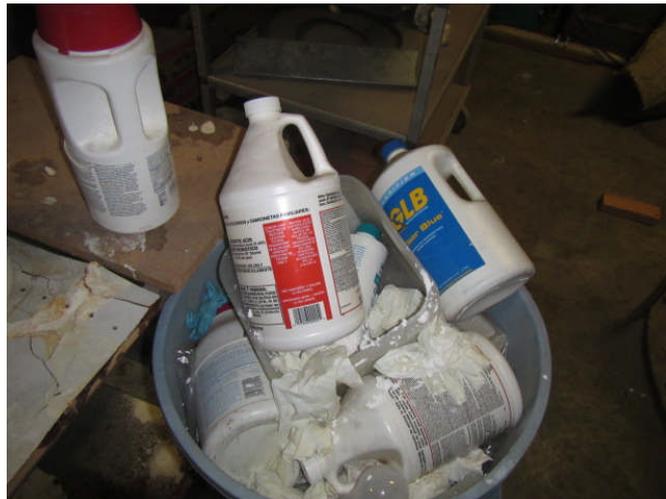
**PHOTO No. 34**

**Basement – Pool Chemical Containers**

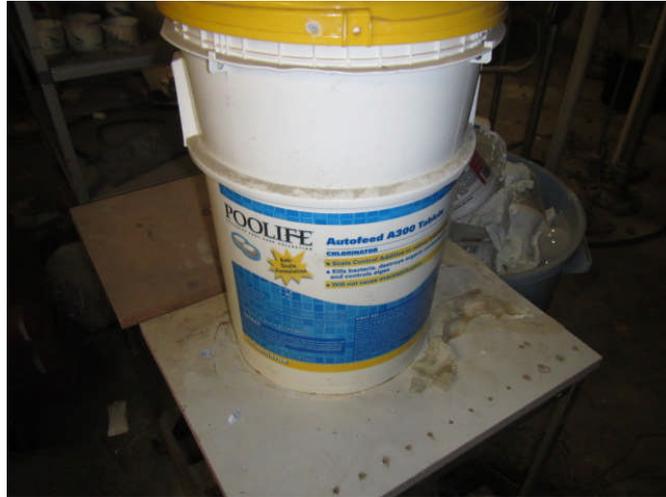
**PHOTO No. 35, February 19, 2013**

**Basement – Pool Chemical Containers**

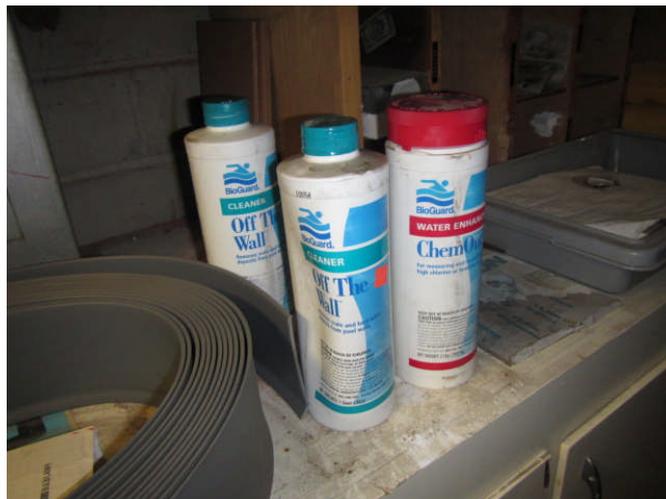
**PHOTO No. 36**

**Basement – Pool Chemicals**

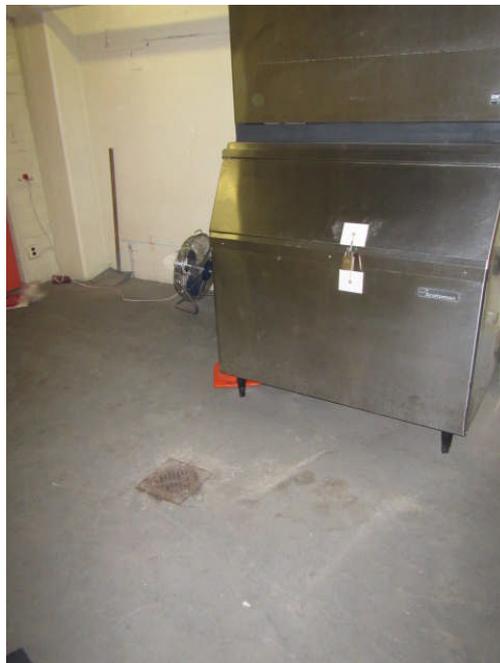
**PHOTO No. 40, February 19, 2013**

Basement – Floor Drain Near Ice Machine

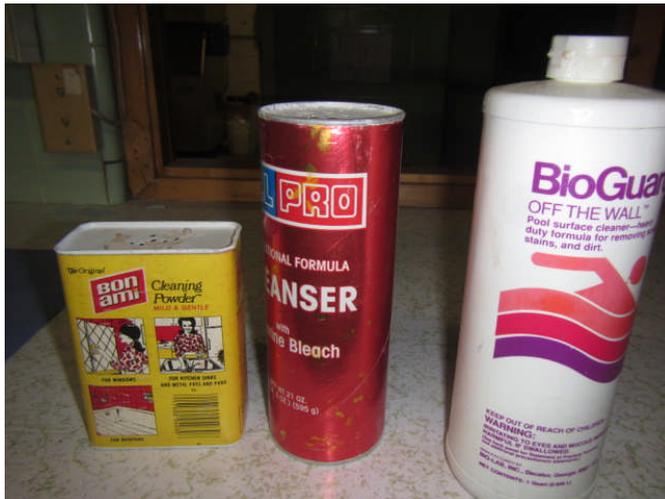
**PHOTO No. 42**

Basement – Chemicals in Storage Area

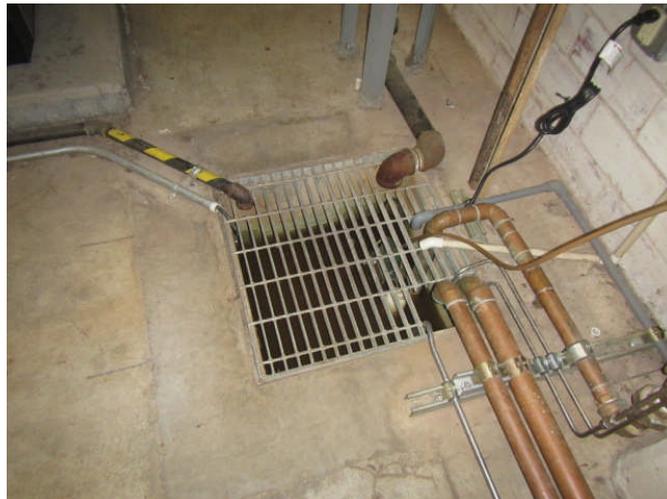
**PHOTO No. 46**

Basement – Mechanical Room Sump

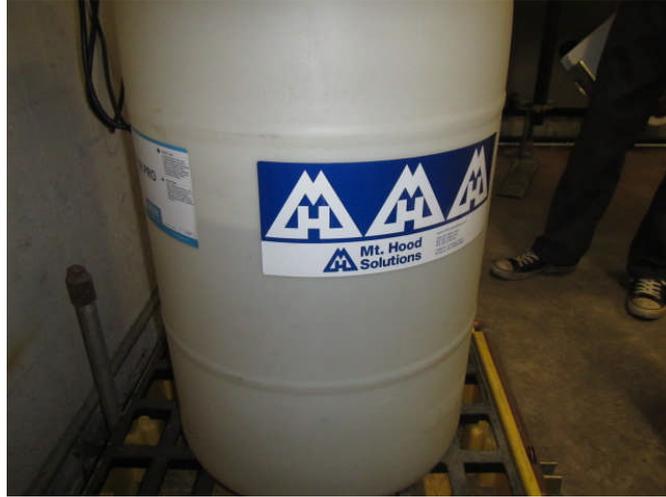
**PHOTO No. 47**

**Basement – 55-Gallon Drum of “Boiler Pro”**

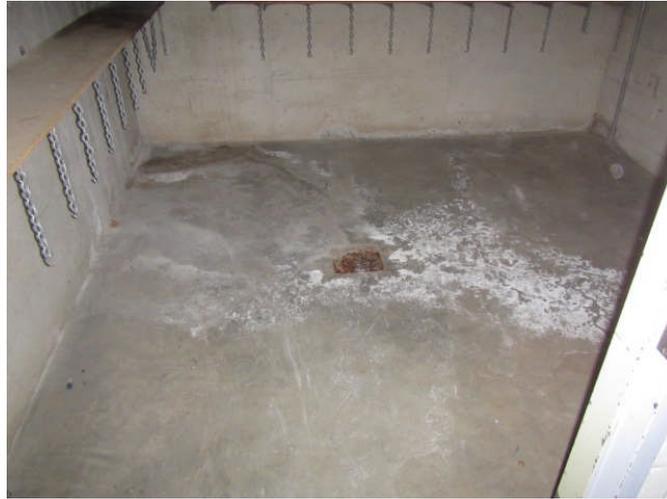
**PHOTO No. 55**

**Basement – Tunnel Going East, Former Gas Cylinder Storage Area**

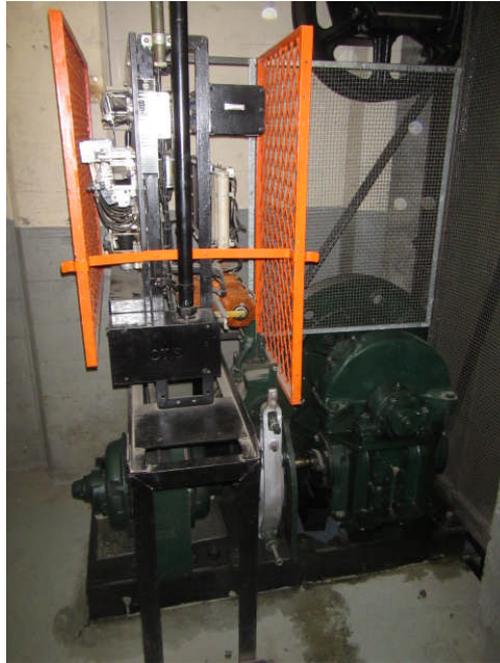
**PHOTO No. 57, February 19, 2013**

Basement – East Freight Elevator Room, Inside

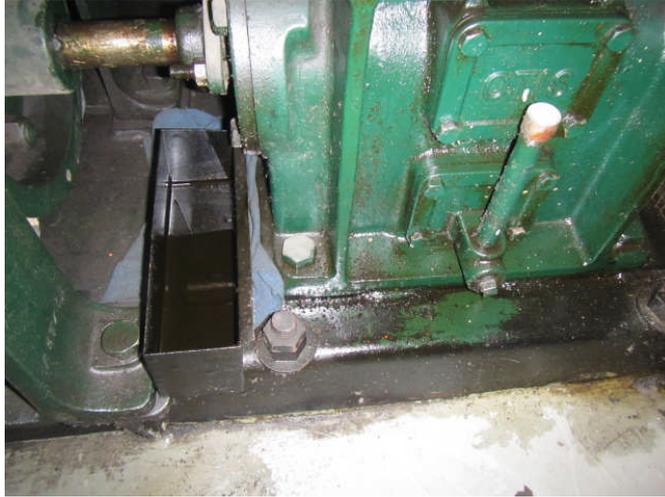
**PHOTO No. 59**

**Basement – East Freight Elevator Room, Oil**

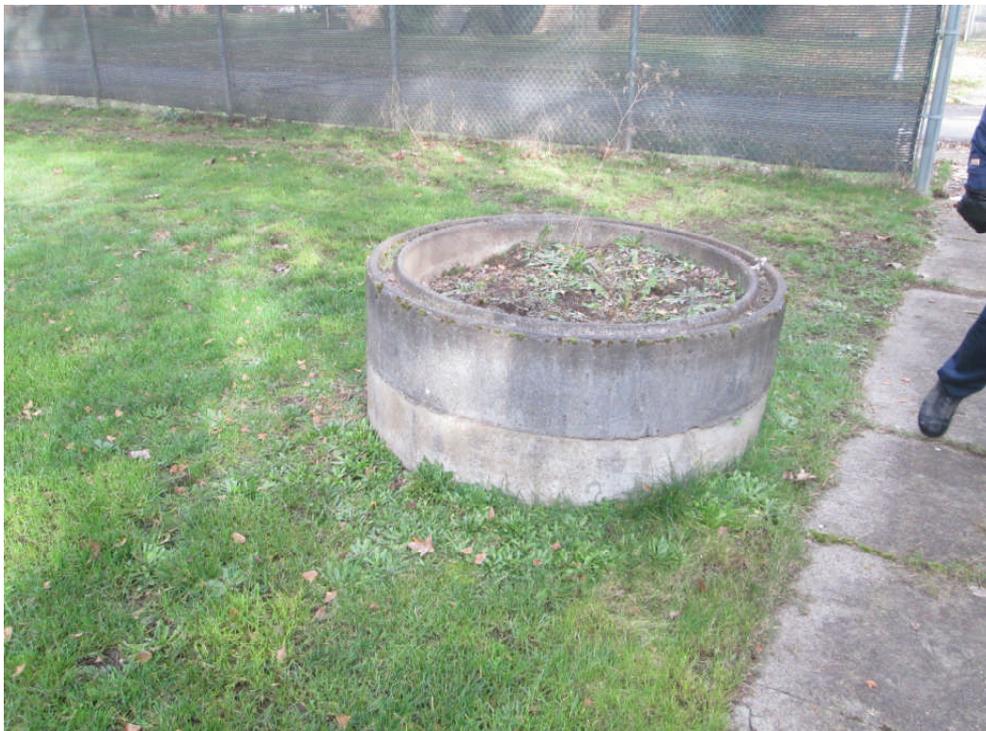
**PHOTO No. 62**

**Yard North of Building – Odd Looking Planter**

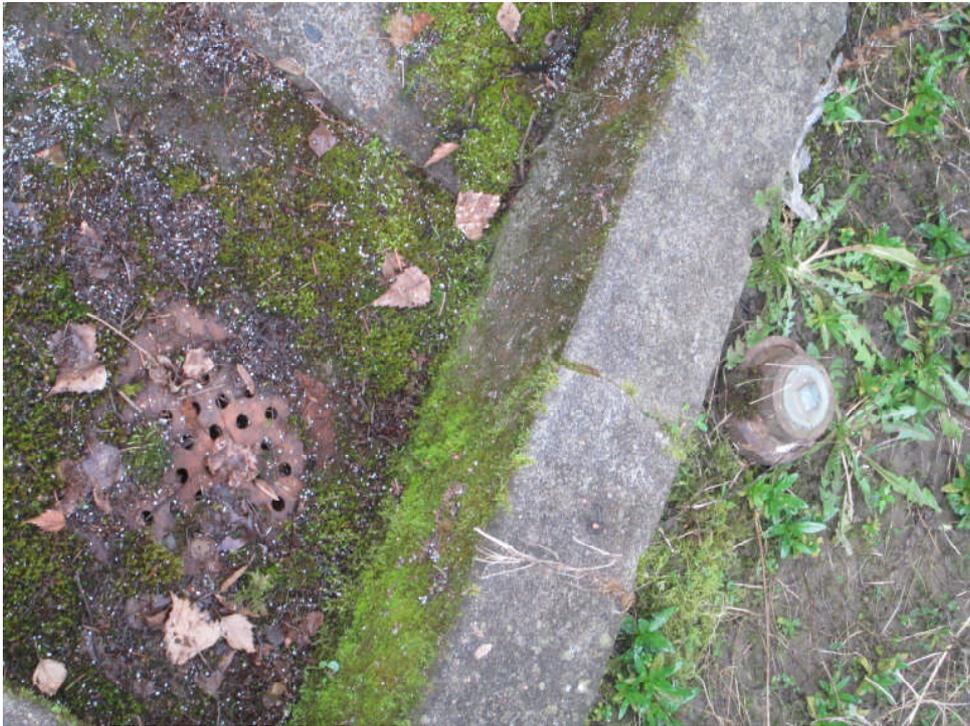
**PHOTO No. 63, February 20, 2013**

Yard North of Building – Drain and Cleanout

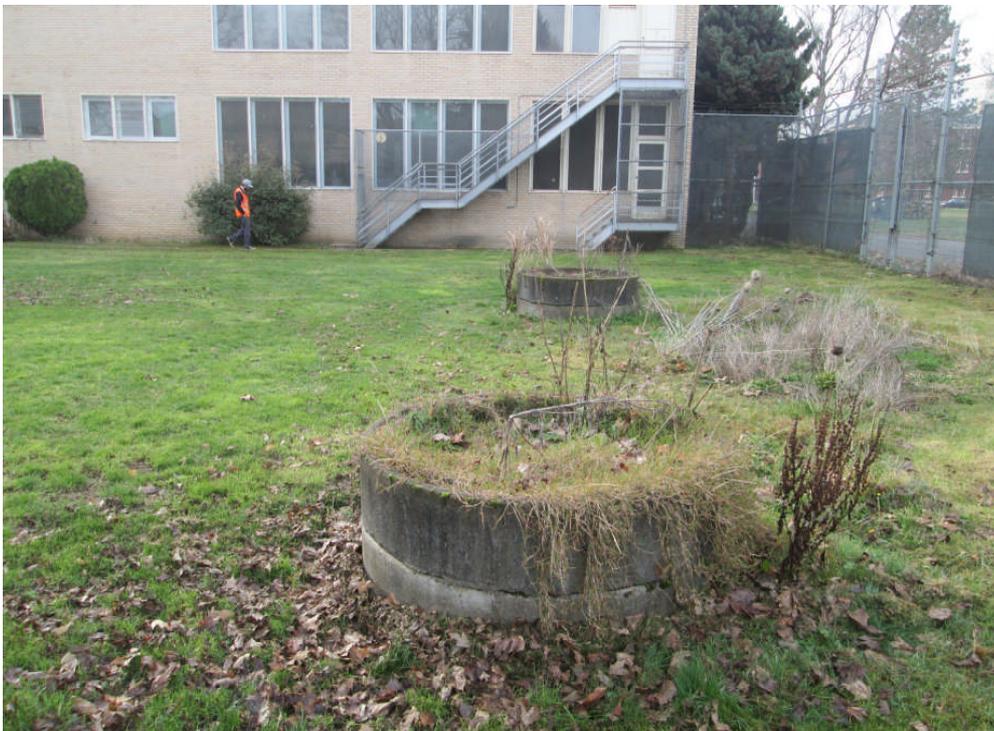
**PHOTO No. 64**

Yard North of West Wing of Building – Odd Looking Planters

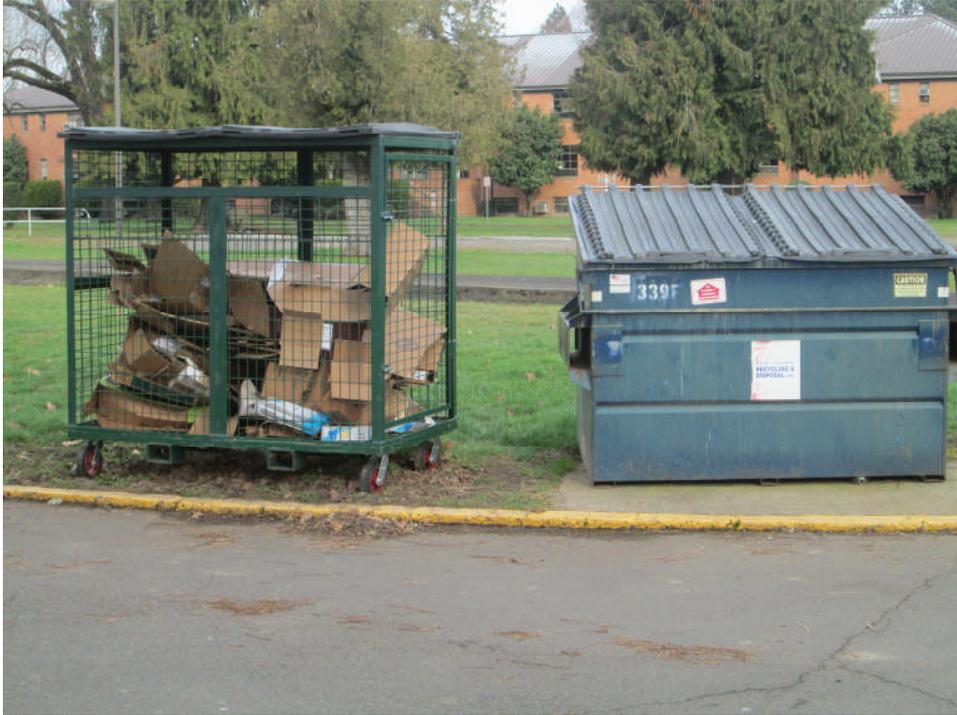
**PHOTO No. 65, February 20, 2013**

Waste Storage Area West of SW Corner of Building

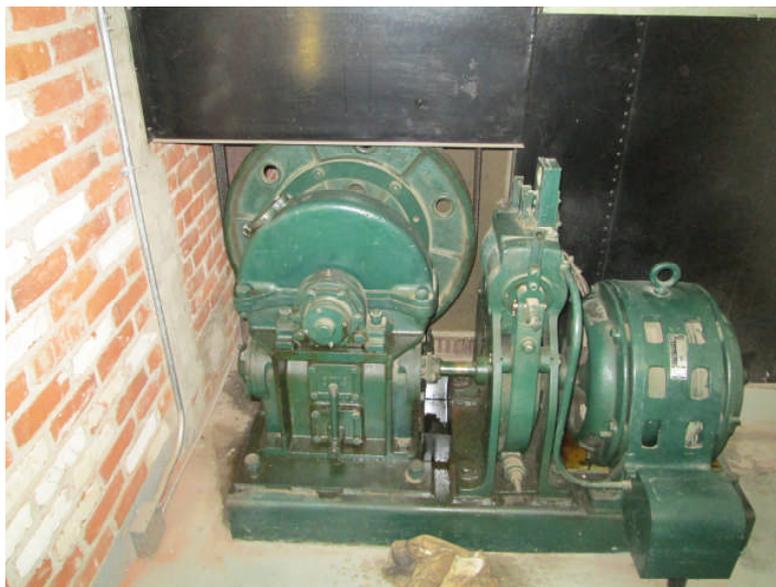
**PHOTO No. 2**

Basement – Elevator Room

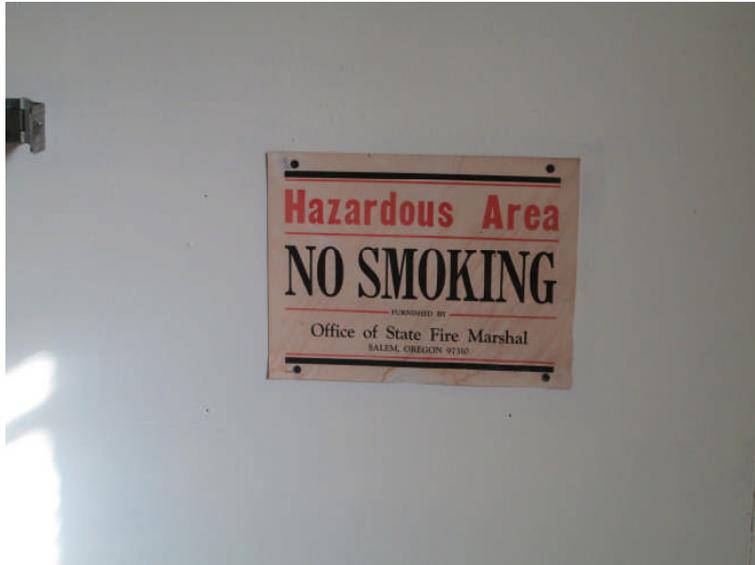
**PHOTO No. 7, February 19, 2013**

Basement – Chemical Storage Room

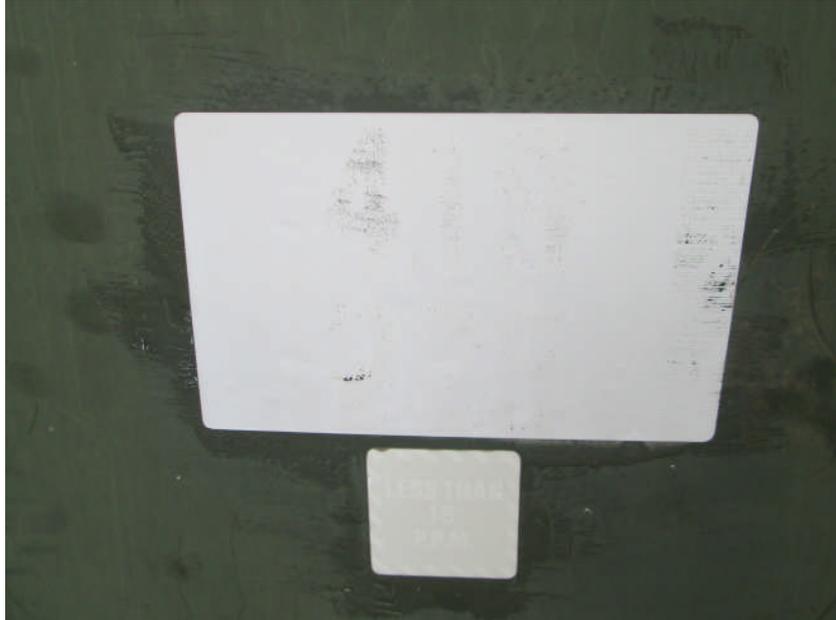
**PHOTO No. 27, February 20, 2013**

Faded Label on Transformer – “Less than 15 PPM”

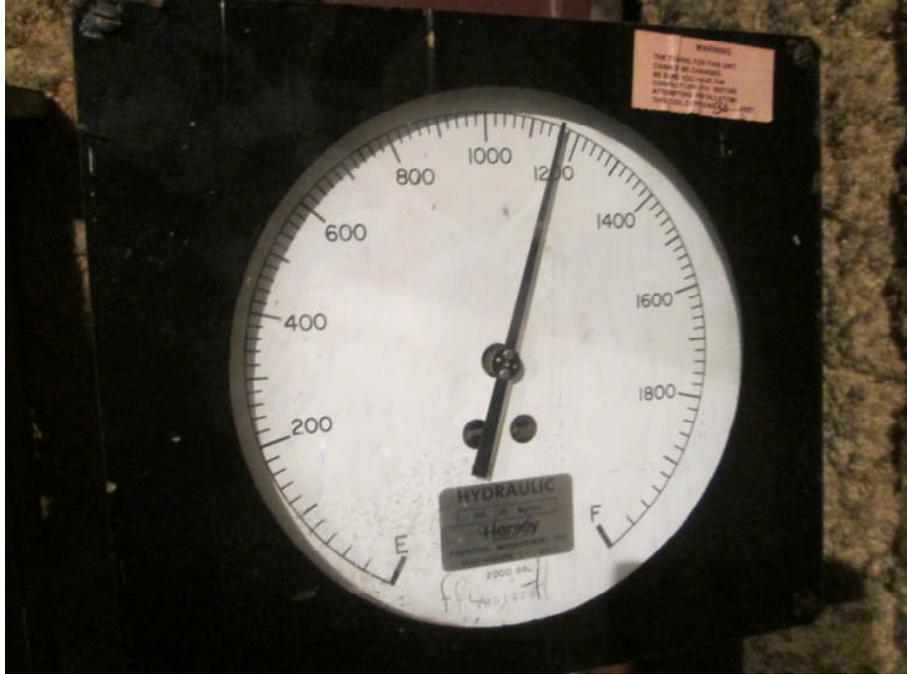
**PHOTO No. 17, February 20, 2013**

A 2,000-gallon fiberglass diesel UST is present east of the east/south wing of Eola Hall (see Eola Hall, Photos 17, 18, 20 and 21 in Appendix A). The UST is associated with the adjacent backup generator for Eola Hall. Based on records provided by the Salem Fire Department (provided in Appendix C), it appears that the current UST was installed in 1999 to replace a UST formerly present in this location. Upon removal of the former UST (also in 1999), it appears as though soil contamination was identified (discussed further in Section 6.3).

UST Gauge Associated with Generator

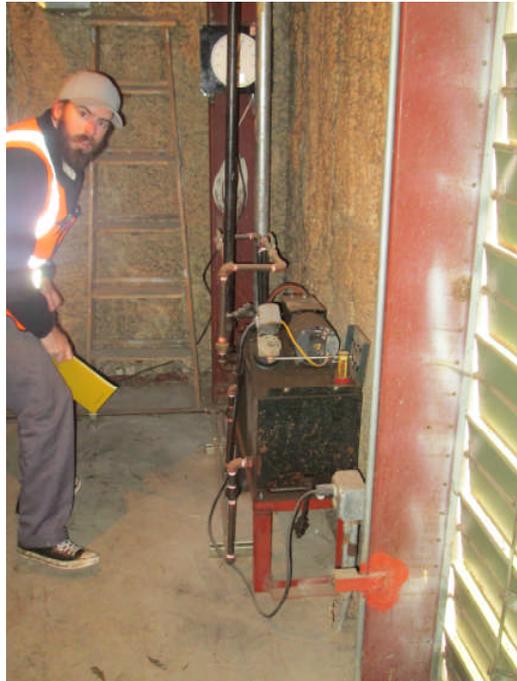
**PHOTO No. 18**

Photos 17, 18, 20 and 21 in Appendix A). Based on records provided by the Salem Fire Department (provided in Appendix C), upon removal of the former UST in February 1999, it appears as though soil contamination was identified. According to ODEQ records, this activity was granted NFA status in 2000, however the presence of an existing UST in this location is considered a REC.

UST System for Generator

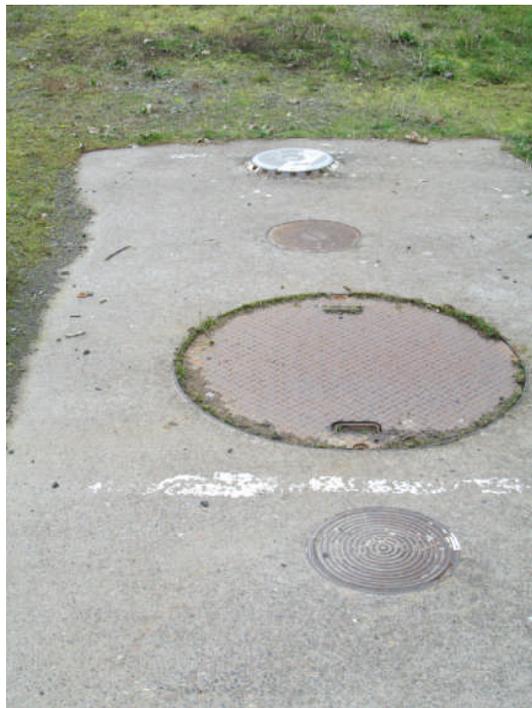
**PHOTO No. 20**

UST Associated with Generator

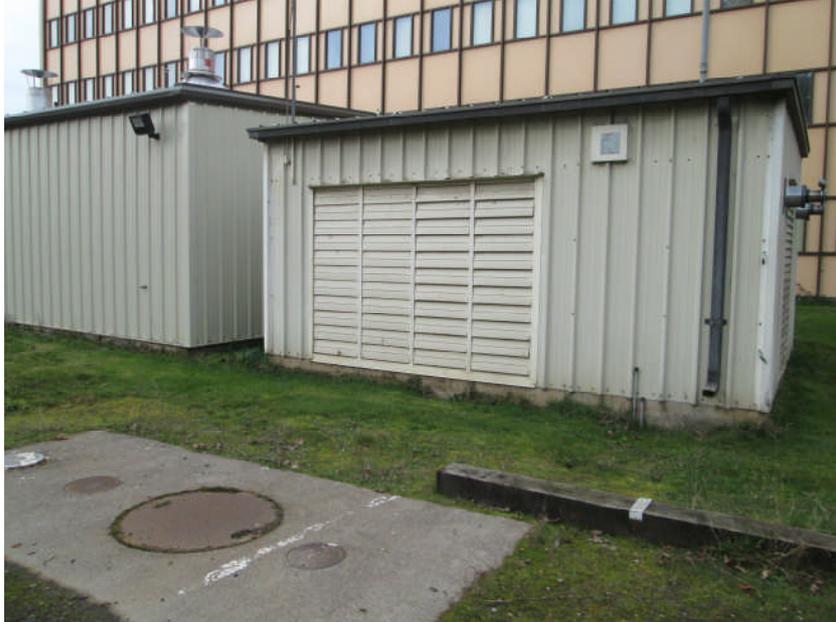
**PHOTO No. 21, February 20, 2013**

UST/Generator Area

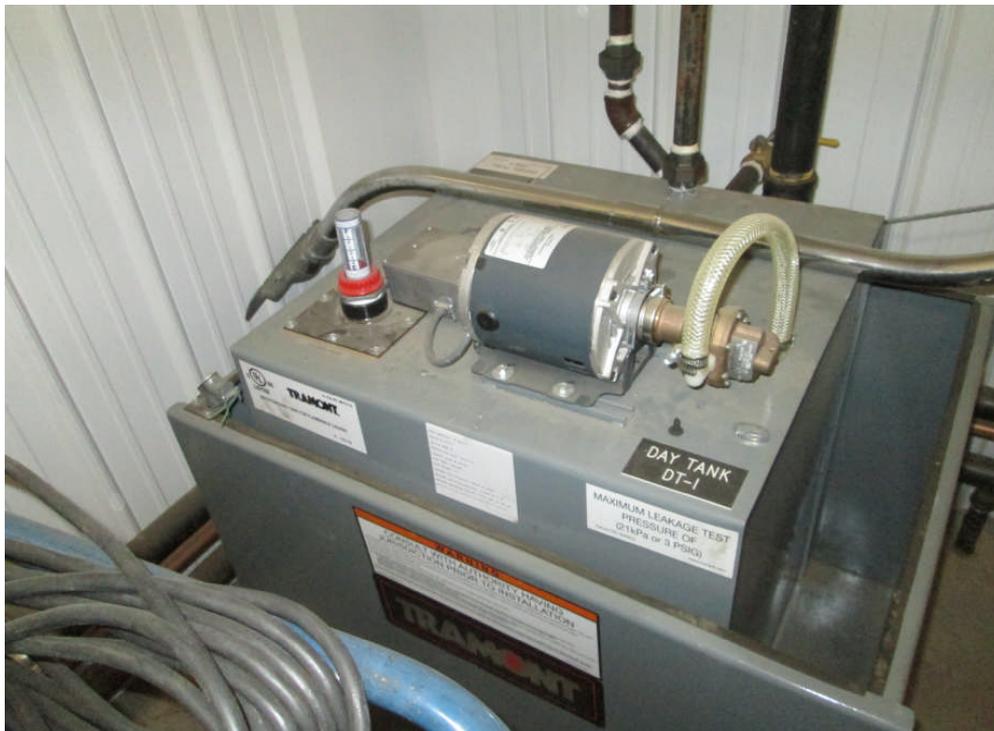
**PHOTO No. 24**

Also, a 75-gallon fuel AST is located in the northeast corner of the outdoor mechanical building east of Eola Hall (see Eola Hall, Photo 24 in Appendix A). The AST did not appear to be in use.

Mechanical Building – 75-Gallon Tank in Northeast Corner (Appears to Be Empty)

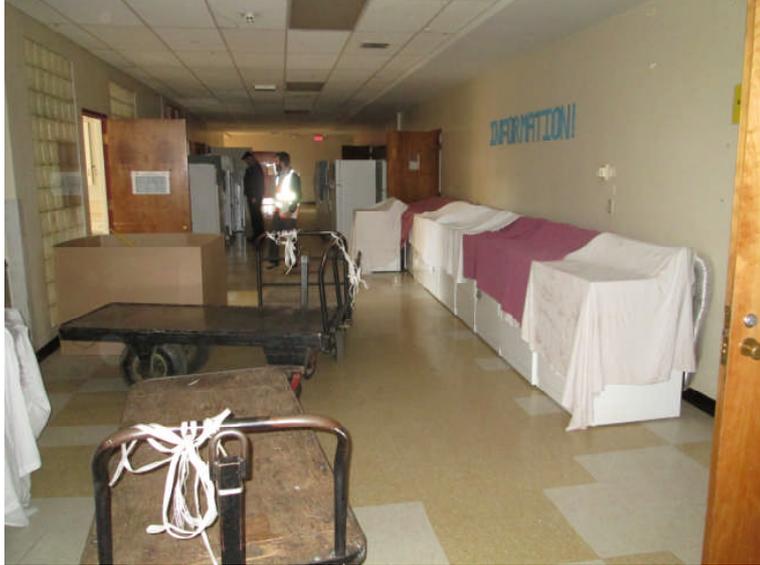
**PHOTO No. 11**

1<sup>st</sup> Floor – Washers/Dryers Etc. Stored in Hallway

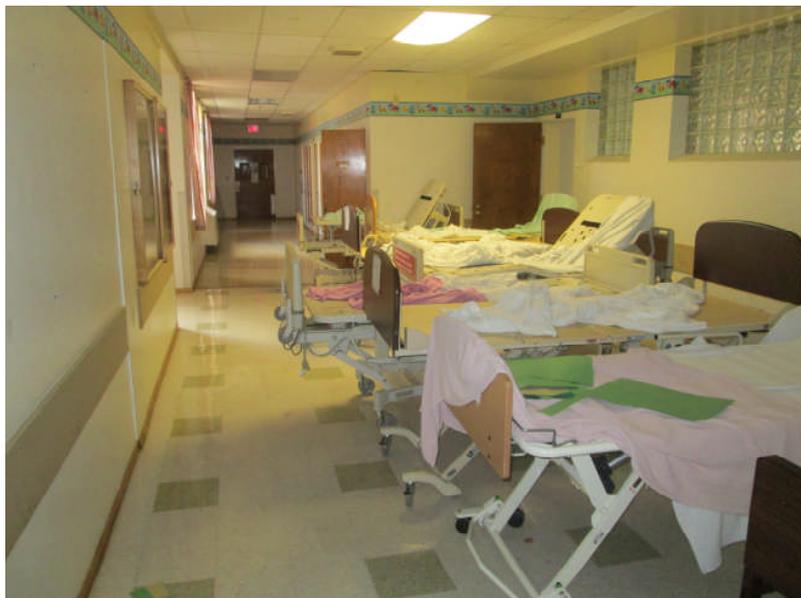
**PHOTO No. 14**

1<sup>st</sup> Floor – Beds Stored in Hallway

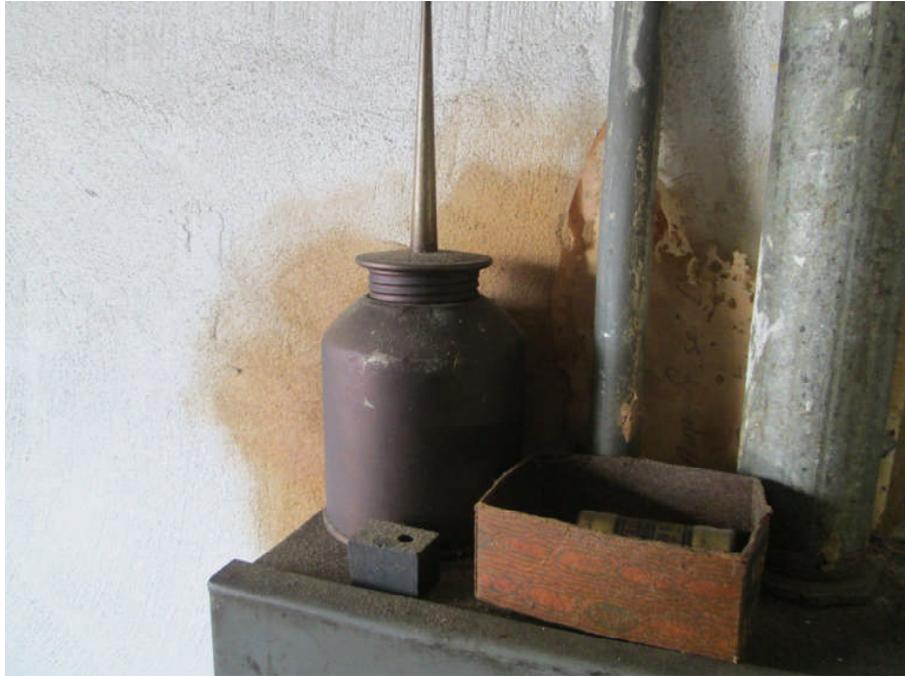
**PHOTO No. 23, February 19, 2013**

Oil Can in Elevator Equipment Room in Attic

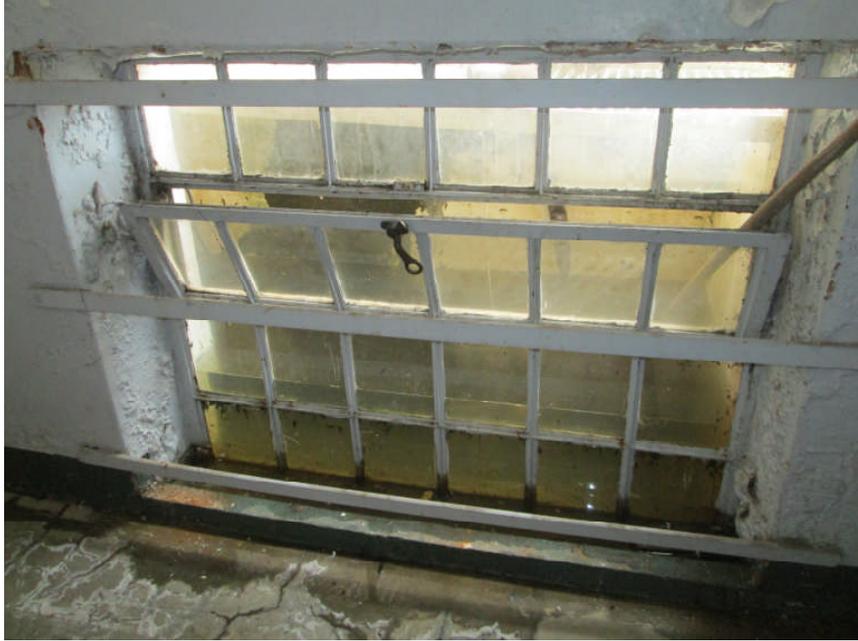
**PHOTO No. 31, February 19, 2013**

Water in Lower Level Window Well

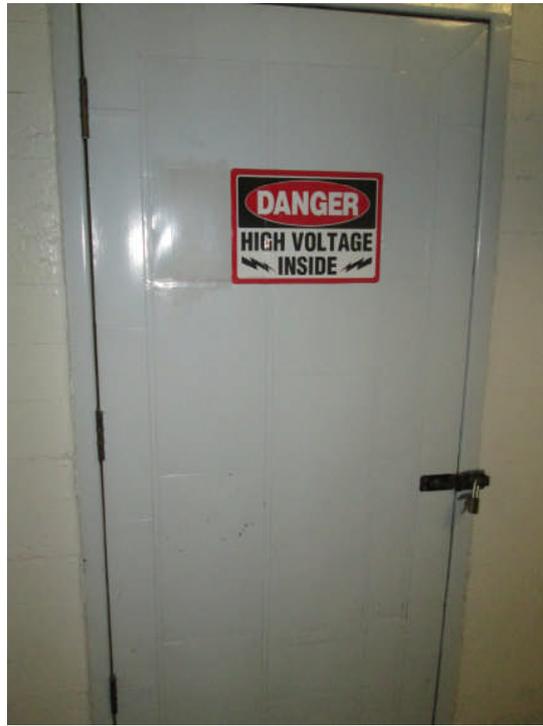
**PHOTO No. 35, February 19, 2013**

Electrical Room in Basement (Not Accessed)

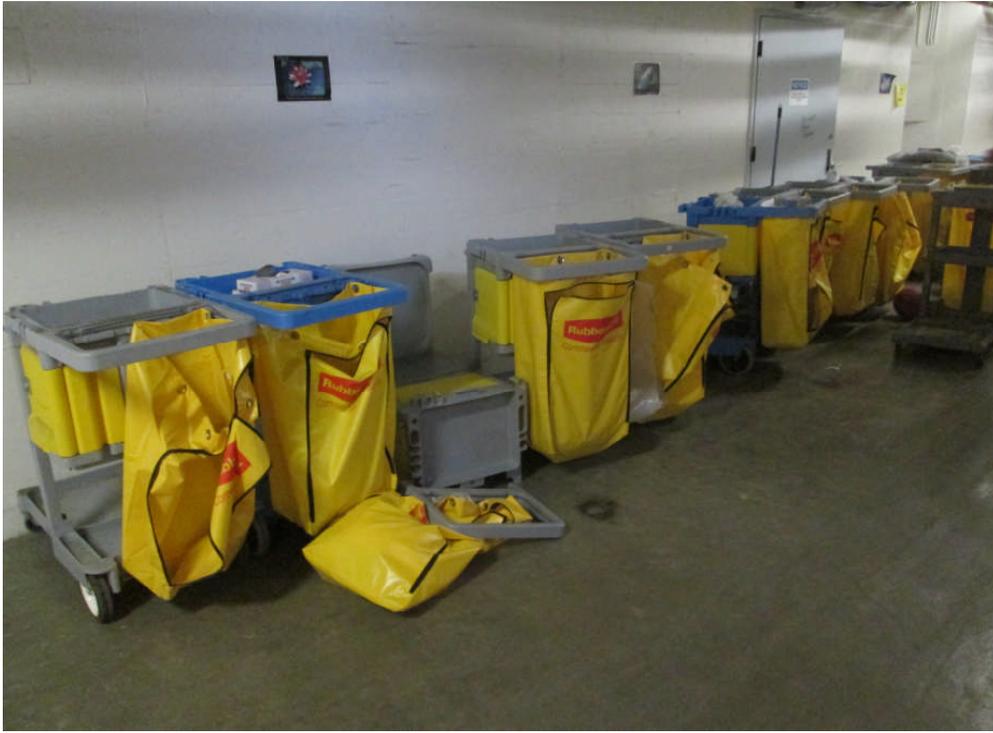
**PHOTO No. 37, February 19, 2013**

**Basement – Cleaning Stations Stored in Hallway/Tunnel**

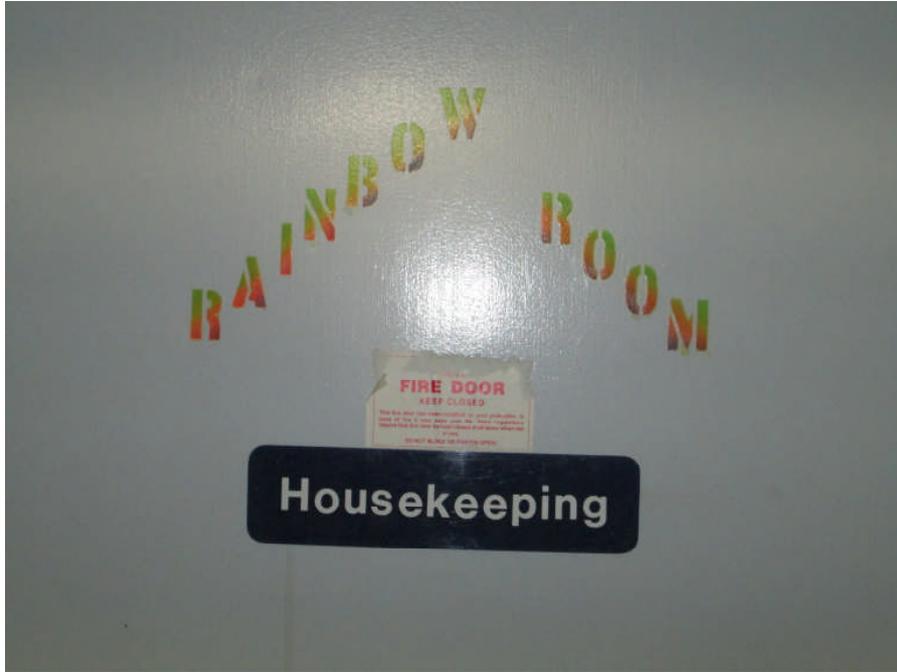
**PHOTO No. 43, February 19, 2013**

Basement – Rainbow Room (No Access)

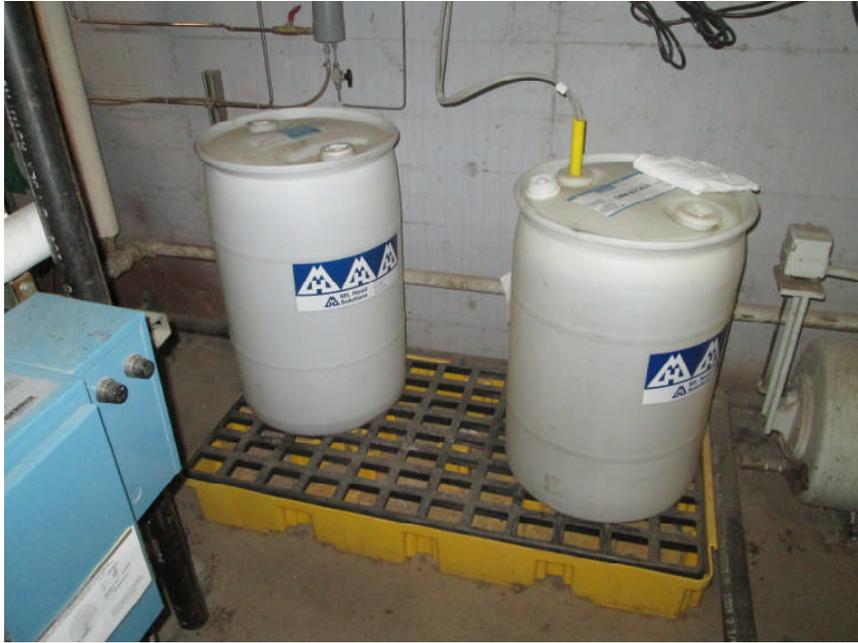
**PHOTO No. 45, February 20, 2013**

Basement – Mechanical Room, Boiler Chemical Drums on Containment

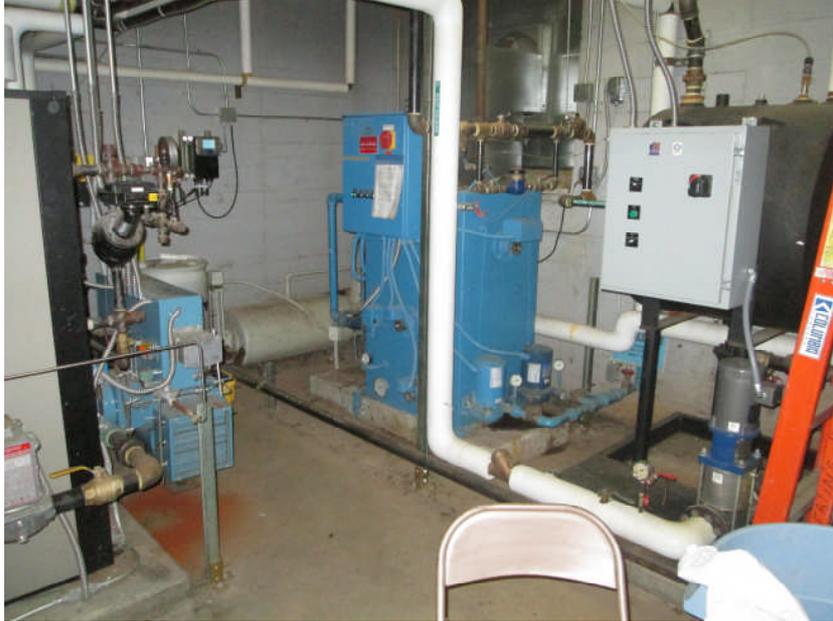
**PHOTO No. 47, February 20, 2013**

**Basement – Mechanical Room**

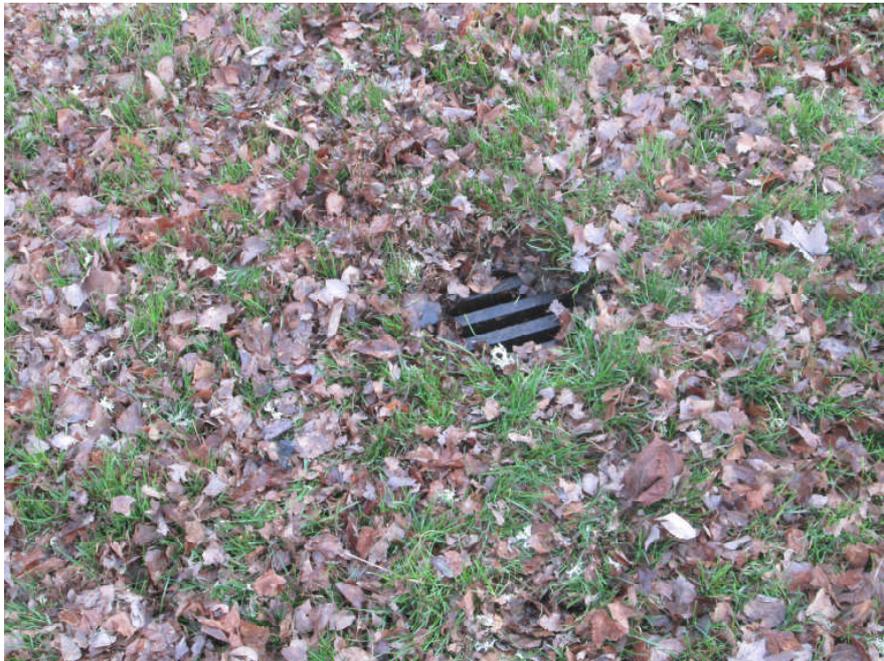
**PHOTO No. 48**

**Storm Drain in Grass West of Building**

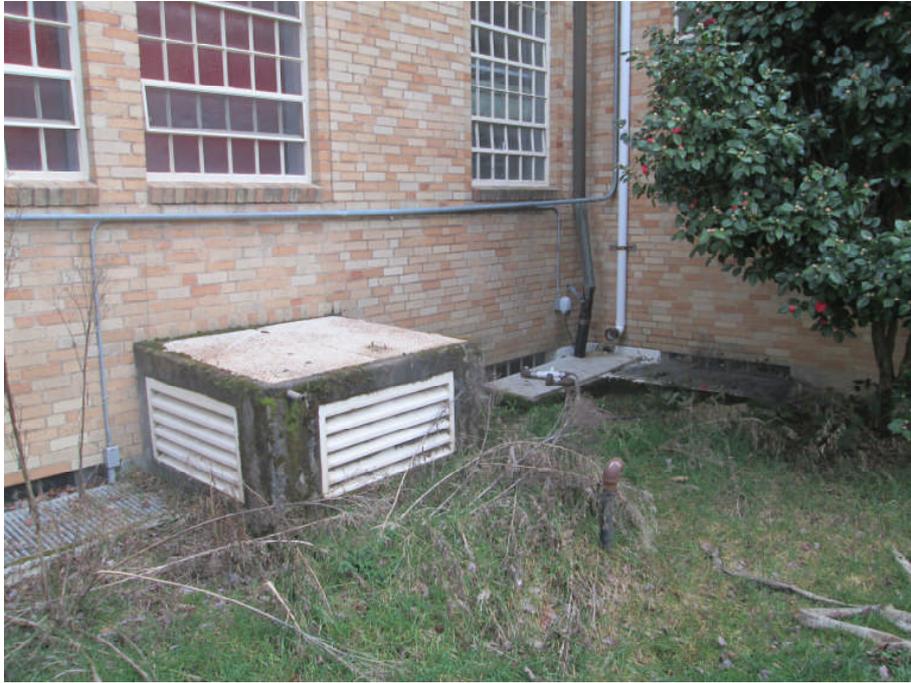
**PHOTO No. 49, February 20, 2013**

West Side of Building, South of Main Entrance – Unknown Structure, Possible UST

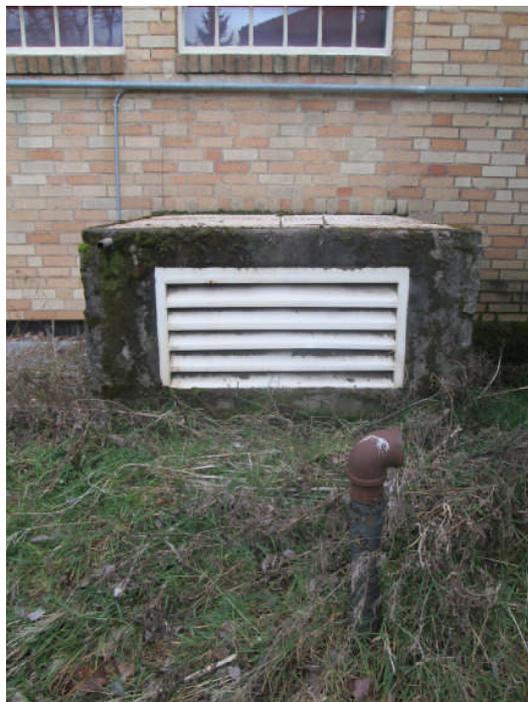
**PHOTO No. 50**

West Side of Building, South of Main Entrance – Unknown Structure, possible UST

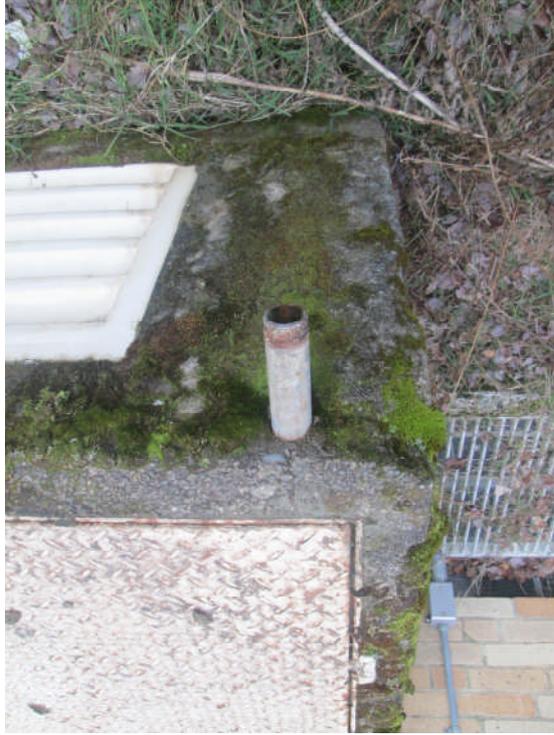
**PHOTO No. 51, February 20, 2013**

West Side of Building, South of Main Entrance – Unknown Structure, Possible UST

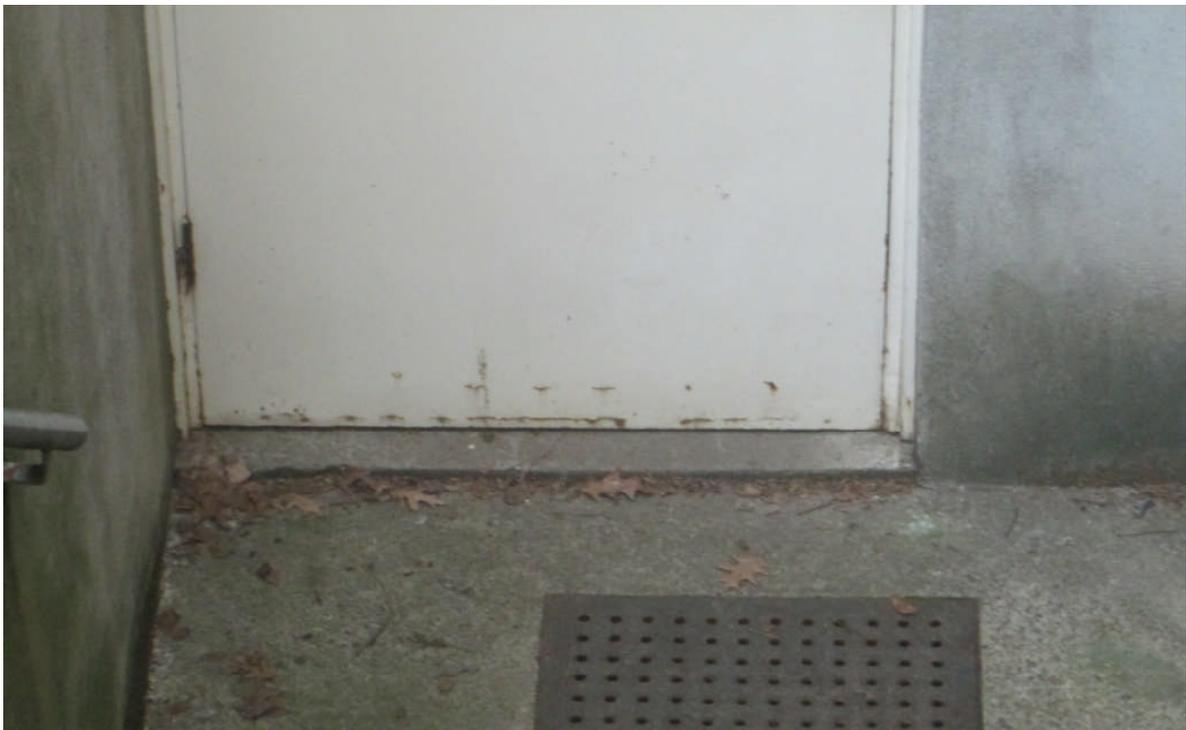
**PHOTO No. 52**

Storm Drain in Stairwell

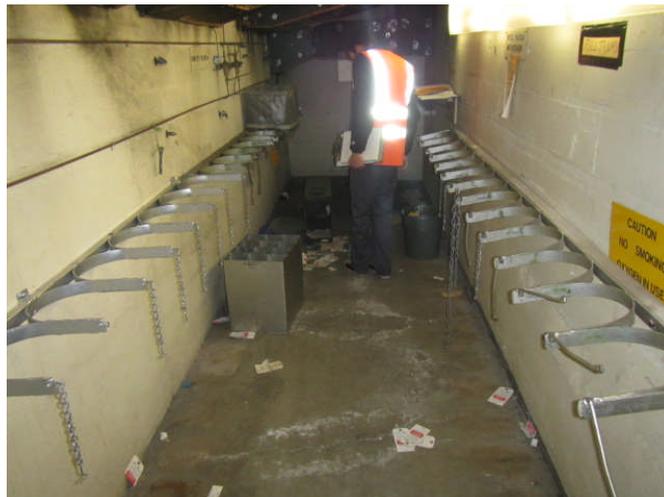
**PHOTO No. 4**

Basement – Storage Room, Former Gas Cylinder Storage

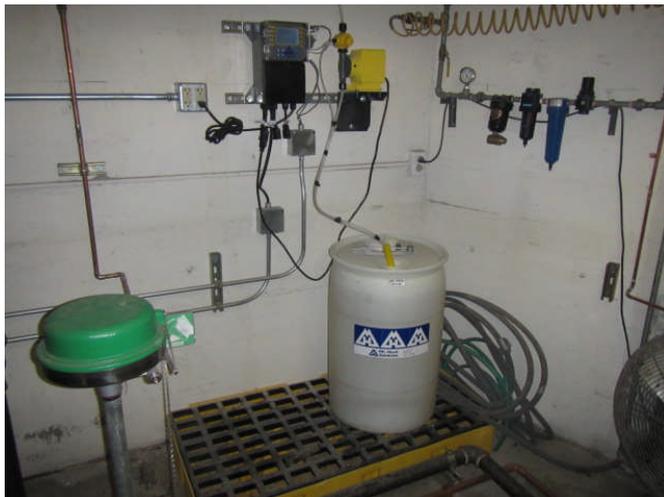
**PHOTO No. 6**

Basement – Mechanical room, Chemical (“Boiler Pro”) on Containment Pad

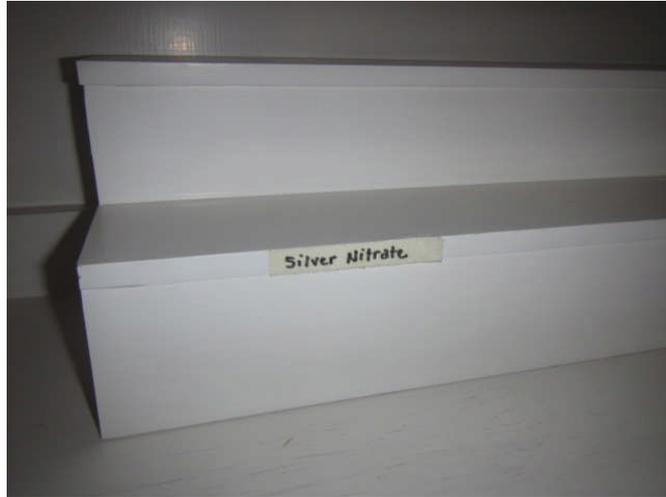
**PHOTO No. 13, February 19, 2013**

2<sup>nd</sup> Floor – Former Chemical Storage Area

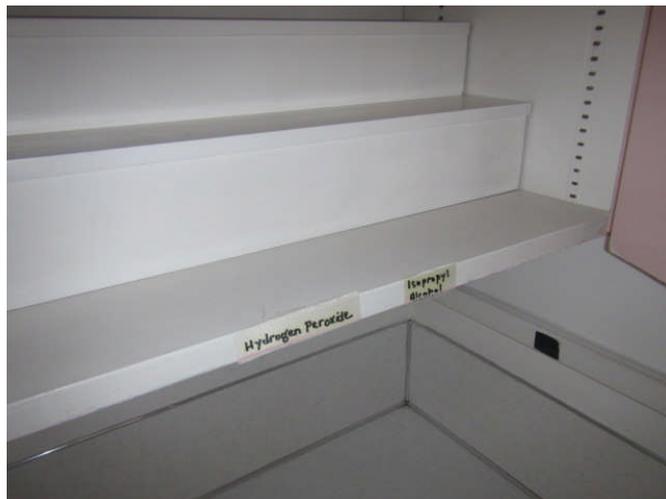
**PHOTO No. 14**

2<sup>nd</sup> Floor – Former Chemical Storage Area
