## **PHASE I ENVIRONMENTAL SITE ASSESSMENT REPORT**

**Oregon State Hospital – North Campus  
2575 Bittern St. NE, 2575-2600 Center St. NE  
Salem, OR 97301**

May 14, 2013  
185750103

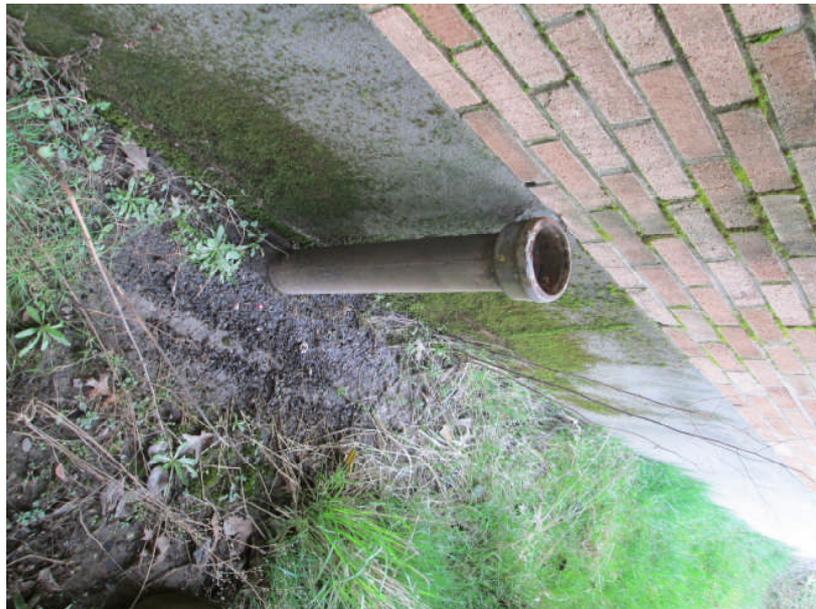
**PHOTO No. 40**

Unknown Pipe Adjacent to Exterior Wall

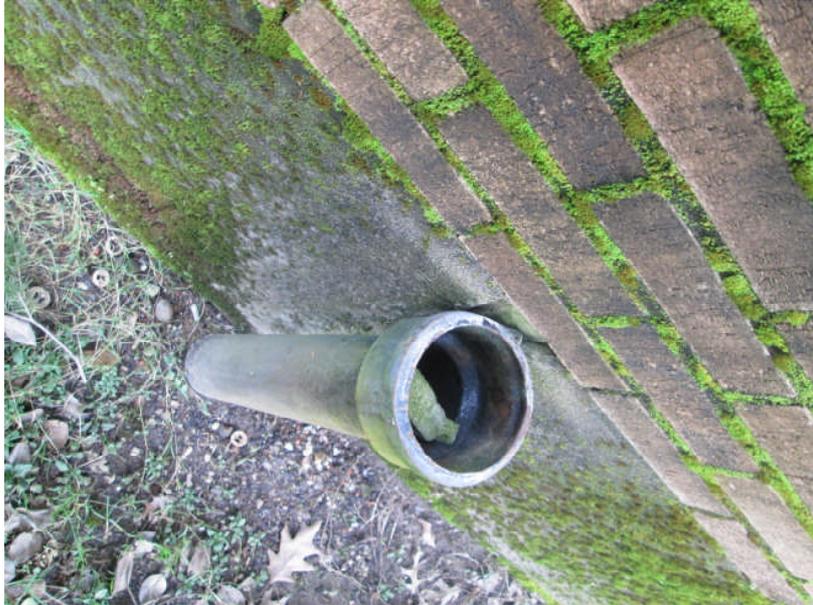
**PHOTO No. 41, February 20, 2013**

Unknown Pipe Adjacent to Exterior Wall

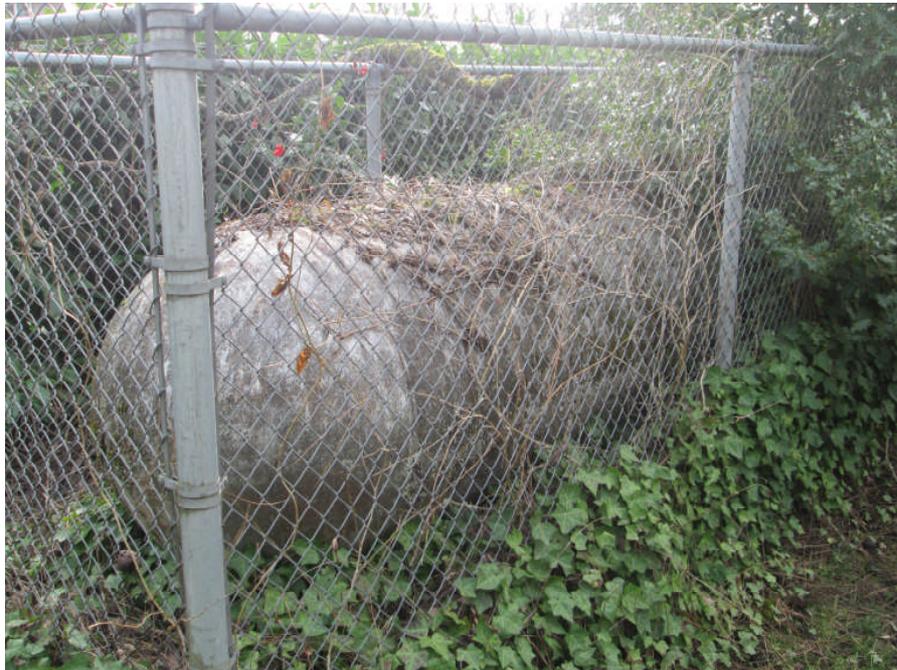
**PHOTO No. 44**

An old propane AST is present east of Santiam Hall (see Santiam Hall, Photos 44 and 45 in Appendix A). The AST does not appear to be in use.

Old Propane Tank East of Building

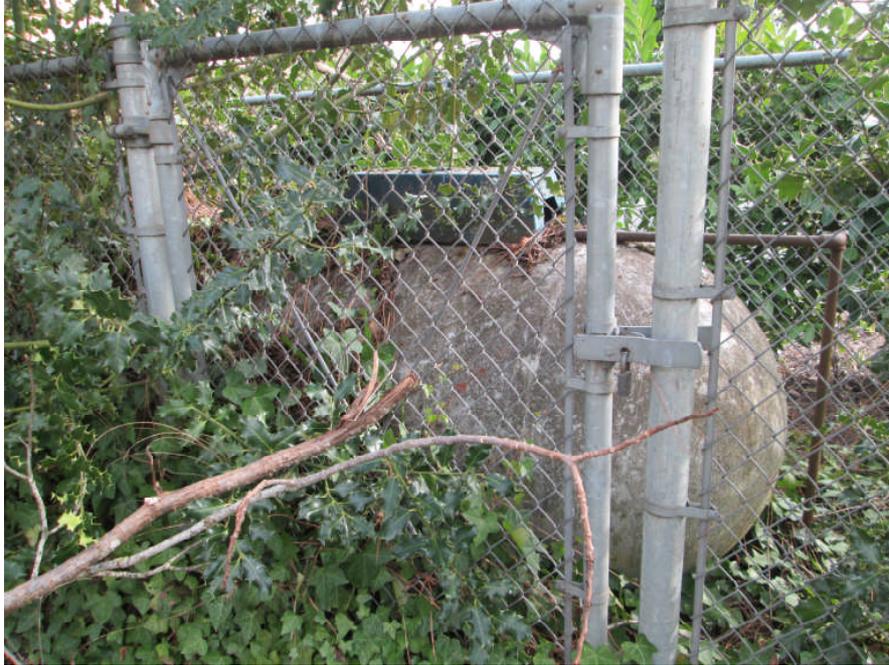
**PHOTO No. 45, February 20, 2013**

Old Propane Tank East of Building

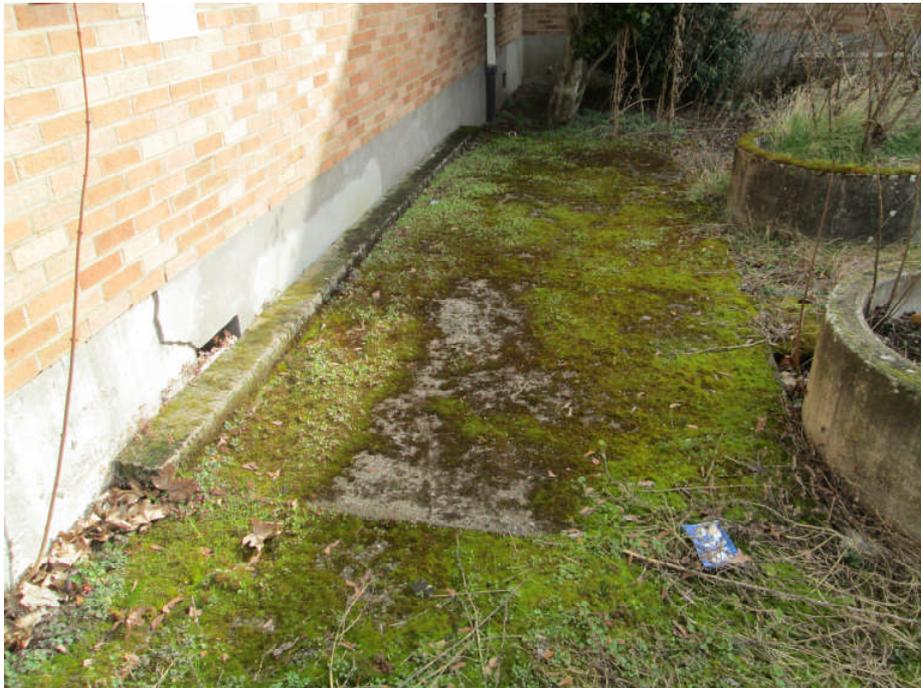
**PHOTO No. 46**

Unknown Concrete Slab Adjacent to South Side of Main (West) Entrance

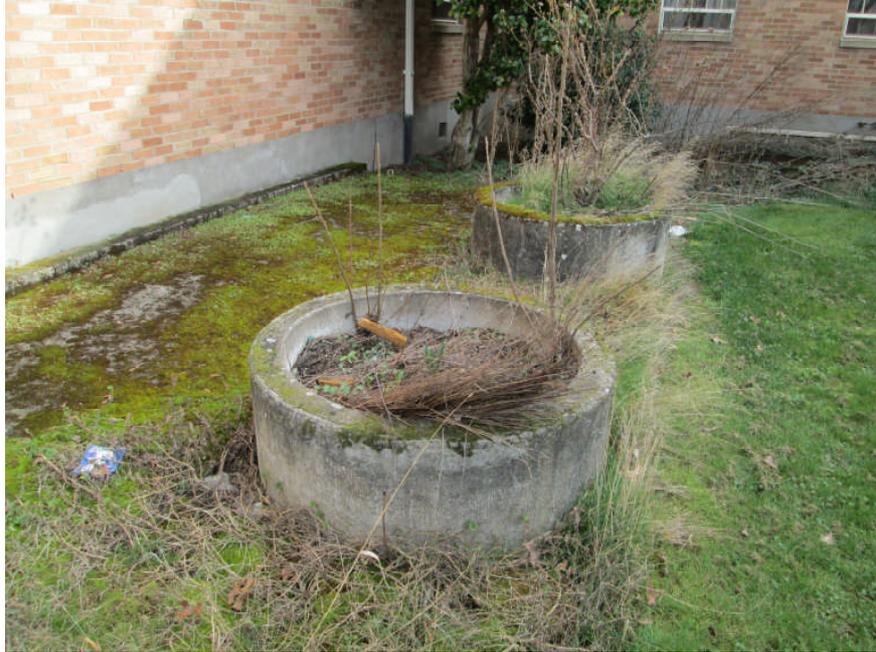
**PHOTO No. 47, February 20, 2013**

Odd Planters Adjacent to Building

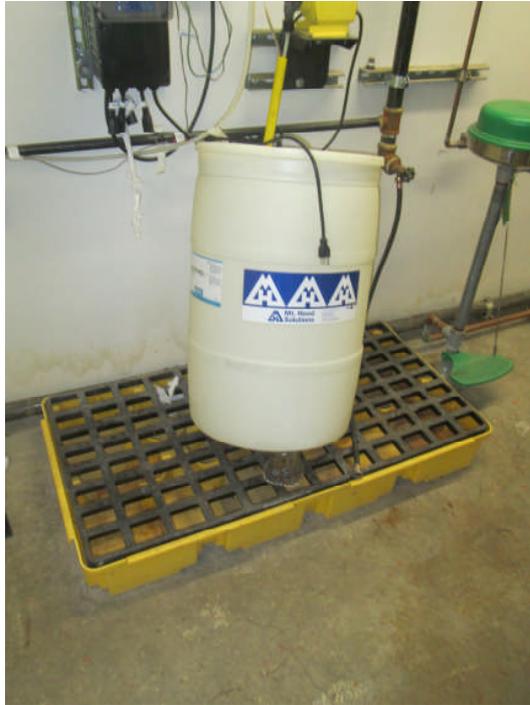
**PHOTO No. 7, February 19, 2013**

Basement – Mechanical Room, Boiler Chemicals on Containment

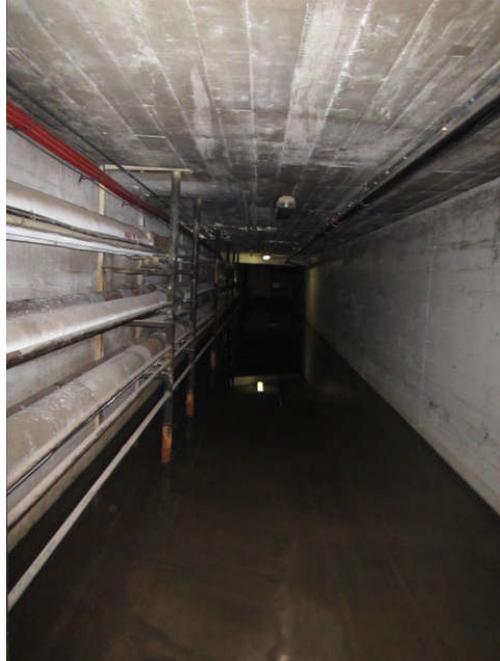
**PHOTO No. 1, February 19, 2013**

Flooding in Tunnel East of Breitenbush Leading South Towards OSH-SC

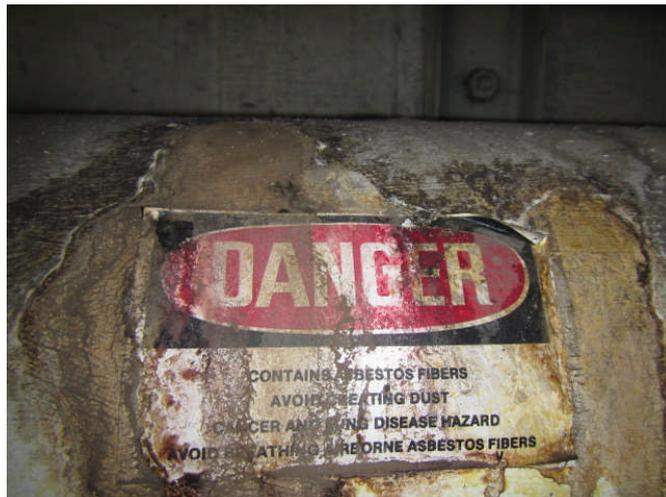
**PHOTO No. 2**

Asbestos Label on Pipe Wrap in Tunnel

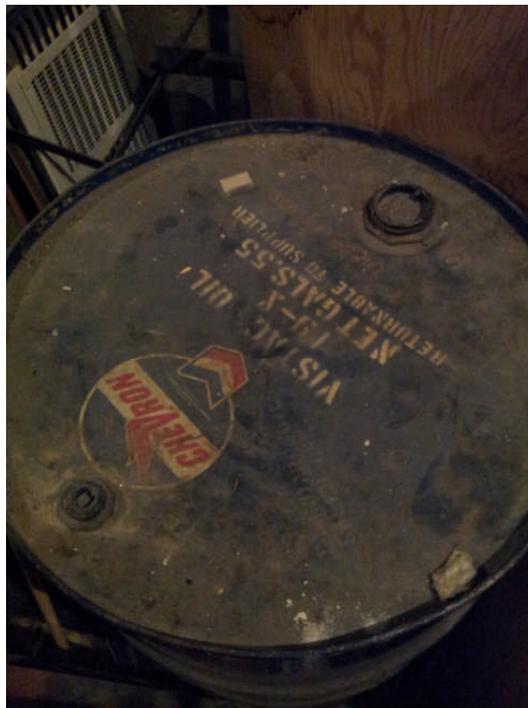
**PHOTO No. 18**

Eola Hall, Basement – Oil drum in storage room B004

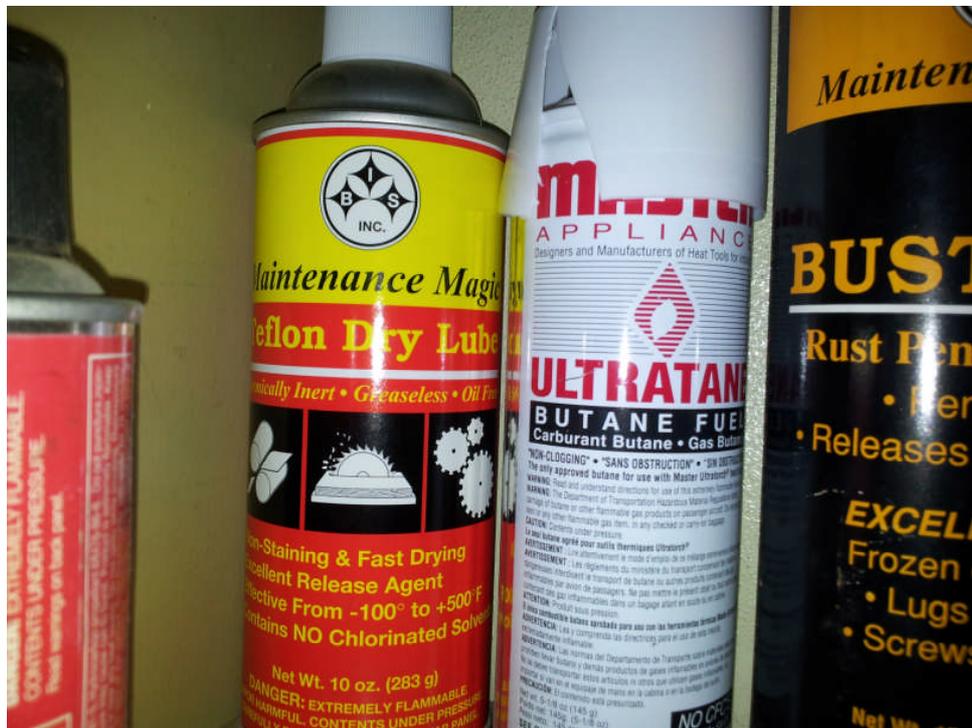
**PHOTO No. 30**

McKenzie Hall, Basement – Storage room B004, containers

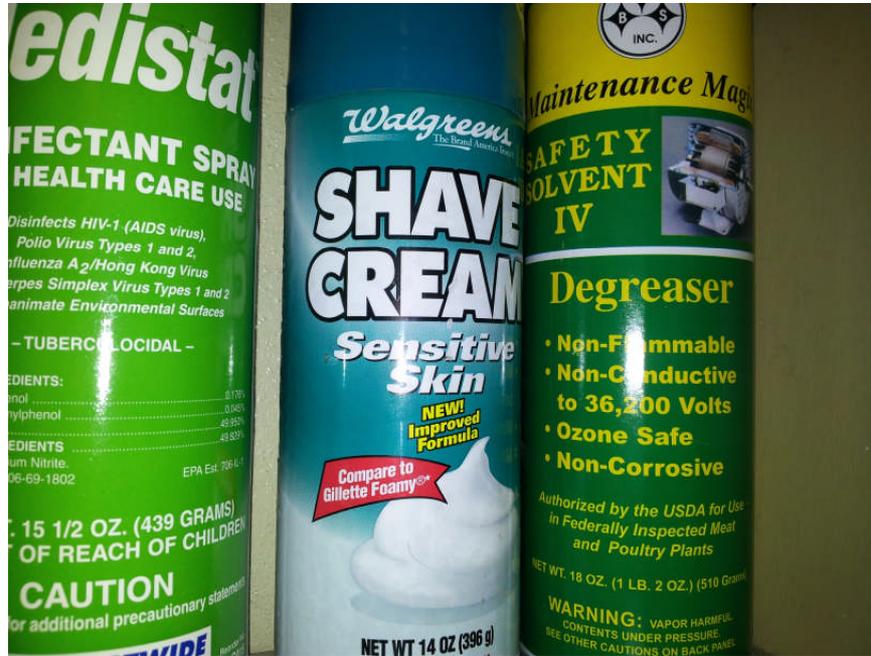
PHOTO No. 31, February 19, 2013

McKenzie Hall, Basement – Storage room B004, containers

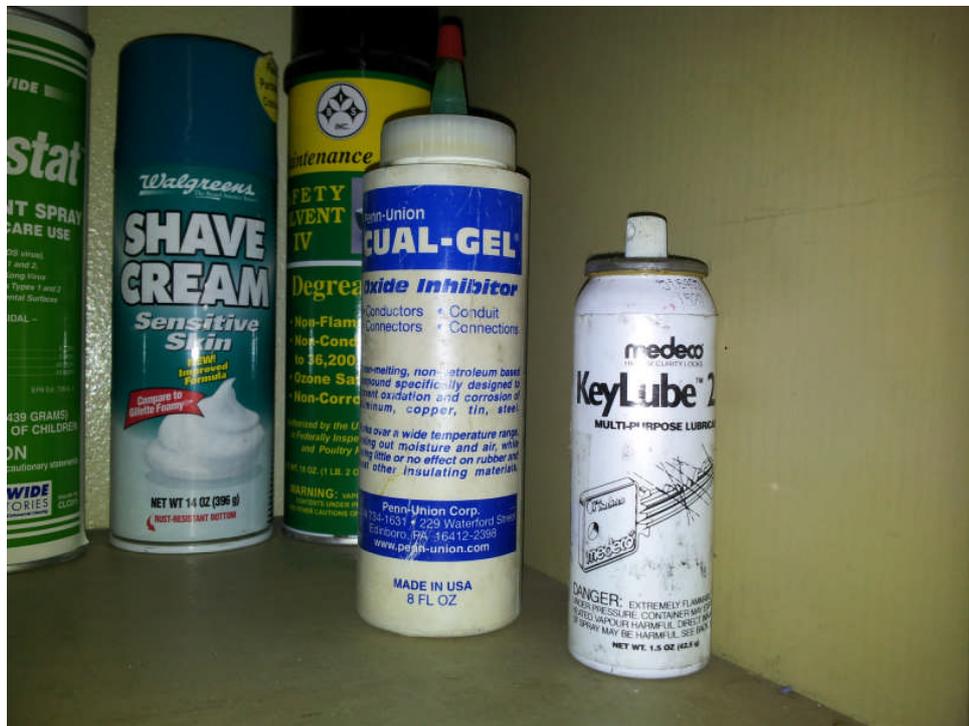
PHOTO No. 32

McKenzie Hall, Basement – Storage room B004, containers

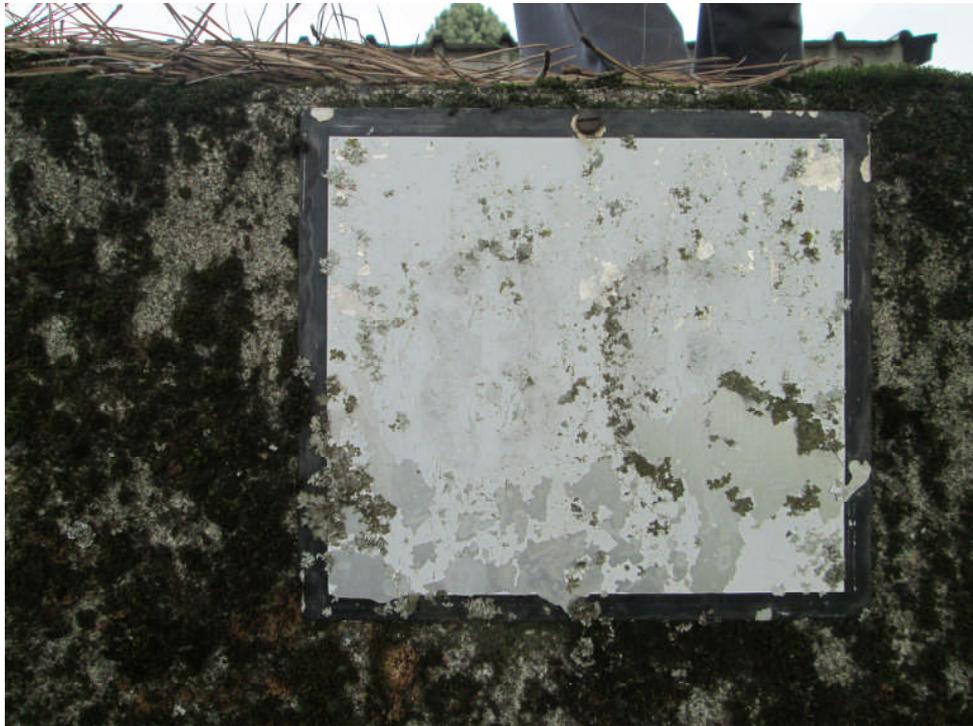
**PHOTO No. 1, February 20, 2013**

Utility Structures West of Dome Building

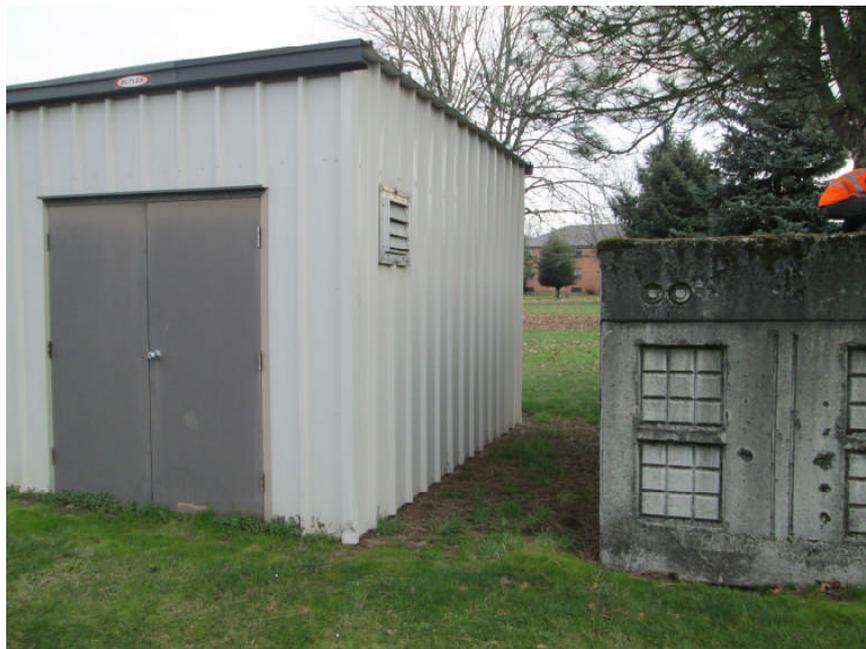
**PHOTO No. 2**

Utility Structures West of Dome Building (No Access)

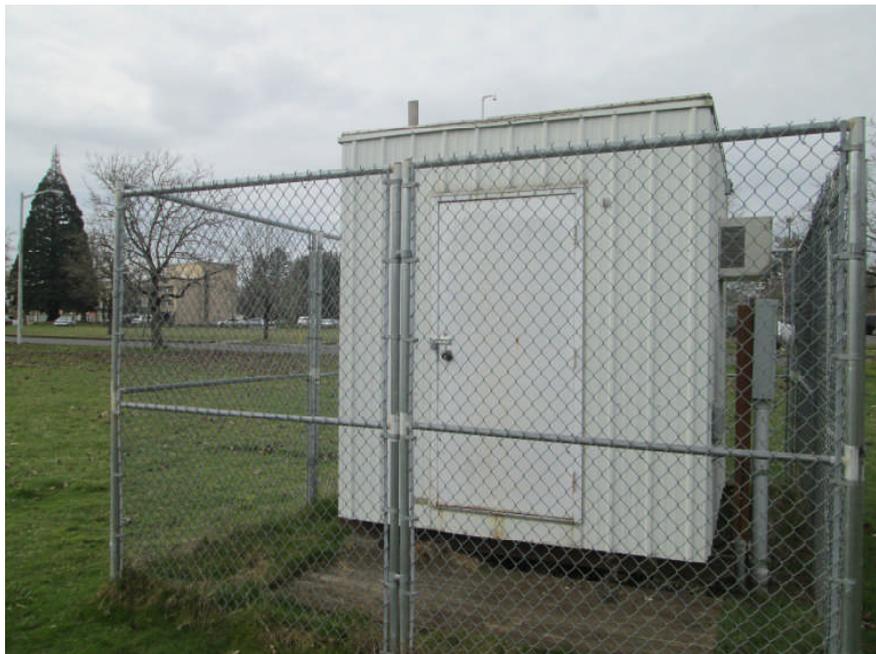
**PHOTO No. 6**

**Utility Building Near NW Corner of Site (Inaccessible)**
