Oregon School for the Deaf

Building Type	County	
School	Marion	
Street		
999 Locust St		
City	State	Zip
Salem	OR	97303
Latitude	Longitude	
44.96597	123.02334	
Tracking Code	Inspection Date	
RVS in 2006	7/20/2006

FEMA 154 Rapid Visual Screening Score Card

Rapid Visual Screening - Senate Bill #2 - Seismic Needs Assessment
Oregon Department of Geology and Mineral Industries

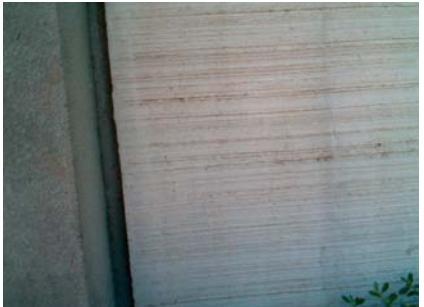
N Primary Structural Type

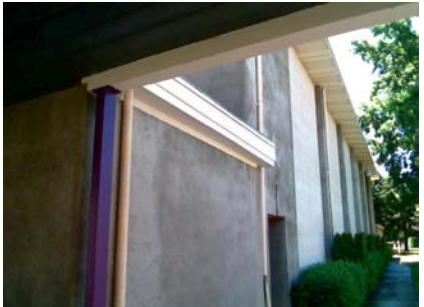
NE Pounding Potential

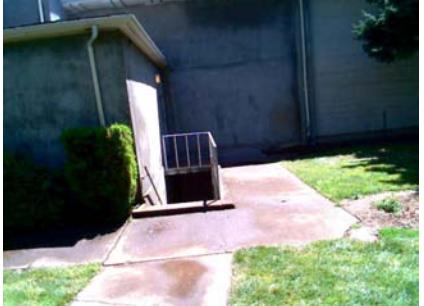
NW Basement

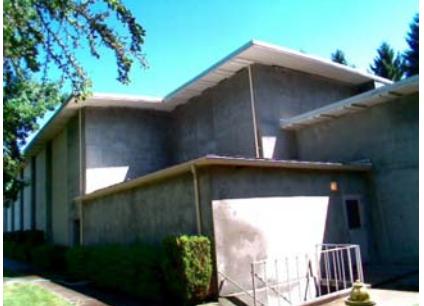
NW Vertical Irregularity Primary

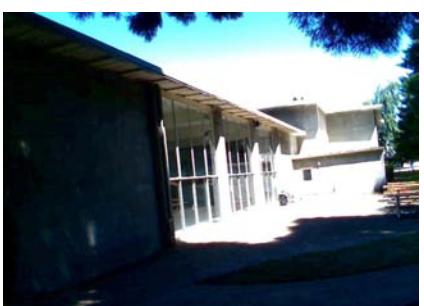
SW Plan Irregularity Primary

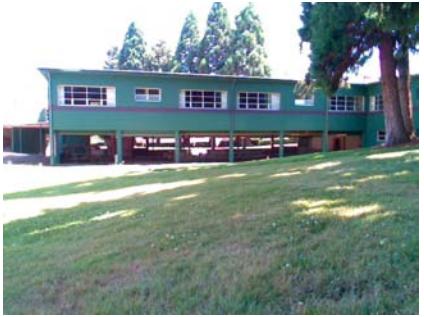
NW General Site	W General Site	NW Plan Irregularity Primary

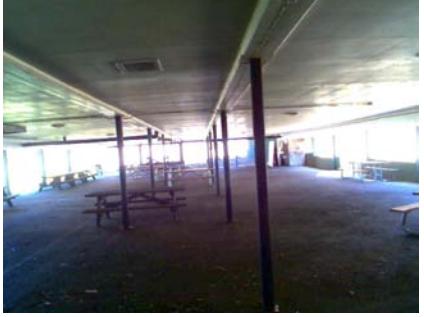
SW Vertical Irregularity Primary	SE General Site	S Pounding Potential

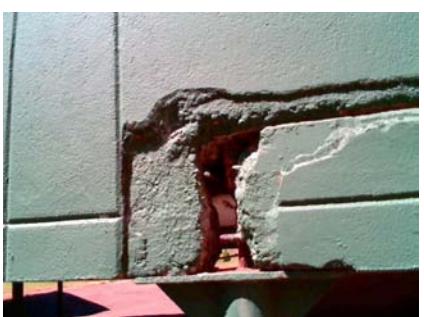
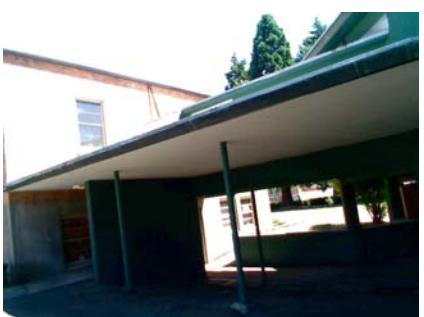
S Pounding Potential	NW Pounding Potential	NE Vertical Irregularity Secondary

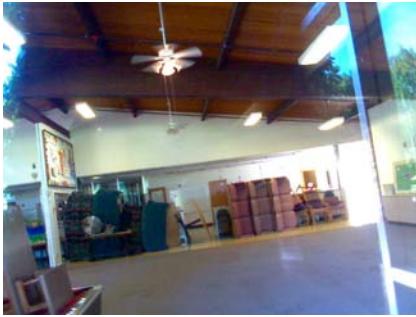
W General Site		W Primary Structural Type

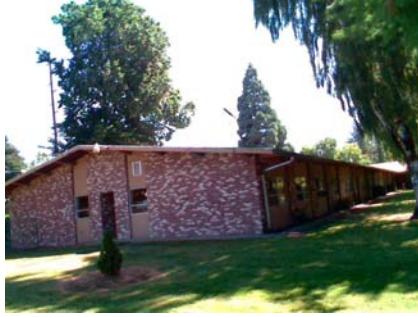
N General Site		N Falling Hazard

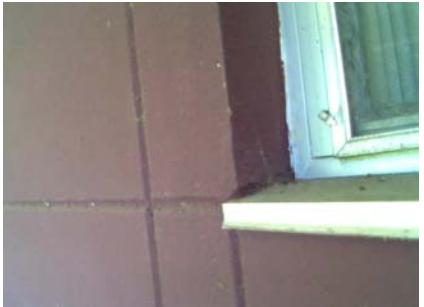
S Primary Structural Type

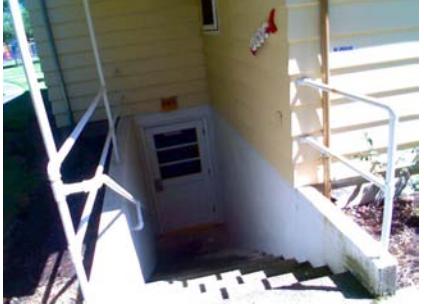
NW Basement

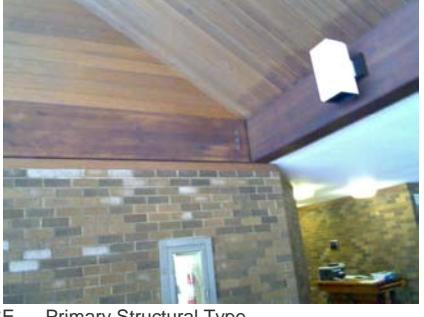
SE Primary Structural Type

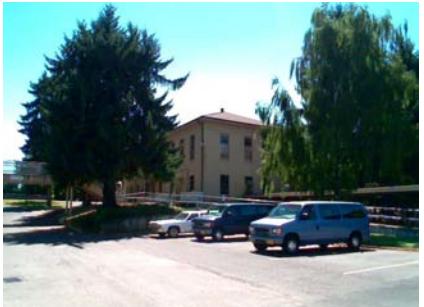
NE General Site		SE Falling Hazard

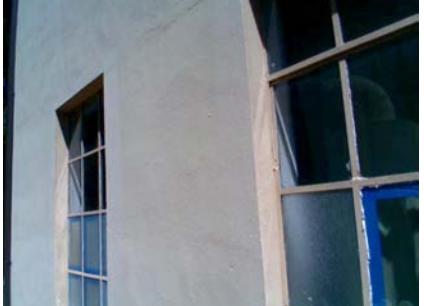
W Primary Structural Type

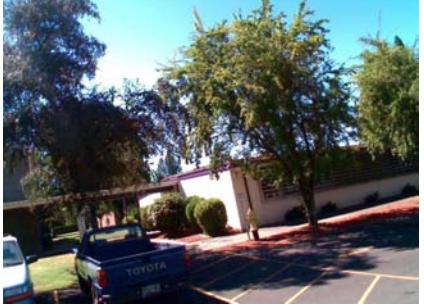
E Pounding Potential

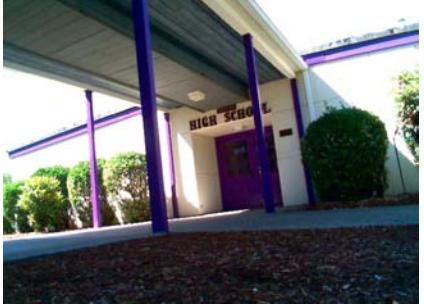
E Pounding Potential

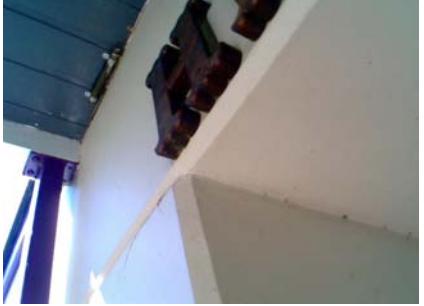
SE Primary Structural Type

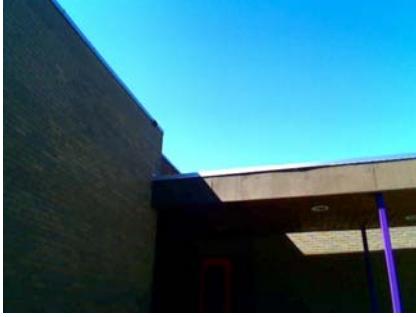
E Pounding Potential

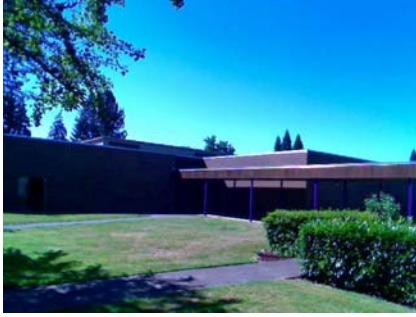
SE Vertical Irregularity Primary

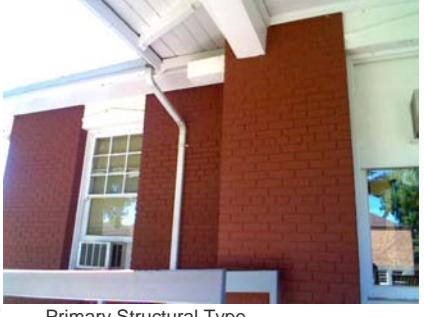
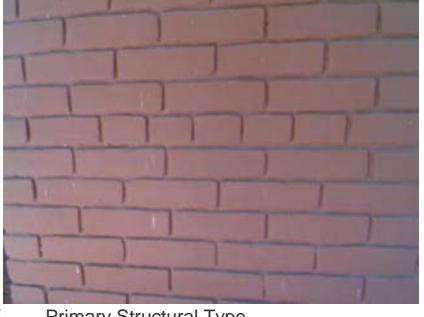
E	Primary Structural Type	E	Primary Structural Type
