Culvert Repair Programmatic Agreement (CRPA) Pilot Final Report

Report Prepared by
William Warncke and Allen Gillette, ODOT

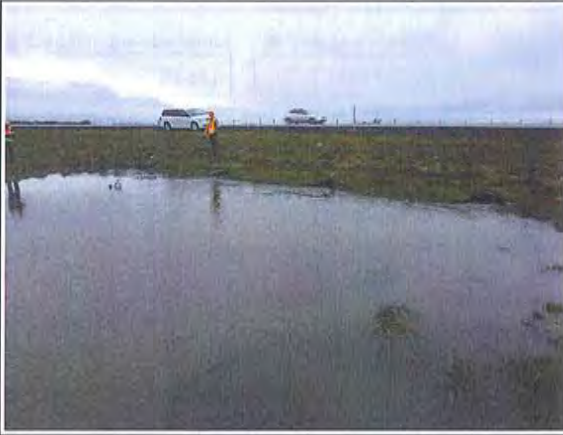
Photo 1: Inlet end (C) -

A set of four culverts that convey a tributary of Lake Creek under I-5 at MP 227.47 are failing and require maintenance. The majority of the length of each of the culverts are made of concrete, but the last 50' on both ends are CMPs. The concrete sections of these pipes are functioning well, but the CMP sections are rusted out. The proposed fix is to remove and replace the 50' CMP sections via an open trench. The proposed fish passage improvement is to construct a boulder weir immediately downstream of one of the four culverts in order to backwater it. Hydraulic analysis shows that one weir will be sufficient to backwater the length of the single culvert and will not create a jump height greater than 6".

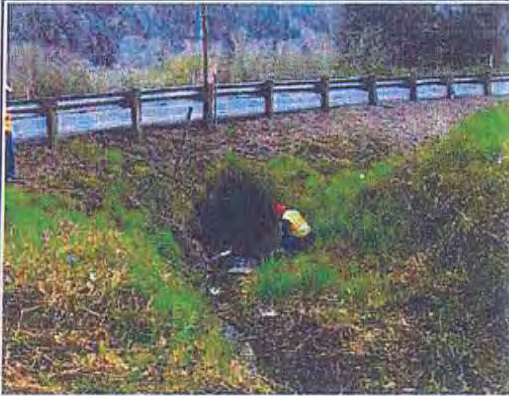
Photo 1: Inlet end (C) -

The culvert carrying an un-named tributary to the Umpqua River under OR 38 at MP 6.42 is in poor condition and in need of repair. The proposed repair will pave the invert of the culvert and replaced a 20' section of culvert. Notched weirs will be added inside the culvert to facilitate and improve fish passage. The culvert is low gradient with no perch at the outlet. The weirs will increase water depth and accommodate fish passage over a wider variation of flows.

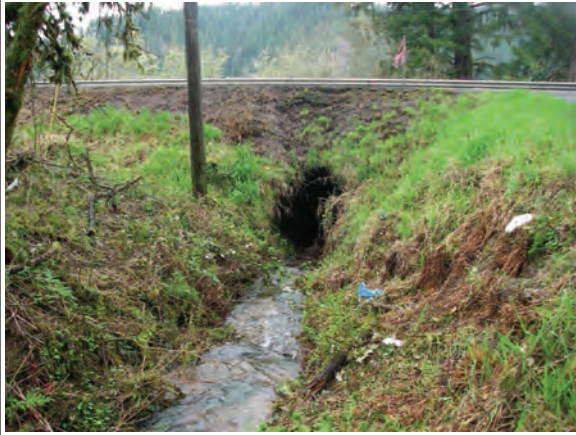
Photo 1: Inlet end (C) -

The culvert carrying an un-named tributary to the Umpqua River under OR38 at MP 6.92 is in poor condition and in need of repair. The repair will consist of paving the culvert inlet. Notched weirs will be added inside the culvert to improve fish passage. The culvert is low gradient and tidally backwatered by the Umpqua River. The outlet ranges between being tidally backwatered to being perched up to one foot, depending on tide and flow conditions in the Umpqua. The weirs will increase water depth inside the culvert and accommodate fish passage over a wider variation of flows.

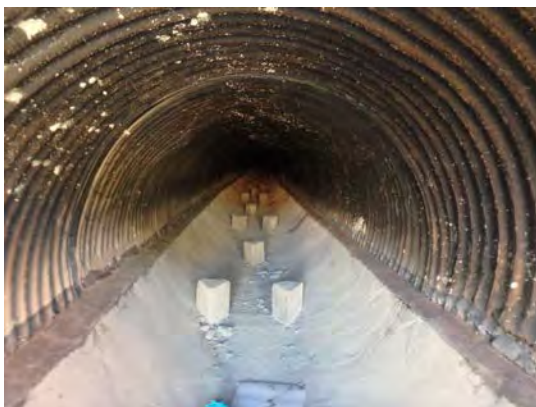
Inside culvert showing invert paving and roughness features (9/20/16)

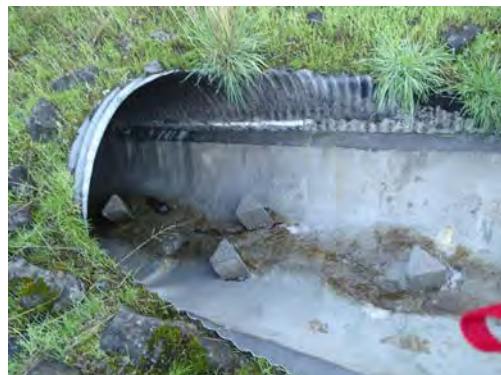
Roughness features creating turbulence, increased water depth, and longer flow path during low flow (10/26/16)

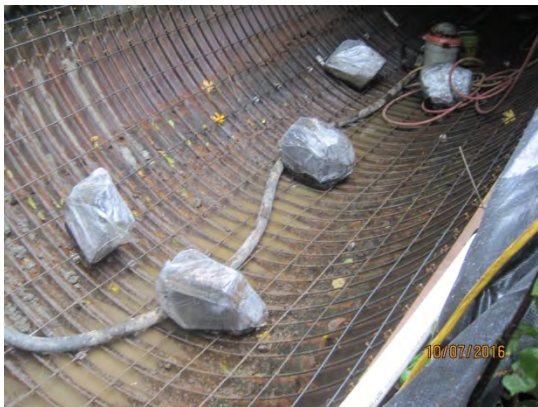
Rebar cage and fish rocks in place prior to invert paving (10/7/16)

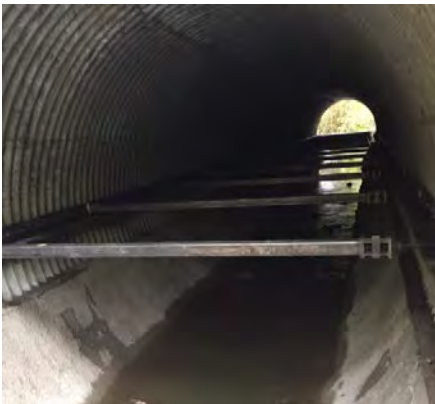
Post-construction bracing and invert paving (10/20/16)

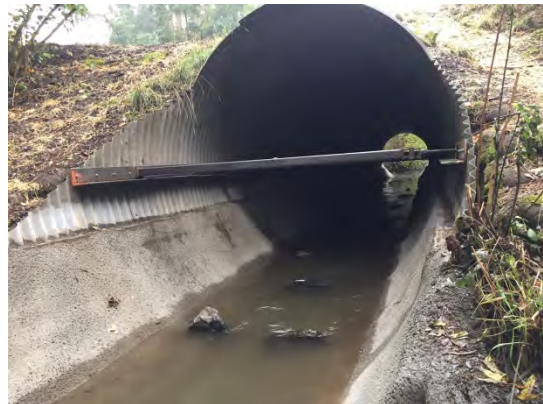
Post construction fish rocks (10/20/16)

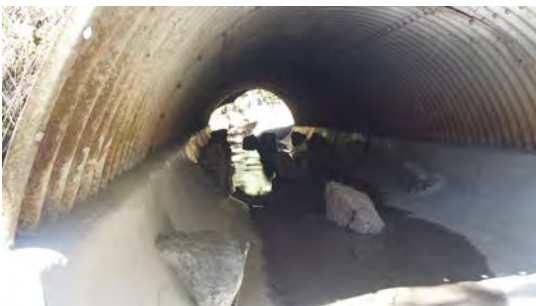
Post-construction - Invert paving and fish rocks installed (9/29/16)

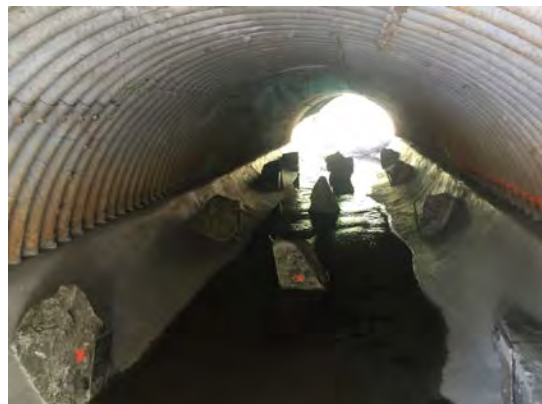
Post-construction - Invert paving and fish rocks installed (9/29/16)

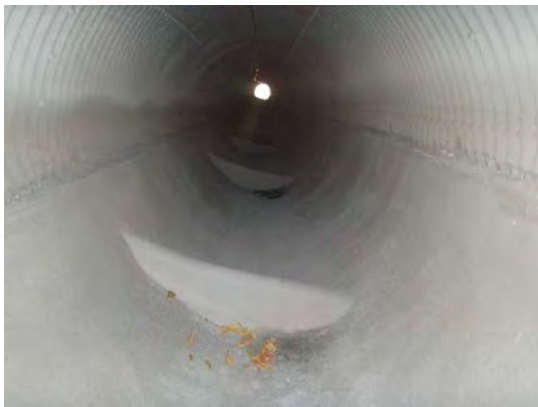
Invert paving with sloped weirs prior to the return of flow (9/20/16)

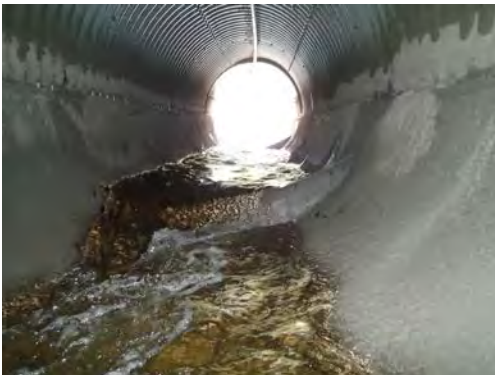
The slump in the middle of the pipe resulted in a less backwater at this weir location (near inlet) than anticipated (10/26/16)

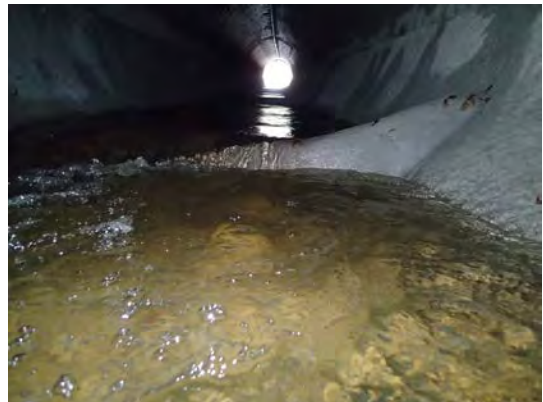
Typical sloped weir configuration with low flow (10/26/16)

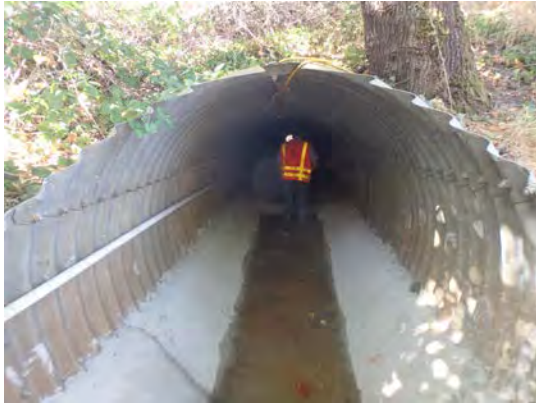
Walking into culvert inlet right post-construction (9/20/16)

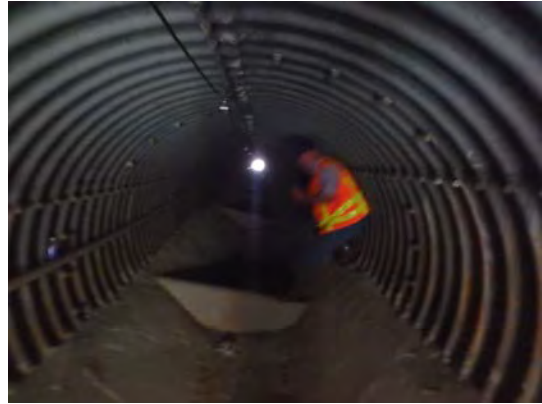
Sloped weirs prior to re-watering of culvert (9/20/16)

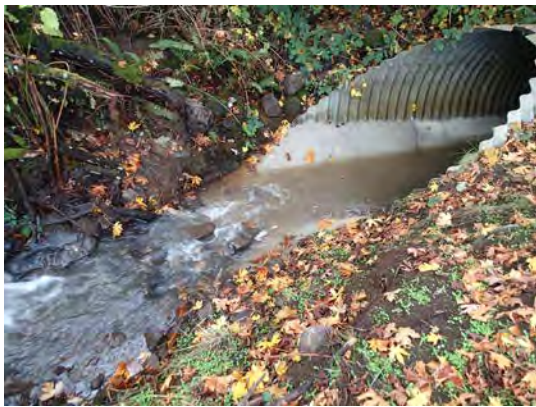
Culvert inlet post-construction (10/26/16)

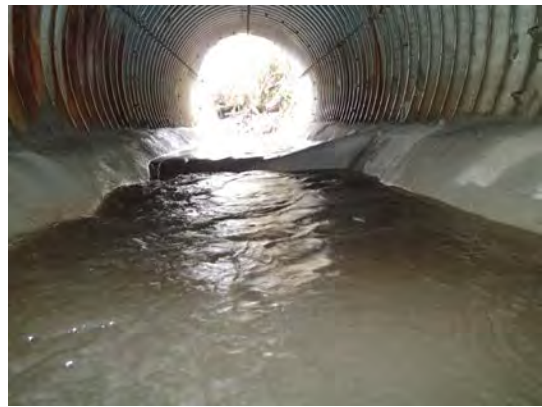
Sloped weir looking upstream toward culvert inlet (10/26/16)

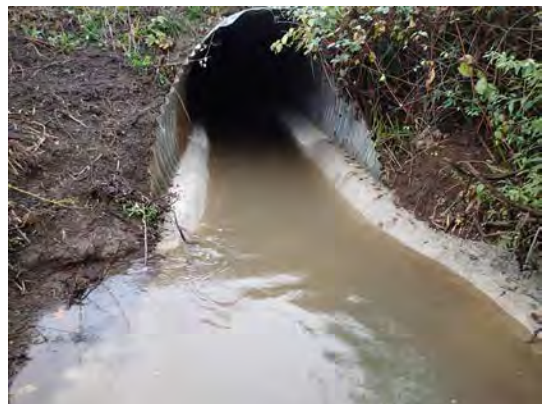
Culvert outlet – backwatered (10/26/16)

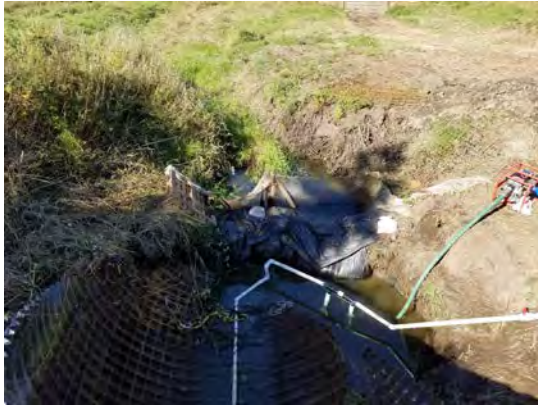
In-water work area isolation at culvert inlet - 2017

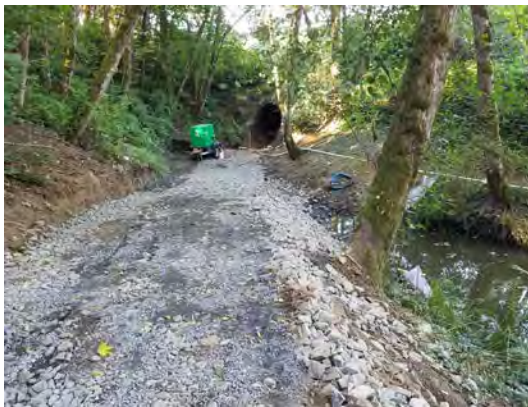
Looking toward culvert outlet and access road - 2017.

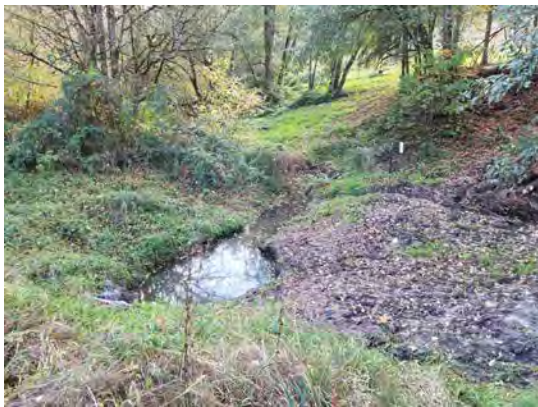
Looking downstream at outlet of culvert

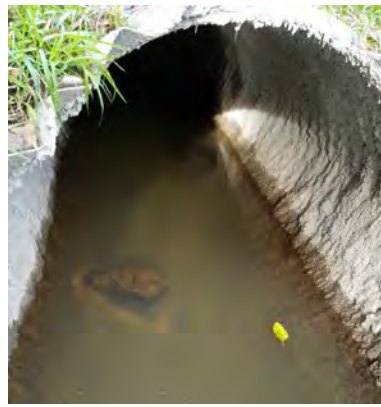
Outlet of culvert is backwatered

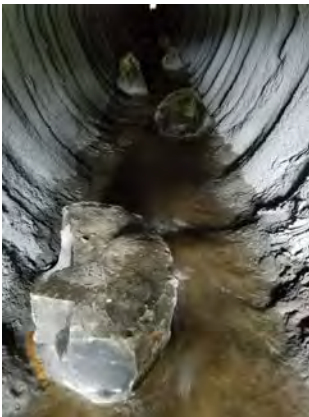
Fish rocks inside culvert

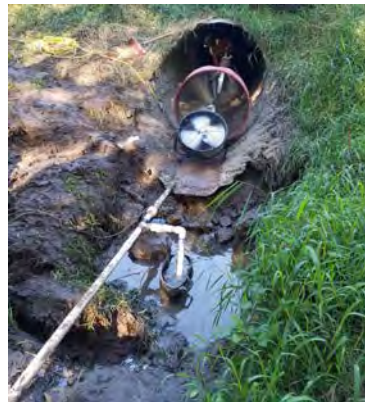
Outlet of
culvert during construction showing work
area isolation

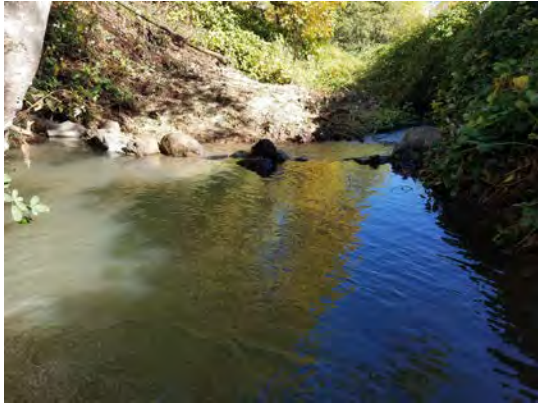
Looking downstream from culvert at boulder weir

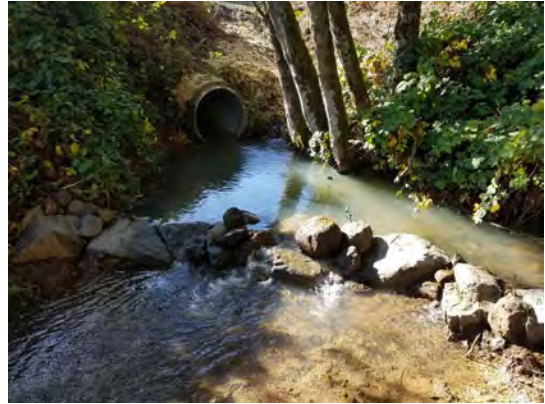
Looking upstream at boulder weir below culvert outlet to back water up into culvert

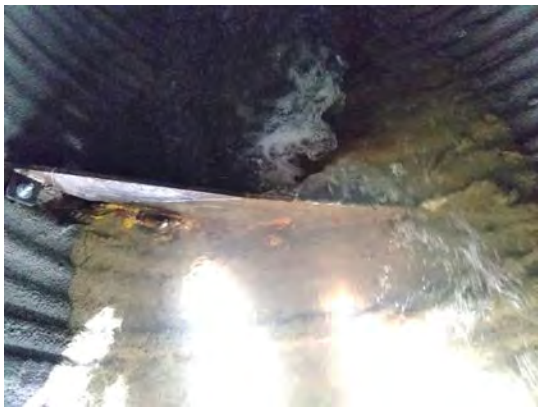
Baffle inside culvert showing resting habitat and deeper water

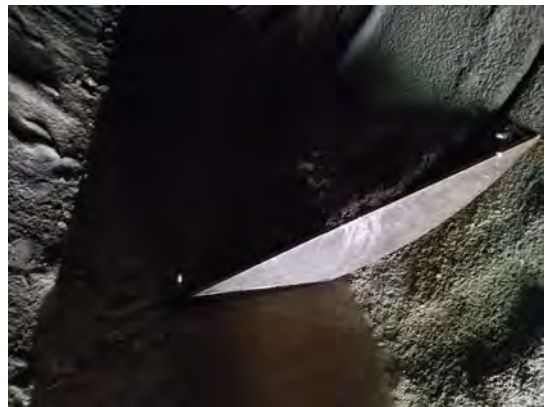
Baffle inside culvert during lower flow – steel corner baffles are bolted to culvert

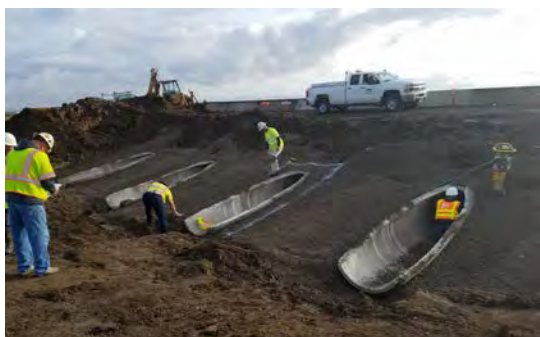
New culvert outlets in construction

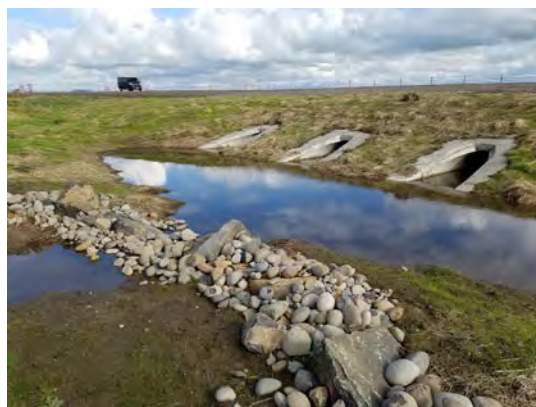
New downstream weir to back water into culverts

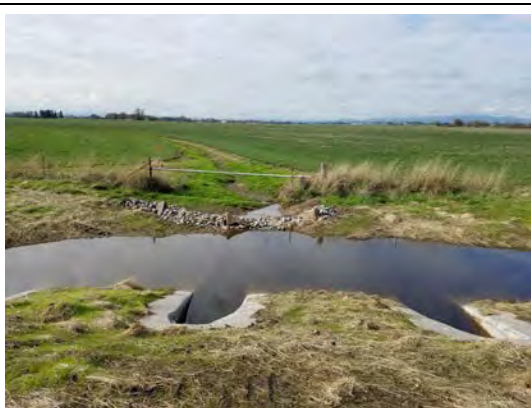
Looking downstream from outlets

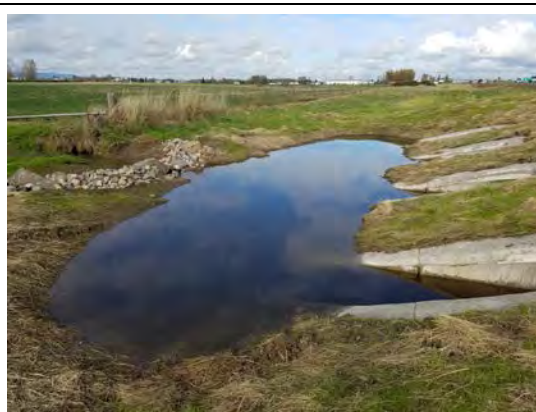
Culvert outlets with weir

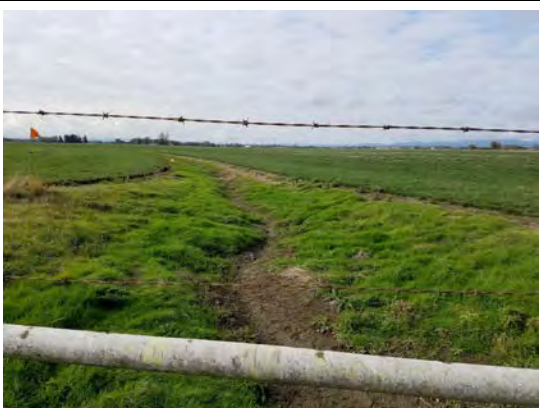
Looking upstream at inlet side of culvert

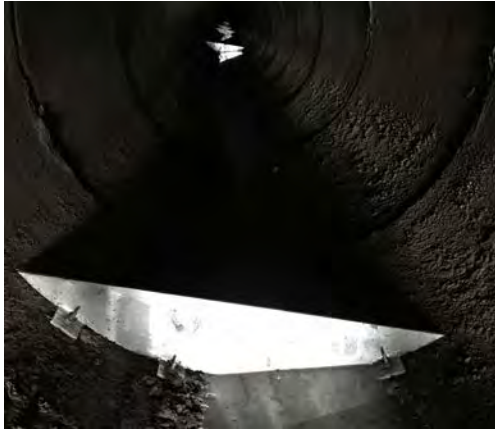
Internal culvert baffles

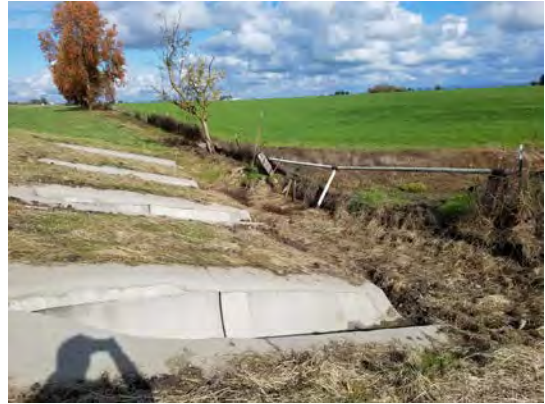
New culvert inlets

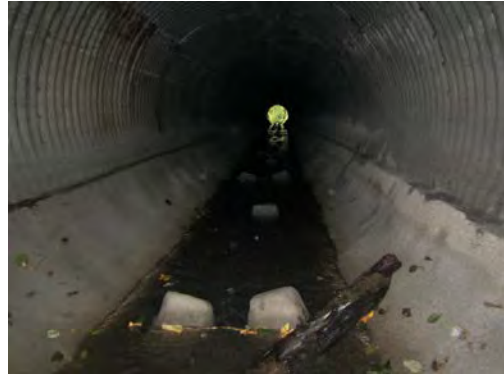
Inside culvert showing invert paving and simulated fish rocks – some debris on double rock installation

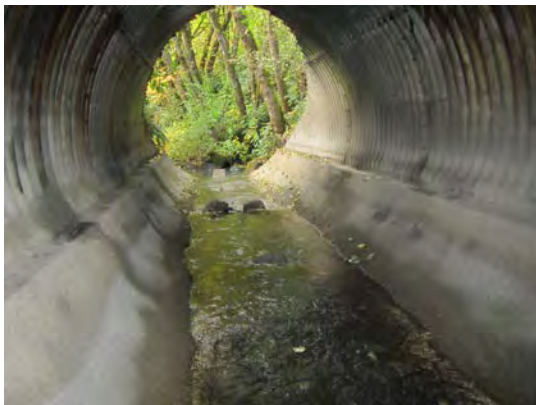
Looking downstream toward culvert outlet showing weir

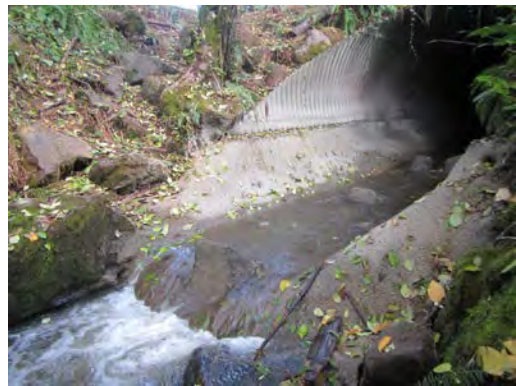
Culvert outlet at winter base flow. There is a steep section at the end of the culvert treatment - 2017

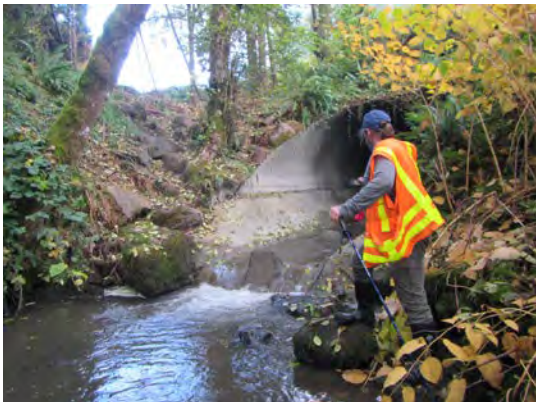
Looking upstream at culvert outlet - fall 2017

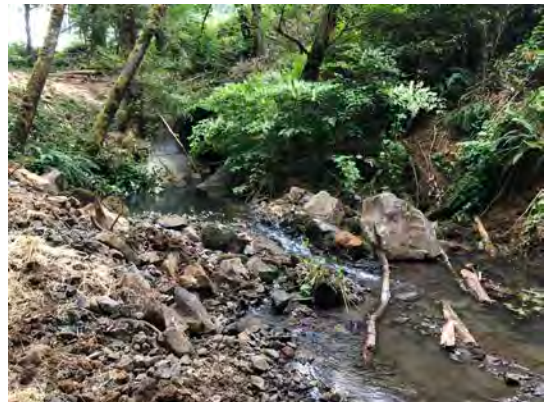
New downstream weir to back water up into culvert. Installed summer 2018

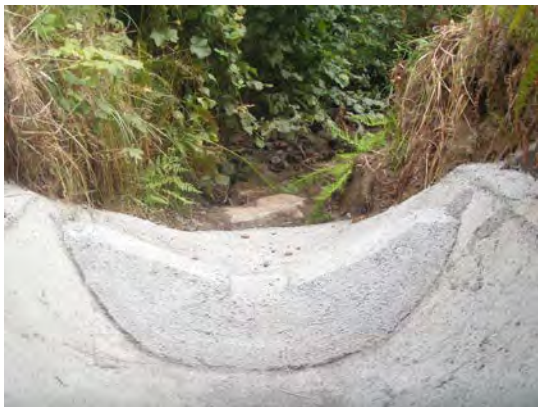
Culvert outlet looking downstream showing weir

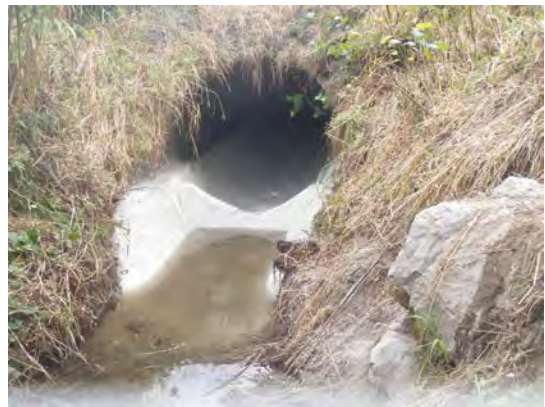
Inlet of culvert flow returning to creek

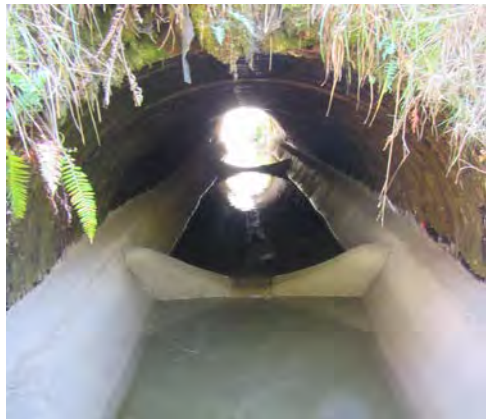
Inside Culvert showing flow returning to creek

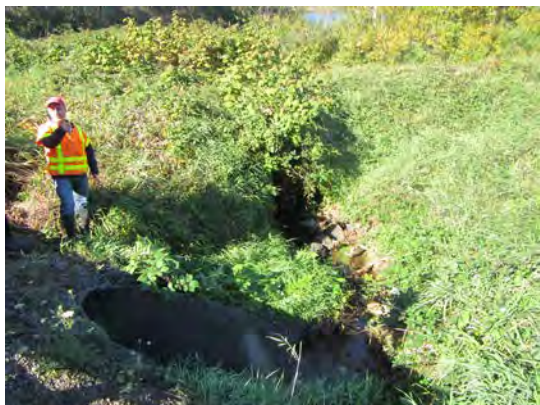
Tributary of Umpqua River OR 38 MP 6.42 – Post-construction photos

Culvert outlet looking downstream toward boulder weir

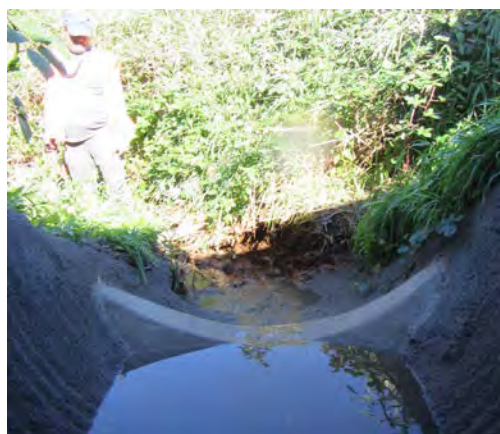
Looking downstream at outlet of culvert
