Over-Height Vehicle Collision Assessment and Repair Methodology

Tanarat Potisuk, PhD, PE, SE

Prestressed Concrete Standards Engineer

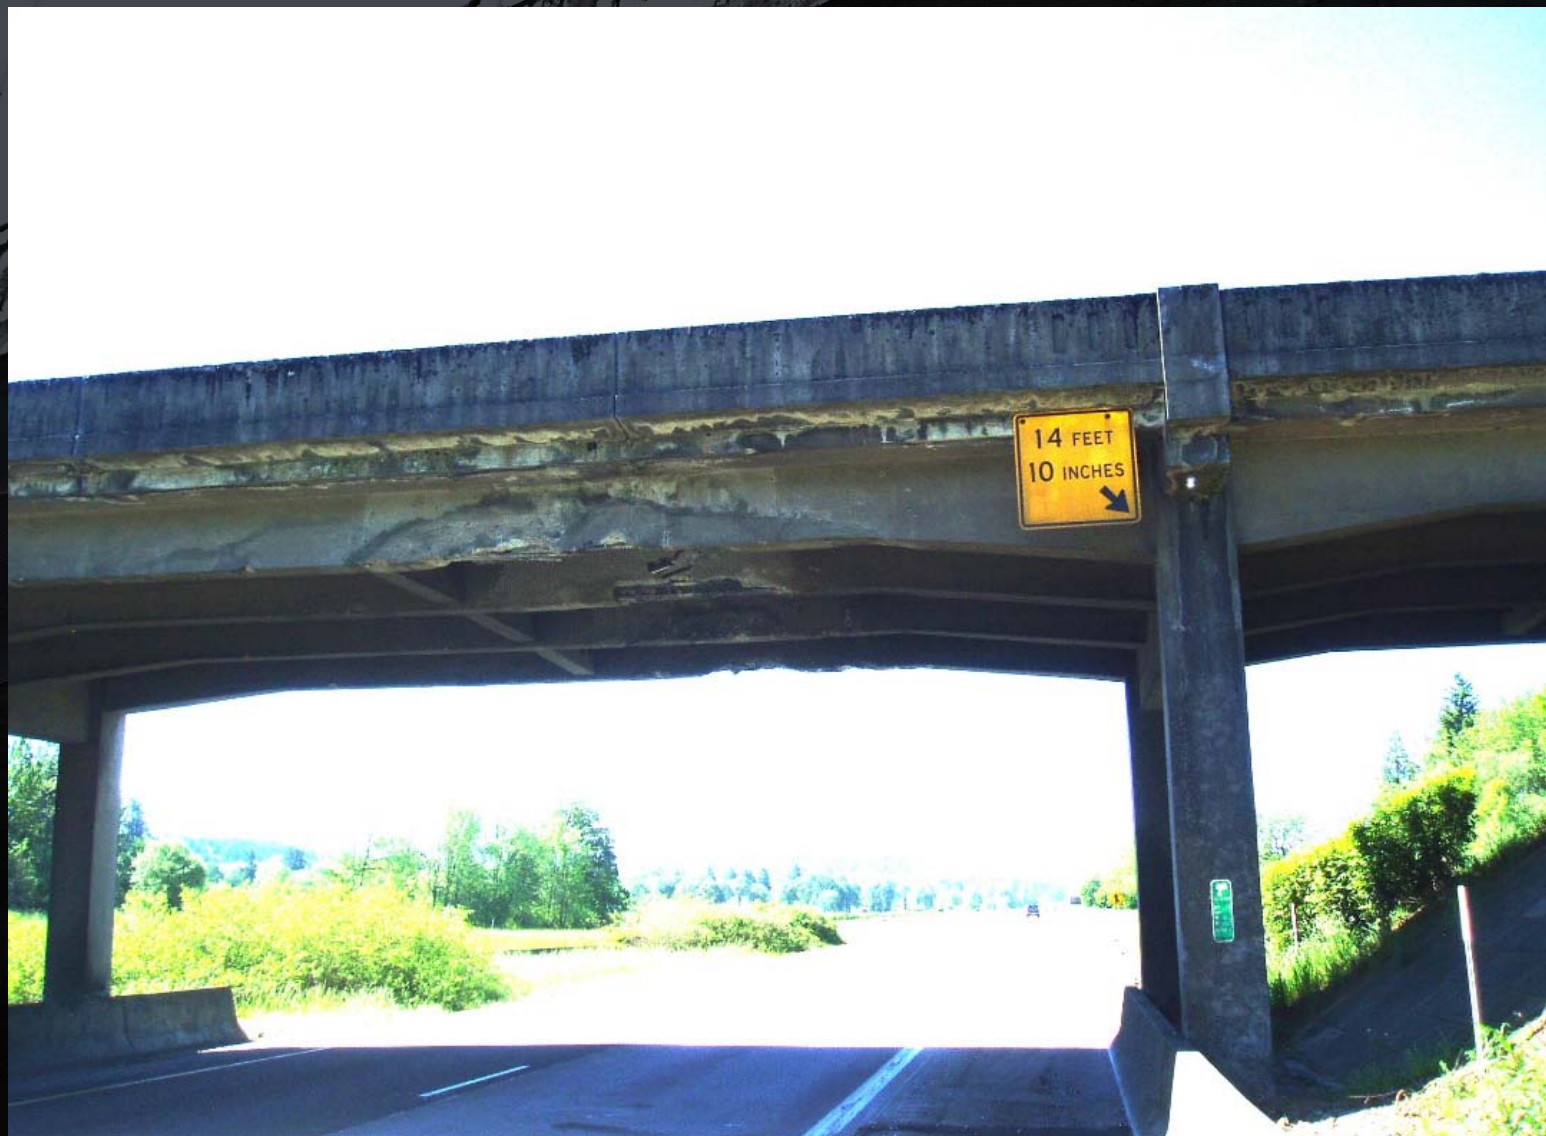
Saginaw Bridge

PAST INCIDENT – REPLACED RCDG

- 2008
- South of Eugene

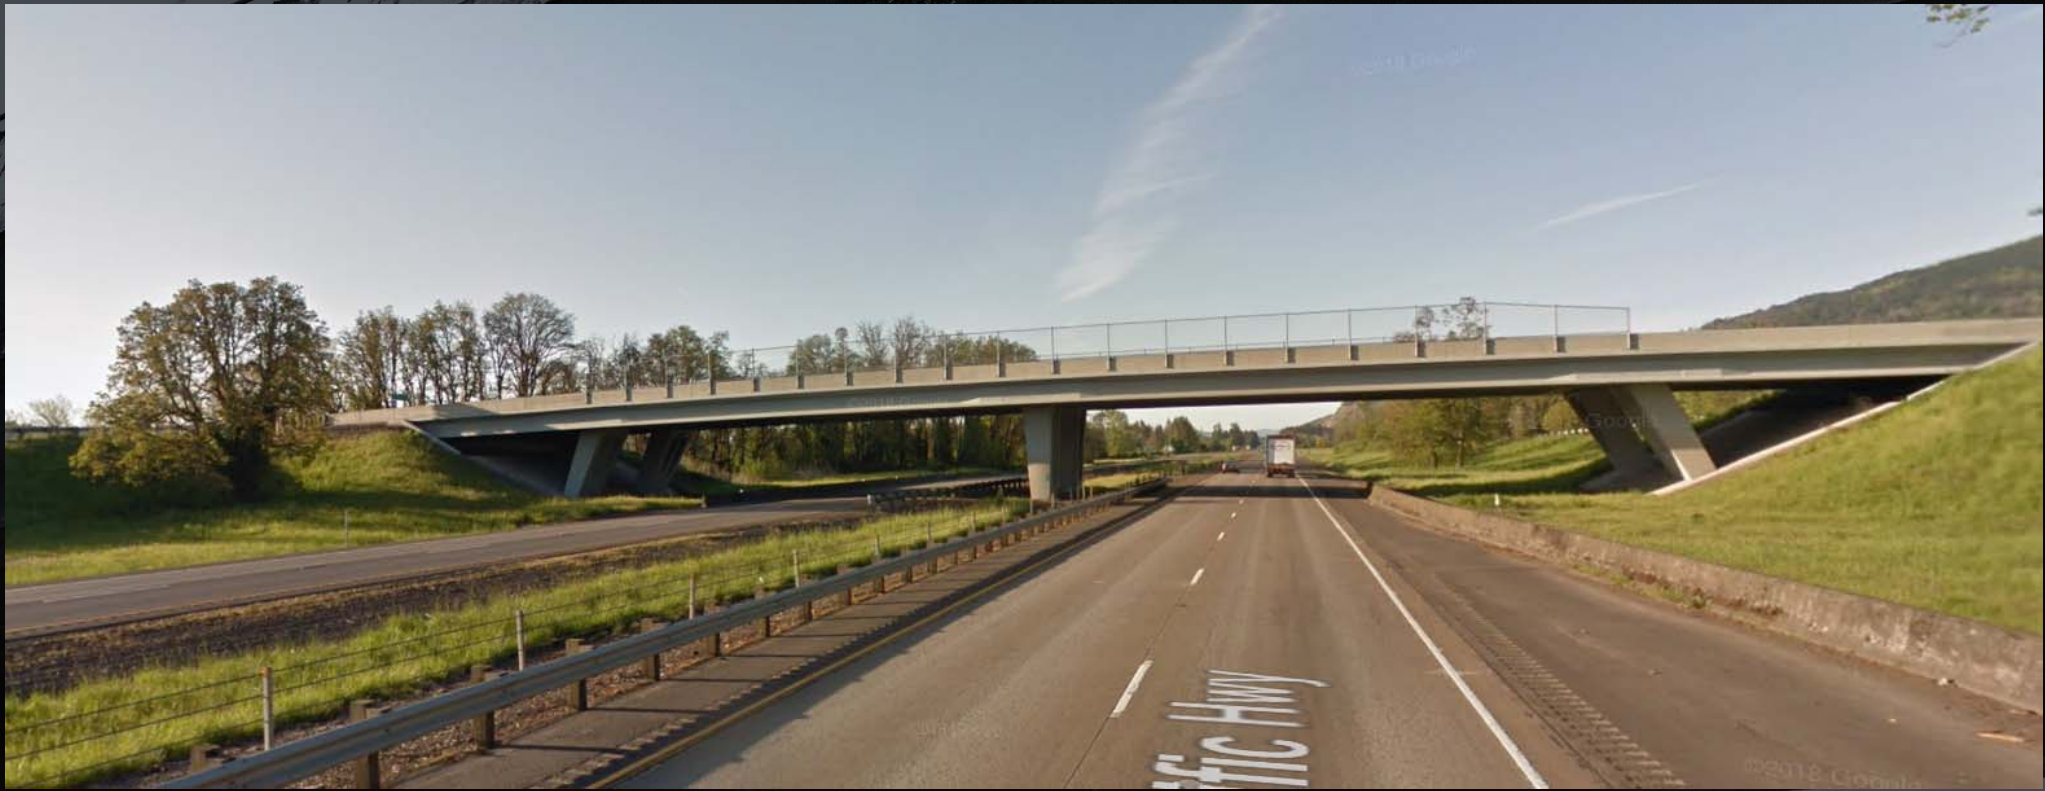
PAST INCIDENT – REPLACED RCDG

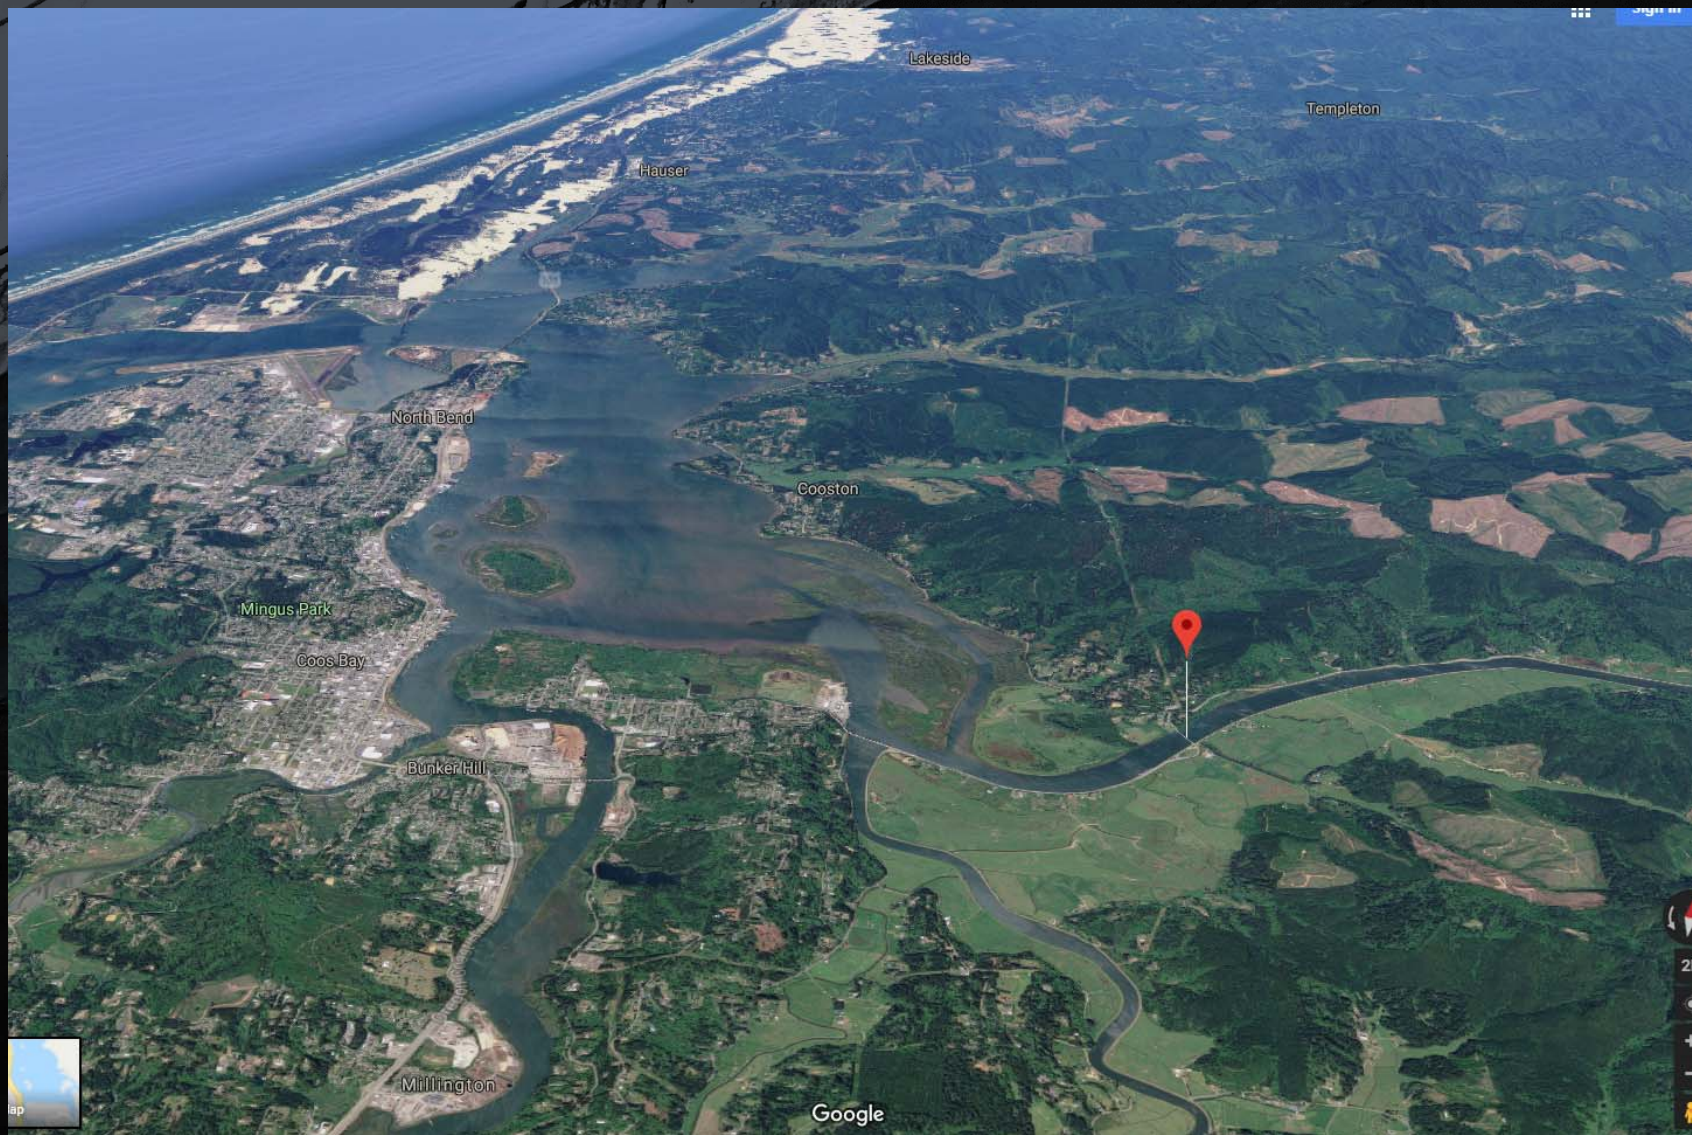
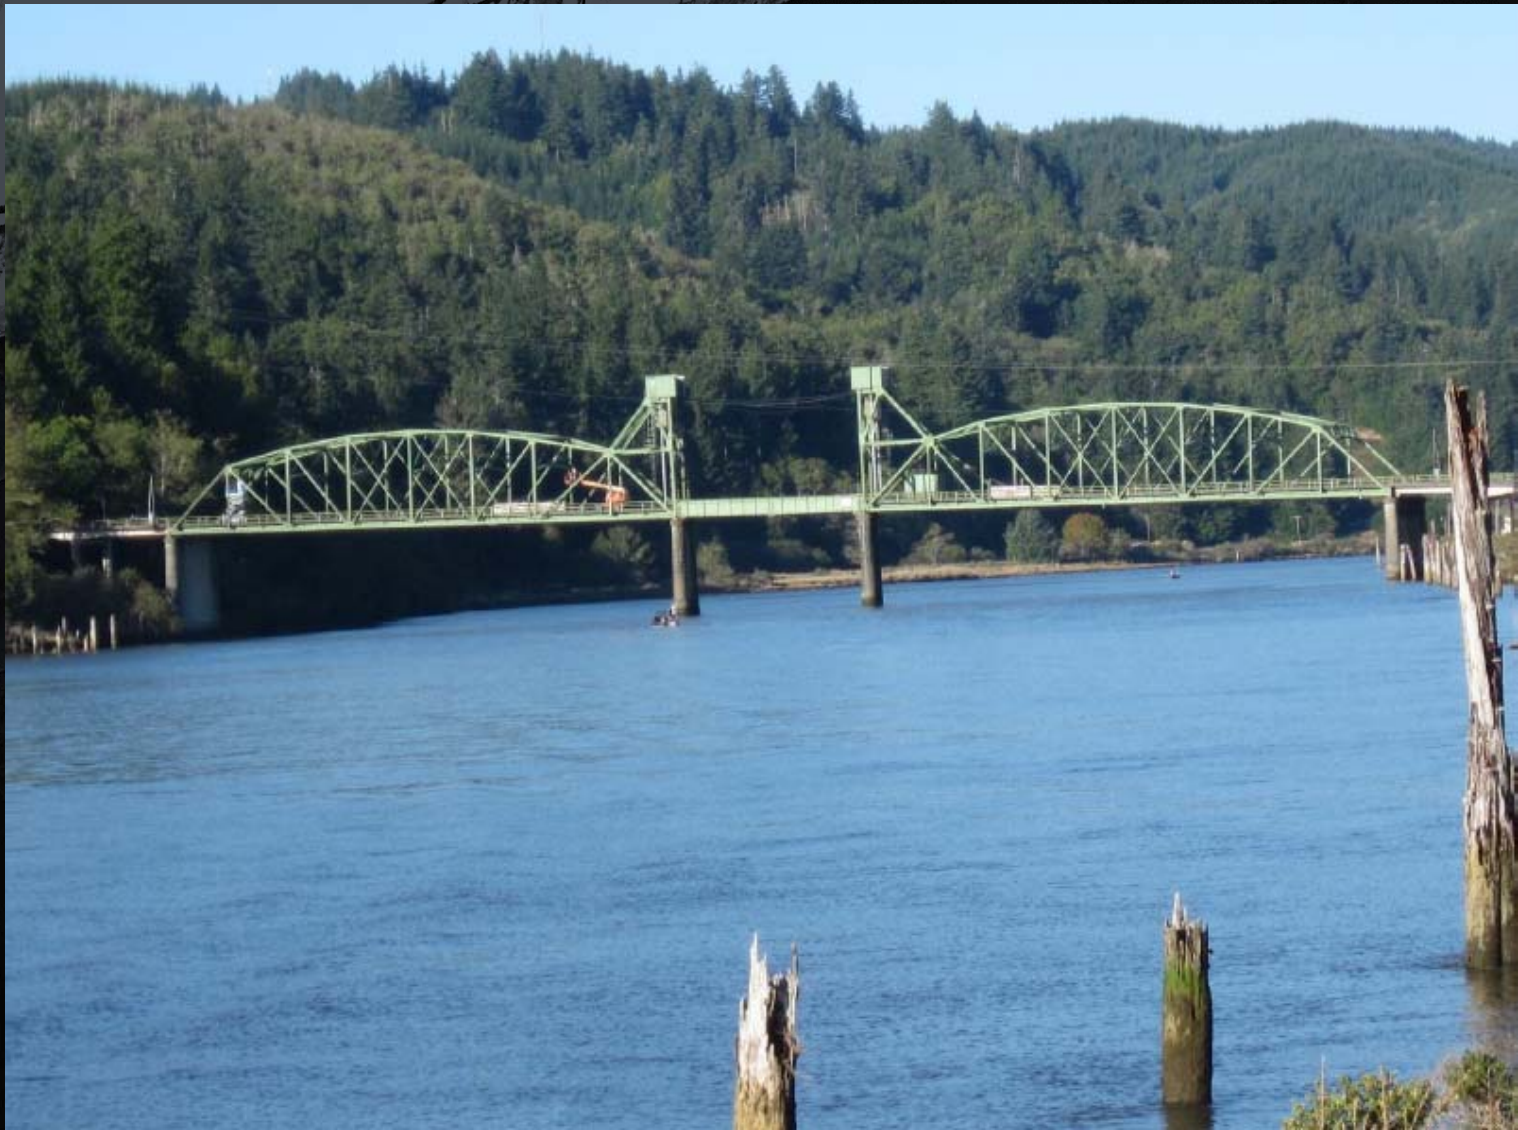
Chandler Bridge

PAST INCIDENT – REPAIR BY BOLTING

- 2013
- Coos Bay

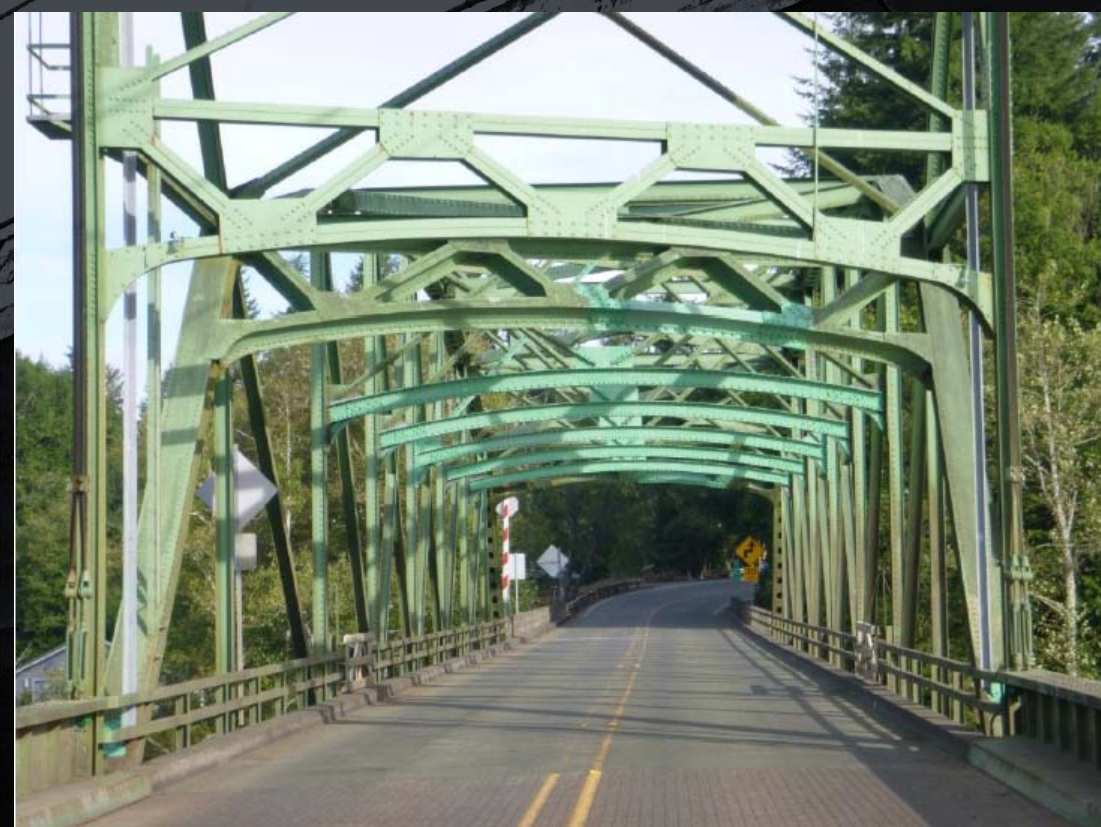
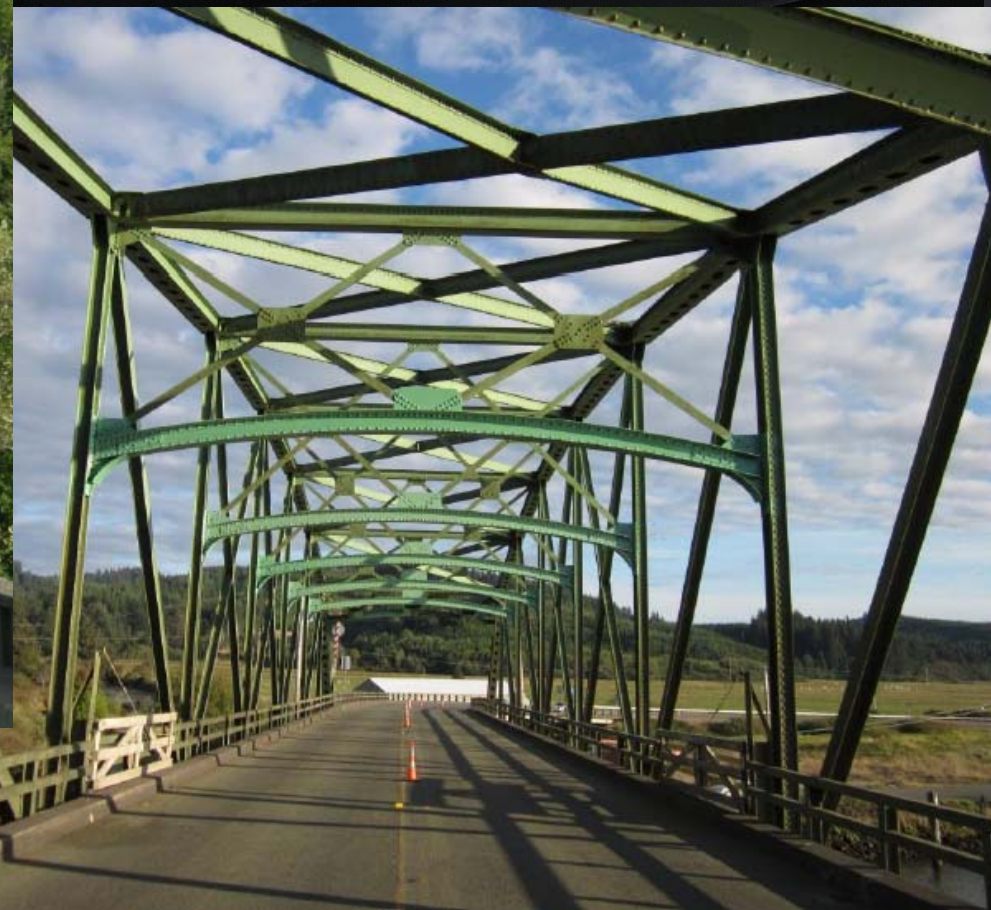
PAST INCIDENT – REPAIR BY BOLTING

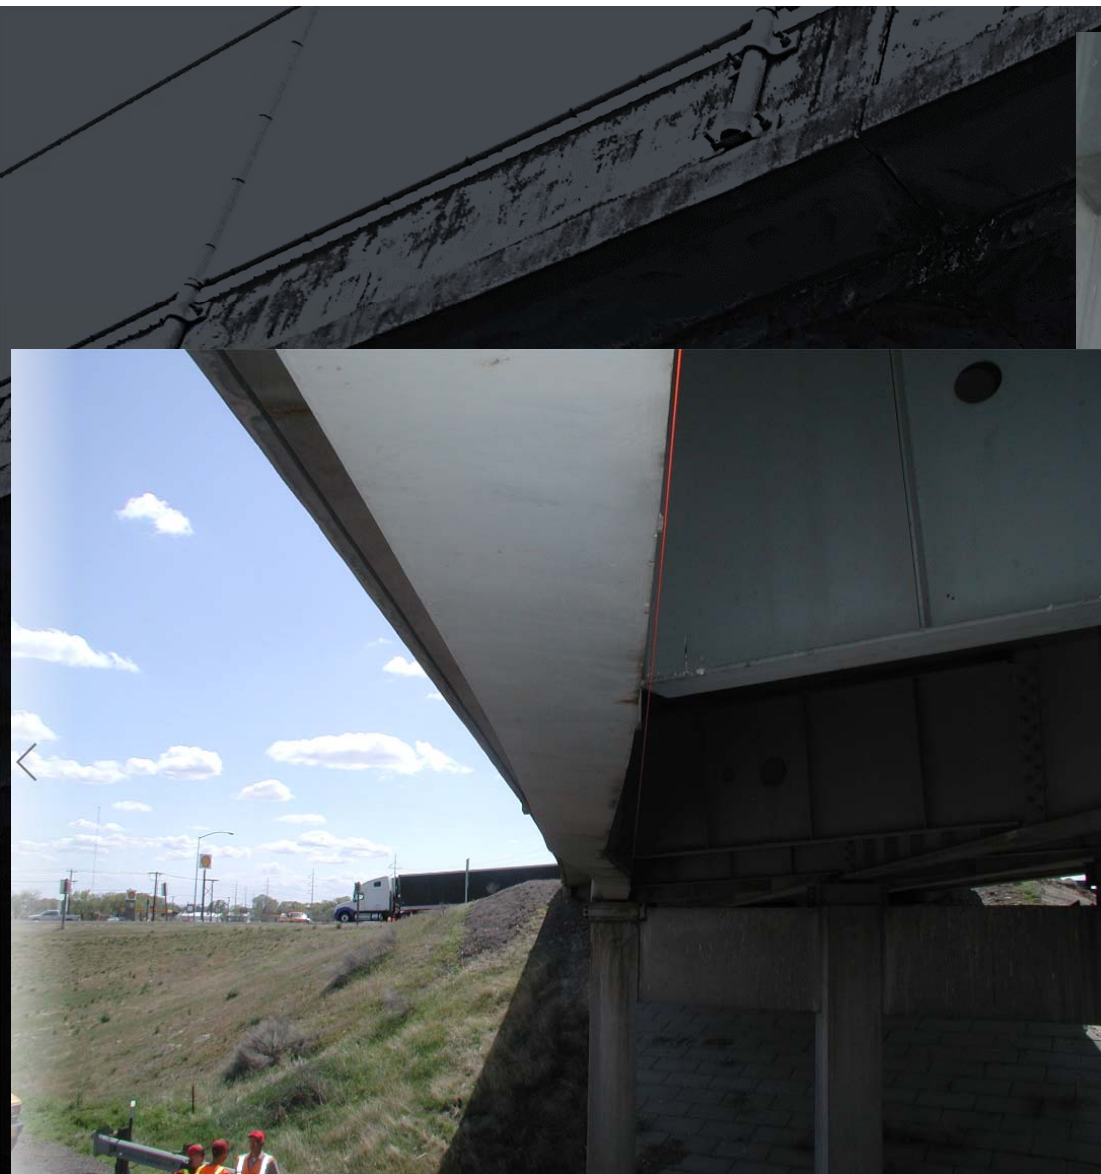
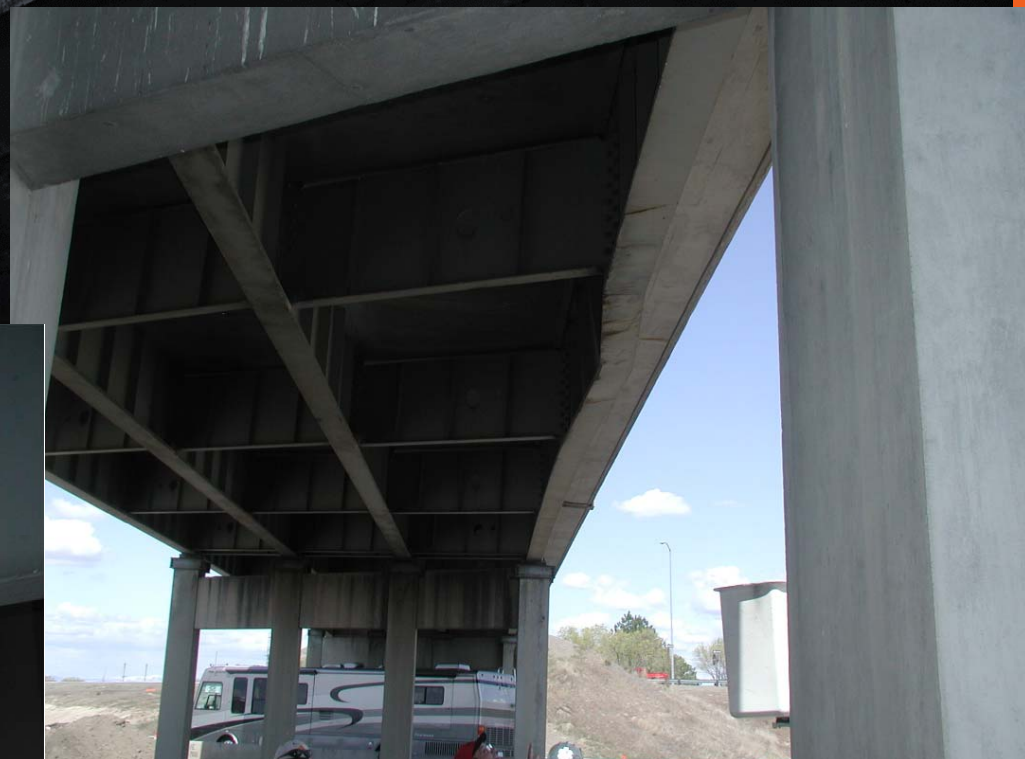
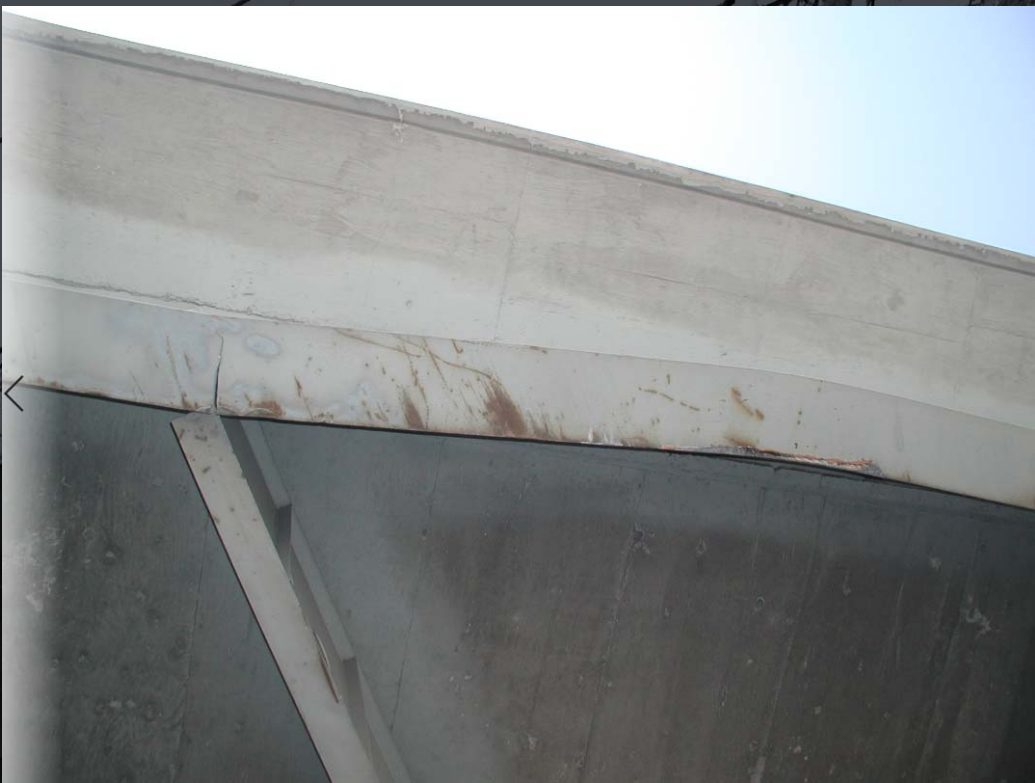
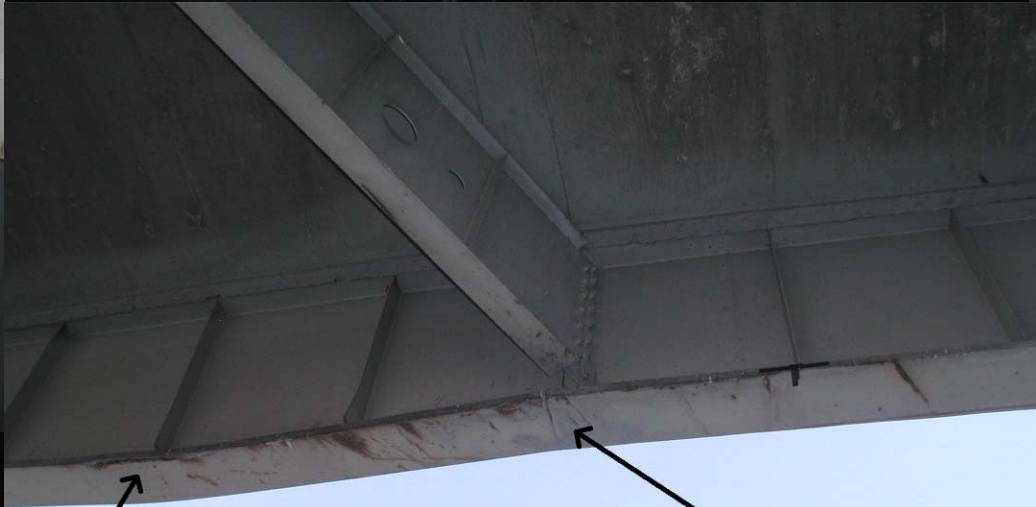
N Ontario Interchange

PAST INCIDENT – REPAIR THEN REPLACED

- 2007
- Ontario

IMPACT POINT

7/8 INCH WIDE CRACK

BR# 08635 GIRDER 1 SPAN 3 PRIOR TO REPAIR

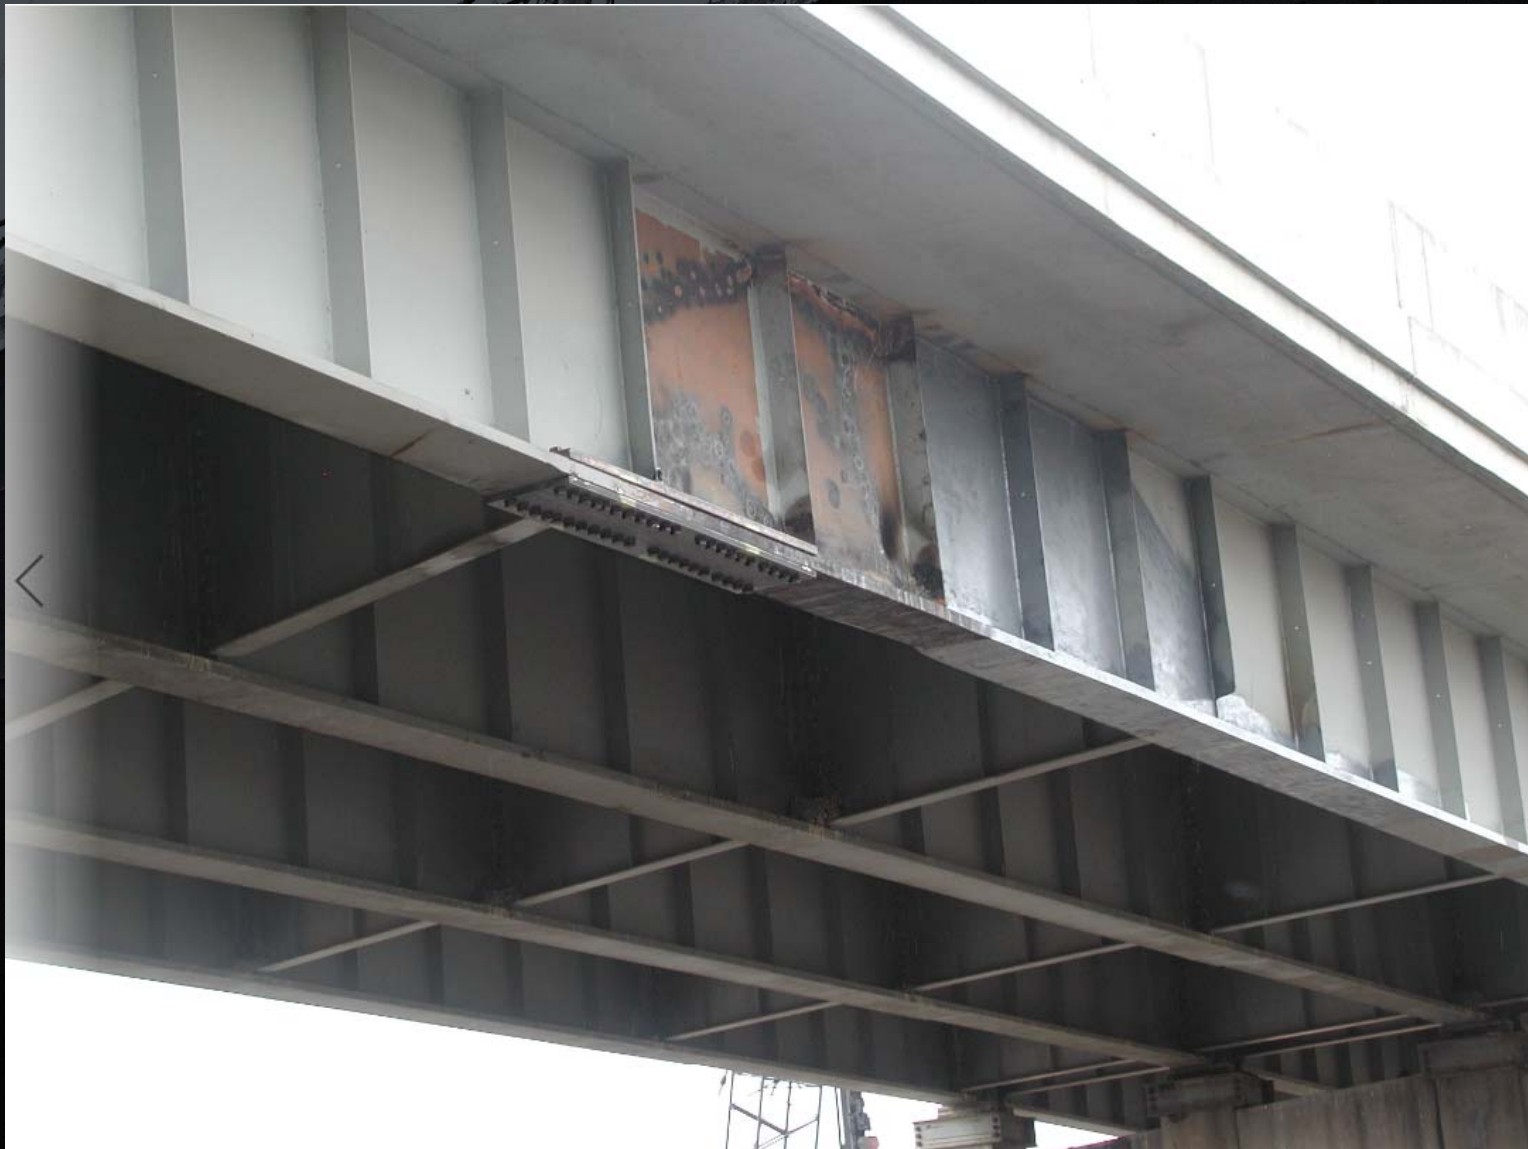
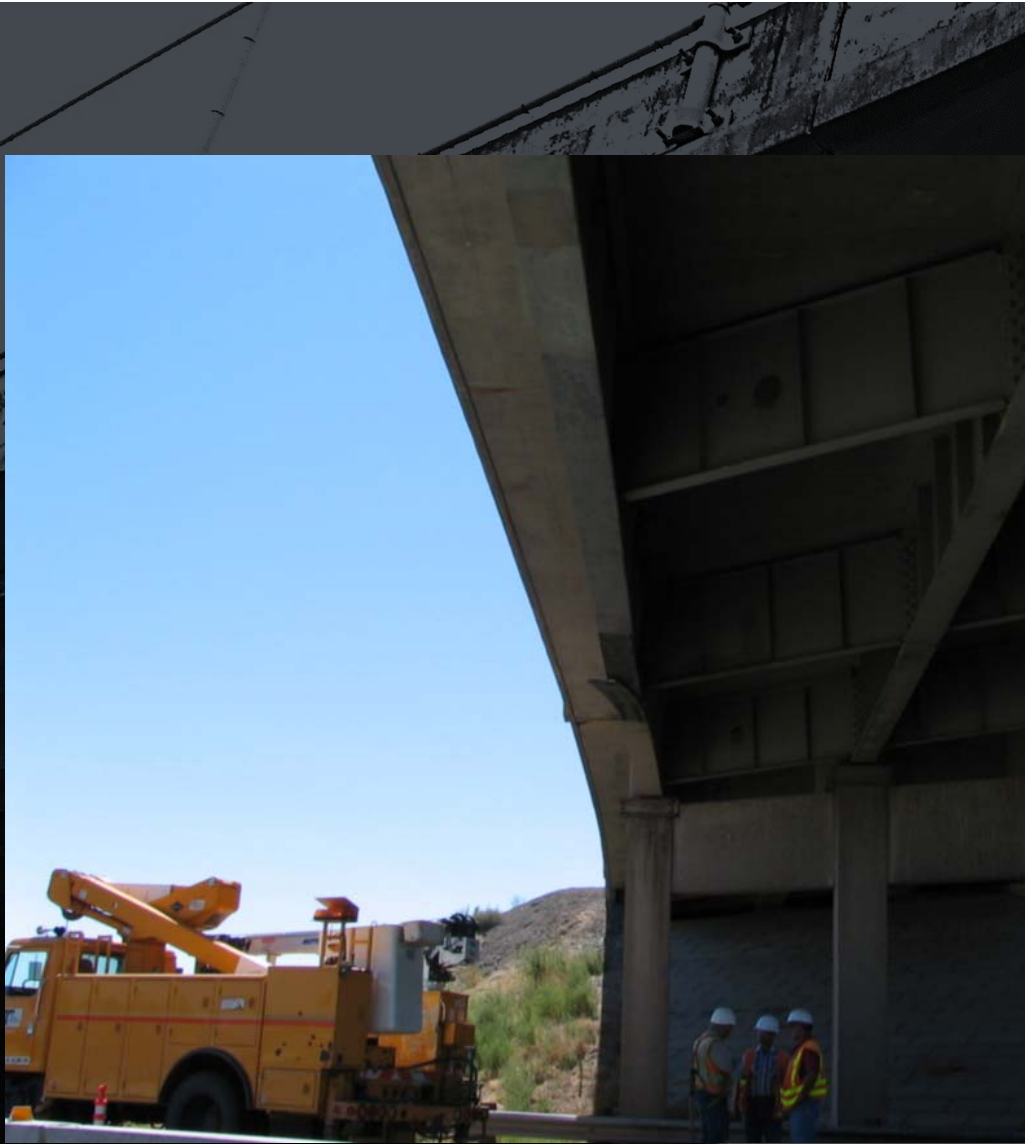
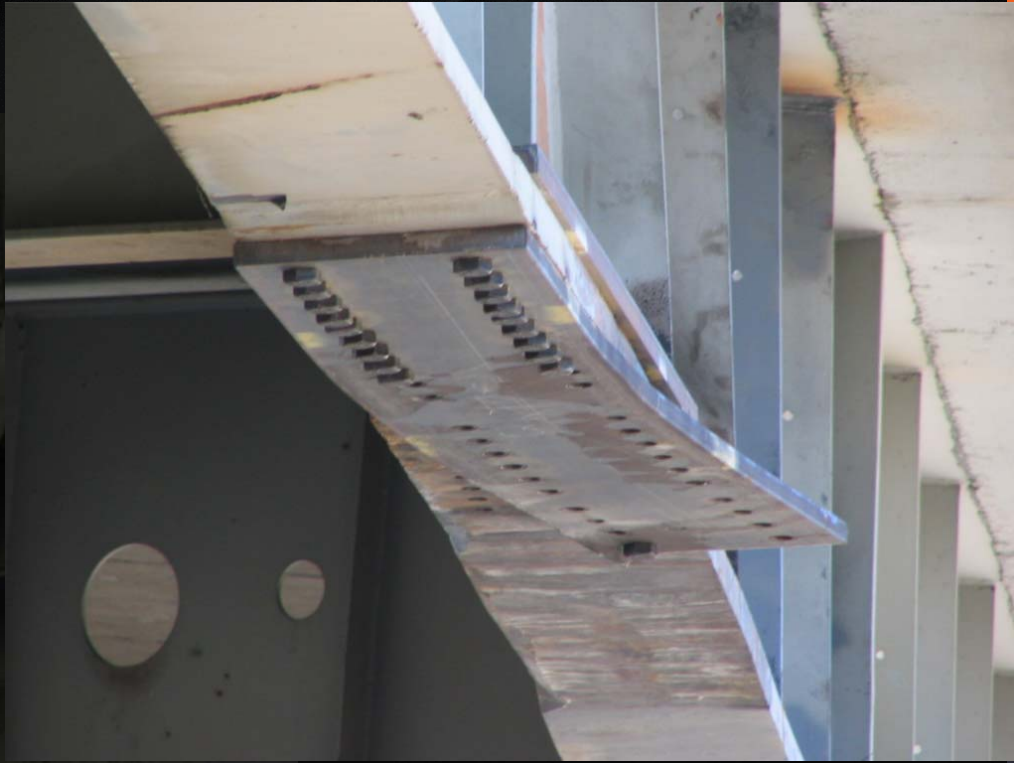
N ONTARIO I/C
BR# 20398 HWY 455 MP 25.20
RT ELEV 10/27/08
IM20398_A1.jpg

PAST INCIDENT – REPAIR THEN REPLACED
