OREGON SCHOOL FOR THE DEAF

Facilities Assessment Update 2024

BRIC ARCHITECTURE, INC. FEBRUARY 2024

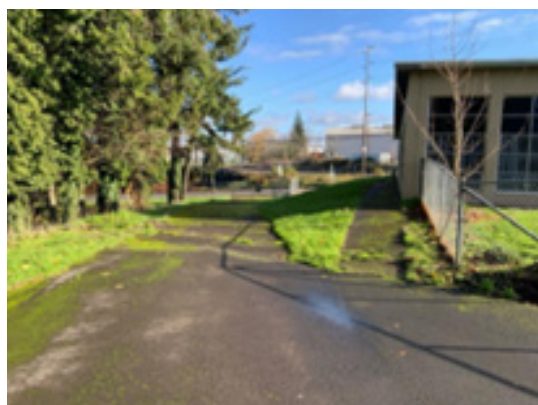
G20 Site Improvements – Deferred Maintenance

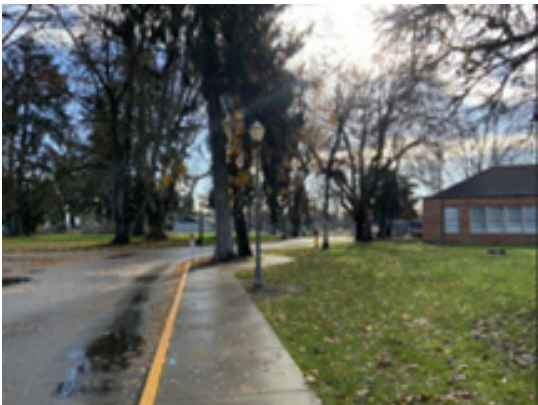
G20 Site Improvements – Deferred Maintenance

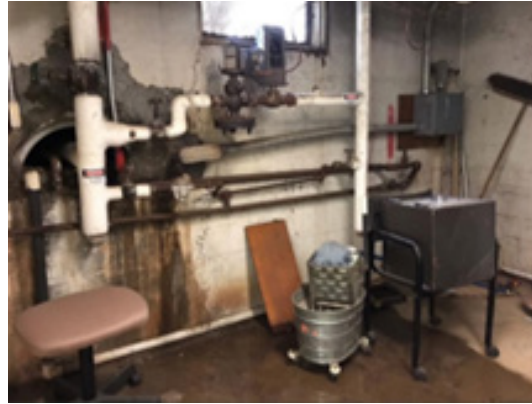
C30 Interior Finishes – Deferred Maintenance

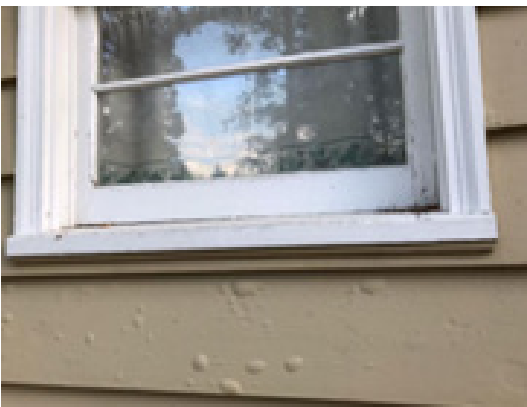
B20 Exterior Enclosure – Deferred Maintenance

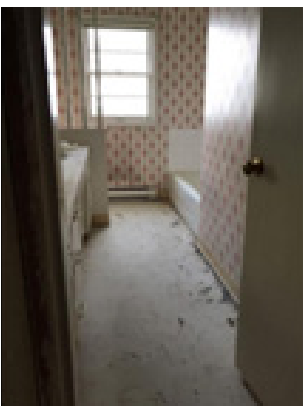
C10 Interior Construction – Accessibility

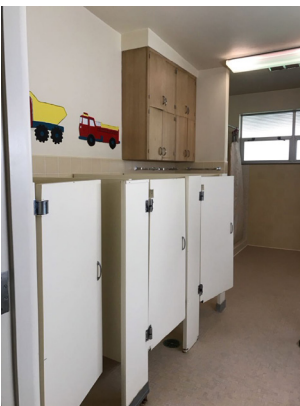
E10 Equipment – Accessibility

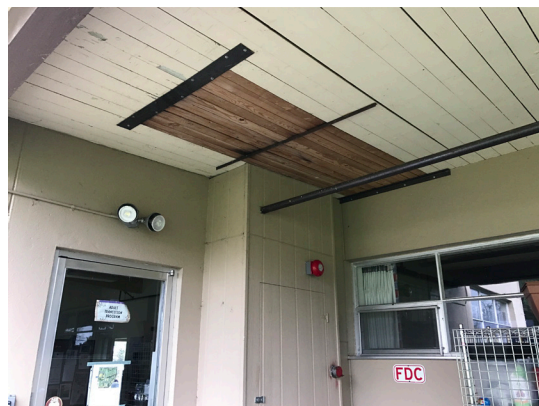
B10 Superstructure – Seismic

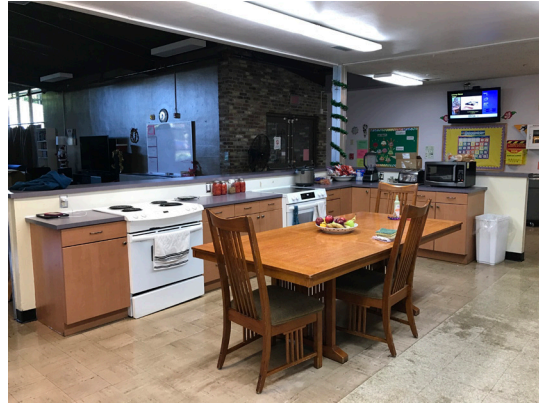
E10 Equipment – Accessibility

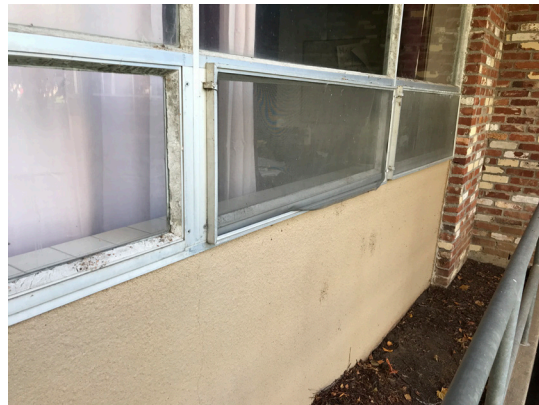
B20 Exterior Enclosure – Energy

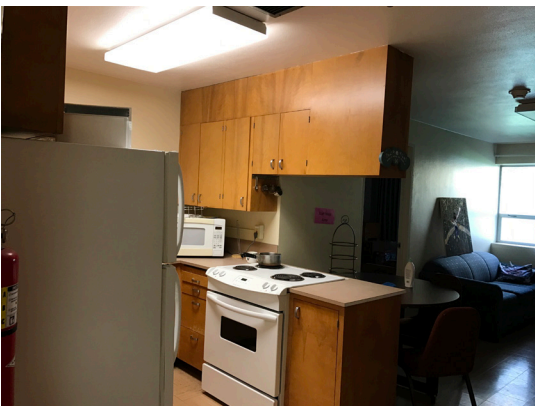
E10 Equipment – Accessibility

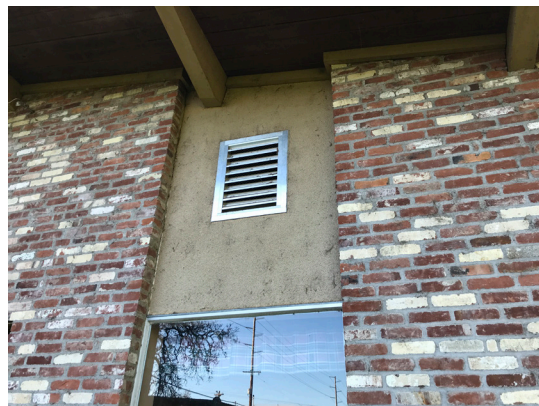
B20 Exterior Enclosure – General Maintenance

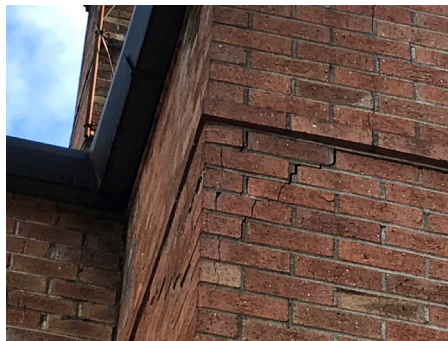
B20 Exterior Enclosure – Deferred Maintenance

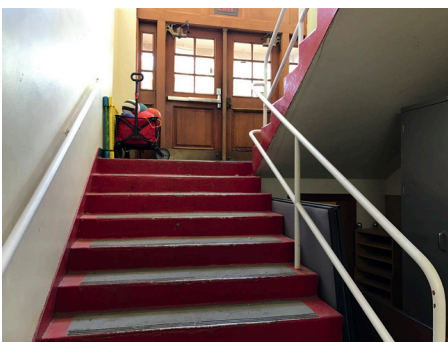
C20 Stairs – Safety

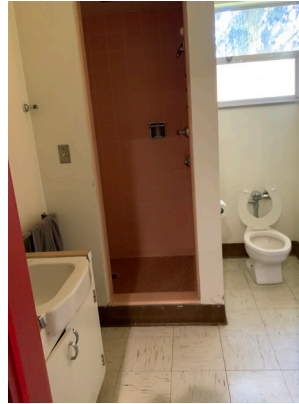
E10 Equipment – Accessibility

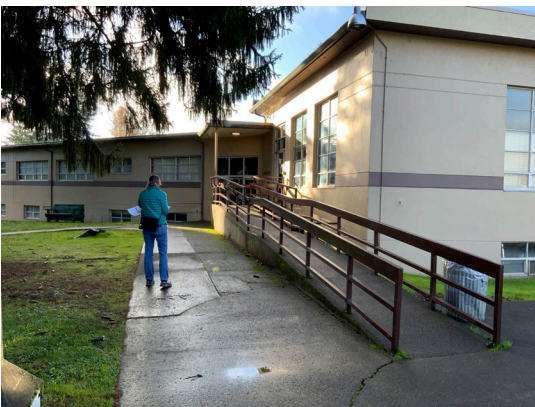
C20 Ramps – Fire Life Safety/Code (Accessibility)

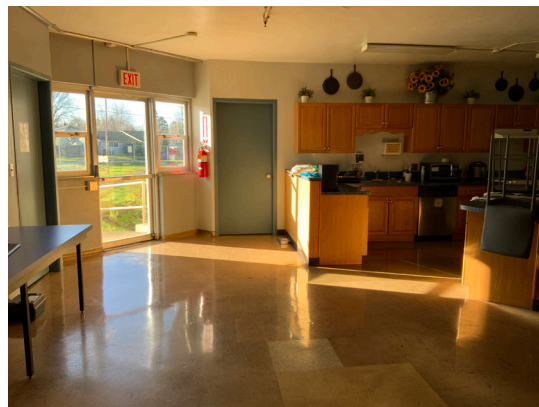
E10 Equipment – Accessibility

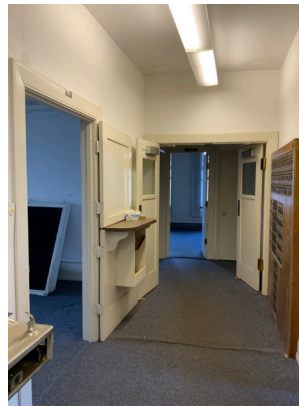
C30 Interior Finishes – Deferred Maintenance

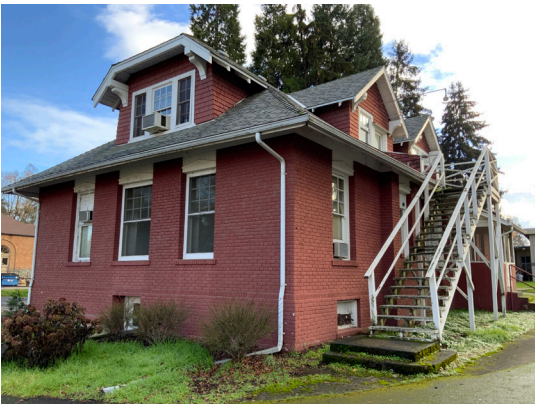
C20 Stairs – Fire Life Safety/Code (Accessibility)

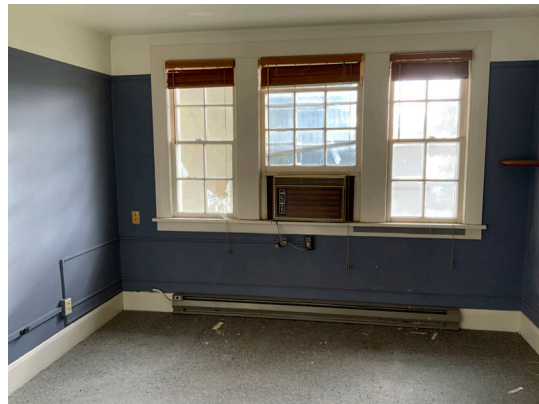
C30 Interior Finishes – Deferred Maintenance

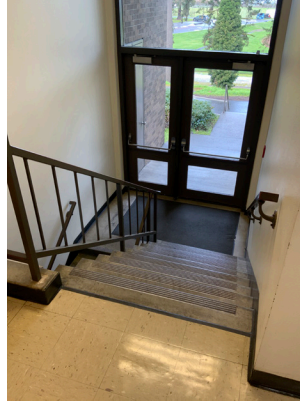
C20 Stairs – Safety

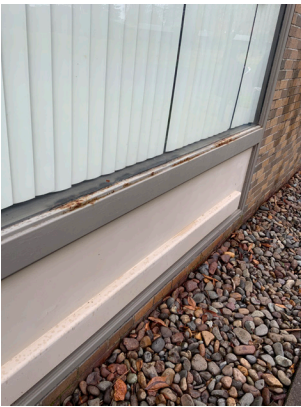
B20 Exterior Enclosure – Energy

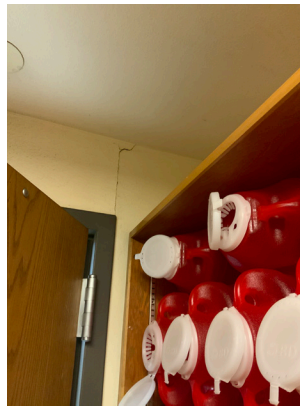
B10 Superstructure – Safety

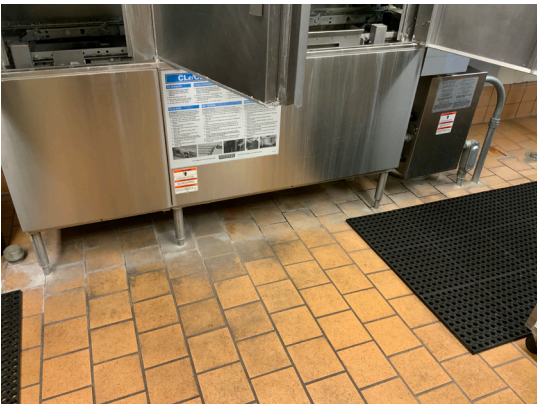
C30 Interior Finishes – General Maintenance

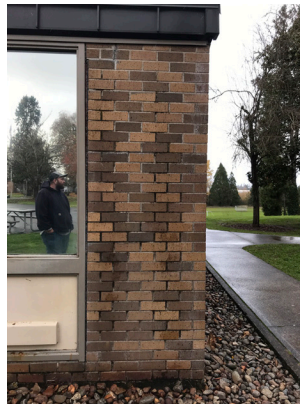
B10 Superstructure – Safety

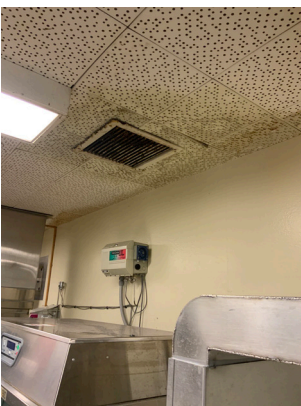
D30 HVAC Systems – Deferred Maintenance

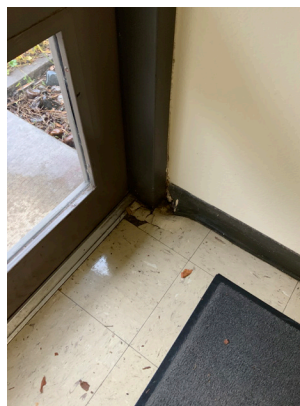
B10 Superstructure – Safety

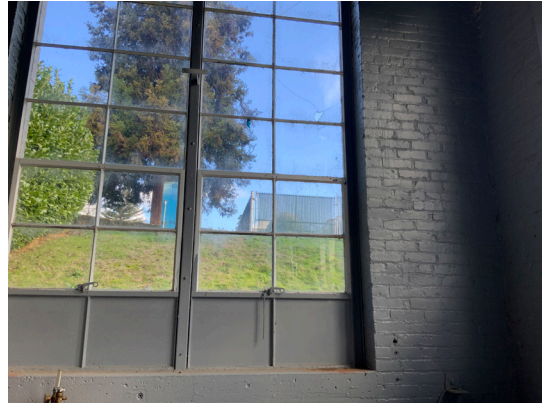
B20 Exterior Enclosure – Energy

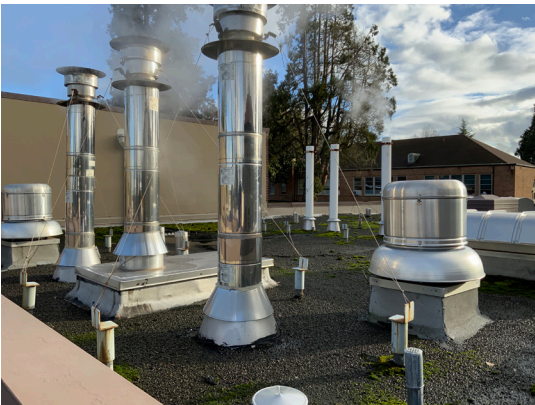
B30 Roofing – Deferred Maintenance

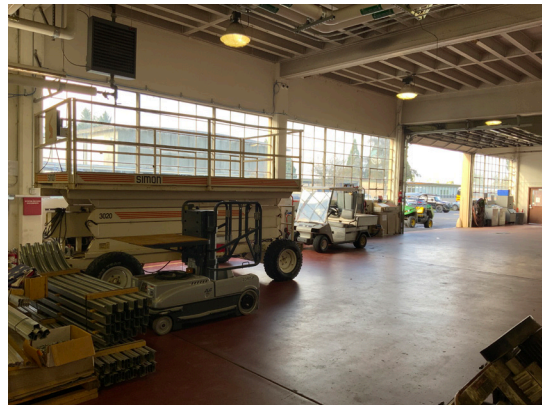
B20 Exterior Enclosure – Energy

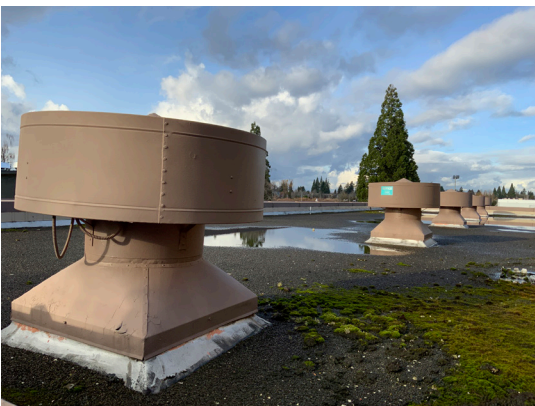
B30 Roofing – Deferred Maintenance

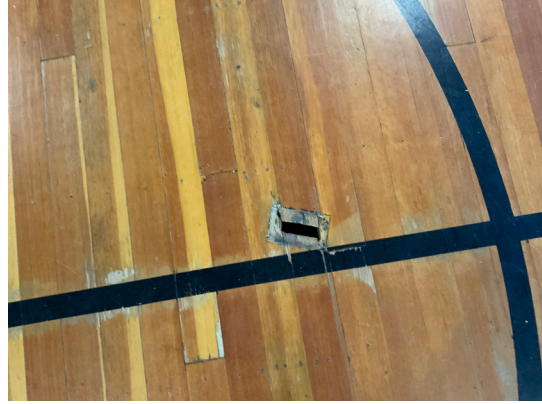
C30 Interior Finishes – General Maintenance

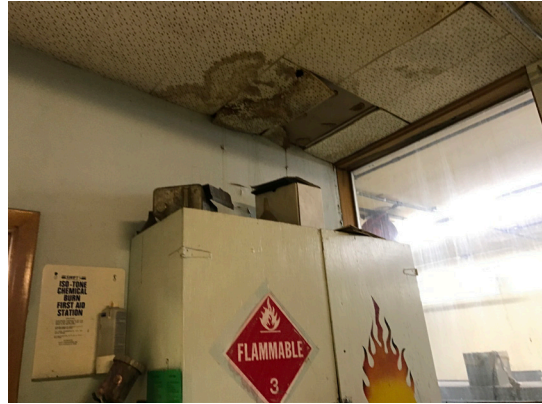
B20 Exterior Enclosure – Deferred Maintenance

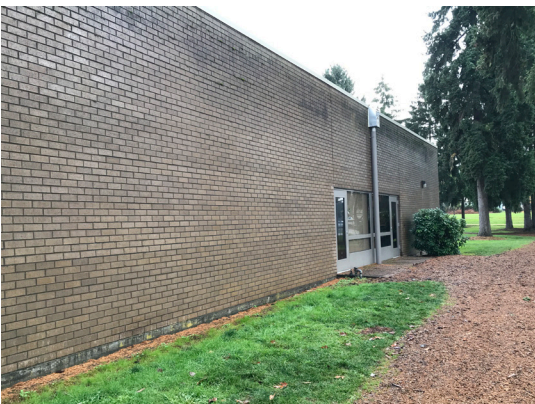
B30 Exterior Enclosure – General Maintenance

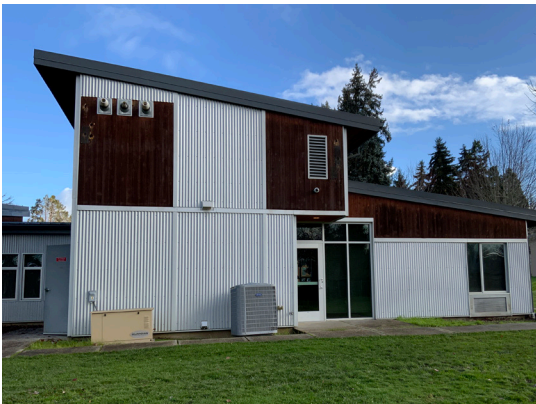
B20 Exterior Enclosure – Deferred Maintenance

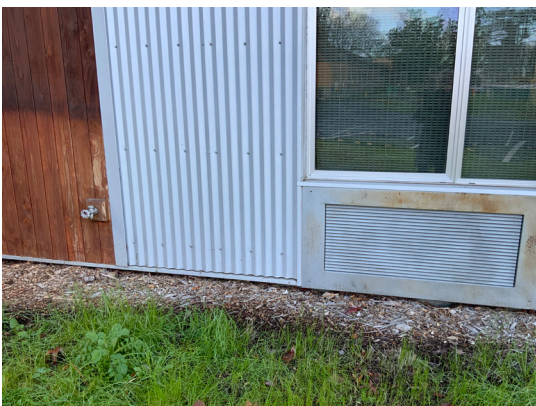
B20 Exterior Enclosure – Deferred Maintenance

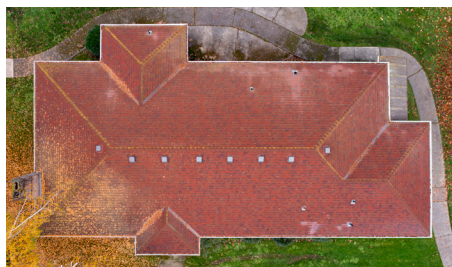
#1 CARPENTER HOUSE

Type Composition Shingle

Age 15-20 years old

Findings Plan to replace in next 10 years.

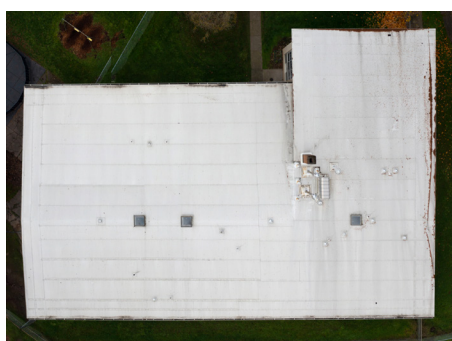
#2 WALLACE HALL

Type Single Ply Membrane

Findings Plan to replace in next 10 years.

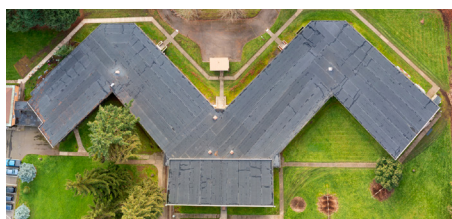
#5 LINDSTROM HALL

Type Built up

Findings May have concealed layers of asbestos roofing. Plan to replace in next 10 years.

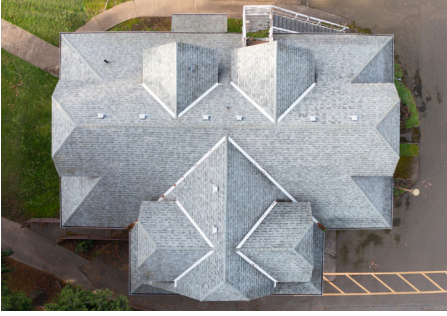
#6 TILLINGHAST BUILDING

Type Composition Shingle

Age 18-20 years old

Findings Plan to replace in next 10 years.

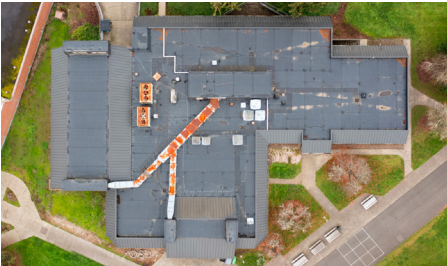
#7 CLATTERBUCK BUILDING

Type Single Ply Membrane

Age Replaced in 2020

Findings Standing Seam Metal perimeter Mansard Roof. Original. Good condition.

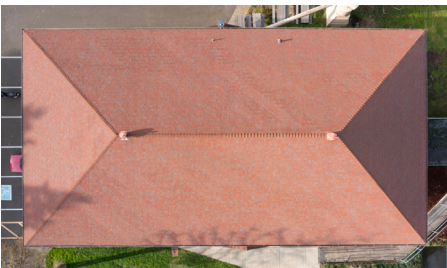
#9 HOKANSON GYM

Type Composition Shingle

Findings Plan to replace in next 10 years.

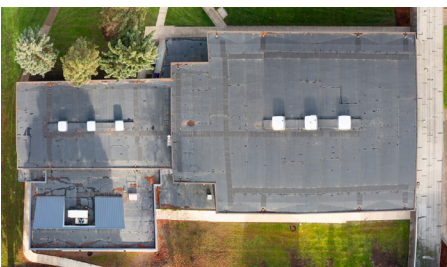
#11 PECK GYM

Type Single Ply Membrane

Age Replaced in 2020

Findings New at locker room addition in 2020. Good condition.

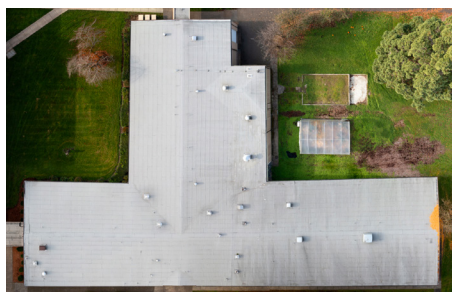
#12 ULMER BUILDING

Type Built-up Roofing

Age 13-14 years old

Findings Plan to replace in next 10 years.

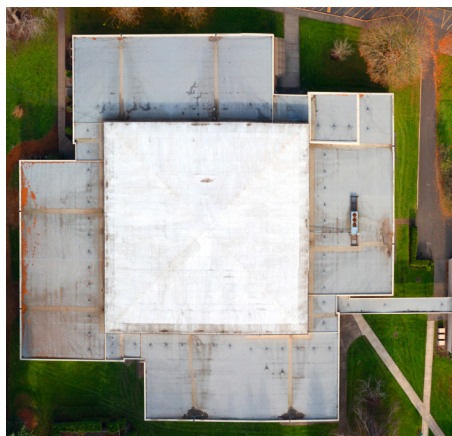
#13 SMITH BUILDING

Type Built-up Roofing

Lower Roof over Classrooms & Admin 5 years old

Findings Plan to replace in next 15-20 years.

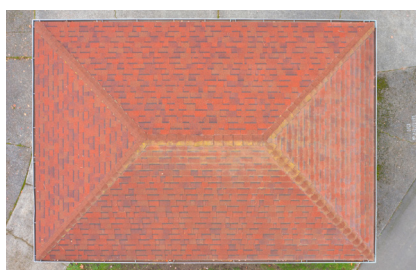
#14 GARAGE BUILDING (NEXT TO CARPENTER HOUSE)

Type Composition Shingle

Age 15-20 years old

Findings Plan to replace in next 10 years along with Carpenter House.

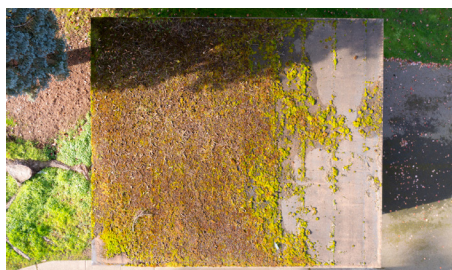
#16 CARPORT (NEXT TO TILLINGHAST BUILDING)

Type Composition Roll

Age Unknown

Findings End of life.

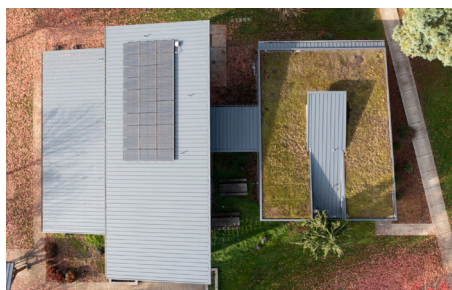
#17 NEW DORMITORY BUILDING

Type Standing Seam Metal & Green Roof

Findings Good condition.
